OCCURRENCE AND REMEDIATION OF COAL MINE BUMPS: A HISTORICAL REVIEW

By Anthony T. Iannacchione¹ and Joseph C. Zelanko²

Pittsburgh Research Center, U.S. Bureau of Mines, Pittsburgh, PA.

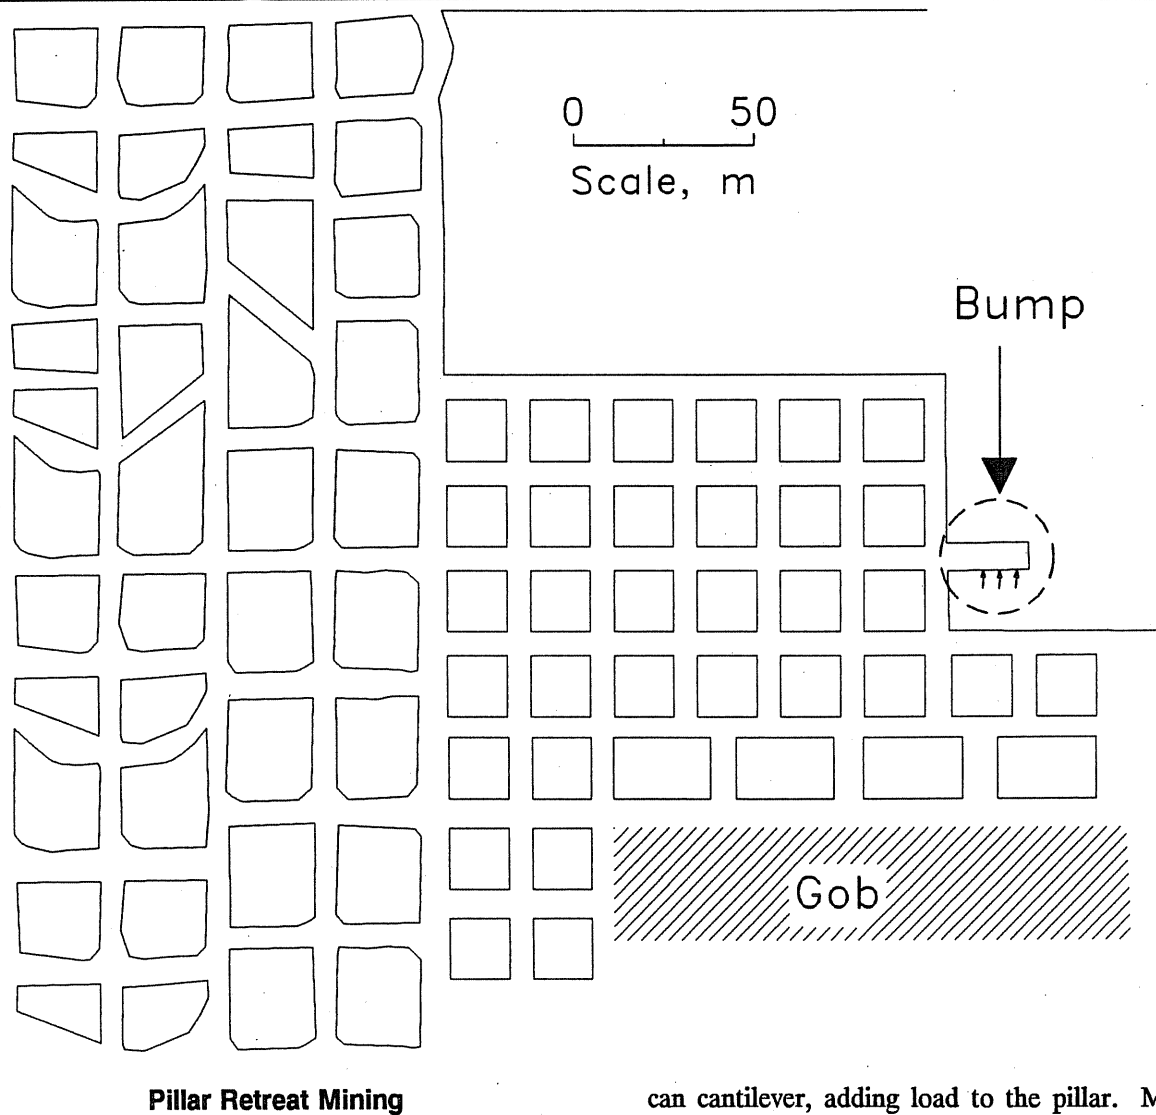
At the Beatrice Mine, development work was underway in the No. 9 unit section off the Skip South Mains, approximately 70 m from an adjacent gob area (figure 6), when there was a violent bump in the face area on July 24, 1976, that injured three miners. Abutment loading from the adjacent gob area may have contributed to the bump. Therefore, this event could be explained as resulting from the barrier-splitting operations. However, because the gob

Figure 6
Violent Bump During Development of Pillar Section Within Beatrice Mine That Injured Three Miners.

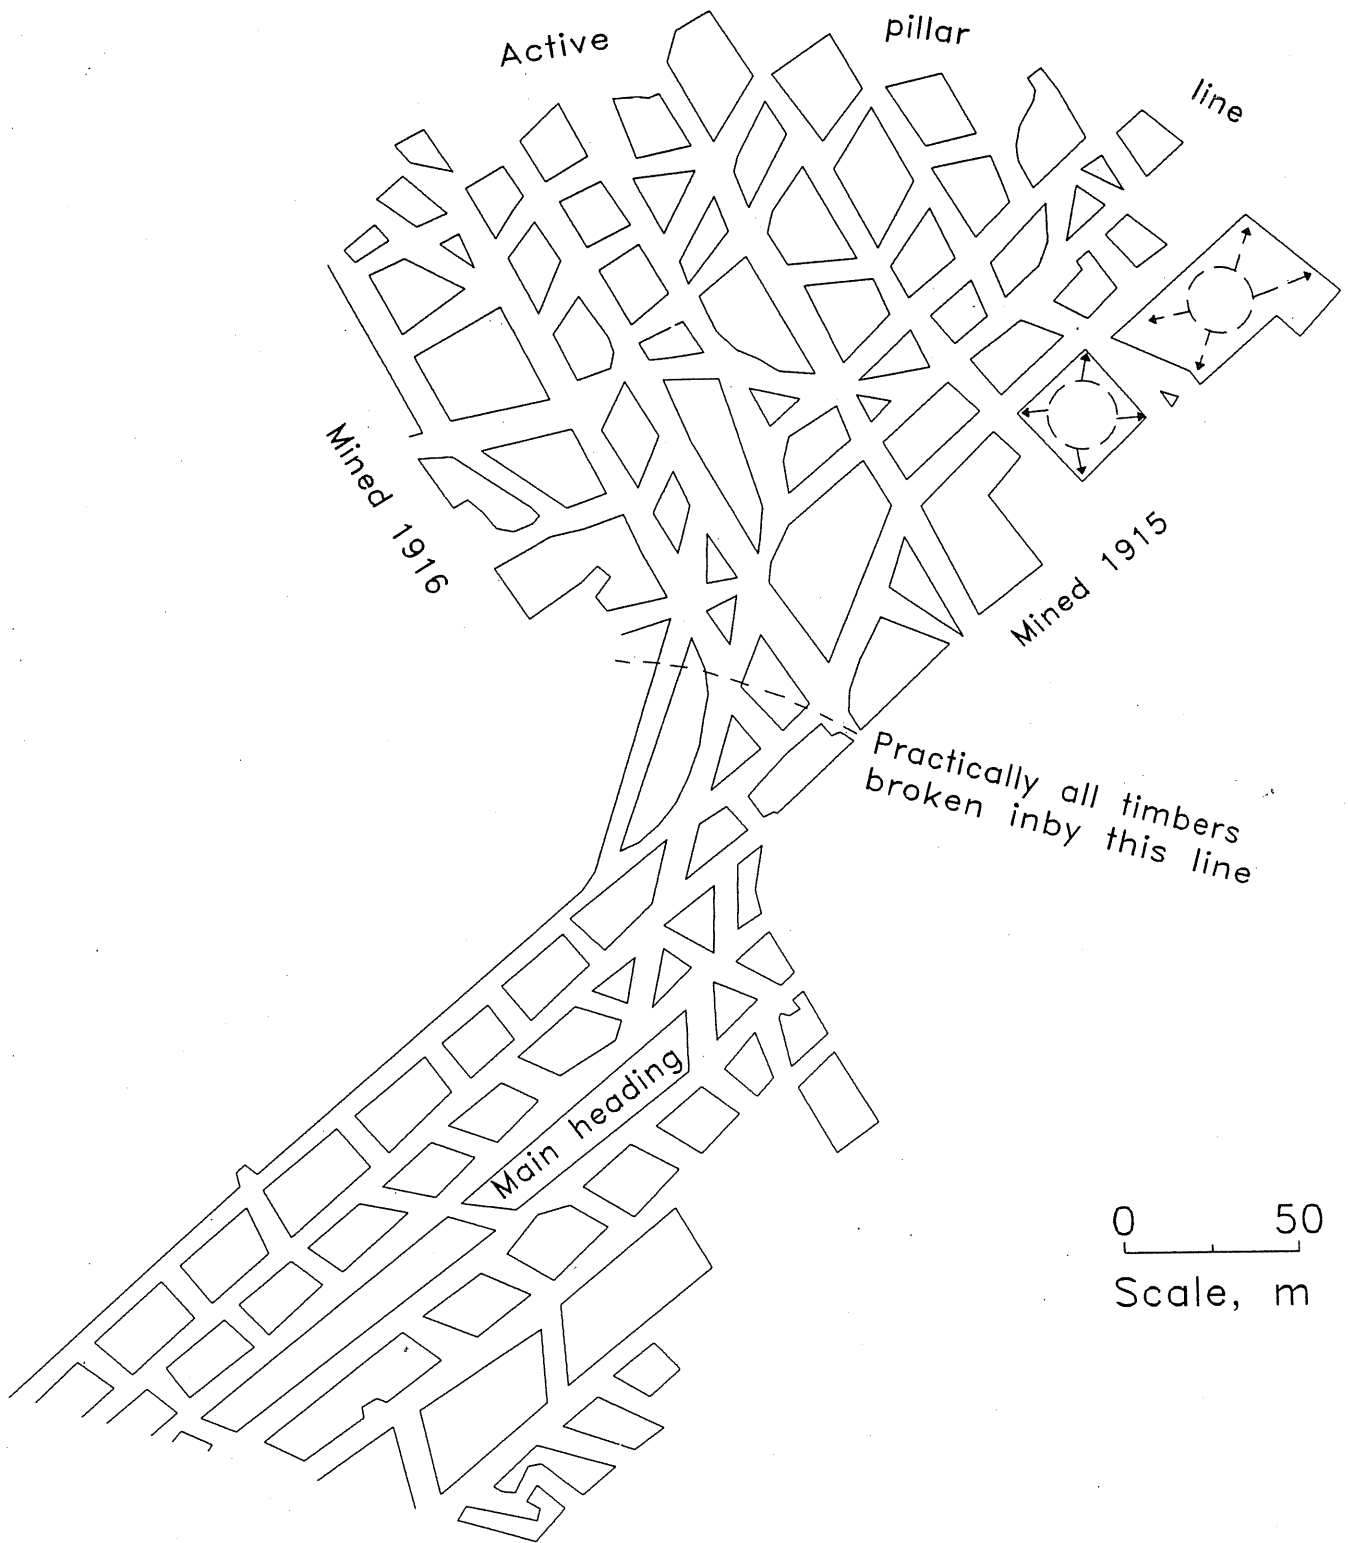
Figure 9
Fatal Pillar Retreat Coal Bump at Gary No. 2 Mine, February 16, 1951.

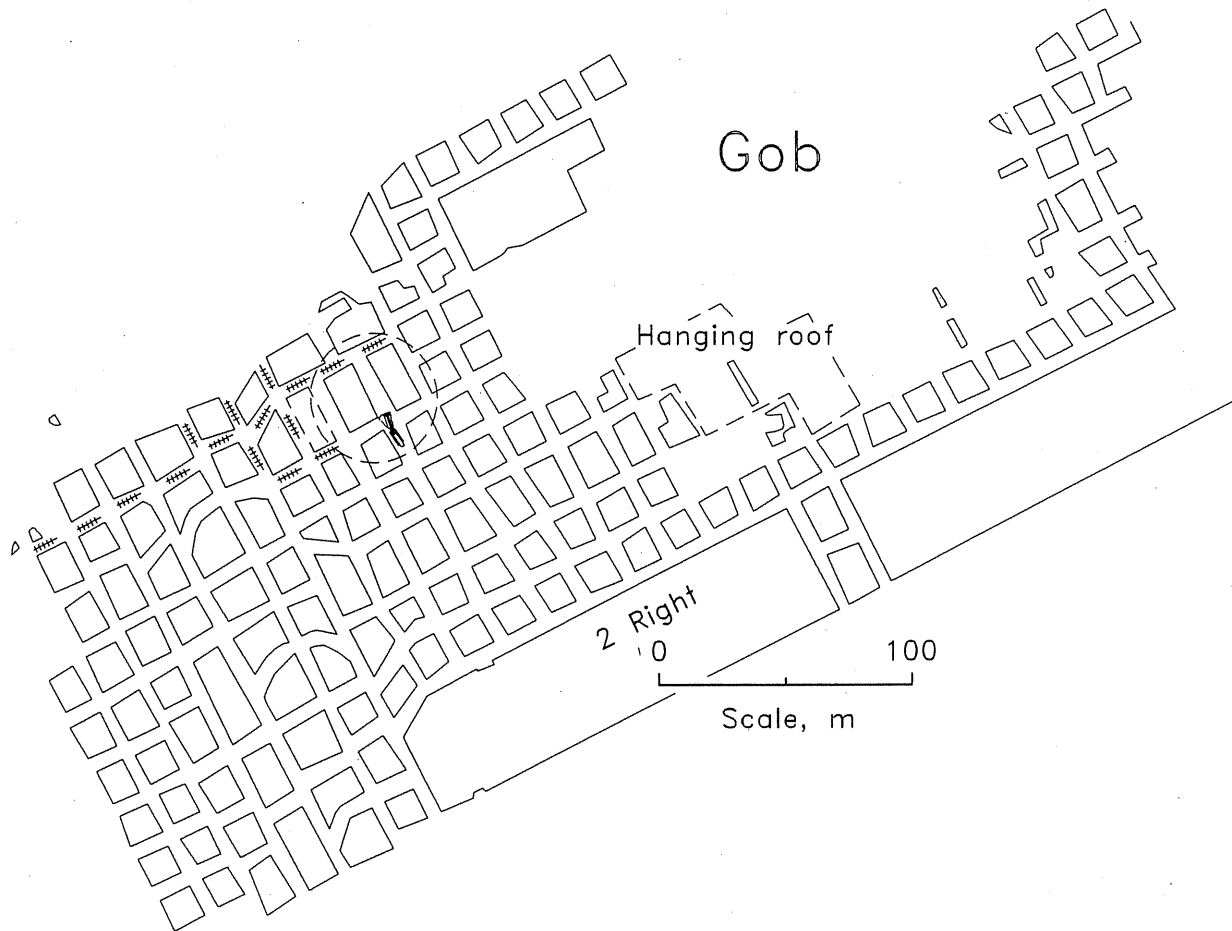
Figure 10

Effects of Pillar Remnants and Hanging Roof Strata on Pillar Retreat Bump at Moss No. 2 Mine, August 4, 1960.

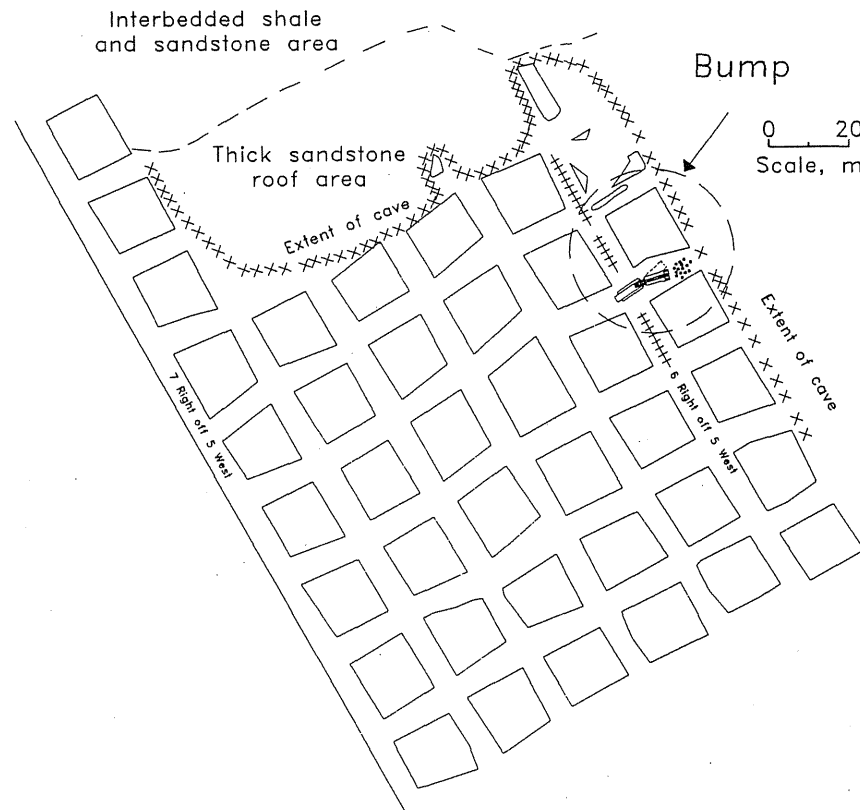
Figure 11
Effects of Roof Strata Characteristics on Pillar Retreat Bump at Moss No. 2 Mine, December 12, 1967.

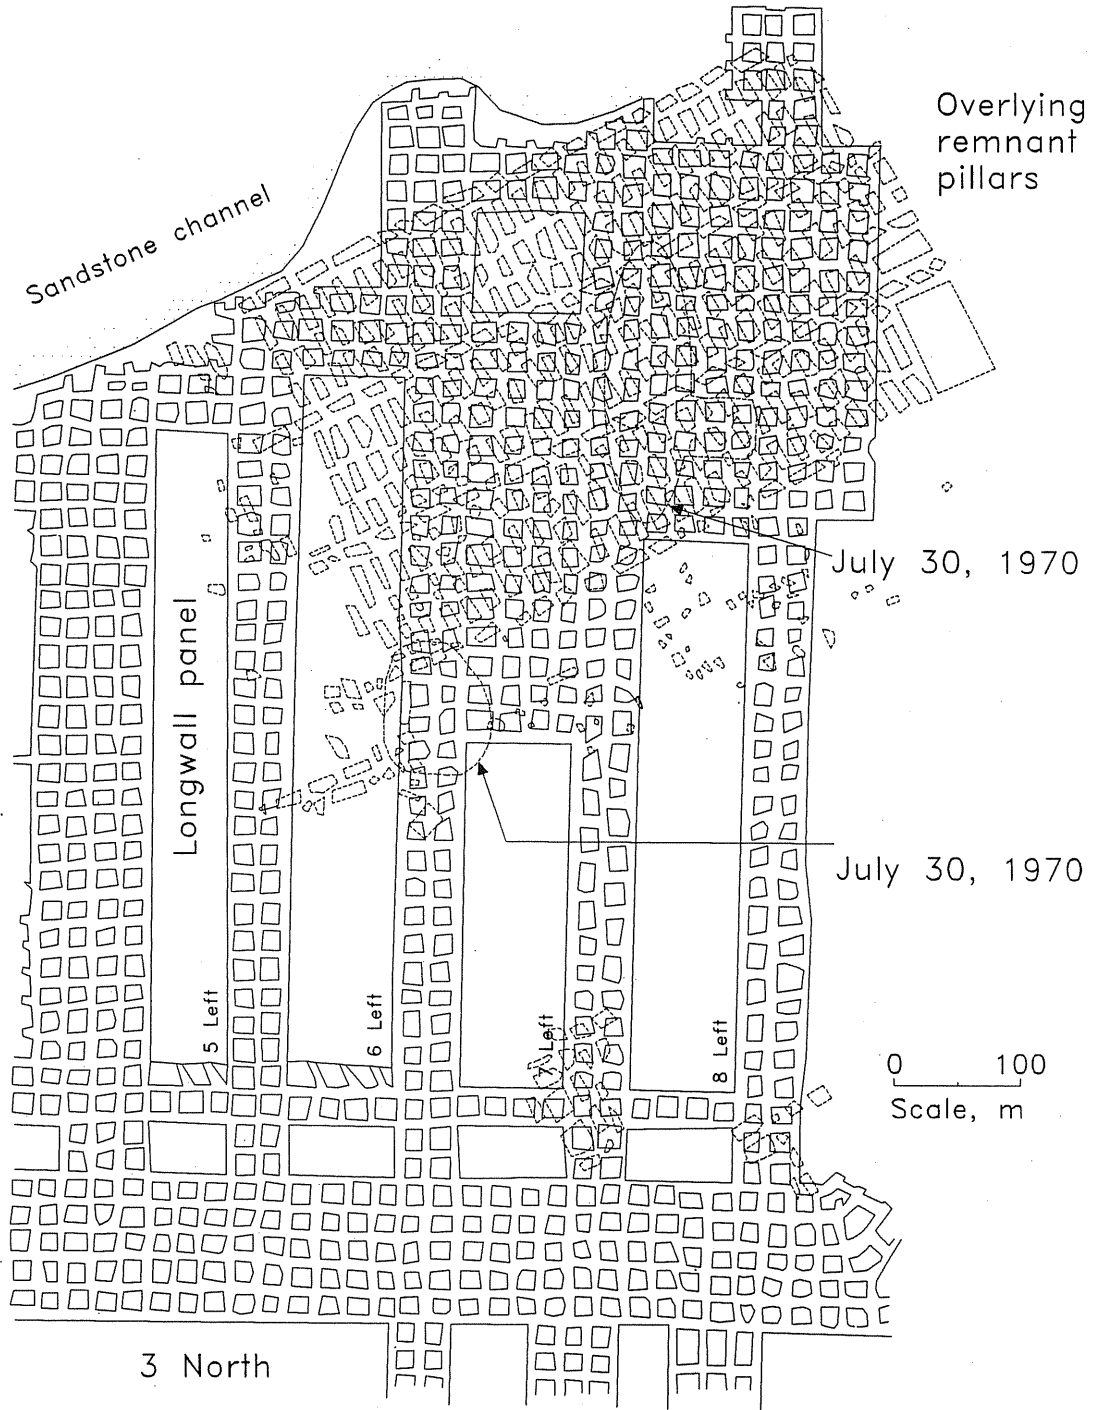
Figure 12
Effects of Overlying Remnant Pillars on Pillar Retreat Bump at Moss No. 2 Mine,
July 30, 1970.

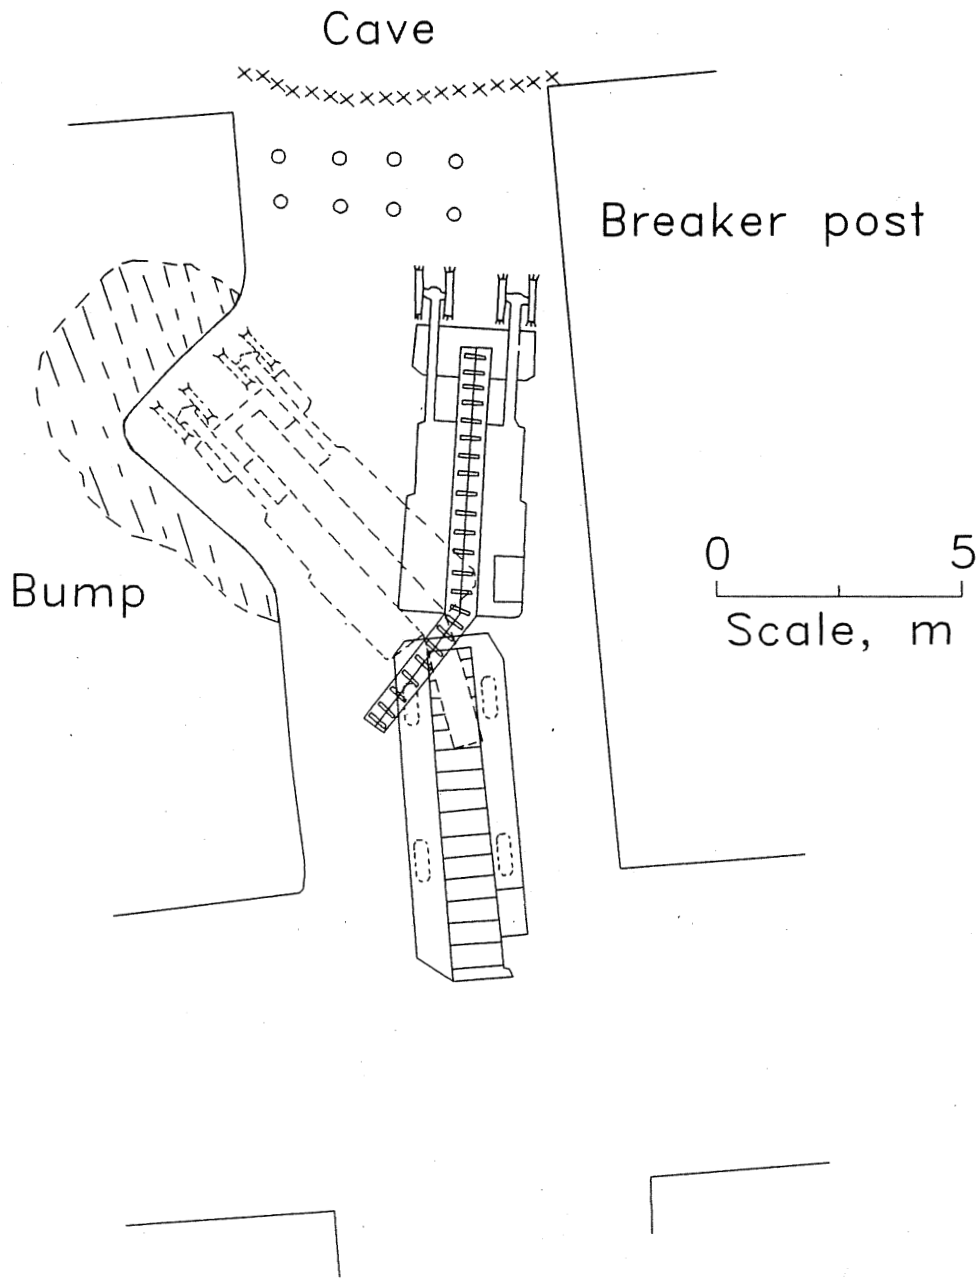
Figure 13
Detailed View of Bump at Moss No. 2 Mine, July 30, 1970.

Note position of caved roof line and postbump continuous mining machine (solid lines).

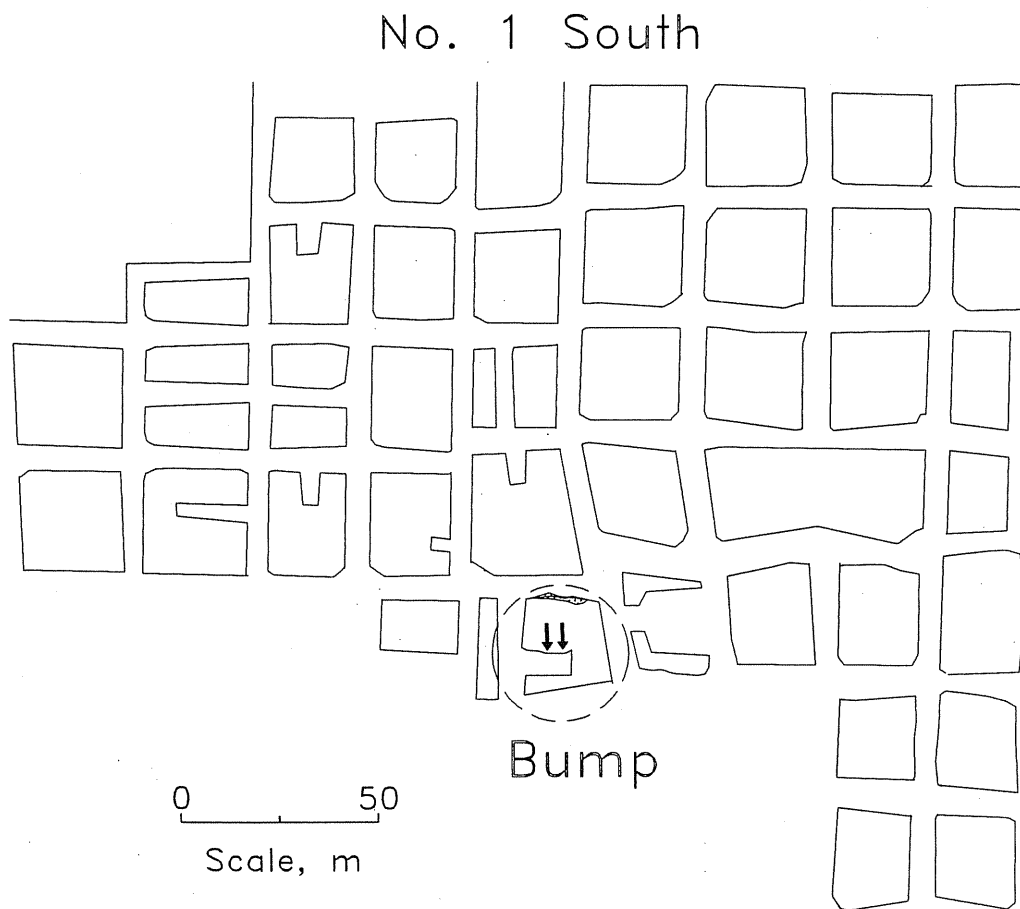
Figure 14
Pillar Retreat Bump at Beatrice Mine, May 30, 1978.

Note use of sequential pillar mining technique.

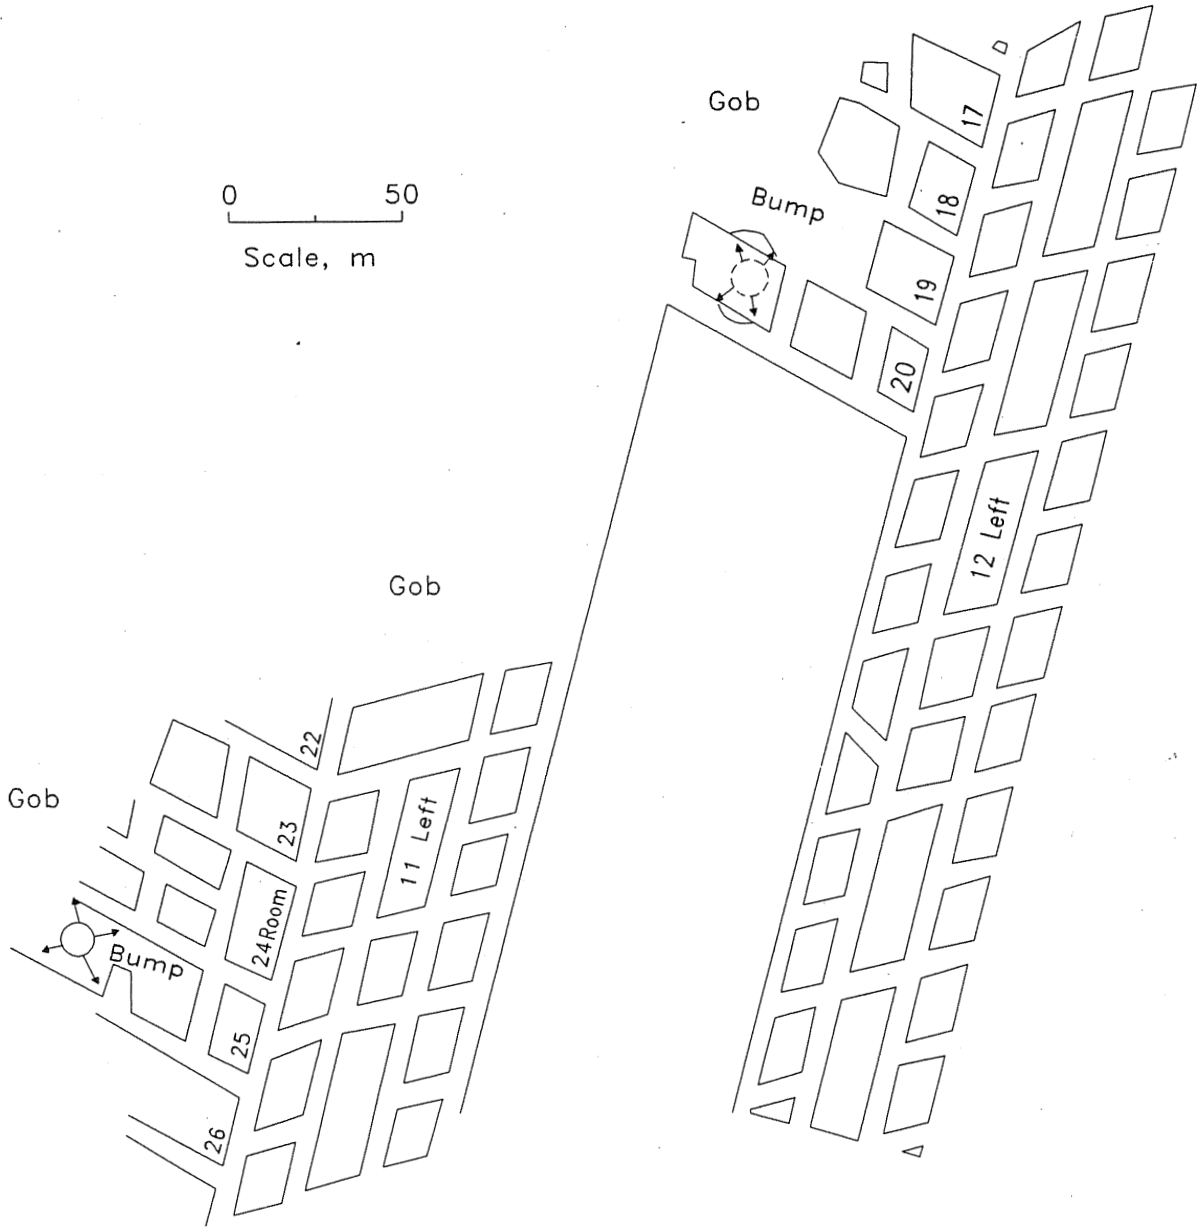
Figure 15 illustrates the Gary No. 2 Mine plan in the vicinity of a bump in the 12-Left section in January 1951. In this mining plan, four-entry development sections were driven at intervals off a set of main entries. Sections were separated from one another by a barrier block that was developed just ahead of the retreat line during second mining. However, as indicated in figure 15, bumps were

Figure 15
Barrier-Splitting Bumps in Adjacent Sections With Similar Layout Positions, Gary No. 2 Mine, January 1951.

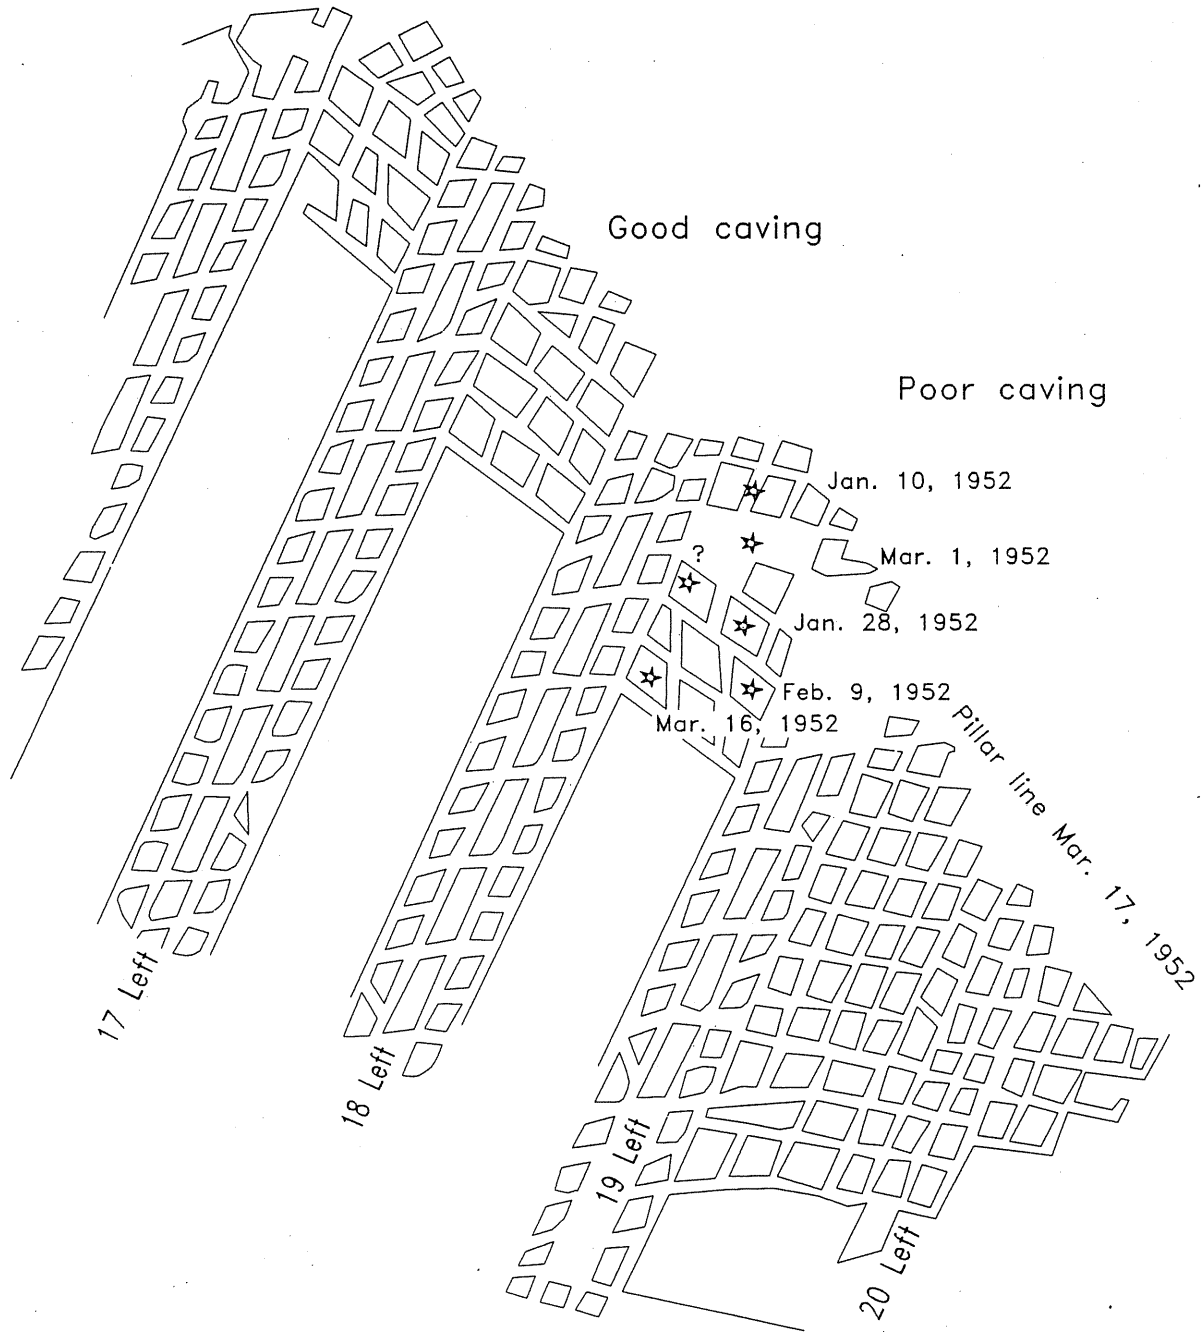
The next-generation mine plan differed from earlier ones in several respects. Figure 16 indicates, for example, that secondary development took place farther out by the retreat line and adjacent sections were retreated simultaneously; when all sections were activated, the length of the pillar line was approximately 670 m. Nevertheless, bumps were encountered in early 1952. Company personnel indicated that poor caving in the gob inby 18 Left contributed to squeeze and bump conditions. Secondary development well in advance of the retreat line appeared to allow the pillars to crush and the massive sandstone main roof to settle into the gob rather than breaking

Figure 16
Multiple Bump Events During Splitting of 18 Left Barrier at Gary No. 2 Mine, 1952.

Star denotes location of mountain bump.

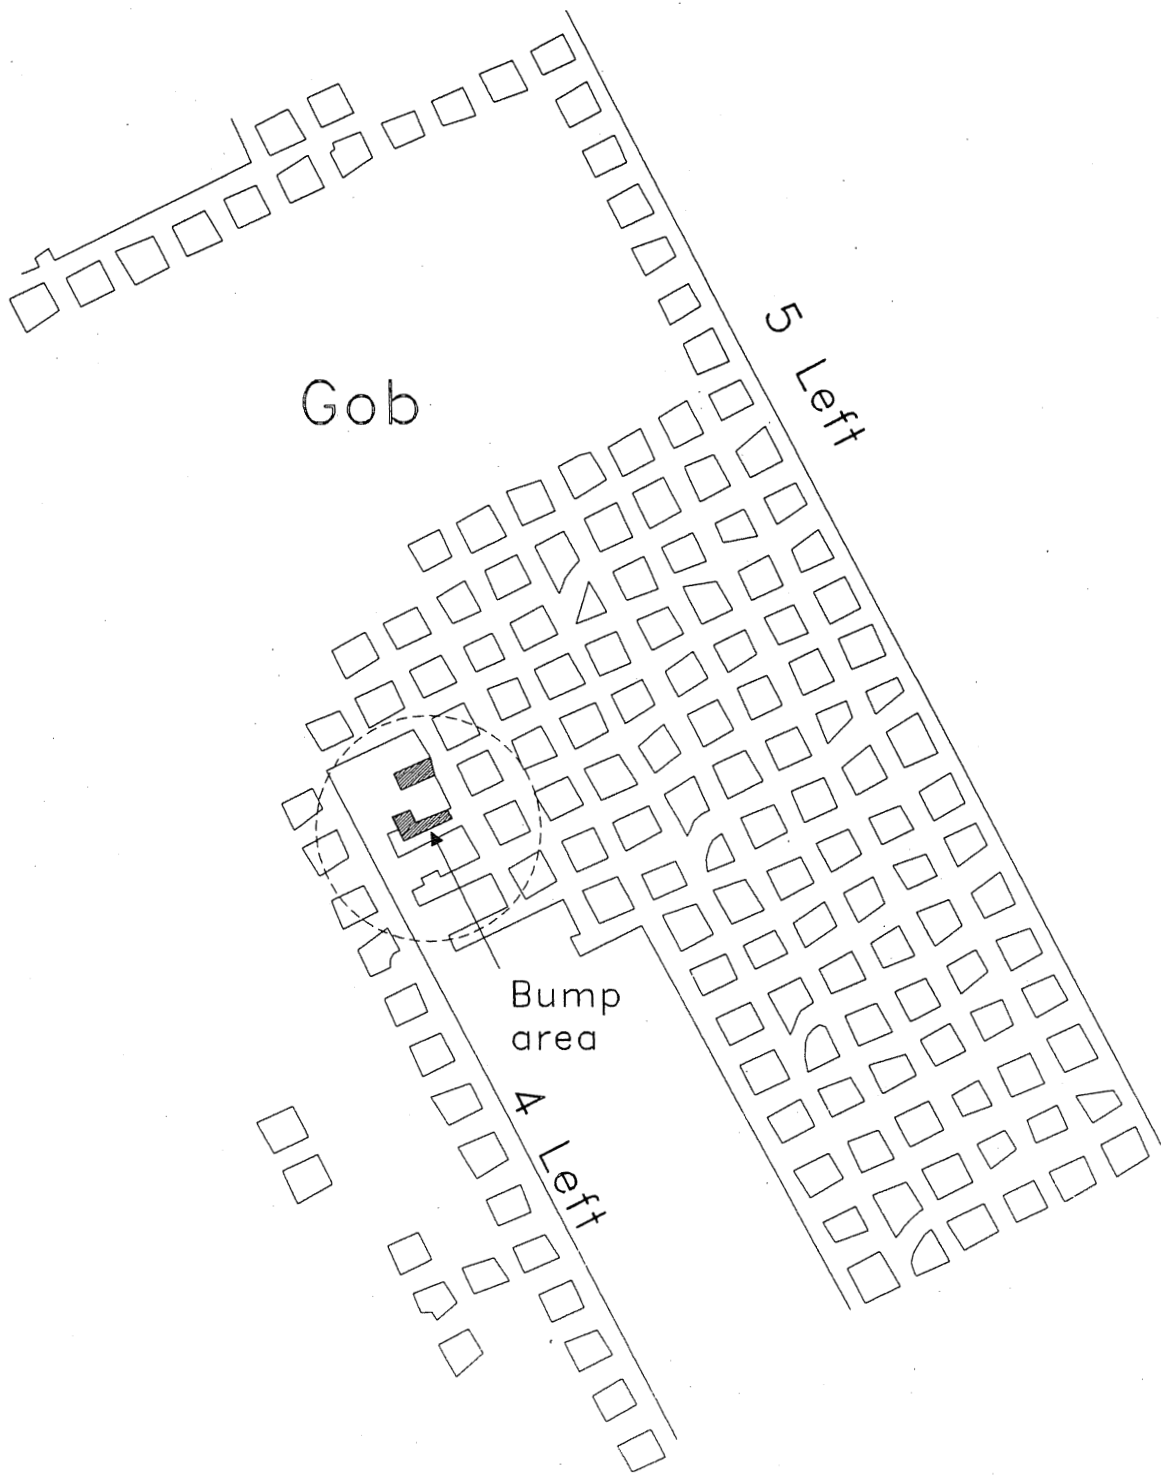
Figure 17
Barrier-Splitting Bump at Moss No. 2 Mine, July 13, 1960.

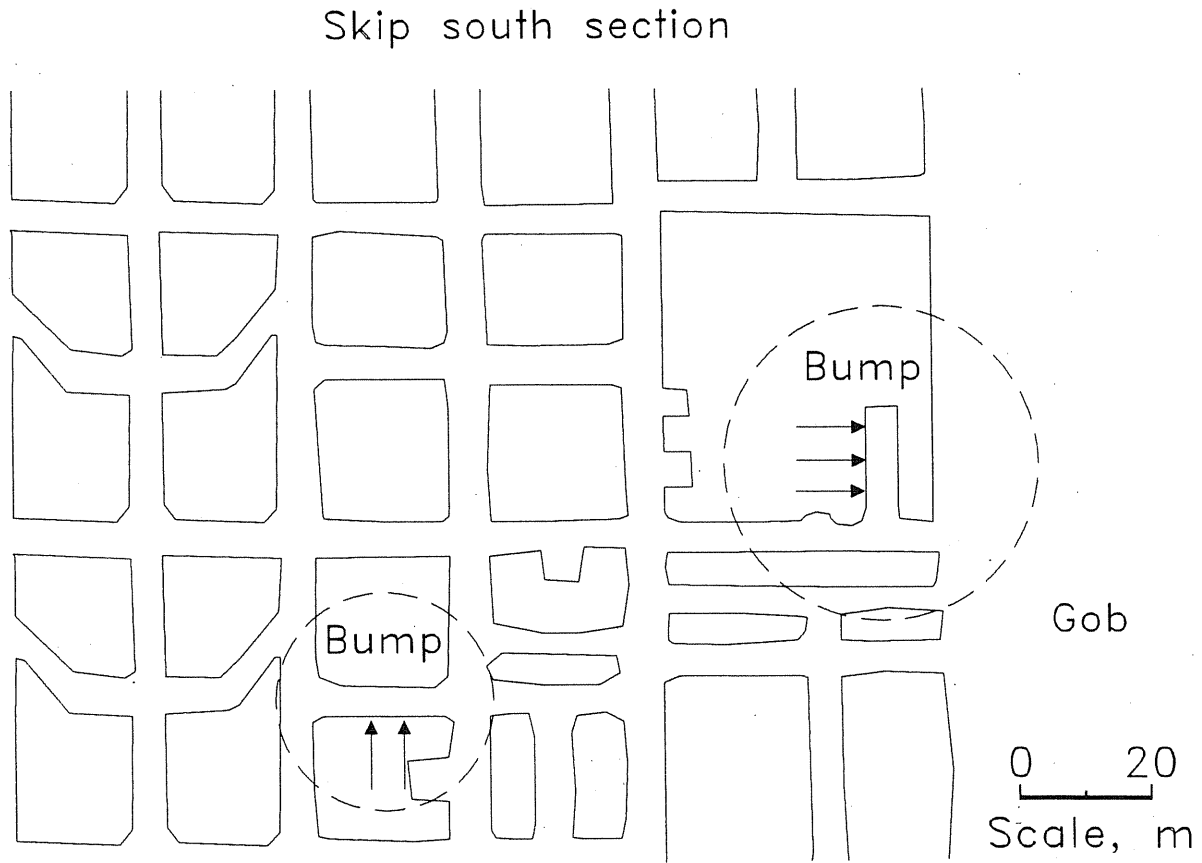
Figure 18
Barrier-Splitting Bump at Beatrice Mine, December 11, 1980.

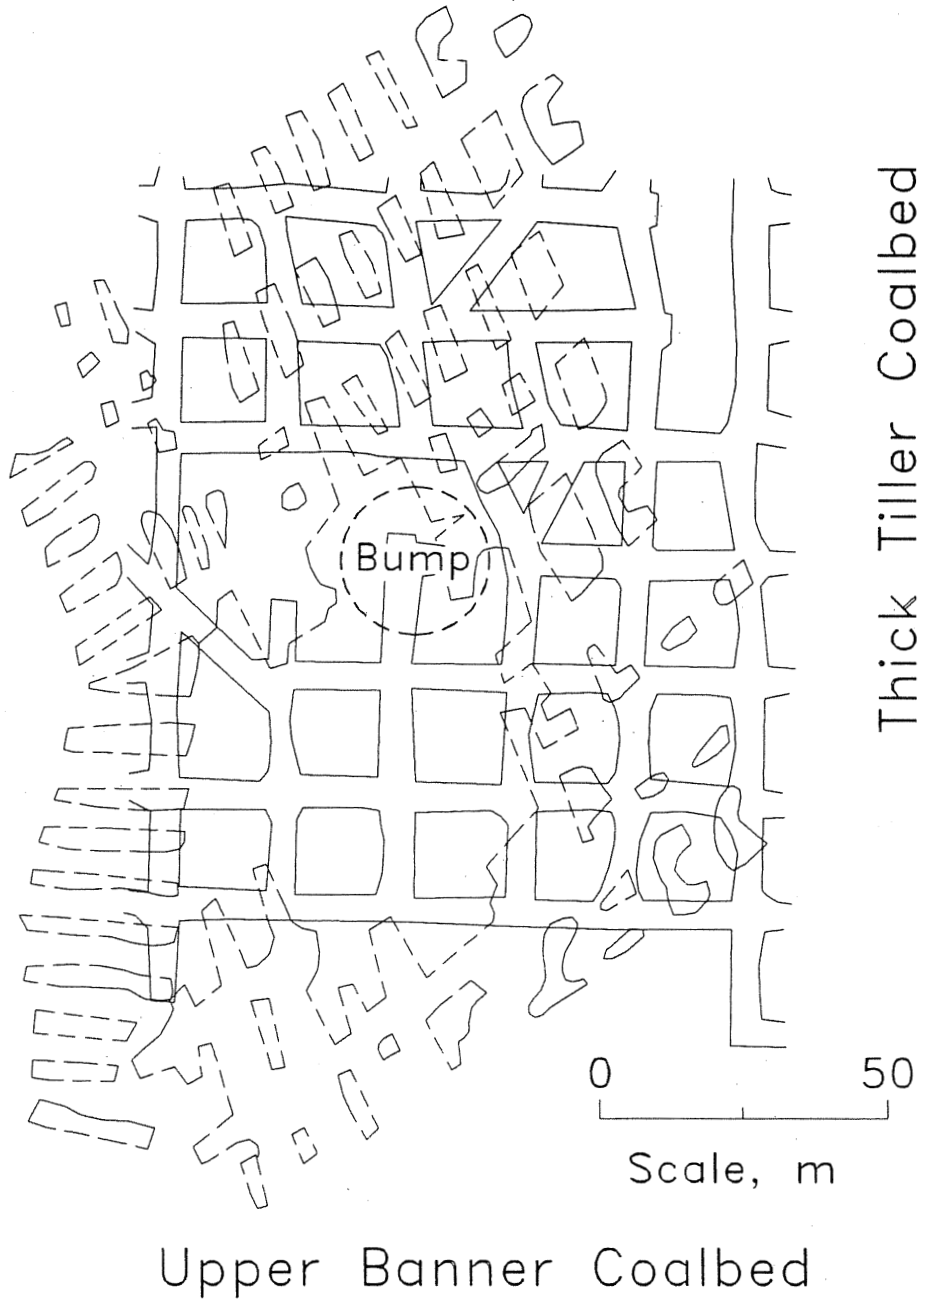
Figure 19
Effects of Multiple-Seam Mining on Barrier-Splitting Bumps at Moss No. 3 Mine, November 4, 1977.

pillar measured about 116 m long by 43 m wide. Adjacent pillars were generally square and appeared to be spaced on 24-m centers. Reports of the Moss No. 3 coal bump did not indicate overburden or interburden thickness between the Thick Tiller and superjacent Upper Banner Coalbeds at the bump site. However, it was concluded that the combined effects of abutment loads generated as a result of barrier-splitting and retreating, along with concentrated stresses caused by overmining, created an excessive stress condition. Isolated pillars that were left in the Upper Banner Coalbed during second mining apparently intensified the stress interaction (figure 19).

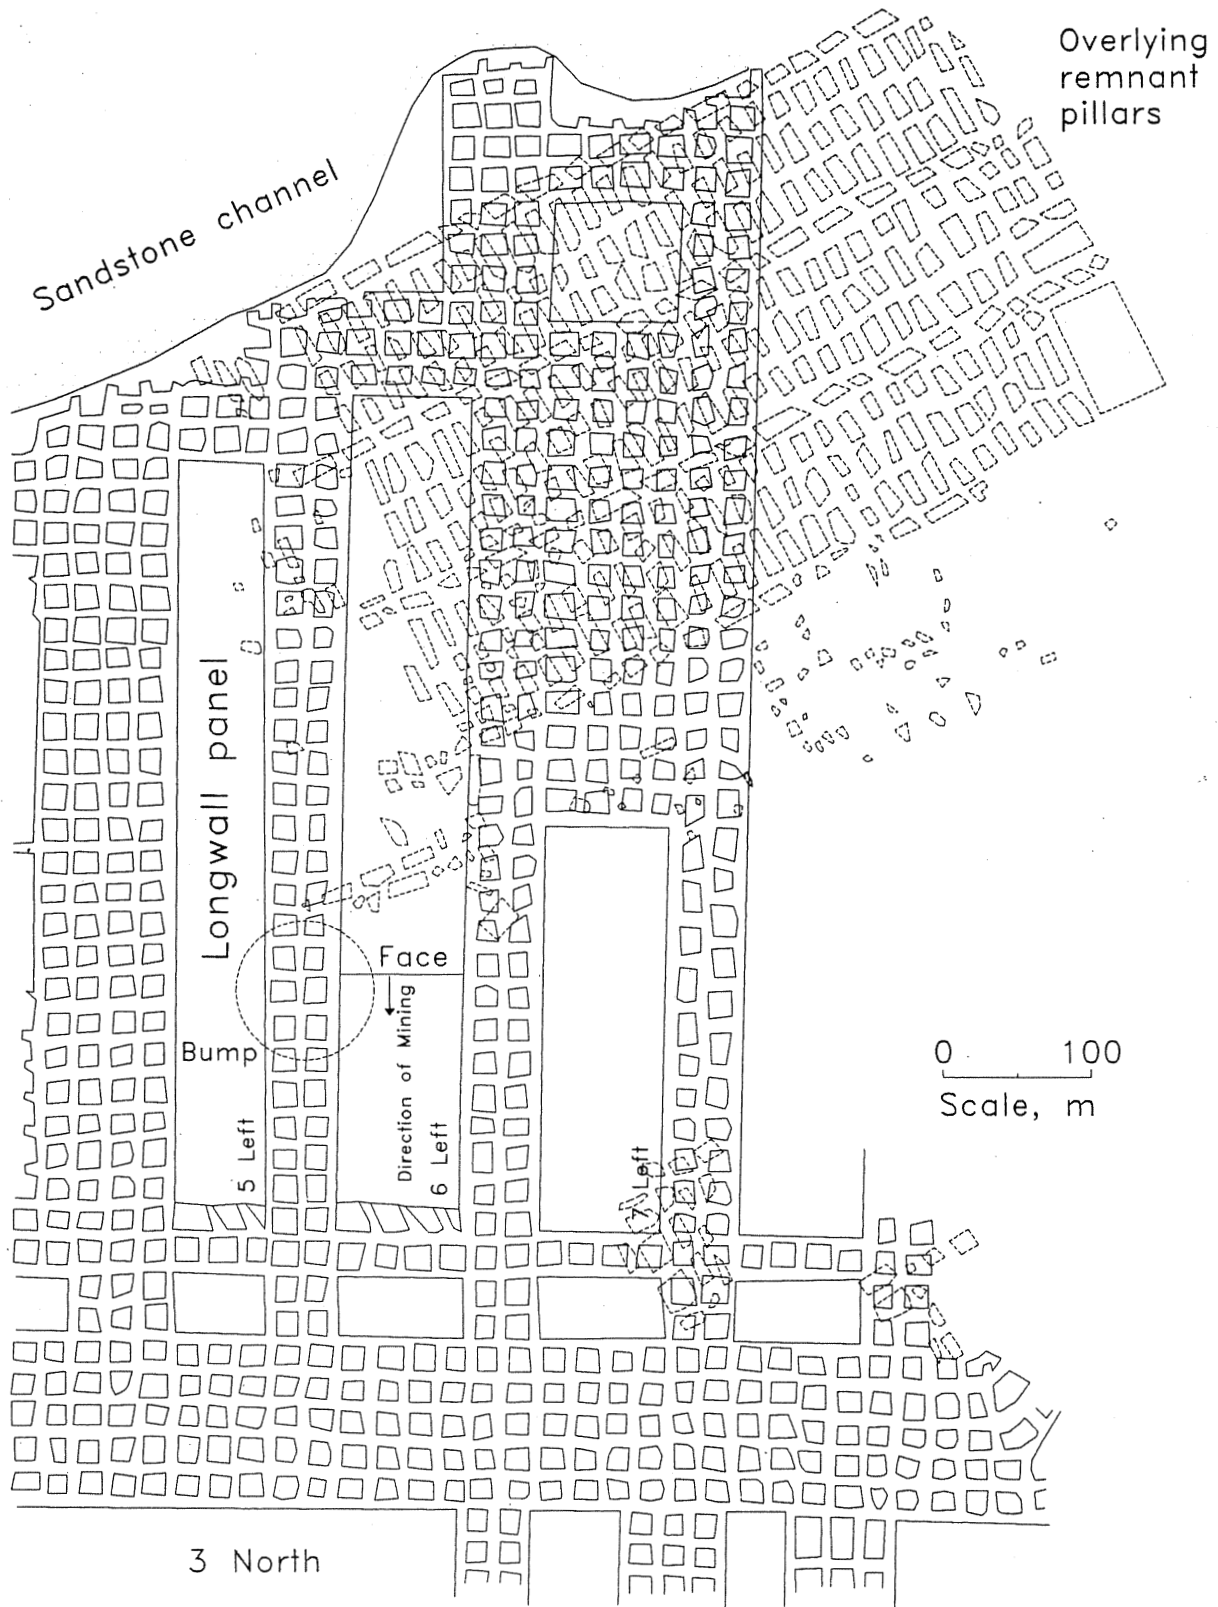
Several contributing conditions were readily apparent. Multiple-seam mining occurred in the overlying Lower and Upper Banner Coalbeds. At the time of the bump, the longwall itself was progressing from under a group of unmined pillars (figure 20). Additionally, a large sandstone channel was located about 450 m inby the face and evidently contributed to the poor caving characteristics in the main roof member. Finally, the chain pillars left to protect the longwall panel were of inadequate size and too weak to withstand abutment loading from the adjacent gob areas.

Figure 20
Effects of Overlying Remnant Pillars and Underdesigned Entry Pillars on Longwall Pillar Bump at Moss No. 2 Mine, January 8, 1970.

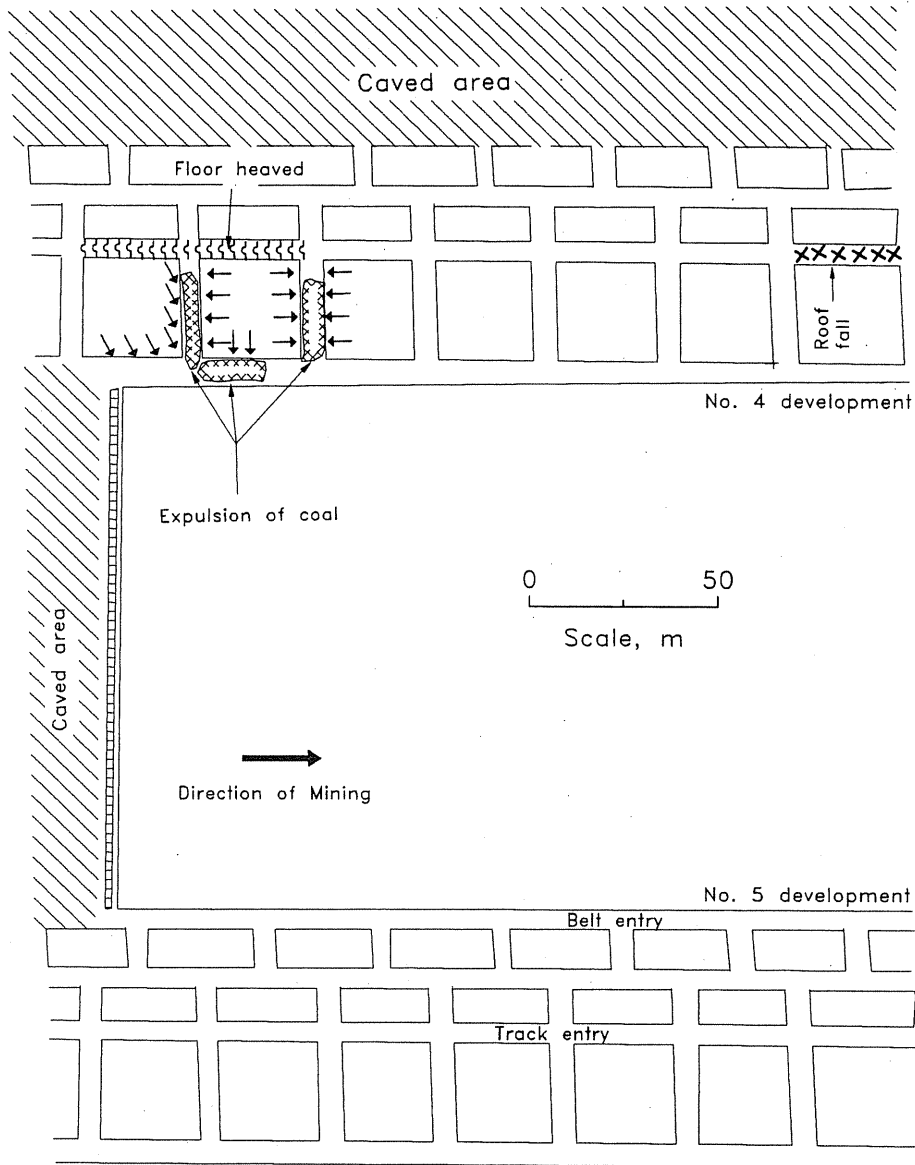
The first coal bumps associated with longwall mining at the Beatrice Mine took place in March 1972 on the tailgate of No. 3 development. At approximately the same panel location on the next panel, another bump occurred on January 26, 1973 (figure 21). Twenty minutes before, the section had been quiet. The bump exploded three chain pillars and completely filled the adjacent entries with loose coal. Several more bumps occurred during the mining of this and the adjacent panel. These events did not appear to be particularly difficult to address and did not result in any injuries.

Figure 21
Longwall Tailgate Entry Pillar Bump at Beatrice Mine, January 26, 1973.

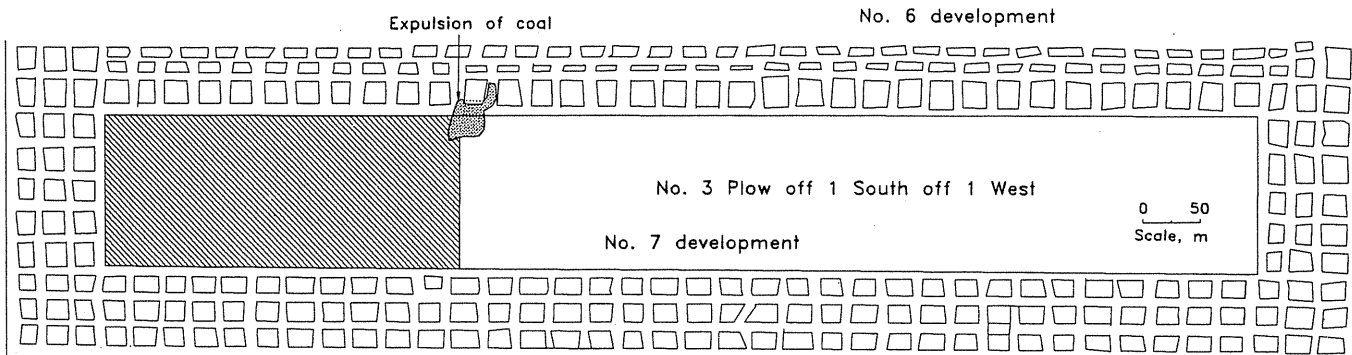
A devastating bump two panels later in the tailgate entry of No. 6 development (figure 22) killed one miner and significantly injured three others. One of these miners was approximately 150 m away from the immediate bump location. The event was 350 m from the startup rooms in a longwall panel 140 m wide by 910 m long. A stall machine was utilized to keep the tail side of the longwall face advanced about 10 m ahead of the face conveyor (figure 23). This system was used to eliminate removal of the previously set cribs during retreat of the longwall face. James Gilley, a recognized authority on coal bumps (31), referred to this occurrence as a "shock impact bump." The

Figure 22
Fatal Longwall Panel Bump Near Tailgate Entry at Beatrice Mine, May 15, 1974.

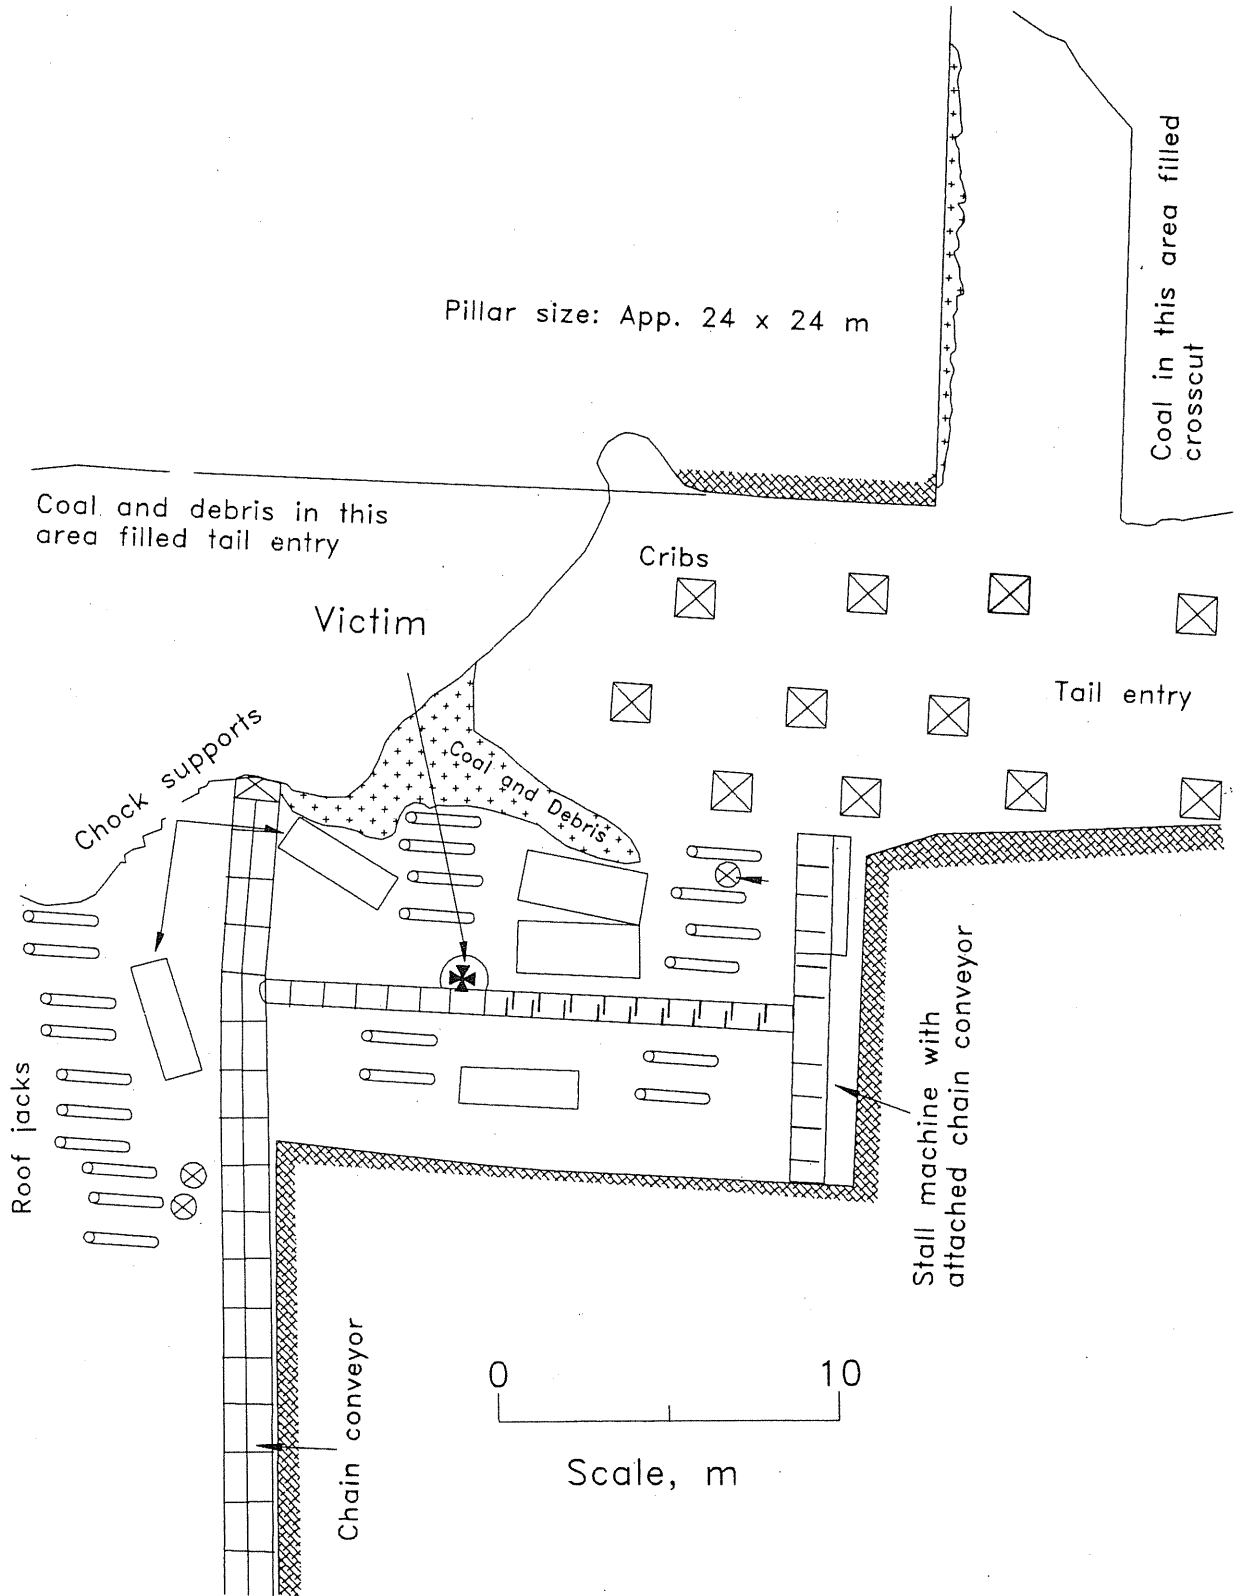
Figure 23
Detailed View of Bump at Beatrice Mine, May 15, 1974.

This section of longwall panel was referred to as the "stall area." X indicates miners.
