OCCURRENCE AND REMEDIATION OF COAL MINE BUMPS: A HISTORICAL REVIEW

By Anthony T. Iannacchione¹ and Joseph C. Zelanko²

Pittsburgh Research Center, U.S. Bureau of Mines, Pittsburgh, PA.

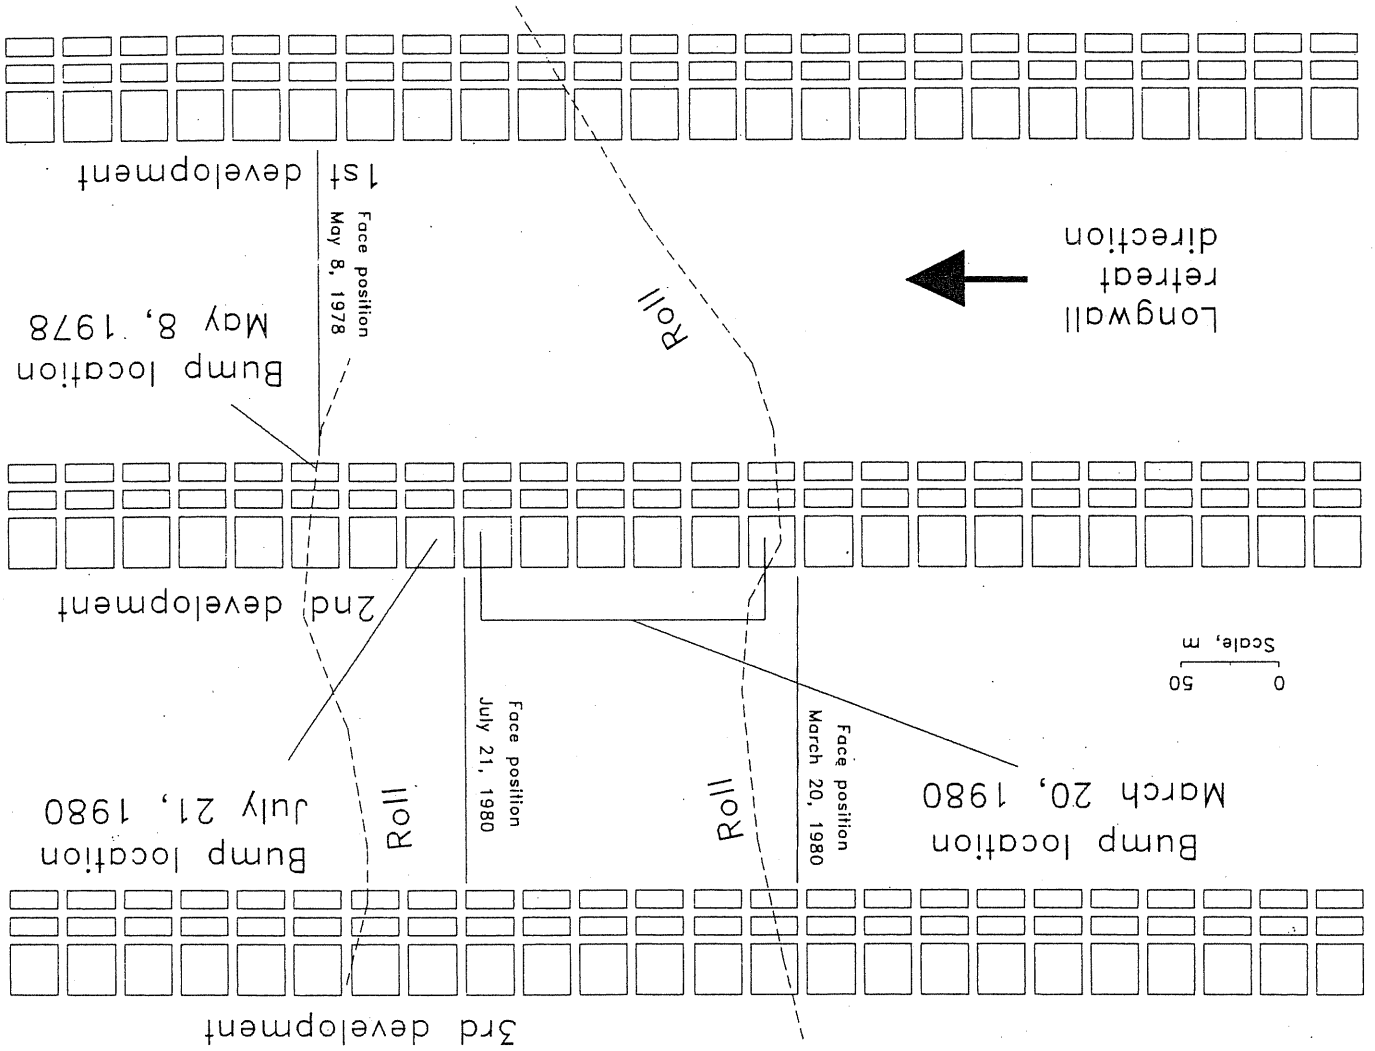
Figure 24
Effects of Large-Scale Structural Roll on Three Headgate and Tailgate Entry Bumps at Beatrice Mine.

longwall panel approached this same roll (figure 24). Then, on March 20, 1980, six narrow pillars bumped, two of them violently (11). No miners were injured in this tail-gate bump. Because the floor in the roll area resisted heaving for a distance of 200 m, the operator decided to volley fire or shot fire ribs of three abutment pillars outby
