PILLAR STABILITY ISSUES BASED ON A SURVEY OF PILLAR PERFORMANCE IN UNDERGROUND LIMESTONE MINES

Gabriel S. Esterhuizen, Sr. Research Fellow
Anthony T. Iannacchione, Acting Geotechnical Engineering Section Chief
John L. Ellenberger, Research Geophysicist
Dennis R. Dolinar, Mining Engineer
NIOSH-Pittsburgh Research Laboratory
Pittsburgh, PA, USA

25th International Conference on Ground Control in Mining

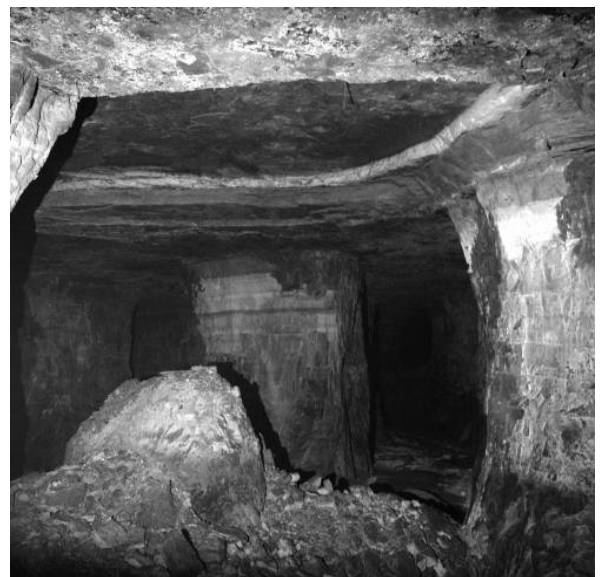
A single collapsed pillar within a layout of otherwise stable pillars was observed at a limestone mine within the Cincinnati Arch area, (Case 8 in table 5). A photograph of the failed pillar is presented in figure 4, which shows that a portion of the roof at the pillar location had failed. The pillars in this layout are square in plan and had been initially developed at a height of 7.0 m (23 ft) and a width of 13.7 m (45 ft). The planned room width was 9.1 m (30 ft) and the depth of cover is approximately 204 m (670 ft). Benching had been carried out to a height of approximately 14.6 m (48 ft), reducing the planned width-to-height ratio of the pillars from 1.95 to 0.93. The average rock mass rating in the vicinity of the collapsed pillar was 64 units, shown in table 7.

Figure 4. Stump of failed pillar at Mine B, showing roof failure at location of pillar and limited spalling of adjacent pillars (Case 8 in table 5).

The area had been mined more than 5 years before the pillar failure occurred and had been used to dispose of fine limestone byproduct by hydraulic placement. The progression of pillar instability and ultimate failure was not observed by the mine staff, since the pillar was located in a disused area of the mine. The surrounding pillars are generally stable, some signs of instability were observed in the form of minor rib spalling in the adjacent pillars, seen to the right of figure 4. The roof span between the remaining pillars was about 32 m (105 ft). It is not known whether the roof failure was simultaneous with the pillar collapse or not. The average pillar stress in this layout is 14.7 MPa (2,100 psi), based on tributary area calculations using specific weight of overburden of 2.6.

The cause of the failure is thought to be a combination of several factors including the weak bands in the pillar, the relatively large overburden load and the moist conditions in the area of the failure. Pillar instability observed elsewhere in the mine showed that progressive spalling of the pillar ribs is bounded by the weak bedding layers, as shown in figure 5, (Case 7 in table 5). These

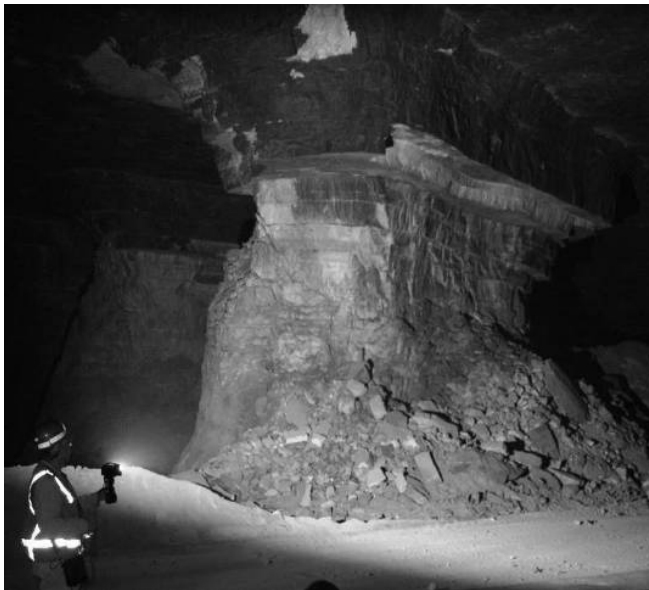
Figure 5. Pillar instability observed in Mine B, showing the influence of weak bedding layers (Case 7 in table 5).

weak bedding layers are not present at all locations in the mine. The fact that only a single pillar failed indicates that the surrounding pillars are sufficiently strong to carry the additional load that was transferred from the failed pillar. The failed pillar and unstable pillars at this mine represent a very small fraction of the total number of otherwise stable pillars in the mine.

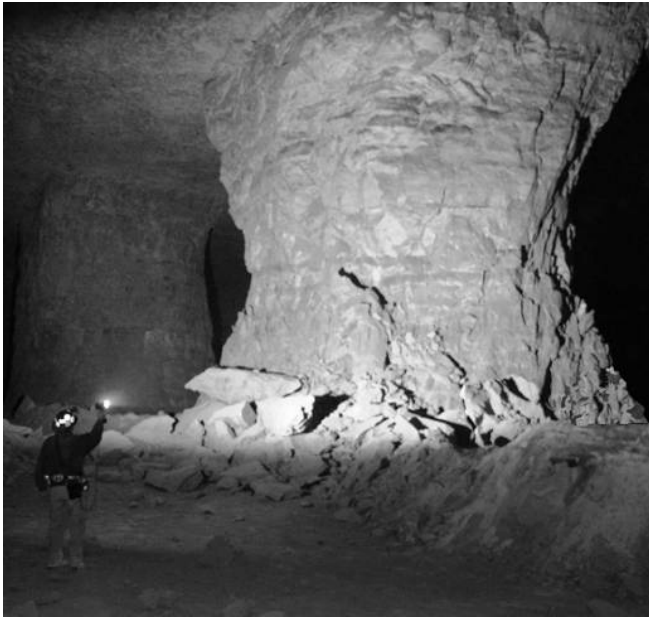
Brittle spalling resulting in hourglass formation at relatively low stress was observed at a mine in the southern Appalachian area, case 5 in table 5. In the area of concern, the pillars were square with side dimensions varying between about 12.2 and 15.2 m (40-50 ft) and were initially benched to 15.8 m (52 ft) high. Further benching was partially carried out, which increased the pillar height up to 27 m (90 ft). The room width was measured to be 16.4 m (53 ft), and the depth of cover is 140 m (464 ft). The width to height ratio of the benched pillars was as low as 0.44 in the 27 m (90 ft) high area and 0.77 in the 15.8 m (52 ft) high area.

The pillars were about 15 years old but benching had been carried out less than 5 years ago. A number of pillars were reported to be progressively spalling to the current hourglass shape, as shown in figure 6. Inspection of the pillars revealed that open vertical fractures or joints existed in the pillar ribs. Evidence of fracture through intact rock and slab formation was seen. Columnar fragments of rock about 2 to 3 m long were scattered about the pillars, as seen in the foreground. The presence of near-vertical open fractures and open joints seems to confirm that stress related failure is taking place in these pillars. The effect of benching and the irregular pillar sizes in this area are thought to have resulted in local pillar stresses in excess of the 15 MPa (2,200 psi) that the tributary area method would predict.

Figure 6. An unstable pillar at the edge of benching operations at Mine C, showing the effect of brittle failure and spalling resulting in an hourglass shape (Case 5 in table 5).

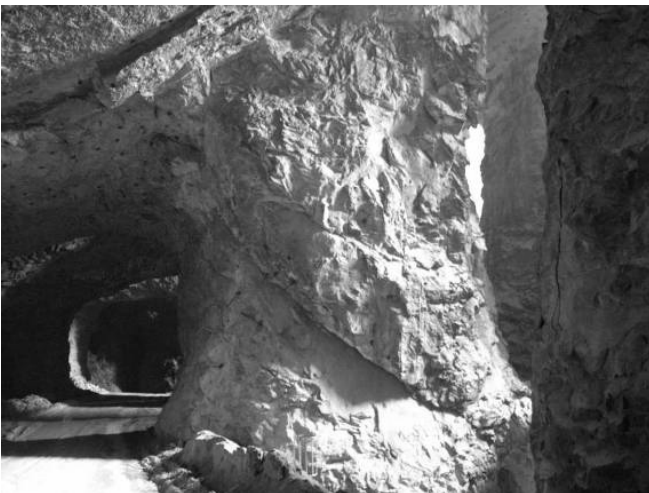
Pillar instability was caused at this mine by the presence of a single continuous geological structure that intersected one pillar, shown in figure 7 (Case 4 in table 5). The limestone formation dips at about 30 degrees and is mined using a room and pillar layout. In the area where the unstable pillar is located, the roof of the workings was excavated to a 30 degree bedding plane, while the floor was mined in horizontal steps. The general rock mass classification in the area was found to be 76, shown in table 9.

Figure 7. Pillar instability caused by a continuous geological structure cutting through the pillar at Mine D. Thread-bar bolts that were installed right through the pillar are visible (Case 4 in table 5).

The unstable pillar was located near the outcrop of the mine workings, under about 80m (260 ft) of cover. The pillar dimensions in the area are 15.3 m x 15.3 m (50 ft) and the room width is about 13 m (43 ft) The pillar height is 29 m (95 ft) resulting in a width to height ratio of 0.55. The average pillar stress is calculated as 3.4 MPa (500 psi), assuming tributary loading.

Special support measures were installed to prevent deterioration and failure of the pillar. Holes were drilled through the pillar and long thread-bars were installed to provide interior reinforcement and provide active resistance to shearing along the inclined discontinuity. Additional bolting was installed to preserve the pillar ribs. The support measures have been successful and the pillar has remained stable for more than 30 years.
