STABILITY OF UNDERGROUND OPENINGS ADJACENT TO THE SINK HOLE AT THE NIOSH LAKE LYNN RESEARCH LABORATORY

D. R. Dolinar, T. E. Marshall, T. M. Barczak, T. P. Mucho
NIOSH
Pittsburgh, PA

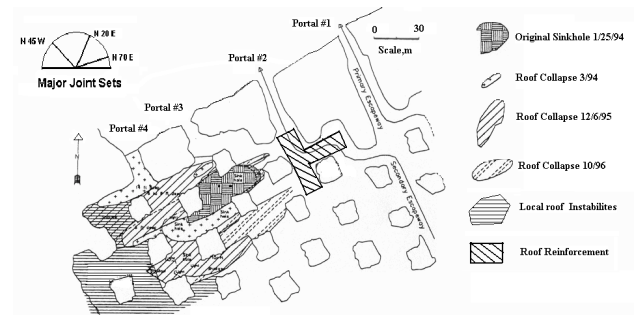
On January 25, 1994 a large roof collapse occurred in the old workings near portals 3 and 4 and in close proximity to the highwall. The roof fall encompassed approximately 2,550 m² of entries and crosscuts. Over the collapsed area, the overburden thickness was approximately 30.5 m. Given the relatively shallow depth and the intersection of two significant joint sets observable through most of the roof rock units a sinkhole formed during the initial collapse. With time, the underground failure and sinkhole have expanded. Figure 1 shows the location of the original roof collapse and sinkhole as well the extension of the failure.

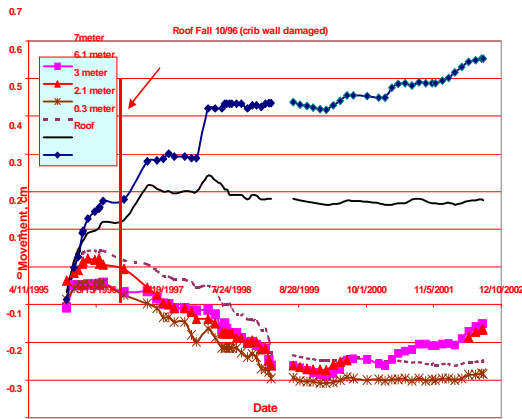
Figure 6. Roof movement measured at extensometer 3 between October 1995 and August 2002. Note: the gap in the data from March to July 1999 resulted from damage to the extensometer.

Figure 6 shows the roof movement at the various anchor horizons for extensometer 3. On the figure, the roof movement is for an anchor at a given roof depth with respect to the 8.1 m reference anchor. Between November 1995 and August 2002 over 0.63 cm of total movement of the roofline was detected with about 0.25 cm movement between 0.3 and 2.1 m movement and 0.25 cm between the roofline and 0.3 m. Through 1999, accelerated movements were initiated in November 1995,

between late October 1996 and March 1997 and mid March 1998. There appears to be a seasonal pattern to the movement with the accelerated movement initiating in the fall or winter. Through March 2000, a fairly large amount of movement occurred but the movement was relatively shallow in the roof with most of the movement below 2.1 m. Since March 2000, there has been less than 0.13 cm of roof movement. However, most of this movement has been between 3.0 and 6.1 m into the roof, clearly much deeper than the previous movement.

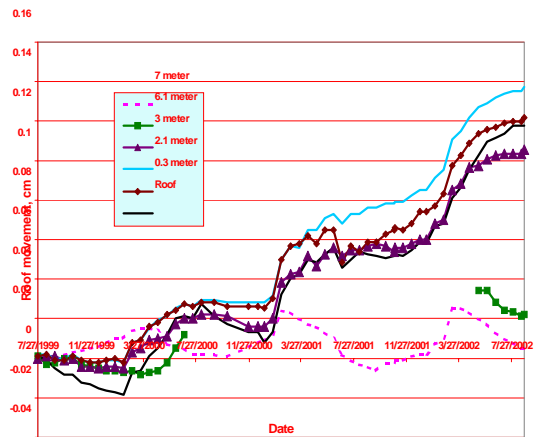
Beginning in March and April of 2000 a pattern of roof movement was observed at extensometer 3 that would lead to the decision to reinforce the entry adjacent to the damaged crib wall. Figure 7 shows the roof movement from July of 1999 to August of 2002. Again, the roof movement is for an anchor at a given roof depth with respect to the 8.1 m reference anchor. Although nearly an order of magnitude smaller, these roof movements were occurring at much greater depths than previously detected (figure 6). During this time period, only about 0.12 cm of movement was measured. However, most of this movement occurred between 3.0 and 6.1 m into the roof, the depth of the October 1996 roof collapse that partially destroyed the crib wall.

Figure 7. Roof movement measured at extensometer three between July 1999 and August 2002.

For three consecutive years, the roof movements were initiated in late January to mid-February. After each period of accelerated movement, there was a period with little or no movement. This movement pattern suggests that overall roof conditions are still stable. However, continued seasonal movement could result in a destabilization of the roof and eventually a large roof fall (Zavodini, 2000). Therefore, because of this pattern of deeper seasonal movement, a decision was made to develop and initiate a roof reinforcement plan to support the section of entry adjacent to the damaged crib wall.

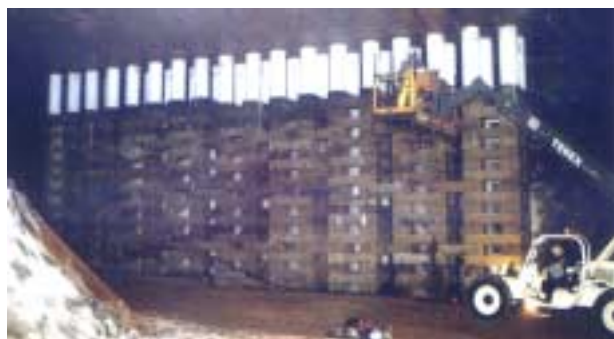
Figure 8. New crib wall C covering the crosscut in front of damaged crib wall.

A new crib wall (C) was built across the entrance of the cross cut just behind crib wall B (Figure 2). Figure 8 shows the completed crib wall that extends for a length of 21.3 m and covers two major joints, spaced 18.3 m apart. The crib wall was built on a steel reinforced concrete pad that was either 0.3 or 0.6 m thick depending of the floor elevation. A total of 9 interlocking 4-point cribs were erected with the height of the concrete crib portion of the wall being 6.71 to 7.01 m. The crib blocks were made from steel reinforced concrete were 0.61 m by 0.3 m and 1.83 m long.

Sixty-centimeter diameter thin-walled steel containers that were 1.22 to 1.68 m high were placed on the corners of each four-point crib and pumped full of a 1,000 psi compressive strength grout. Prestressing cells were then placed on the filled containers. The cans are a stiffer system than the wood timber packs used on the original walls. Further, the cans will minimize any long-term creep and moisture affects that can occur with the wood cribs. These prestressing cells were 66 cm in diameter and consisted of two thin metal sheets that were welded around the perimeter to form a circular pancake cell. An inlet valve allowed the cells to be pressurized with a polyurethane resin. The grout-filled wall was then pressurized specially designed flat jacks

placed on top of each can. Each flat jack was pressurized to between 0.34 and 0.69 MPa resulting in a total load of between 3,560 to 4,000 kN being applied to the roof and crib wall. Once the resin hardened, the cells provided a rigid support system.
