Bureau of Mines Report of Investigations/1987

Effects of Stimulation Treatments on Coalbeds and Surrounding Strata

Evidence From Underground Observations

By William P. Diamond and David C. Oyster

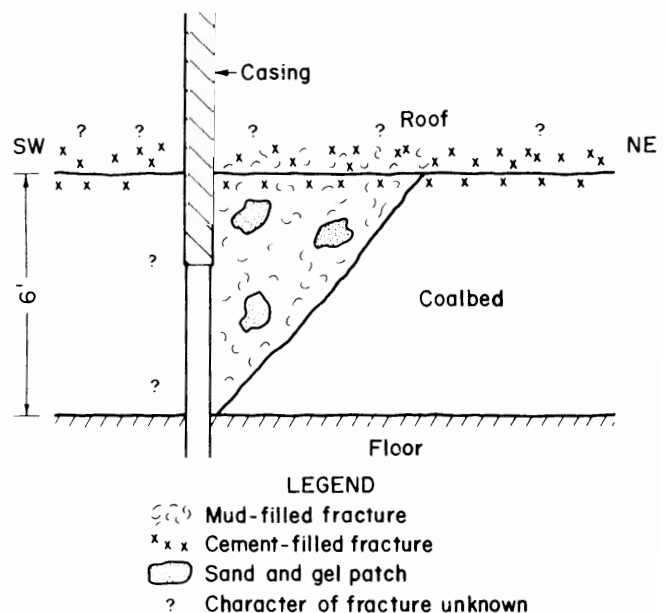
Figure 4.—Schematic cross section parallel to face cleat fractures at borehole TW-1 (18).

wellbore below the coalbed. The primary evidence for this is the minimal amount of treatment fluids and sand observed in the exposed coal section around the borehole. Also, gas was bubbling up through the water filling the open wellbore in the mine floor. It was further speculated that the lower gas production rates observed from this borehole were the result of fractures being filled with drilling mud, cement, and unbroken gel, which prevented propagation of sand-filled fractures in the coalbed and also reduced fracture permeability near the wellbore, thus hindering gas and water flow.

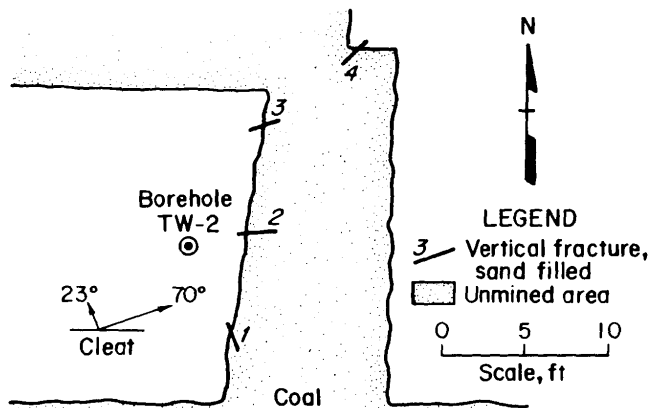
Figure 6.—Mine map, borehole TW-2, with fracture orientations. (Modified from Lambert (20))

The vertical portions of the three sand-filled fractures were oriented as shown on figure 6, and, according to Lambert (20), "followed local fracture planes in the coal." The fractures to the north of the borehole (locations 2 and

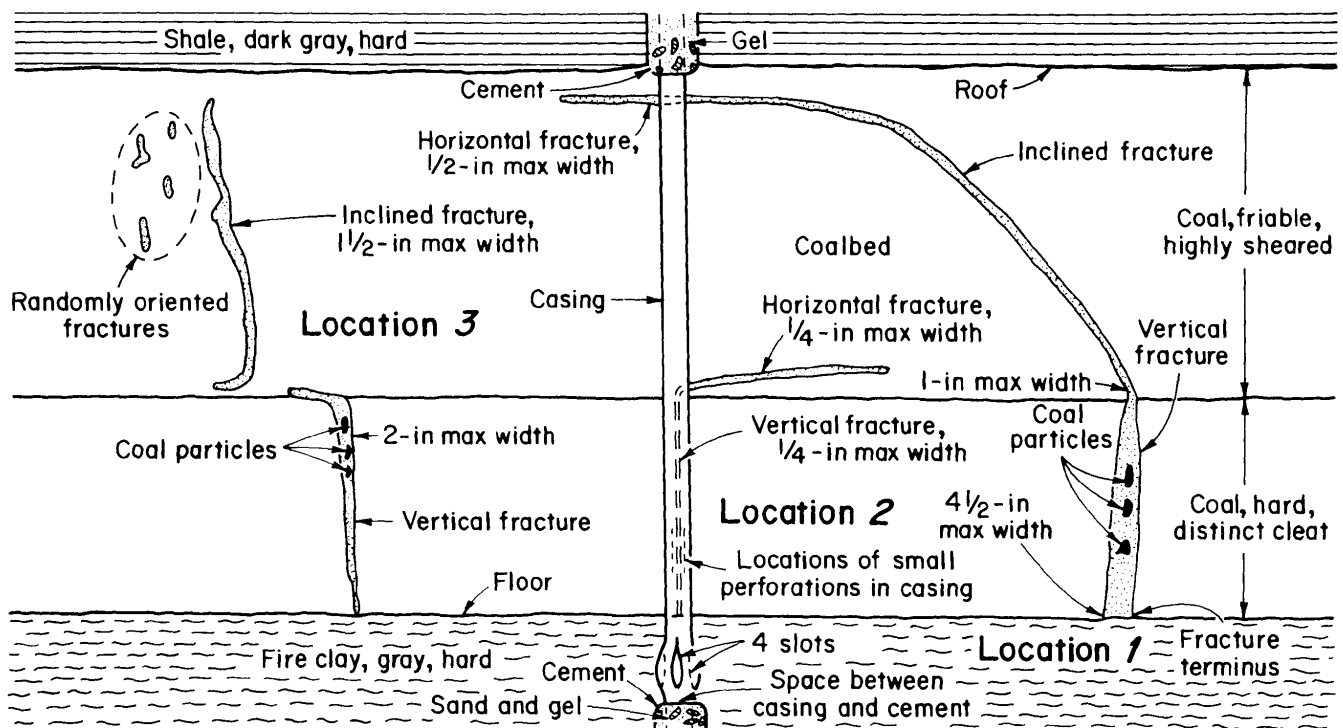
Figure 7.—Cross section of coal face at borehole TW-2, with fracture orientations. (Modified from Lambert (20))

The two primary fractures observed in the more friable upper section of the coalbed appeared to have intercepted and propagated along inclined shear planes in the coal. No penetration of the roof strata was observed.

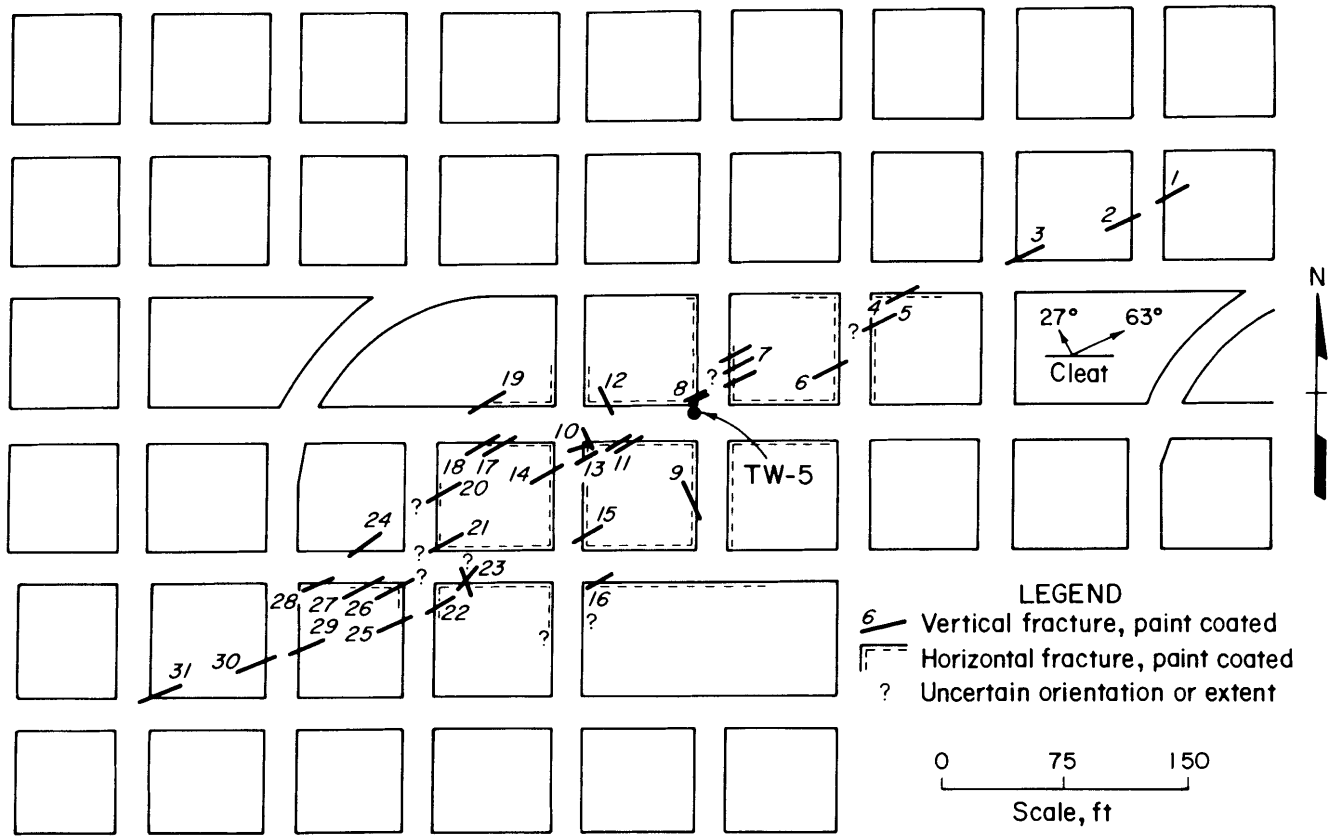
Figure 14.—Mine map, borehole TW-5, with fracture orientations. (Modified from Mahoney (22) and Boyer (19))

Figure 14 shows the location and orientation of vertical paint-filled fractures observed in the vicinity of borehole TW-5. If an orientation on the fracture was not obtained but was recorded as being in the face cleat direction, the fracture trace was plotted as being oriented at an azimuth similar to that measured for nearby fractures. These fractures are identified by a ? in figure 14.

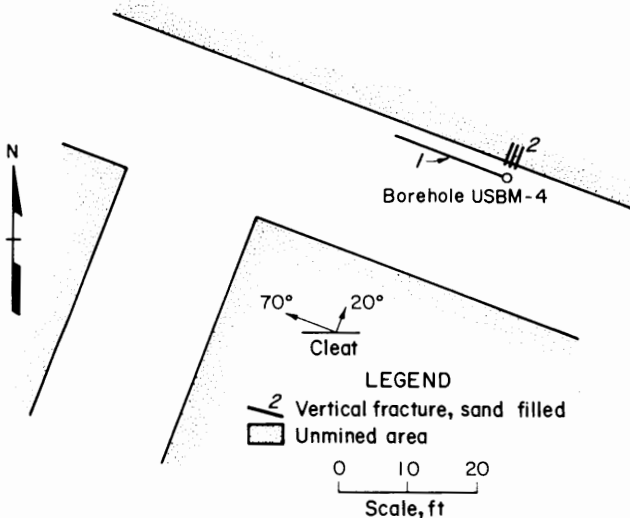
Figure 18.—Mine map, borehole USBM-4, with fracture orientations. (Modified from Elder (8))

There was no apparent butt cleat fracture observed on the rib south of the borehole nor was there any face cleat fracture reported to the east of the borehole. The maximum extent of the butt cleat fracture into the northern rib is not known, but the maximum extent of 20 ft reported for the face cleat fracture is far short of the designed 219 ft of sand-propped fracture length. There were no roof penetrations or adverse mining conditions

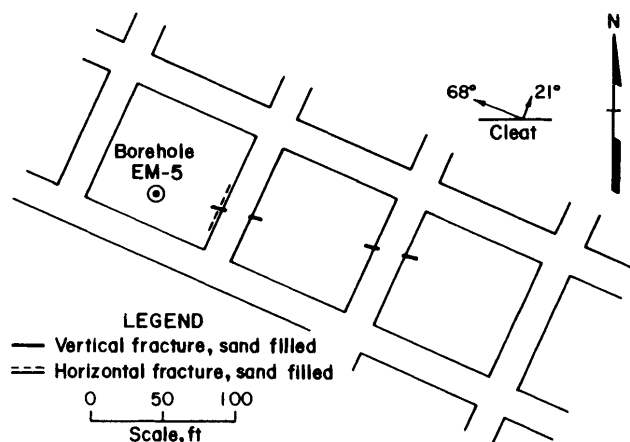
Figure 22.—Mine map, borehole EM-5, with fracture orientations. (Modified from Lambert (9))

A fracture wing from borehole EM-5 was intercepted by mining on July 21, 1978, approximately 2 yr after stimulation. The borehole location itself was not exposed by mining. The area of the fracture interception is shown in map view on figure 22. At the rib closest to the borehole, a single vertical sand-filled fracture up to 1½ in wide was observed extending from the floor to the roof (fig. 23). At the interface between the top of the coalbed and the overlying hard shale, the vertical fracture became horizontal. The sand-filled horizontal fracture was ⅛ to ¼ in wide, and at its maximum lateral extent was observed 50 ft from the presumed borehole location. The sand-filled vertical fracture could be traced across two entries of the mine, and at its maximum observed extent, it was approximately 140 ft from the presumed borehole location. The vertical fractures were propagated along face cleats, which averaged N 68° W in orientation. The width of the vertical sand-filled fracture varied from 1½ in at the exposure nearest the borehole to only a hairline at its maximum extent, where it was only partially filled with sand. No evidence of penetration of the roof strata was observed associated with the stimulation treatment at borehole EM-5.

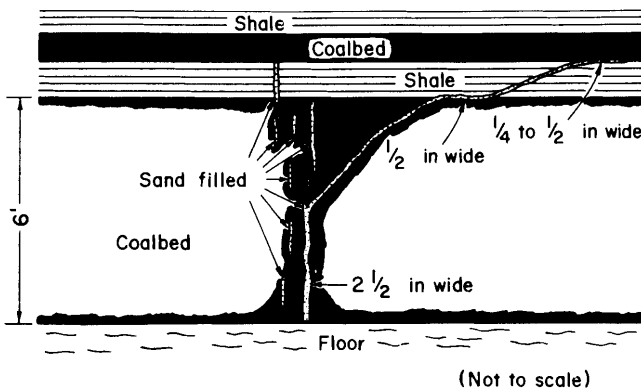
Figure 26.—Cross section of fractures on rib west of borehole EM-6. (Modified from Lambert (9))

An inclined fracture split off from the main vertical fracture and stairstepped its way up to the top of the coalbed where it became horizontal for a short distance before inclining through the thin (8-10 in) roof shale and finally becoming horizontal at the base of the rider coal. The sand-filled horizontal fracture on top of the main coal bench was about ½ in thick and the horizontal fracture at the base of the rider coal was ¼ to ½ in thick. No additional exposures were observed for the fractures seen on the ribs adjacent to the borehole. The extent of the fractures into the ribs is unknown. No adverse mining conditions were encountered due to the penetration of the

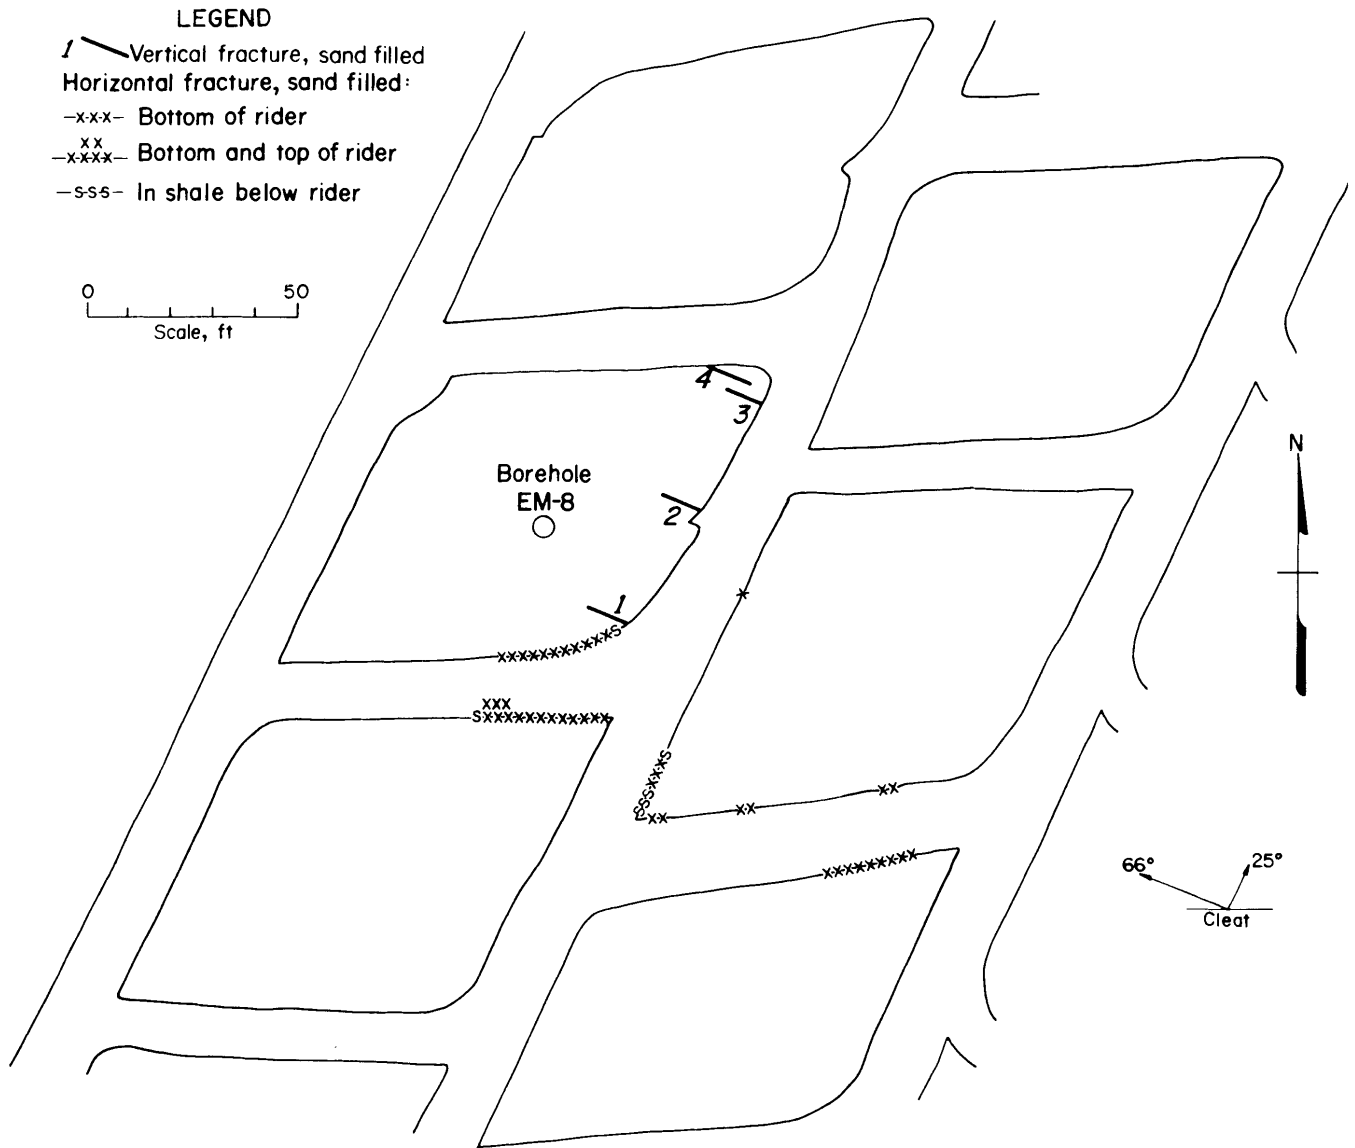
Figure 28.—Mine map, borehole EM-8, with fracture orientations.

Horizontal fractures were observed at several locations, generally to the south of the borehole (fig. 28). The fractures were found on horizontal bedding planes in the thin shale below the rider (above the main bench), and on the shale-coal interface above and below the rider coal. At some locations, horizontal sand-filled fractures could be found on more than one of the described horizontal surfaces. The fractures ranged from $\frac{3}{16}$ in to essentially only a single sand grain in thickness. The maximum distance a horizontal sand-filled fracture was observed from the presumed location of the borehole was 115 ft.

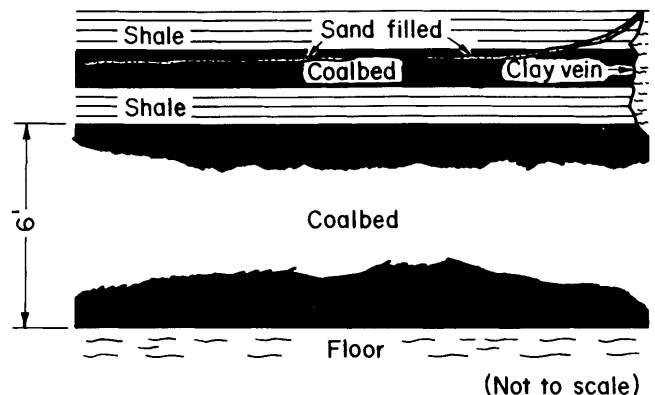
Figure 34.—Cross section of fractures on rib near borehole EM-11. (Modified from Lambert (9))

The penetration of the upper shale bed at this location may have been influenced by the presence of a clay vein. Clay veins are commonly characterized by planes of weakness at their interface with surrounding strata. The location of the exposures of horizontal fractures was approximately 110 ft from the presumed location of the borehole. No other exposure of sand-filled fractures was observed, and no adverse mining conditions were reported related to the presence of the horizontal fractures in the rider coal, which is commonly mined along with the main bench. Since borehole EM-11 was not completely mined around, additional sand-filled fractures may have been created, but not mined through. Vertical fractures that would have extended from the borehole in the face cleat direction could have been intercepted by the mine

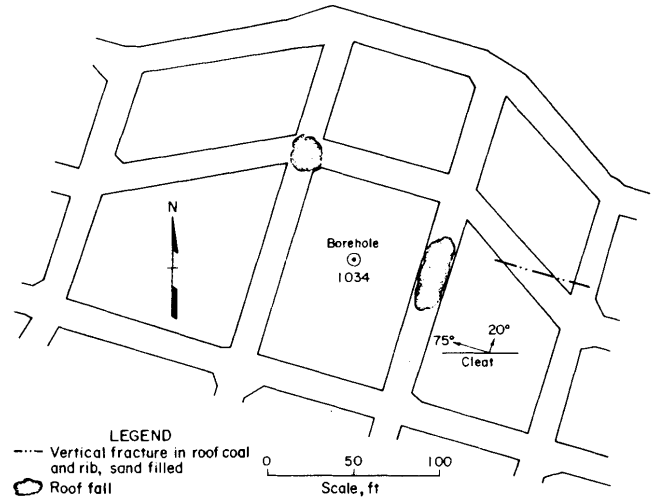
Figure 35.—Mine map, borehole CNG-1034, with fracture orientations (19).

Fractures from borehole CNG-1034 were intercepted in 1981, approximately 4 yr after stimulation. A vertical fracture filled with sand was observed 85 ft to the east of the presumed location of the borehole (fig. 35). The fracture extended from the floor to the roof along face cleat

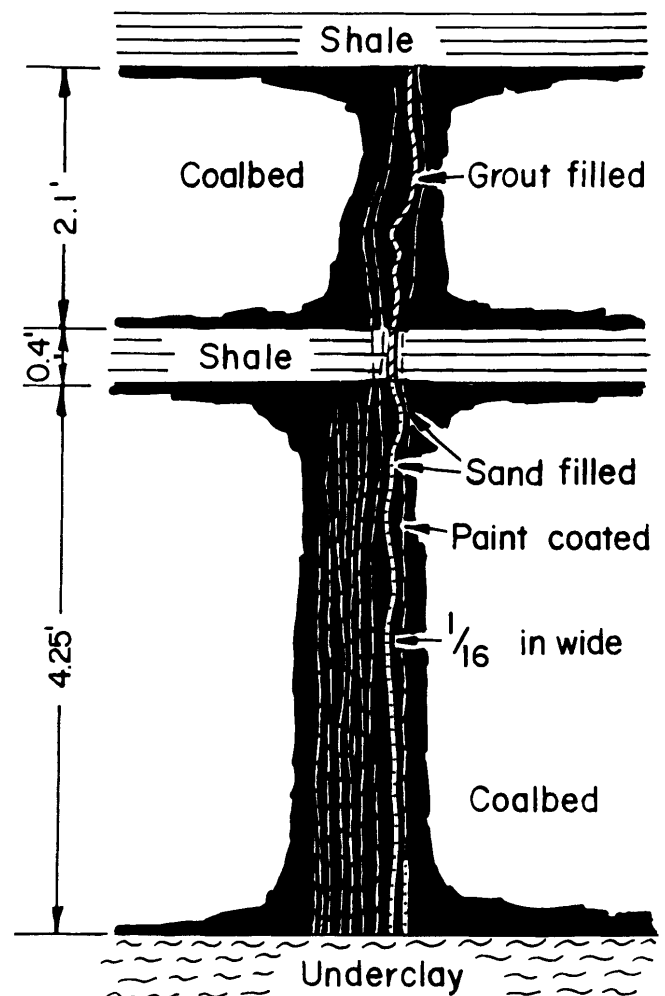
Figure 38.—Cross section of fractures at location 25 on the southeast rib near borehole RP-1. (Modified from Murrie (12))

The vertical fractures either terminated at the roof or before reaching the roof. No evidence of roof penetration by the stimulation was observed. A small roof fall did occur at an intersection approximately 25 ft southwest of the borehole several days after being mined. The roof fall was attributed to the presence of compactional slips in the black shale roof. Examinations of the area with the ultraviolet light failed to detect any paint on any surface associated with the fall or around the fall. Similar roof falls related to slips are common in this area of the mine.

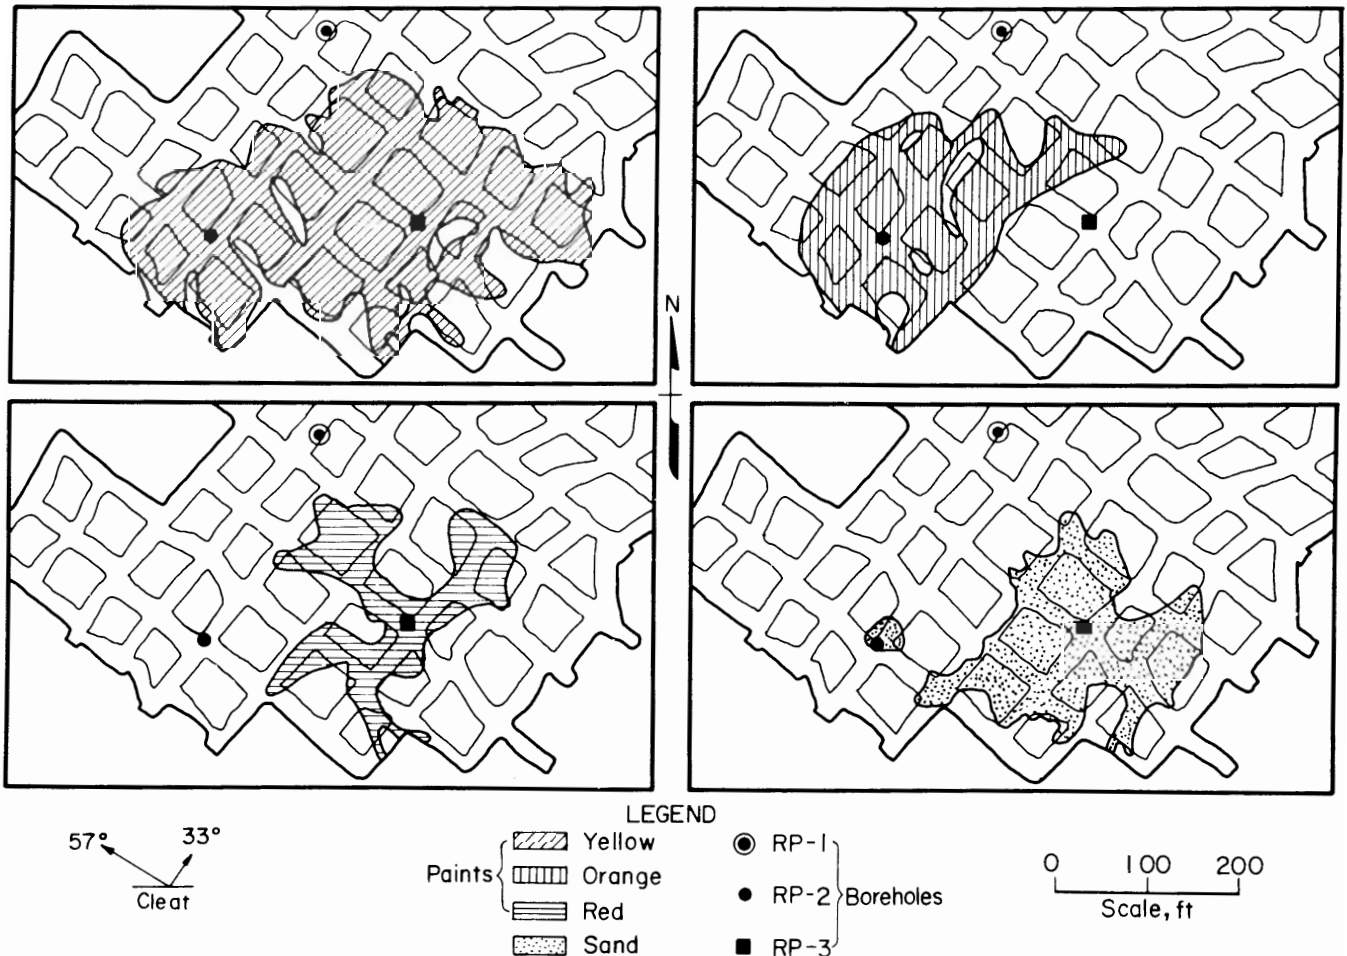
Figure 42.—Mine map, boreholes RP-1 through RP-3, with horizontal distribution of paint and sand on top of shale parting (12).

Sand on the interface between the top of the shale parting and the upper bench of coal was found a maximum of 200 ft from the borehole (fig. 42). Yellow was the most widespread paint on top of the binder, extending a maximum of 200 ft, however, there was an apparent overlap with the yellow paint injected in borehole RP-2. Red paint was found over a wide area, and was distributed in a pattern that consisted of several lobes elongated parallel to the face and butt cleat directions. This again suggests some control of the horizontal fluid placement by the cleat system in the coalbed. Very little orange paint was found on the top of the shale parting, perhaps because it was masked by the red and yellow paints. No blue paint was seen in any of the fractures at the Lucerne No. 6 Mine, probably because of the inability to distinguish it from the glow of the ultraviolet light being used and because of large areas of blue fluorescent hydraulic fluid (from leaking hoses on mining equipment) on the ribs. No sand was found on the interface between the roof and the top of the coalbed, but red and yellow fluorescent paint were mapped as shown in figure 39.

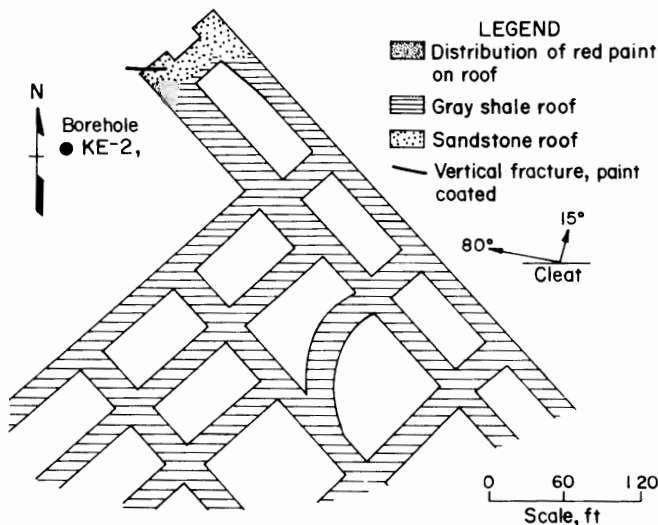
Figure 46.—Mine map, borehole KE-2, with fracture orientation. (Modified from Murrie (12))

A paint-coated fracture from borehole KE-2 was intercepted on November 18, 1982, approximately 8 months after stimulation. The stimulation treatment from borehole KE-2 was intercepted at a point approximately 85 ft from the borehole (fig. 46). A single vertical face cleat plane with red paint was observed. No sand proppant was found. The paint terminated at the floor and disappeared before reaching the roof. A small area of red paint was found on the roof shale approximately 38 ft from the vertical fracture, but none was observed on the sandstone roof exposure closer to the vertical fracture. Poor roof conditions were found in the transition zone between the shale and sandstone roof; however, similar roof conditions are common throughout the Kitt No. 1 Mine. Because of the poor roof conditions generally associated with this type of transition zone, several longwall panels were shortened to avoid mining through the zone and under the sandstone roof rock. Because of the change in the mining plans, the underground characterization of the stimulation was limited. There was no evidence of any penetration of the roof by the stimulation treatment nor any evidence of any influence on the roof conditions.
