# ***Death in the line of duty...***

**A summary of a NIOSH fire fighter fatality investigation**

**August 20, 2013**

## ***Volunteer Captain Dies While Participating in Advanced Dive Training at Quarry—Ohio***

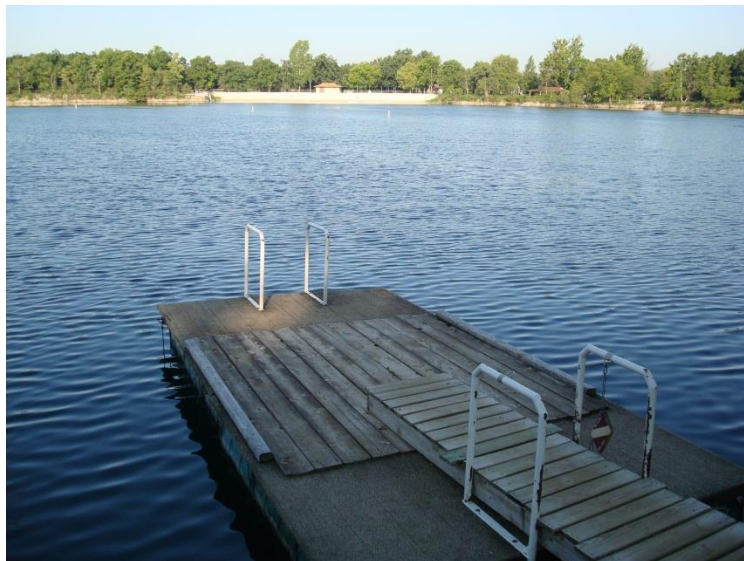
**Dock where victim was pulled from quarry.  
(NIOSH Photo)**
