**REPORT#: 18MI213**

**REPORT DATE: 6/24/20**

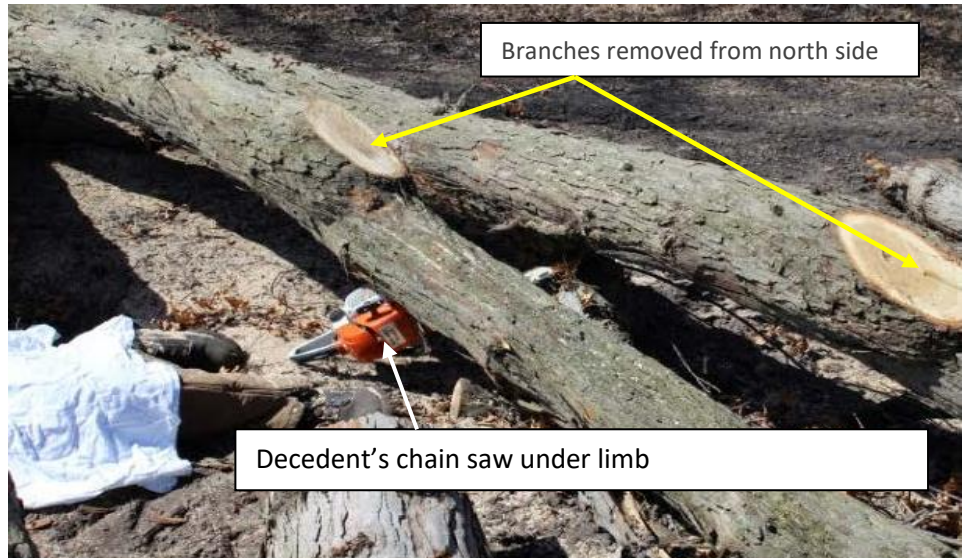
*Photo 6. Close view of chainsaw location under limbs and branches removed when working from north side*
