FATALITY ASSESSMENT AND CONTROL EVALUATION

Equipment Operator Fatally Crushed by the Bucket of a Front-End Loader at a Scrap Yard
Case #: 18NY019

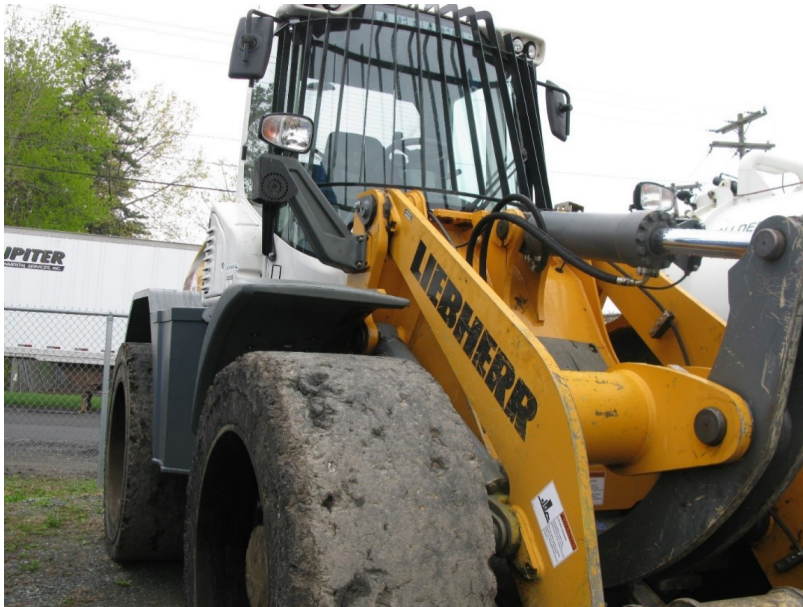
Photo 3. The front wheel fenders that were missing at time of the incident were reinstalled after the incident.

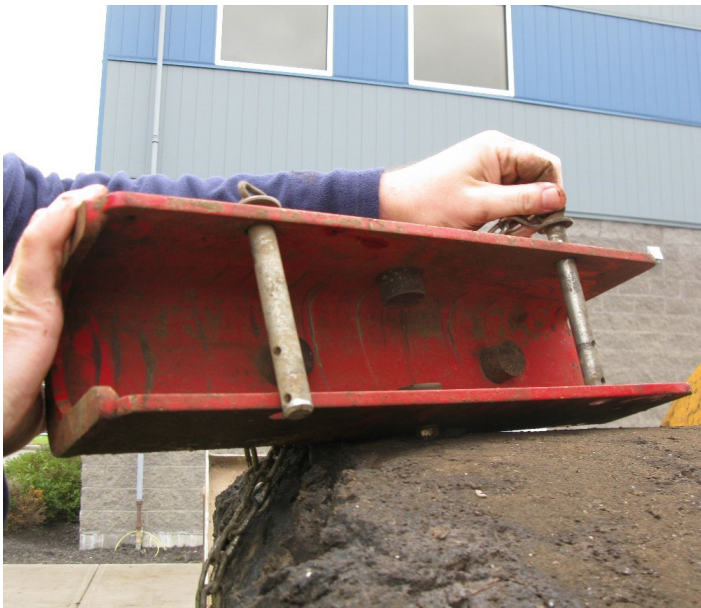
Photo 4. The lift lock, a metal piece (13" X 4"X 4") with two cotter pins, was used to secure the bucket.

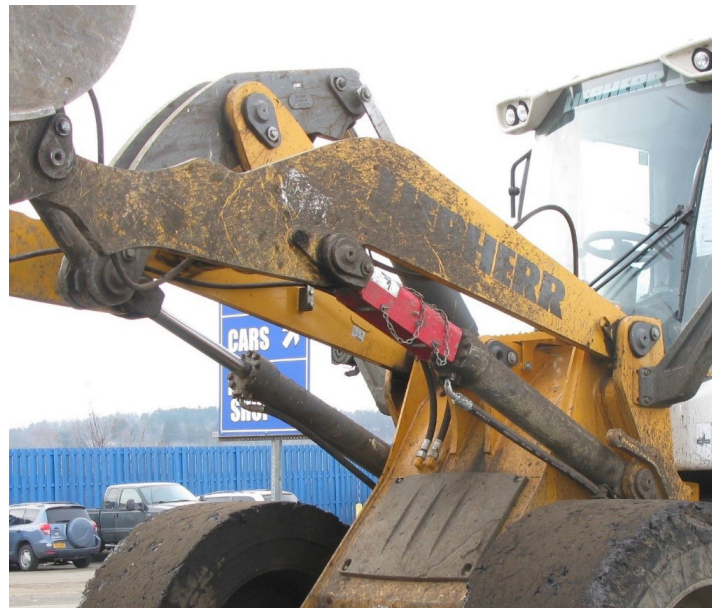
Photo 5. The lift lock is placed on the piston rod of the lift cylinder to secure the bucket and prevent it from dropping.

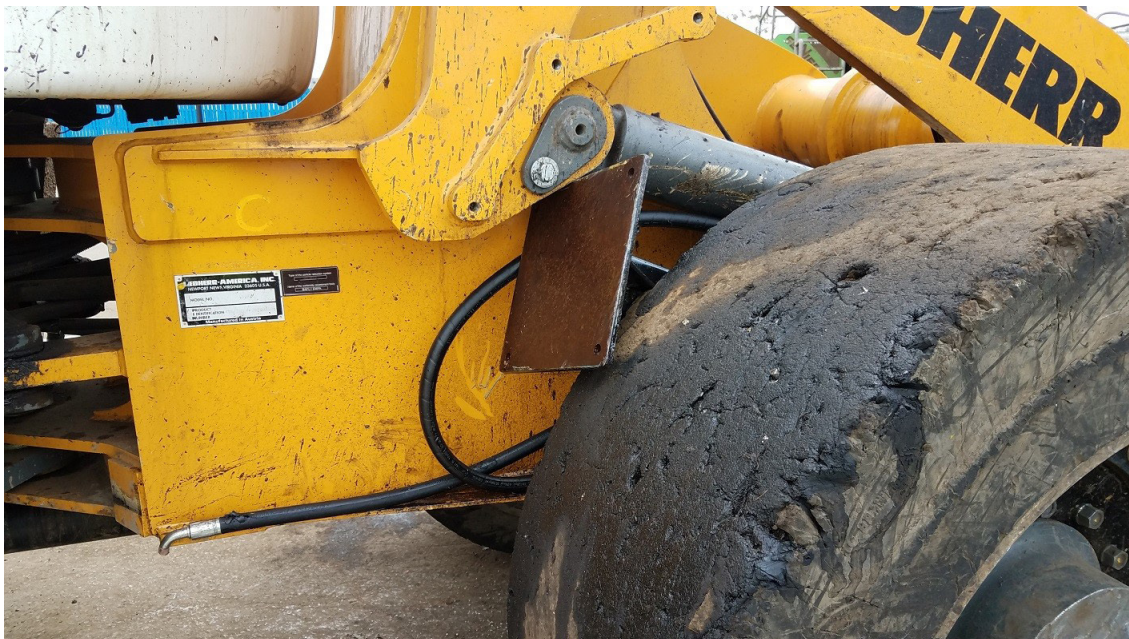
Photo 6. A scrap piece with a square plate became wedged between the lift cylinder and the wheel, and it pulled the hydraulic hose off its fitting.
