MIFACE Investigation Report: #14MI118

Subject: Farm Worker Died When Unsupported Combine Head Fell Onto Him During Repair Activities in a Bean Field

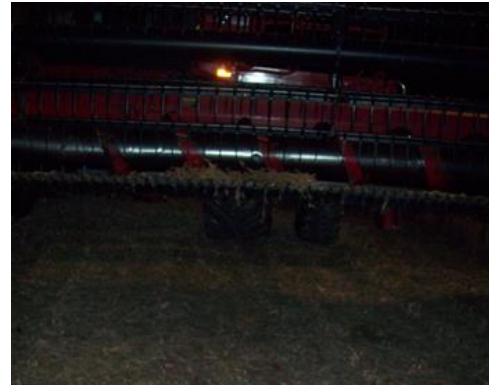
Figure 1. Combine and header involved in incident in field.

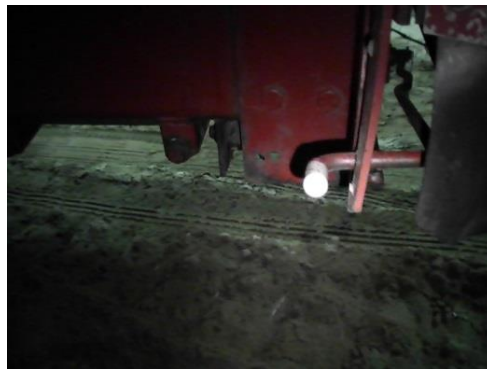
Figure 2. Sensing adjustment to the combine head.

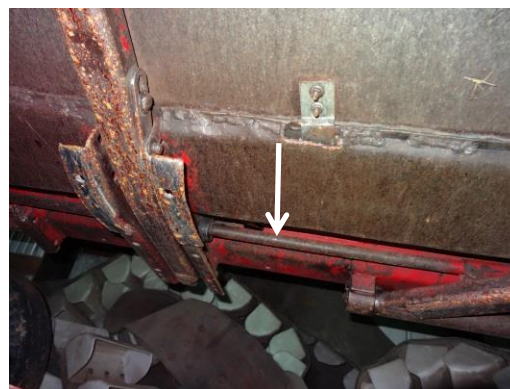
Figure 3. Arrow pointing to sensing rod he may have been trying to unjam.
