TO: Director, National Institute for Occupational Safety and Health

FROM: California Fatality Assessment and Control Evaluation (CA/FACE) Program

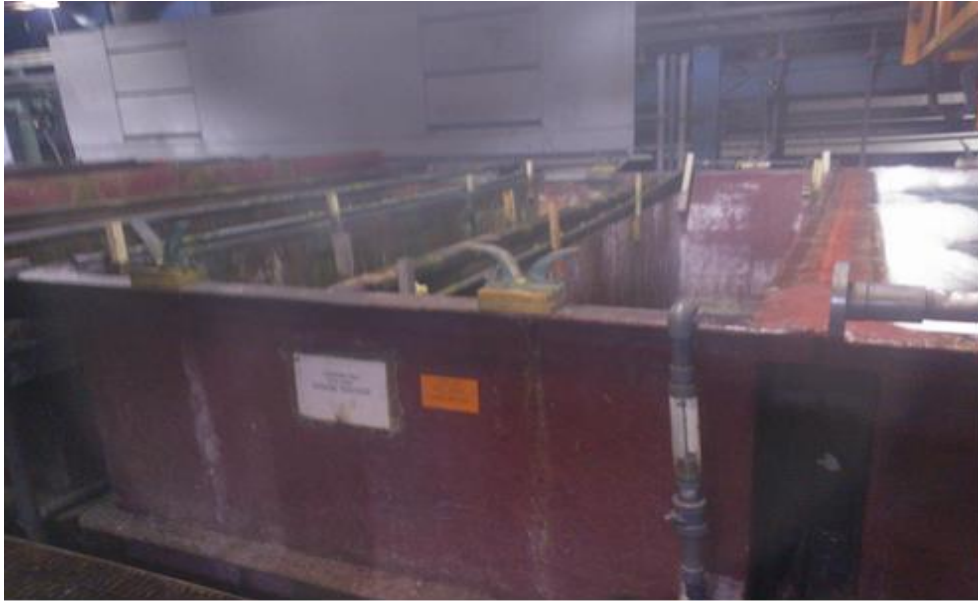
Exhibit 2. The chrome plating tanks.
