# Fatality Investigation Report

OR 2005-43-1

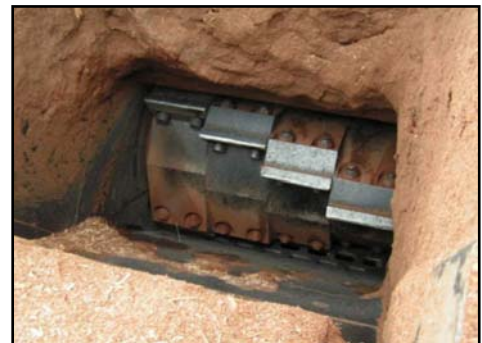
Looking down the throat of the hog inside the infeed chute of the wood chipper shows the hammers that pulverize wood into boiler fuel.

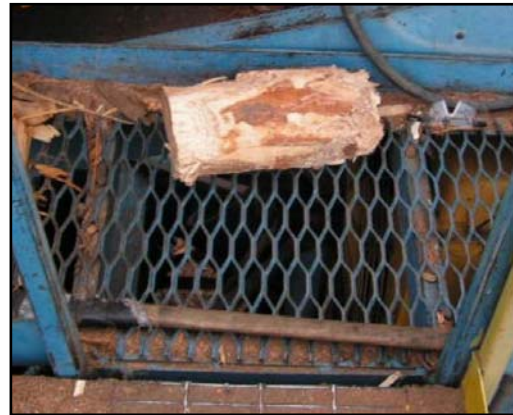
The 18-inch chunk of wood that struck the victim was only slightly shaved by the hog before it was forcefully ejected beyond the open hood of the bin.
