The National Institute for Occupational Safety and Health (NIOSH)

Promoting productive workplaces
through safety and health research / **NIOSH**[®]

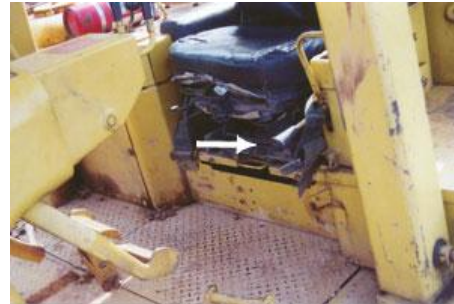
Figure 2. The arrow points to the transmission neutral safety lock.
In this position, as it was found, the bulldozer is ready for immediate movement.
Pushing the lever down towards the floor board locks the transmission into neutral.

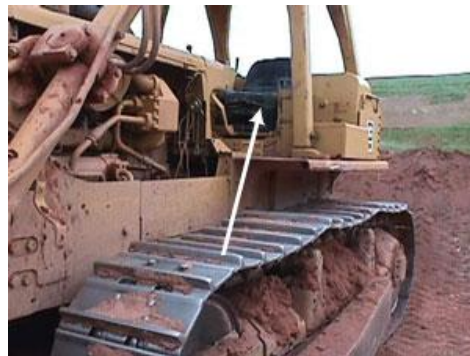
Figure 3. The arrow represents the victim's reported path of bulldozer access.
The tip of the arrow indicates the location of the transmission selector control.

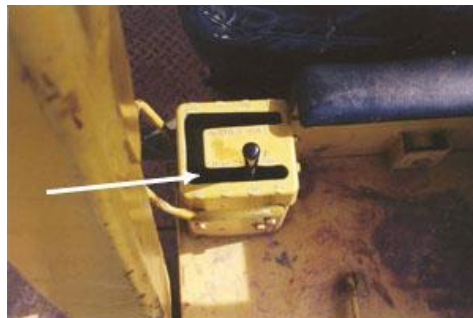
Figure 4. This photo shows the transmission selector lever in 2nd speed reverse as it was found after the incident.
The arrow represents direction of the victim's access as well as the direction of lever movement.

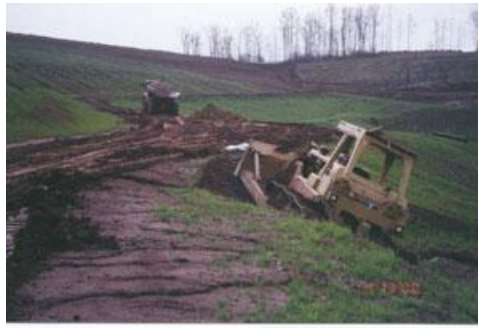
**Figure 5. This was the bulldozer's final resting place.
It was found running at full throttle in 2nd speed reverse, beginning to bury itself.**
