Four Construction Workers Die after Cantilever Launching Gantry Collapses at Bridge Construction Site - Ohio

Fatality Assessment and Control Evaluation (FACE) Program

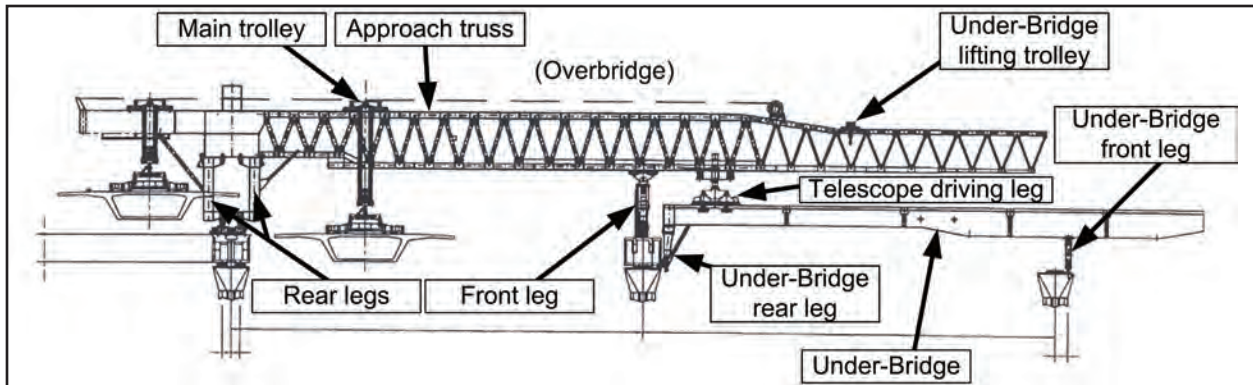
Figure 1³. Main components of the cantilever launching gantry (Courtesy of the General Contractor.)
