FACE Report Number: 2003-12

January 23, 2004

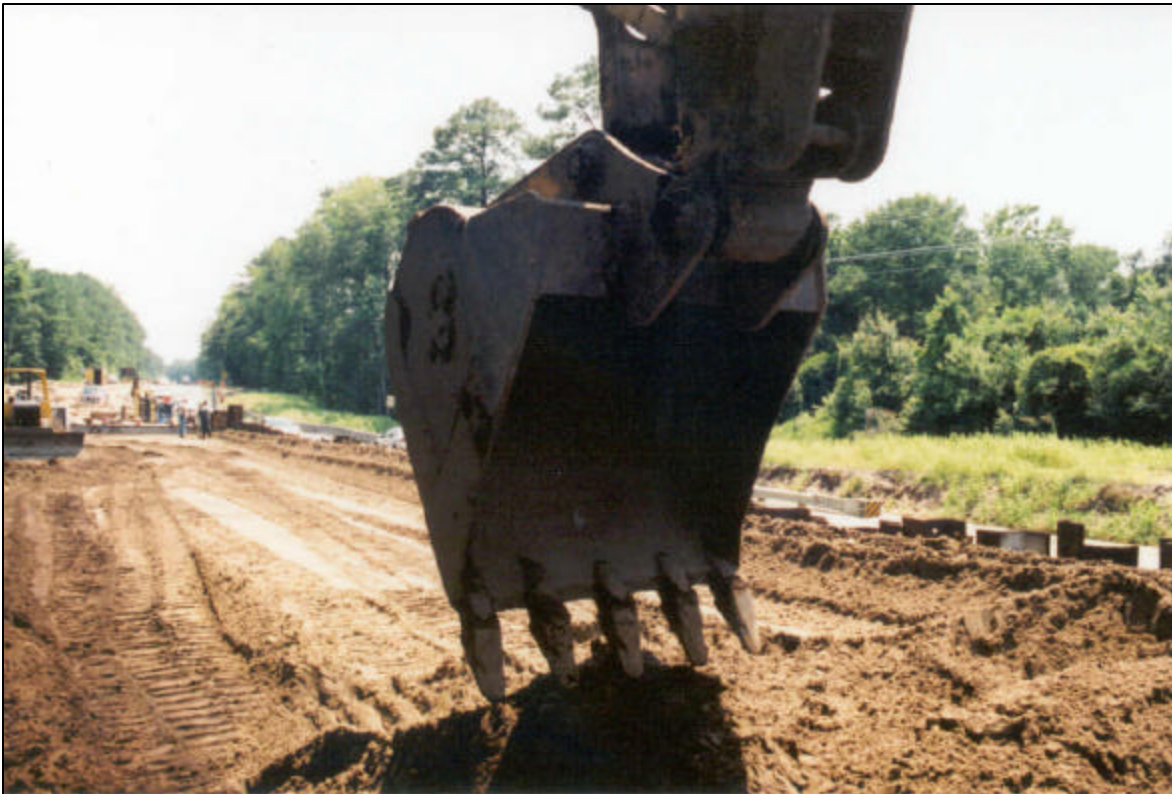
*Photo 1. Excavator bucket and bucket teeth*

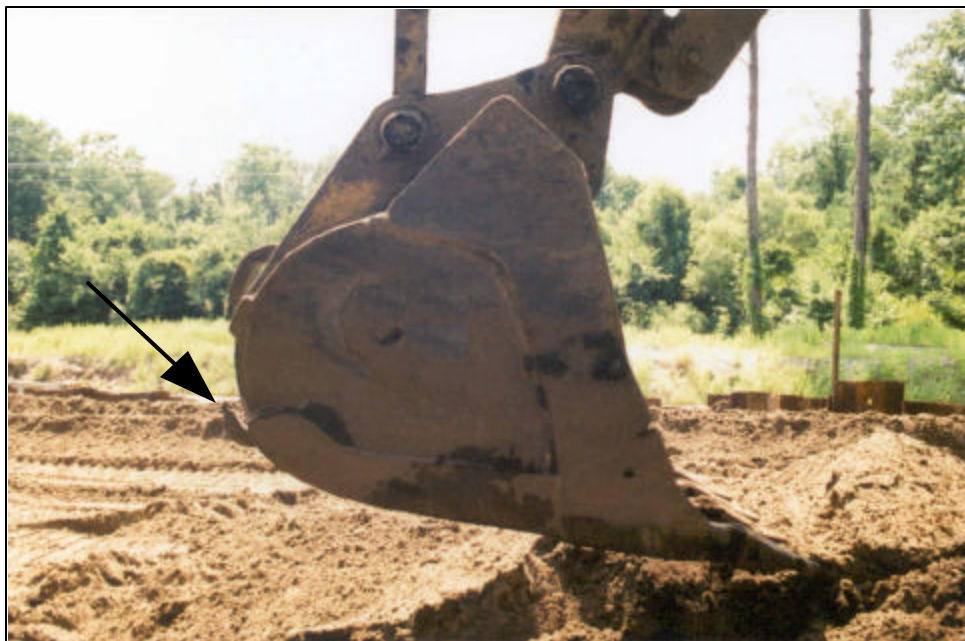
*Photo 3. The arrow points to the hook on the bucket used to attach the rigging*
