FACE Report Number: 2002-04

August 26, 2002

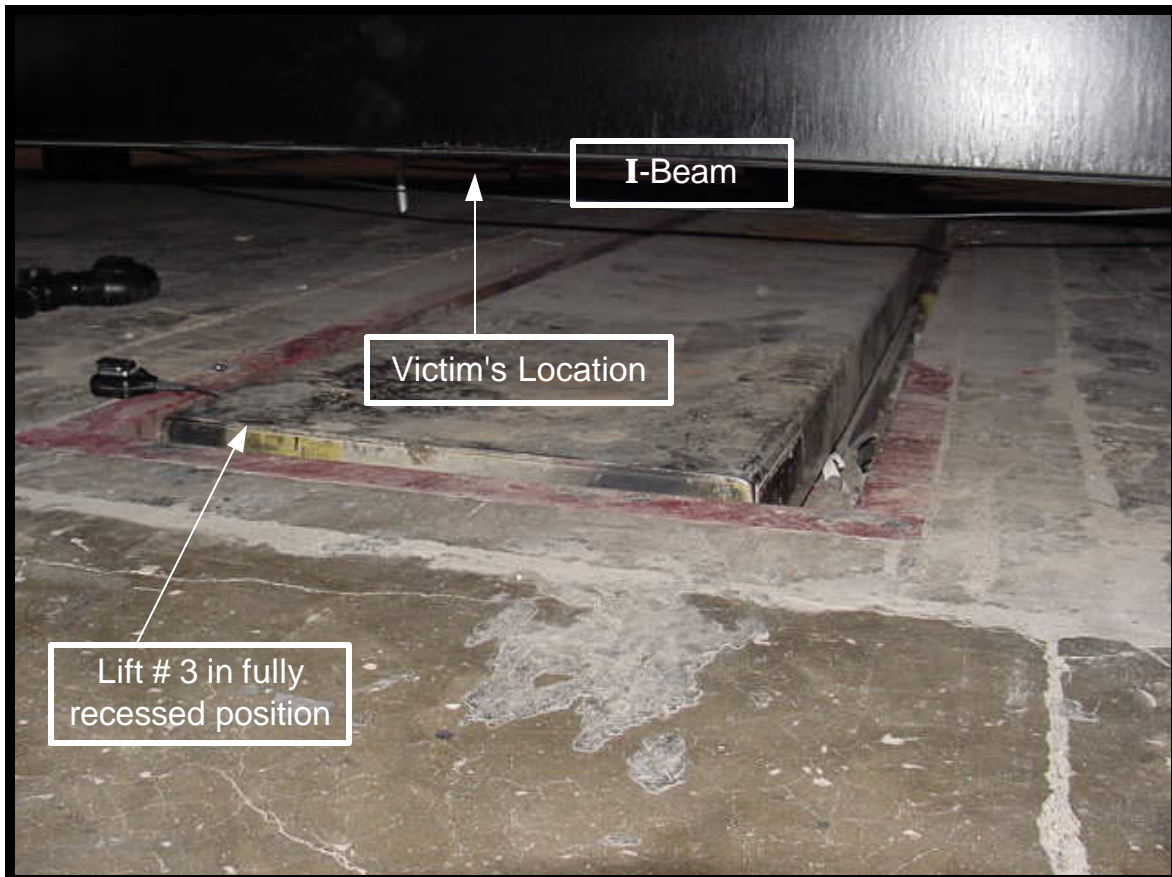
Photo 3: This photograph illustrates tandem lift #3 where the victim was lying when the scissors lift was activated. An arrow indicates the black I-beam beneath which the victim was located. The lavatory drain was found on the floor to the left of the lift after the incident. Photo courtesy of TOSHA.
