Fatality Assessment and Control Evaluation Program

Division of Safety Research • 1095 Willowdale Road • Morgantown, West Virginia 26505 • Phone: (304)285-5916

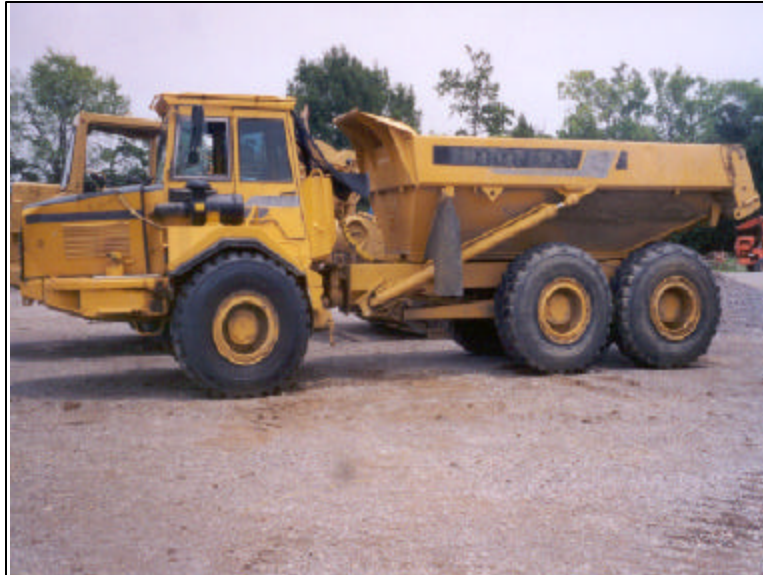
Machine involved in incident

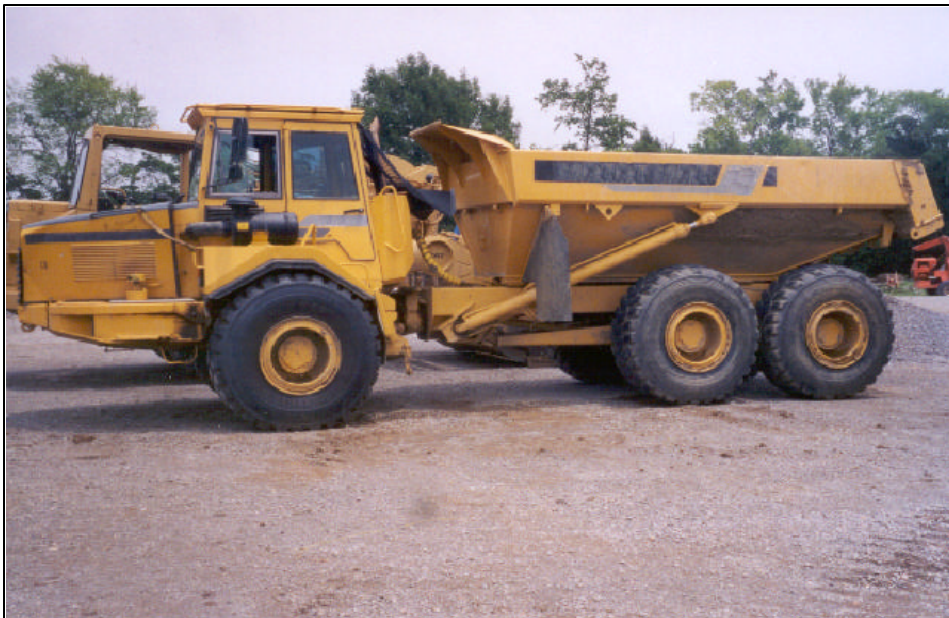
Photo1. This photo illustrates the machine that was being serviced at the time of the incident.

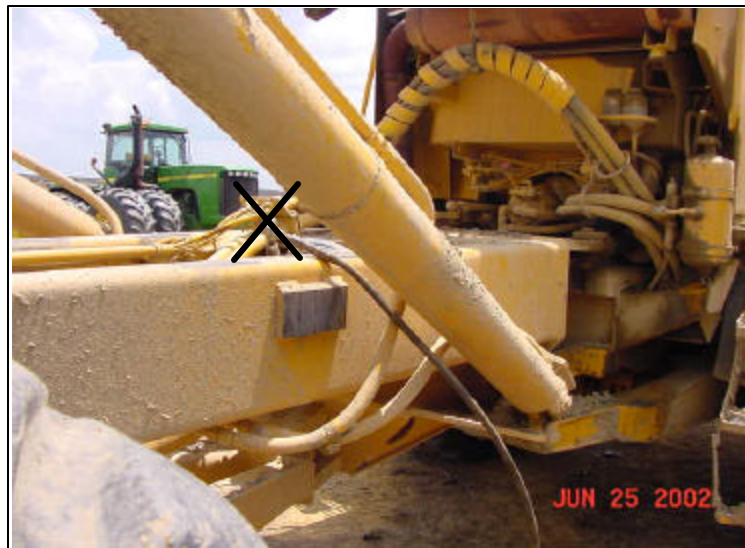
Photo 3. This photo illustrates the area of the truck where the victim was working at the time of the incident. Note the grease gun's rubber hose. The X demonstrates the approximate location of the victim following the incident. Photograph courtesy of TOSHA.
