HETA 78-000-012

HAZARD EVALUATION AND TECHNICAL ASSISTANCE REPORT  
TA 78-12  
OREGON STATE UNIVERSITY  
CORVALLIS, OREGON

May, 1978

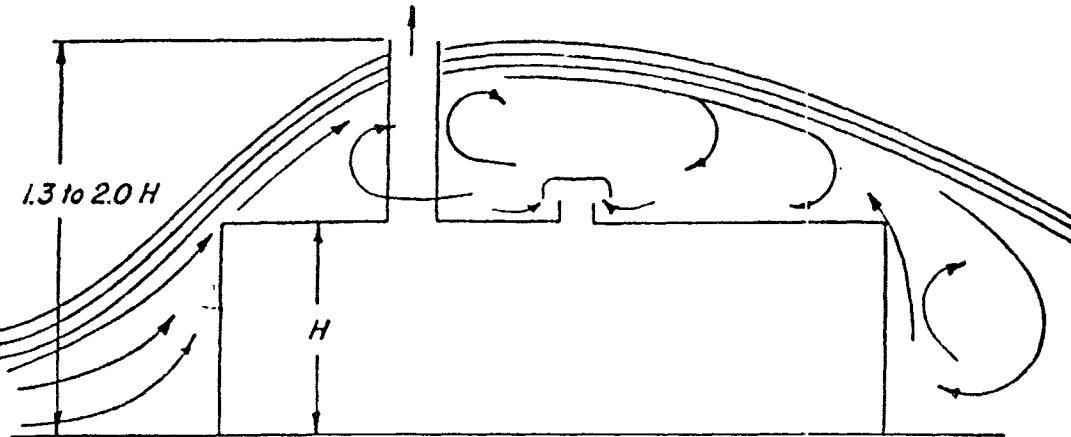
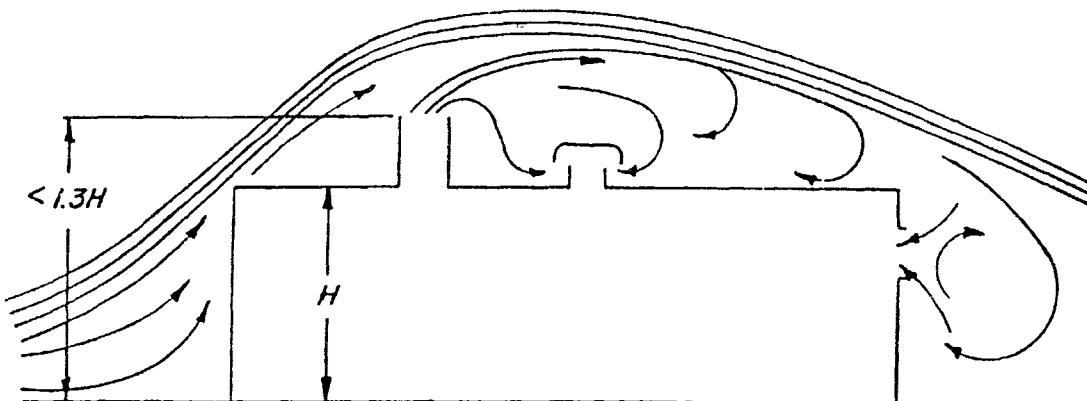
# ATTACHMENT 3

and the open windows on the upper floors. Most of the laboratory hood exhaust dischargers are on the south and east side of the mechanical rooms and exhaust horizontally and downward about two feet from the roof of the mechanical room. One unit exhausts vertically, however, there is no duct work above the fan outlet. There are two fan inlets on the east side of the mechanical room, one on the south and one on the north end, that supply air to the south and north controlled environment rooms located on the fourth floor. Because of the proximity of the hood exhaust dischargers to the supply air inlets, it is possible for reentry to occur. About 1½ years ago, the inlet to the south end air supply unit was revised. The new air inlet is just above the roof. In this position, reentry is still possible. A second place where reentry could occur is from the laboratory exhaust dischargers located across the quad-rangle from the new addition. These dischargers exhaust horizontally toward the supply air of the new addition. The old portion of the building contains one less floor than the new addition, so these discharge points are just slightly lower than the air intakes on the new portion. The prevailing wind is from the old to the new portion of the building making reentry possible. A third place for reentry is through open windows on the upper floors. Again, because the exhausts are discharged horizontally, under certain weather conditions reentry could occur.

*GOOD*

*High discharge stack relative to building height,  
air inlet on roof.*

*POOR*

*Low discharge stack relative to building height,  
air inlet on roof and wall.*

It is recommended that all the laboratory exhaust air be discharged vertically through exhaust stacks that extend above the mechanical rooms far enough to not be affected by the local meteorological conditions. Attachments #2 and #3 describe how the exhaust systems should be designed and placed.
