# PPE CASE

## *Personal Protective Equipment Conformity Assessment Studies and Evaluations*

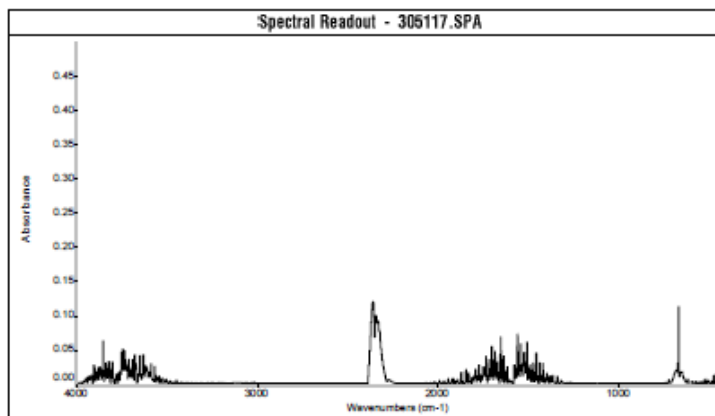
IMPORTANT: This air/gas or substance was tested ONLY against a specified standard and may contain undetected items which are beyond the purpose or scope of this analysis. More extensive testing can be conducted upon request. This does NOT guarantee the condition nor safe application of the analyzed air/gas or substance. Results reported relate only to the items tested. This report shall not be reproduced except in full, without the consent of Lawrence Factor, Inc. Methods used: FTIR, GC, electrochemical, microgravimetry, and sniffing. Estimated Measurements of Uncertainty values for the reported analytes are available upon request. This report / certificate is not issued for an unbounded duration. KIR#: 320265 - Frequency: Single - Date Received: 05/17/16 - Issue ID: LF305117 - Page 1 of 1

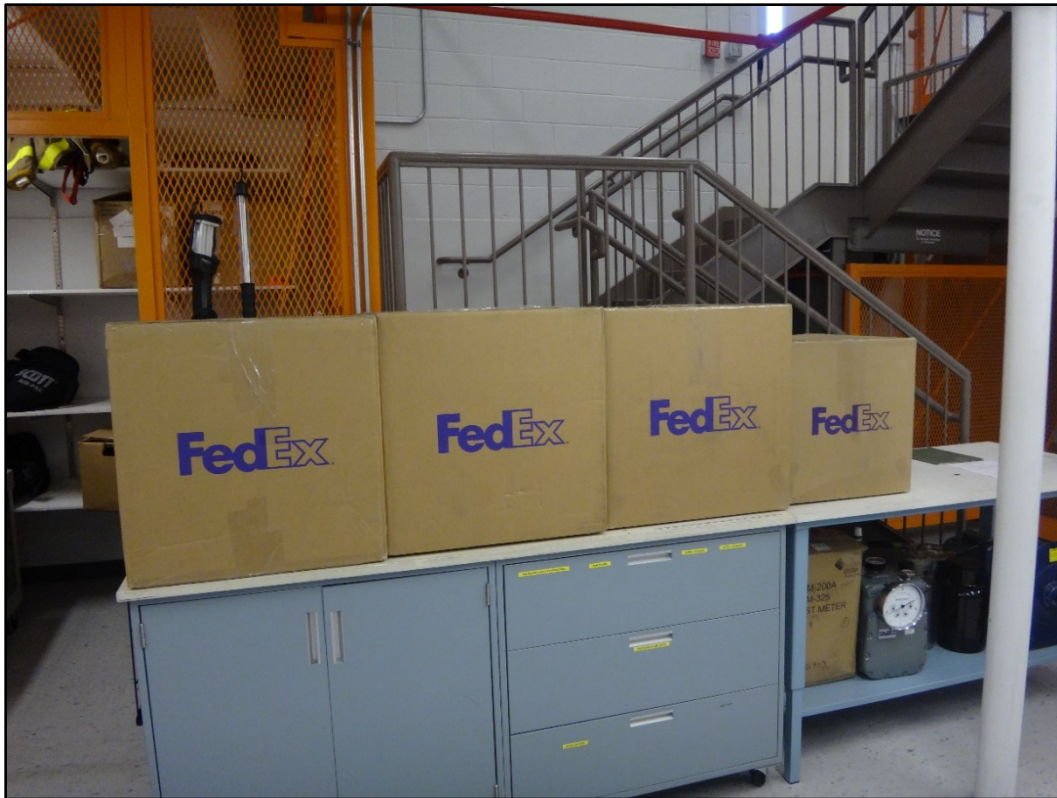
**Figure 1: Cardboard box containing SCBA**

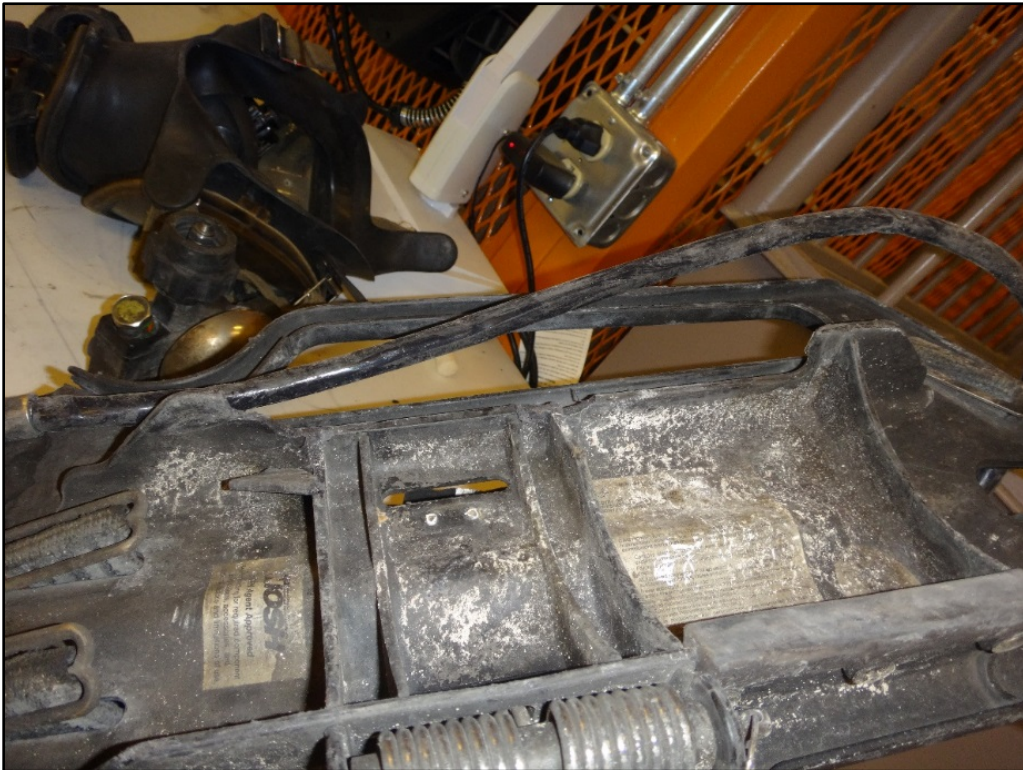
**Figure 29: Damage to right rib of backframe**

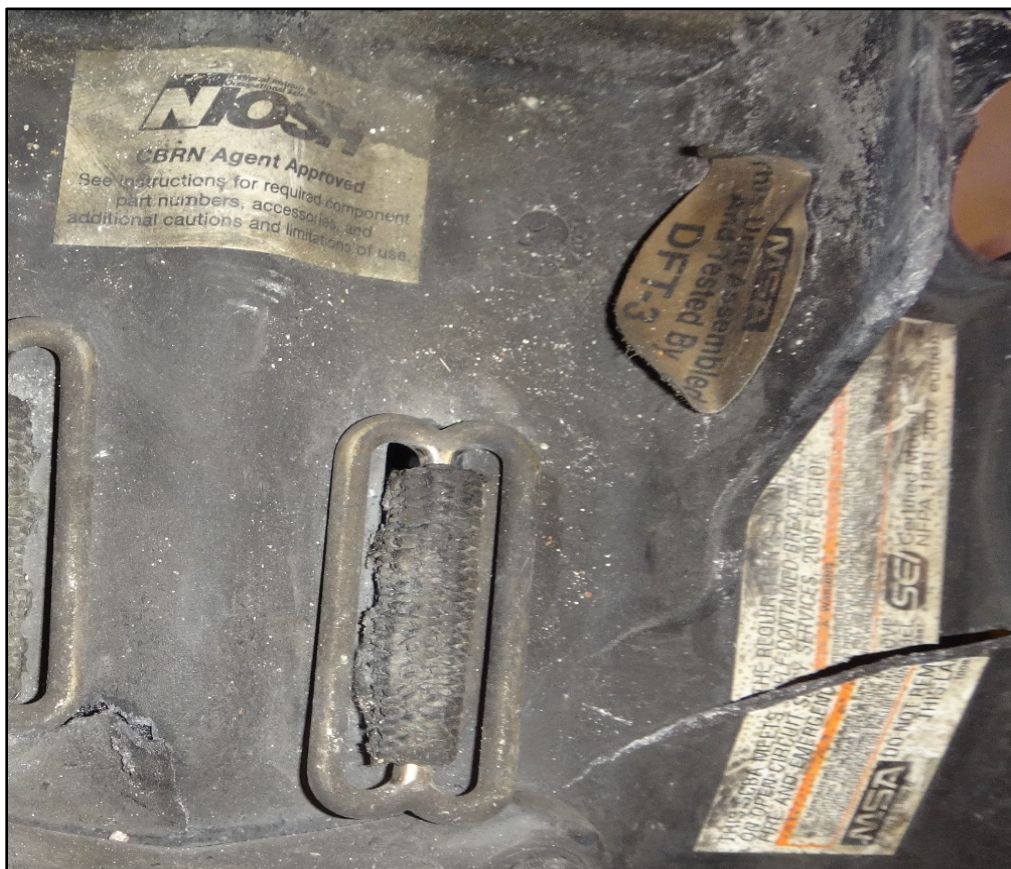
**Figure 30: Labels inside of pack, damage to left side**

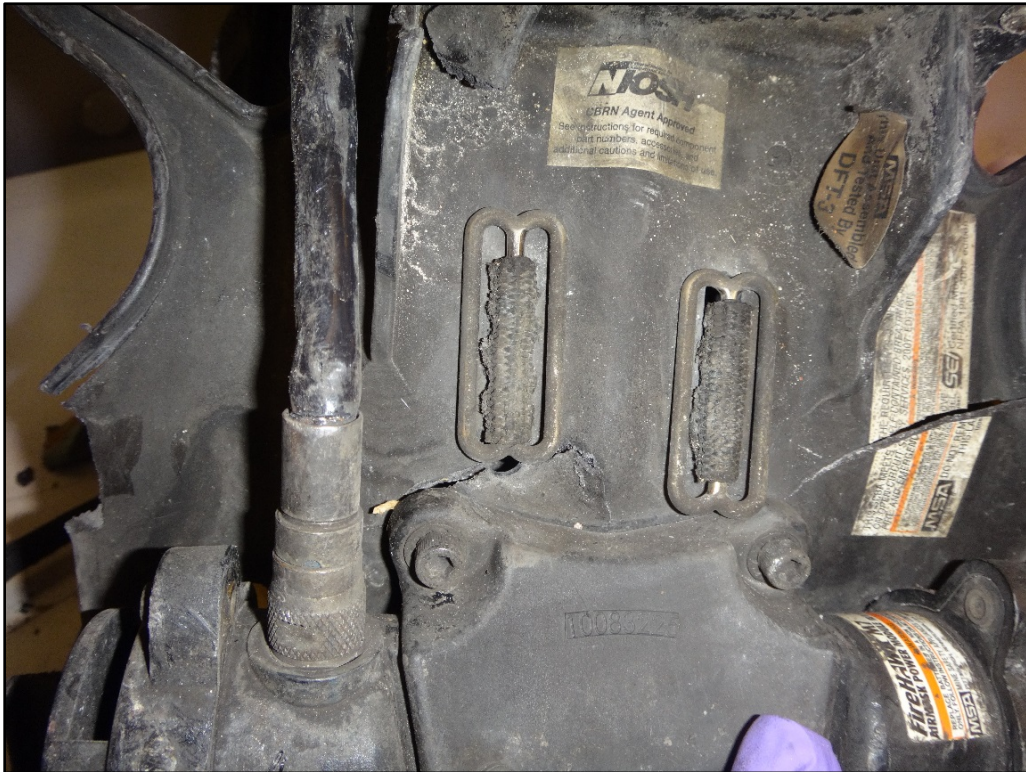
Figure 31: Damage/cracking to back frame at PASS control module connection

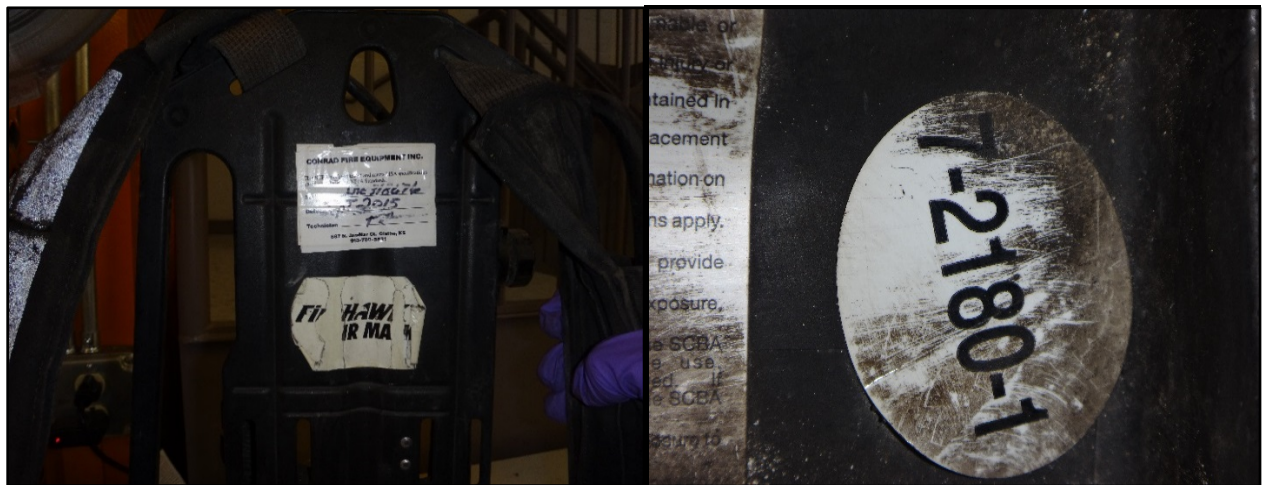
Figure 32: Labels on backframe

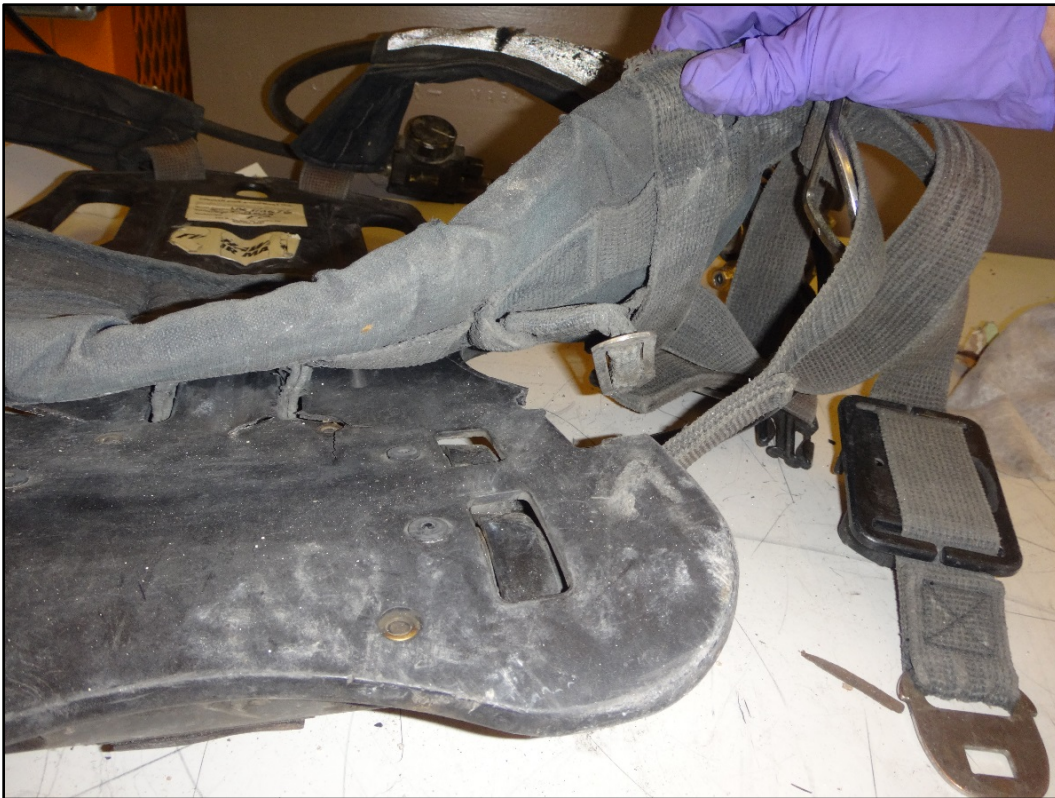
**Figure 34: Broken lumbar attachment**

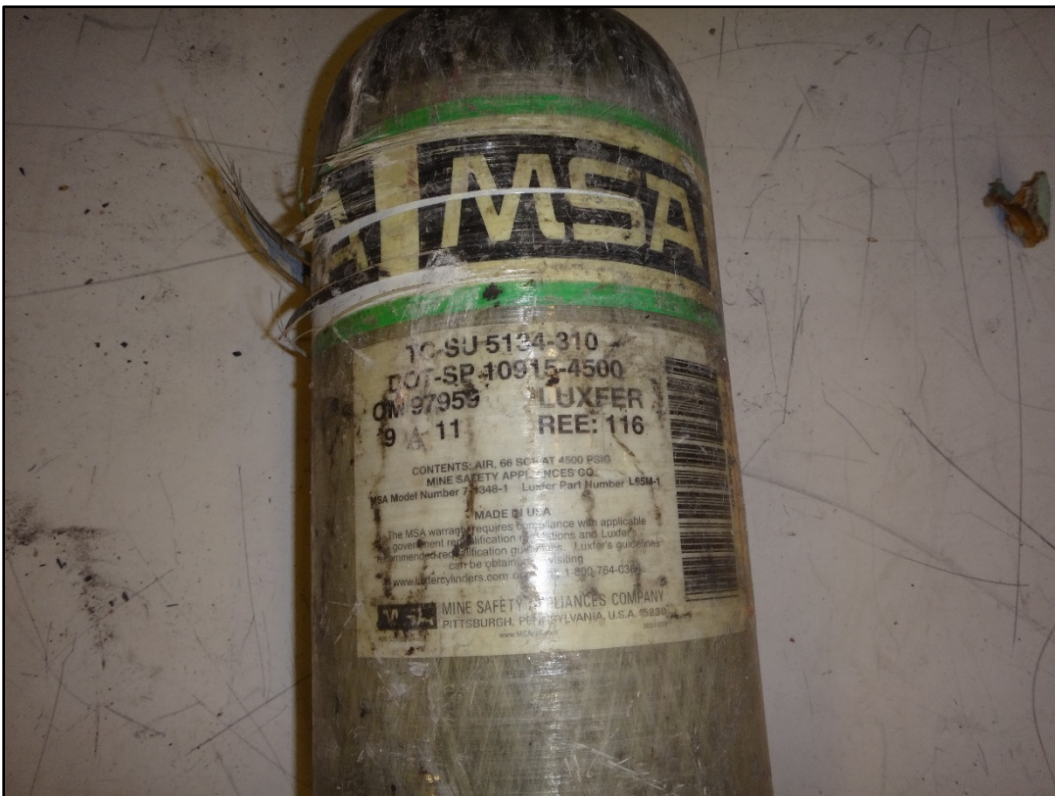
**Figure 35: Overview of cylinder label**

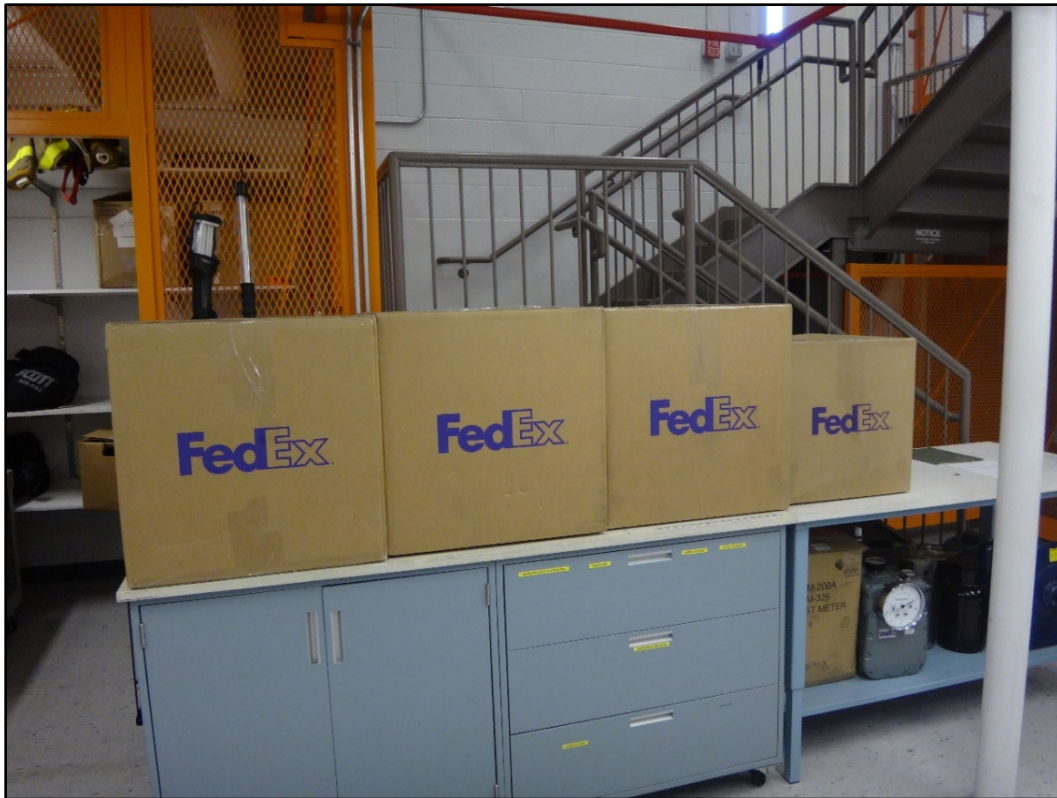
**Figure 1: Cardboard box containing SCBA**

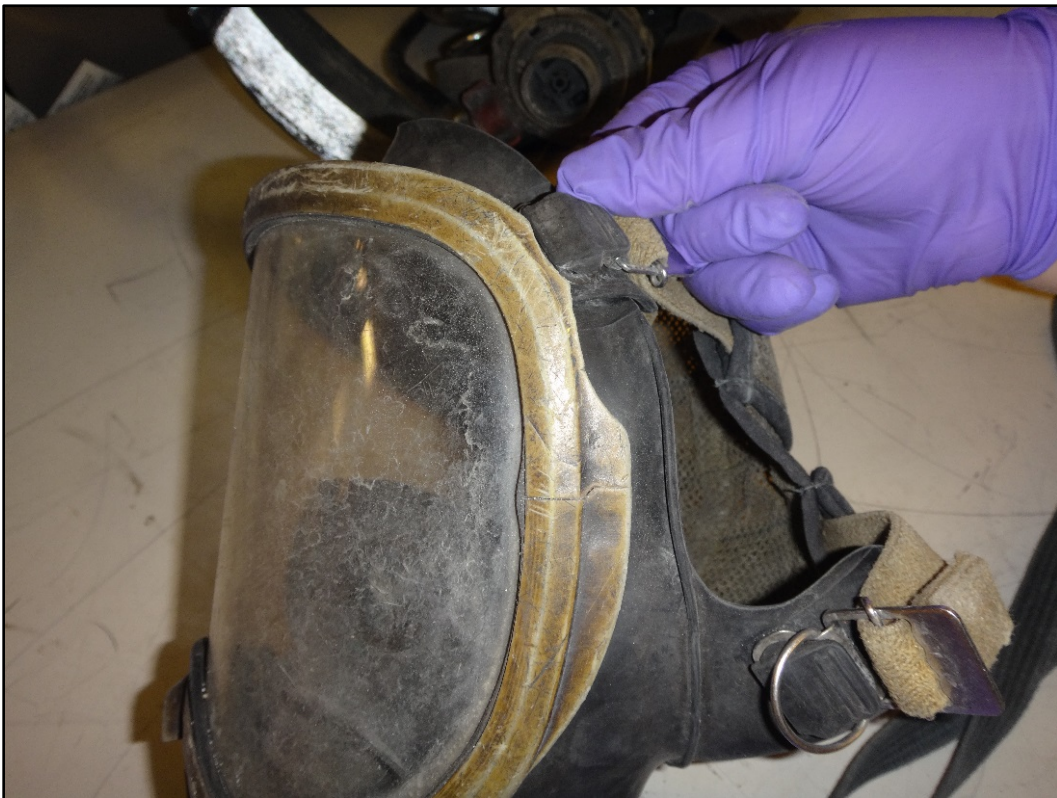
**Figure 8: Damage to upper left corner of lens retaining ring**

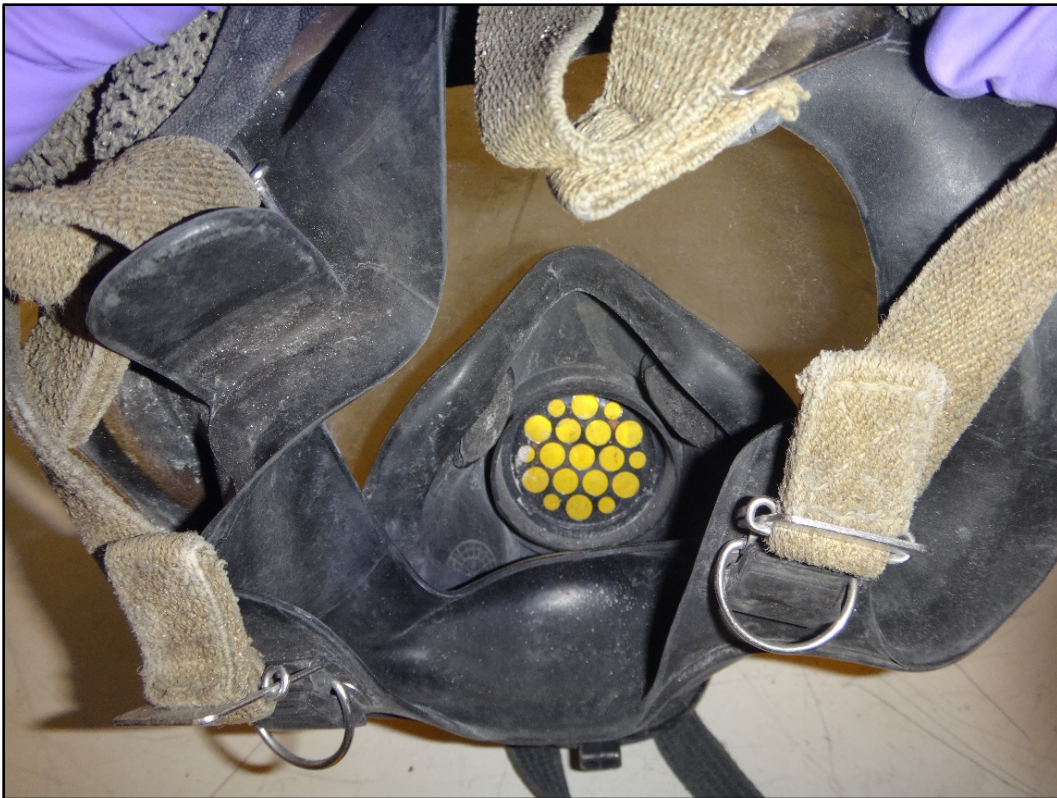
**Figure 9: Inside of facepiece one, HUD is not present**

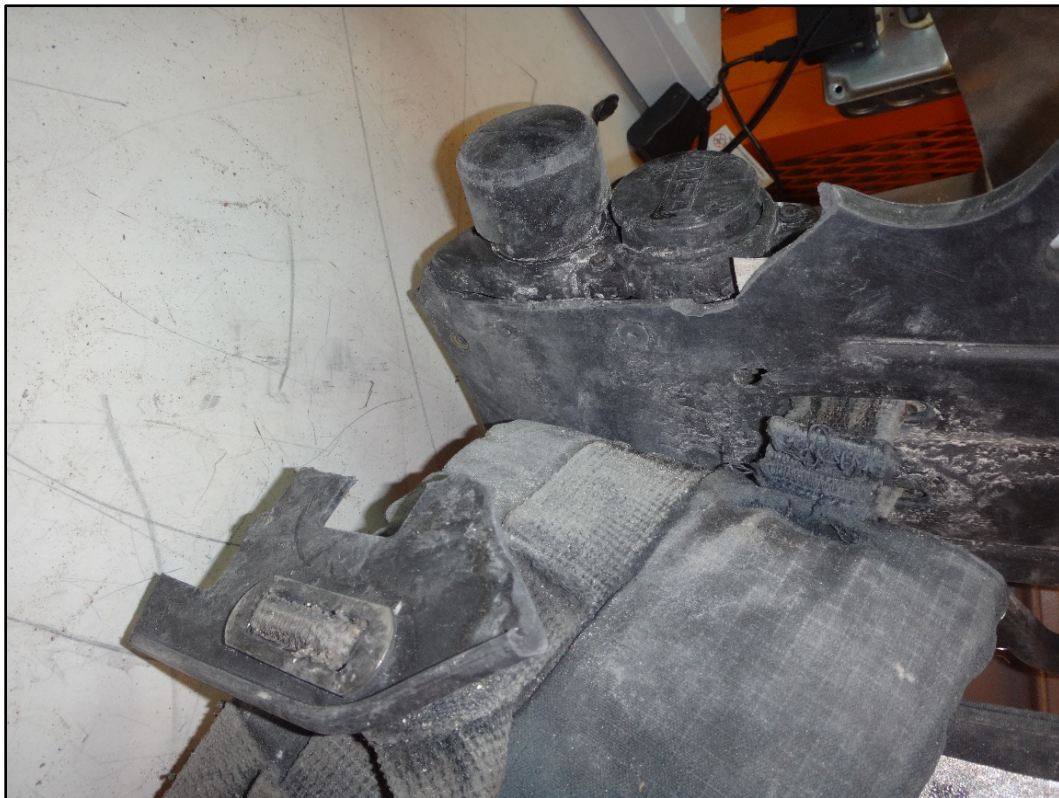
**Figure 30: Damage to pack at bottom right corner**

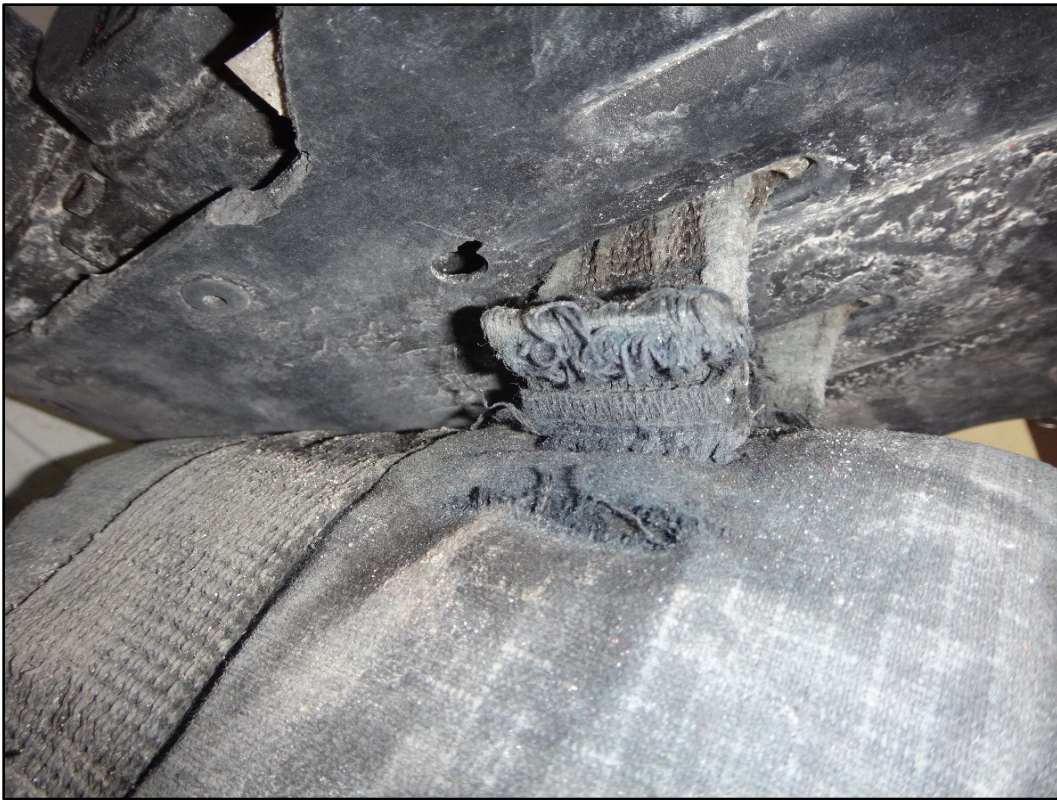
**Figure 31: Ripped attachment on lumbar strap**

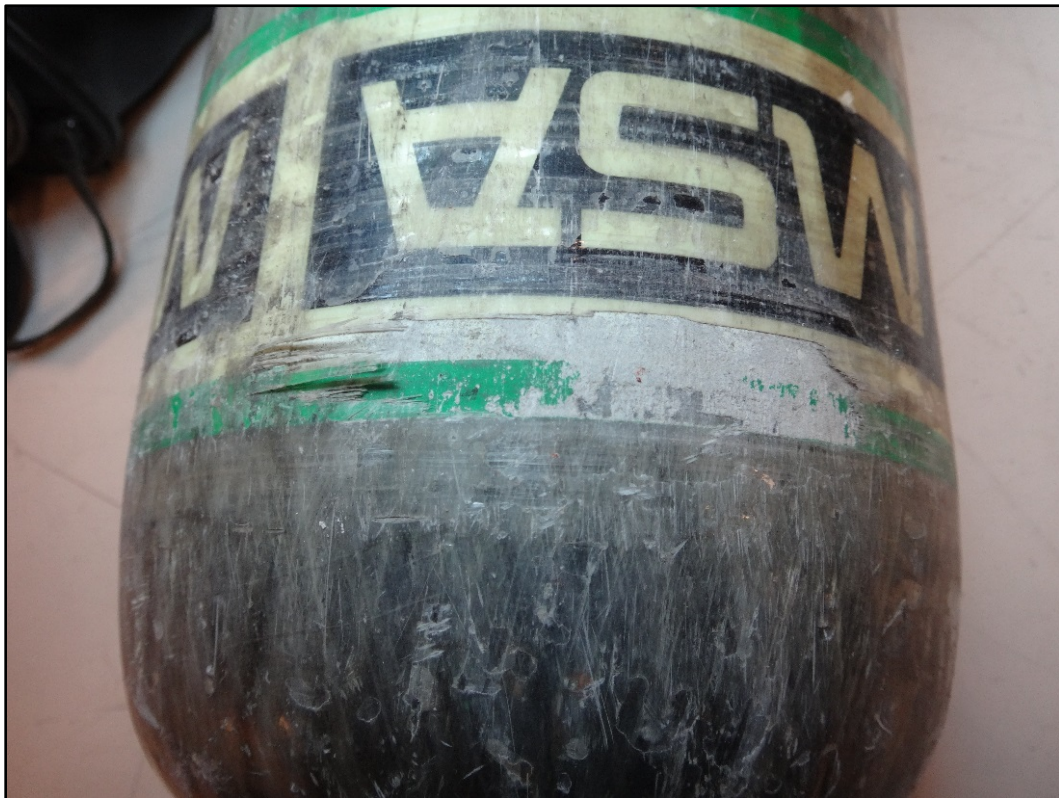
**Figure 38: Damage to cylinder coating**

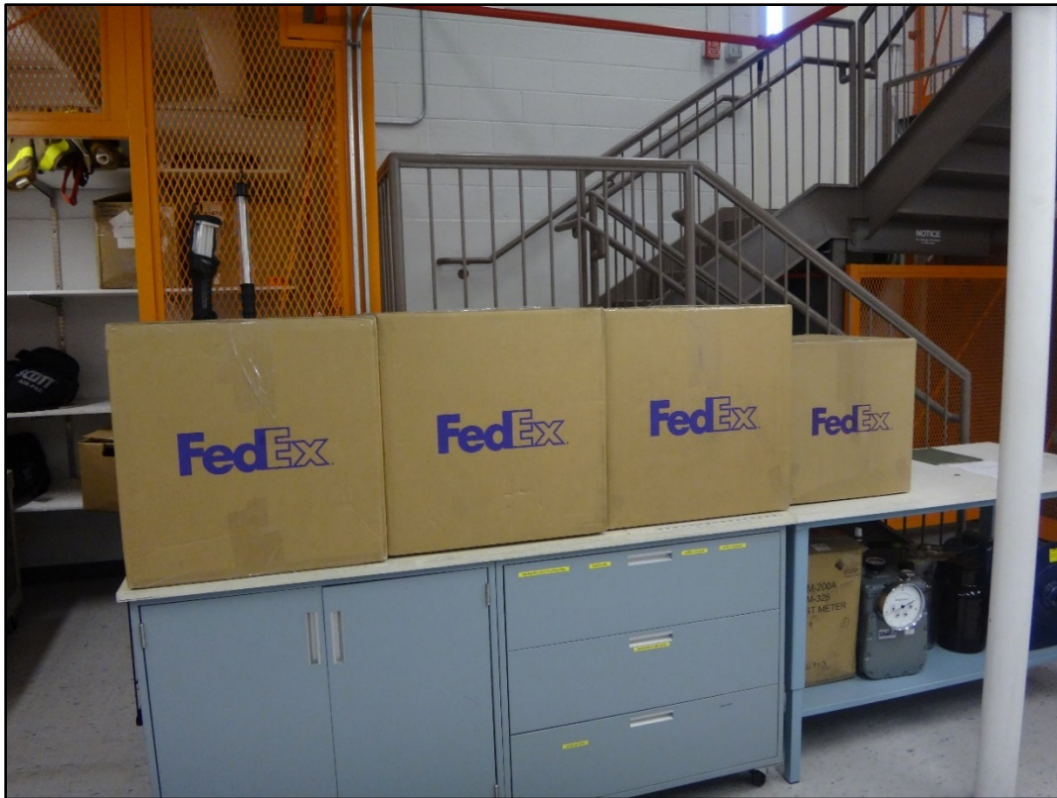
**Figure 1: Cardboard box containing SCBA**

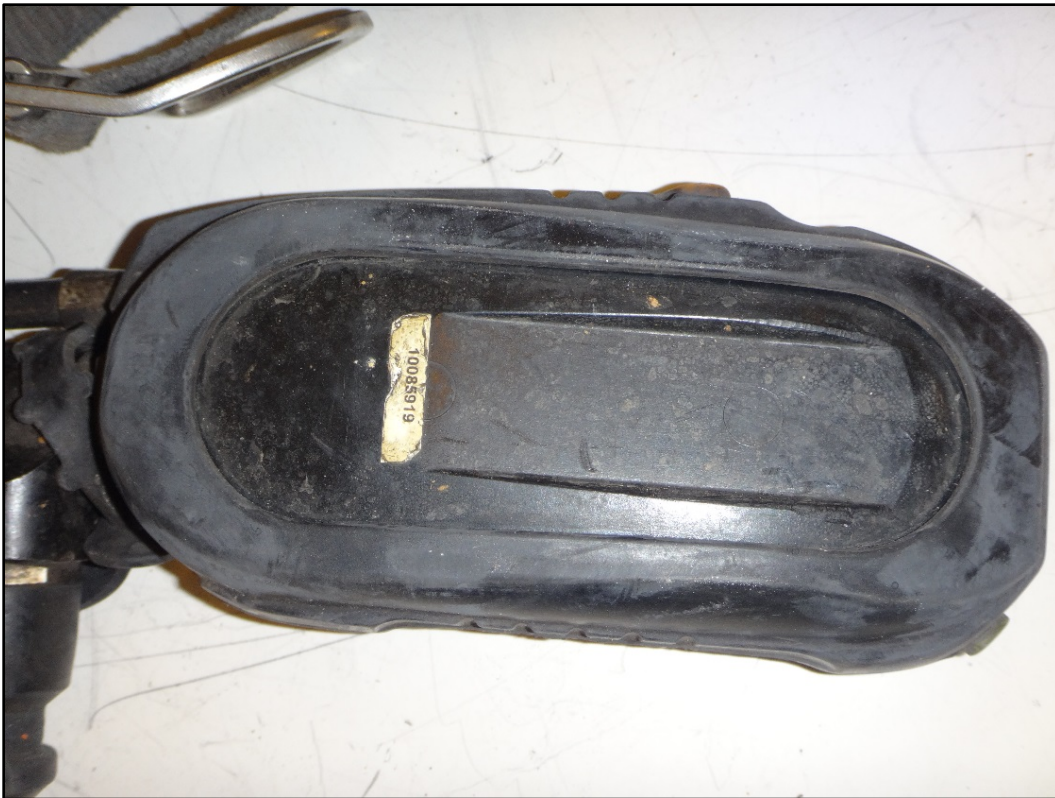
**Figure 15: Back of PASS console, SEI label missing**

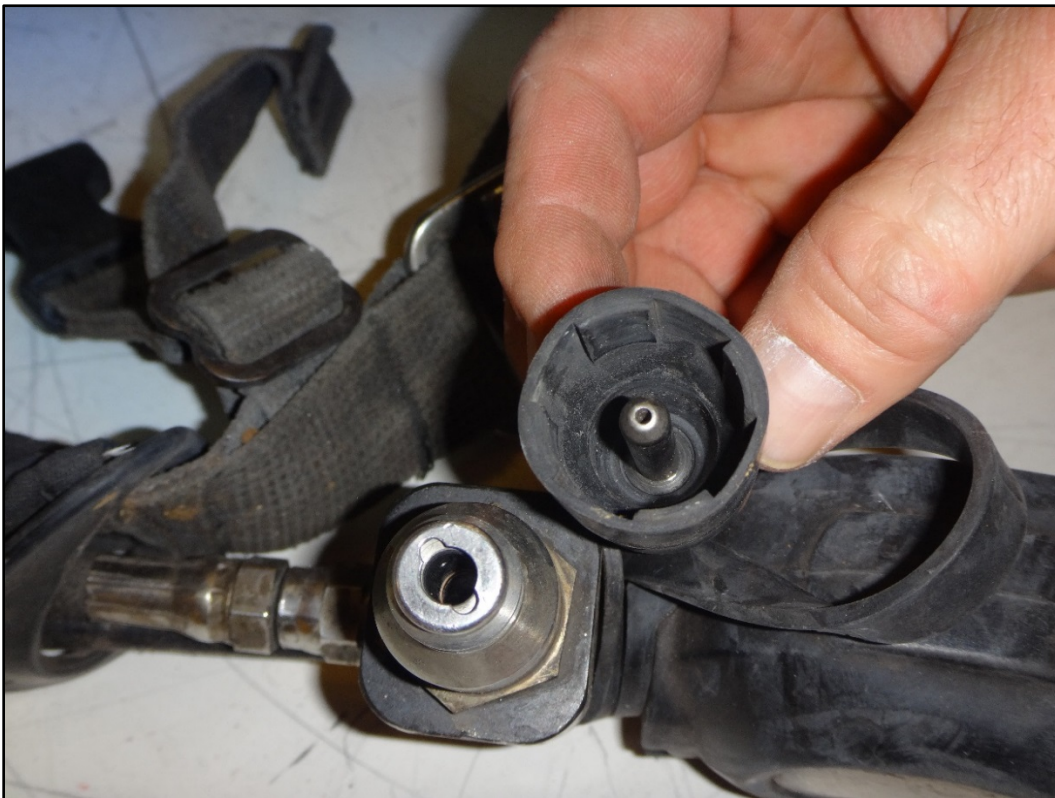
**Figure 16: Additional Quick-Fill port on console**

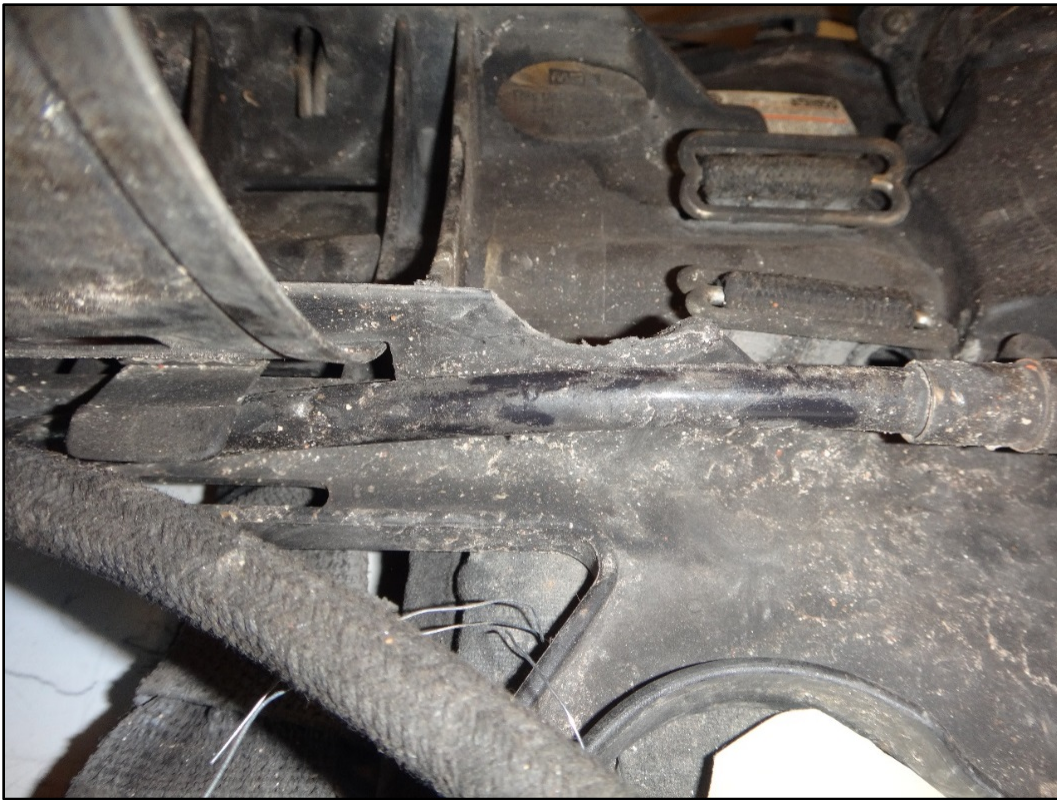
**Figure 21: Broken rib of back**

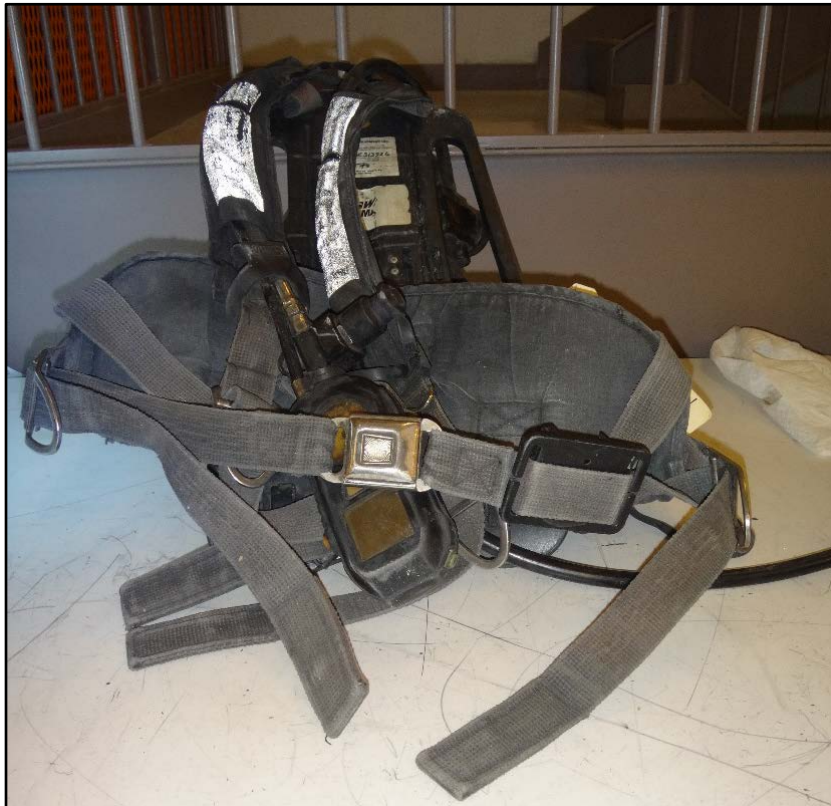
**Figure 22: Overview of buckles and straps**

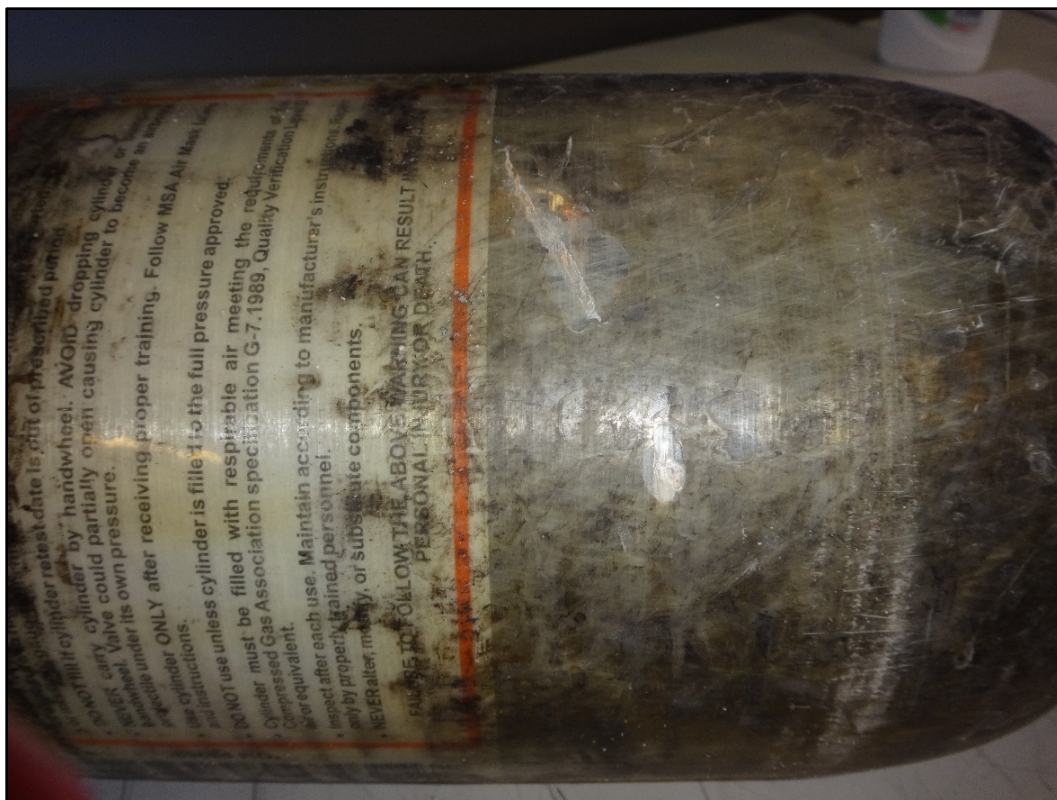
Figure 25: Damage to cylinder

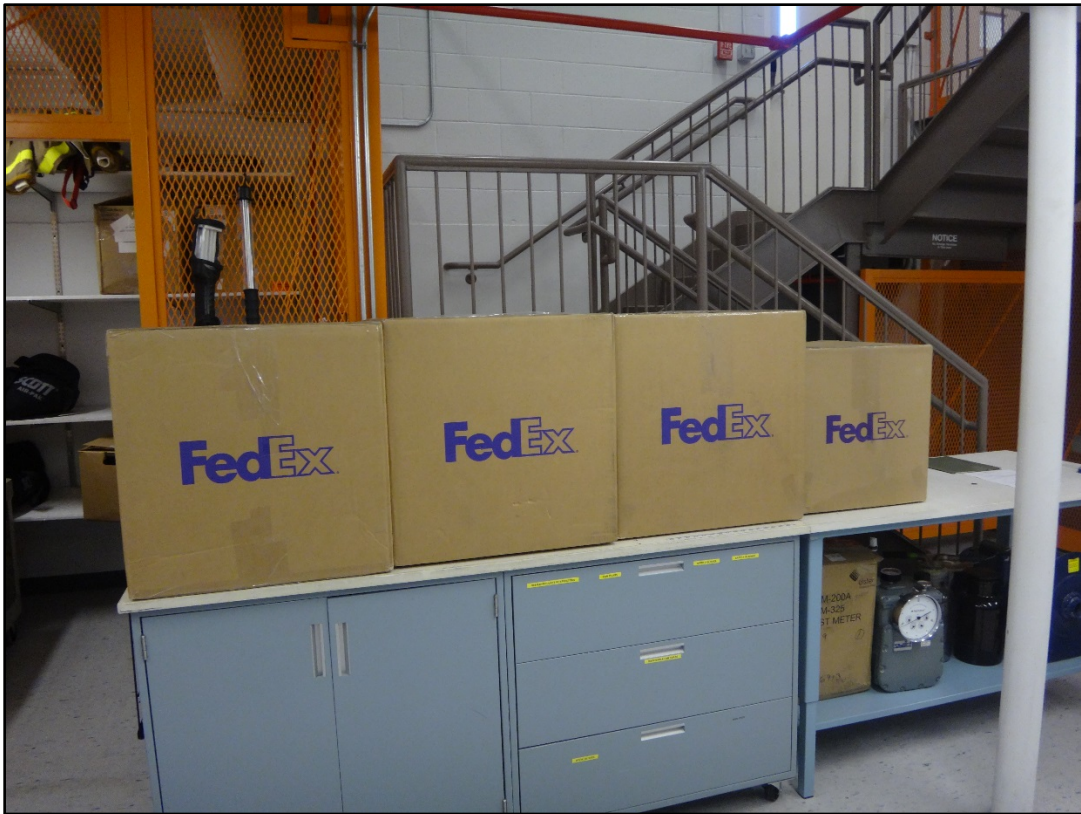
**Figure 1: Cardboard box containing SCBA**

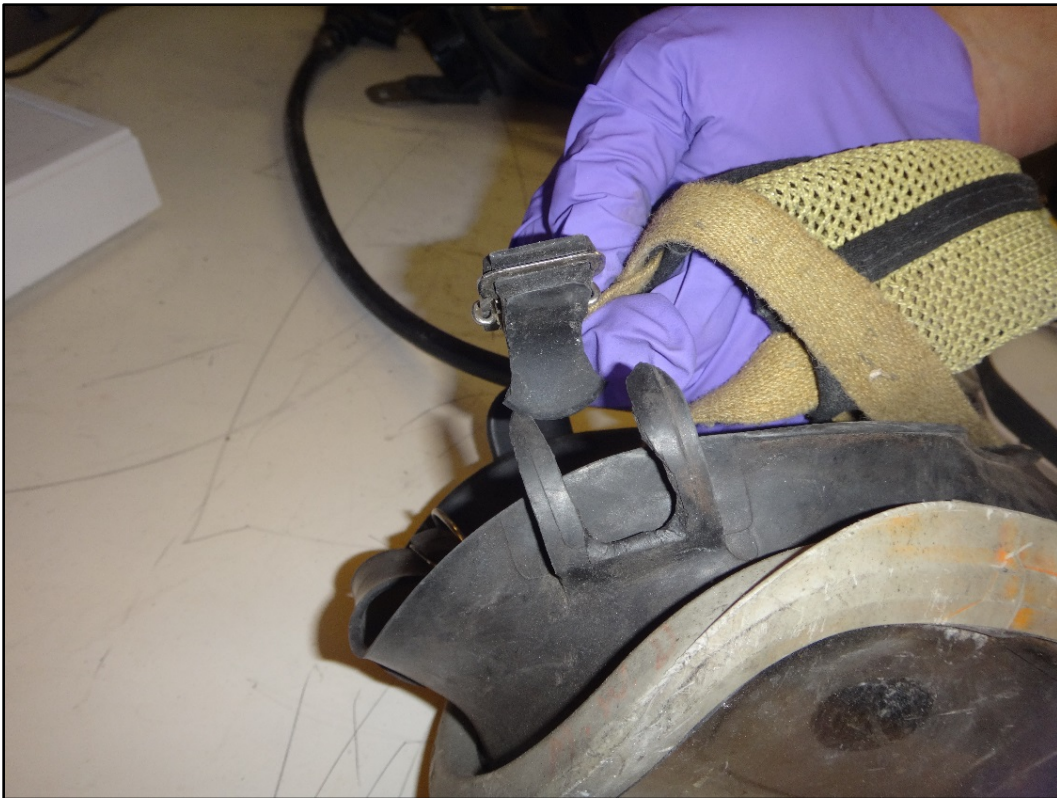
**Figure 5: Broken hairnet attachment, upper left corner of facepiece**

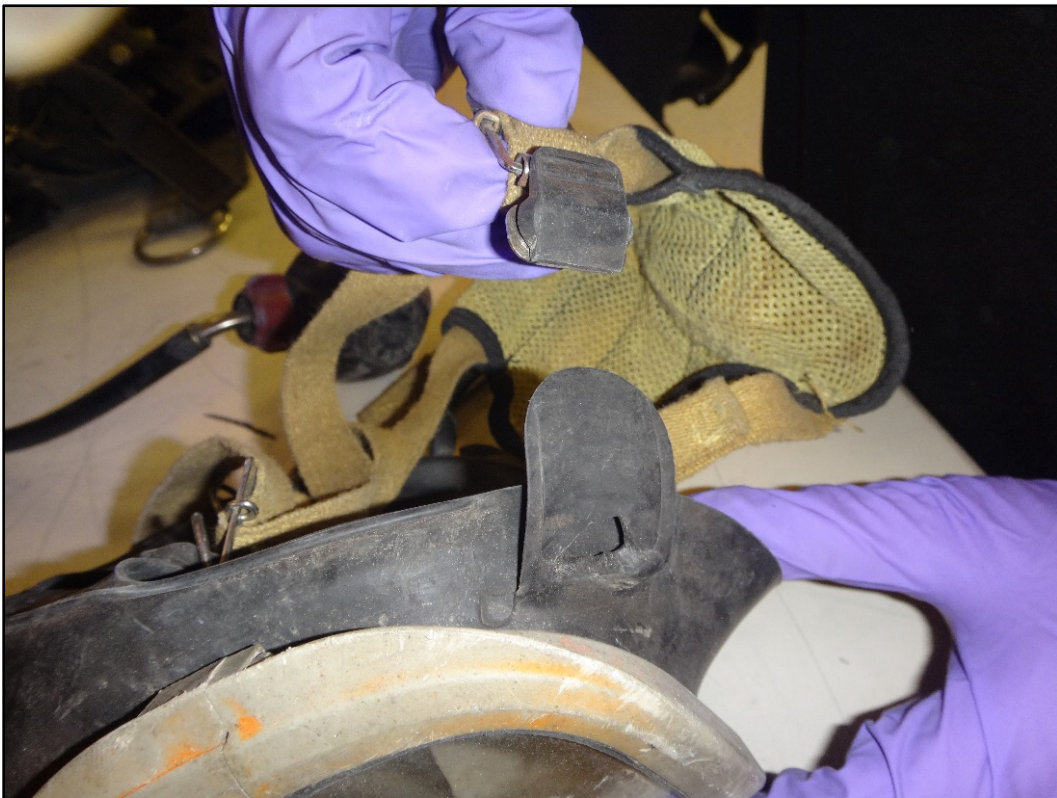
**Figure 6: Broken hairnet attachment, upper right corner of facepiece**

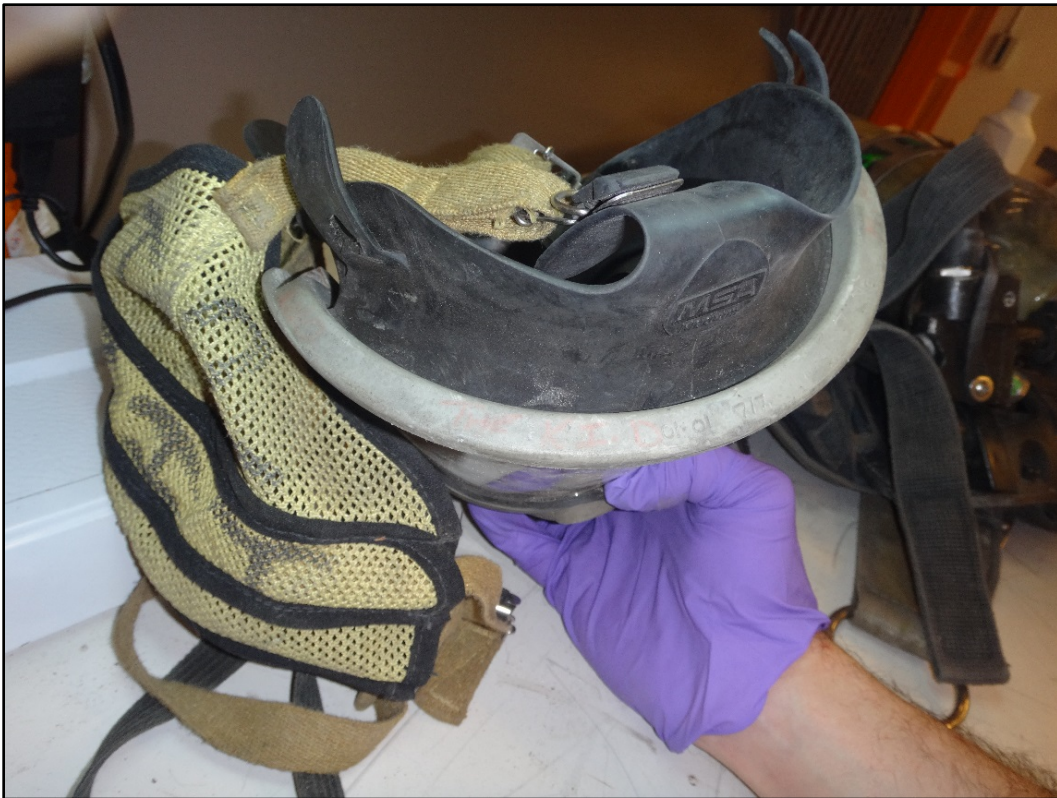
**Figure 7: Red markings “the Kid”**

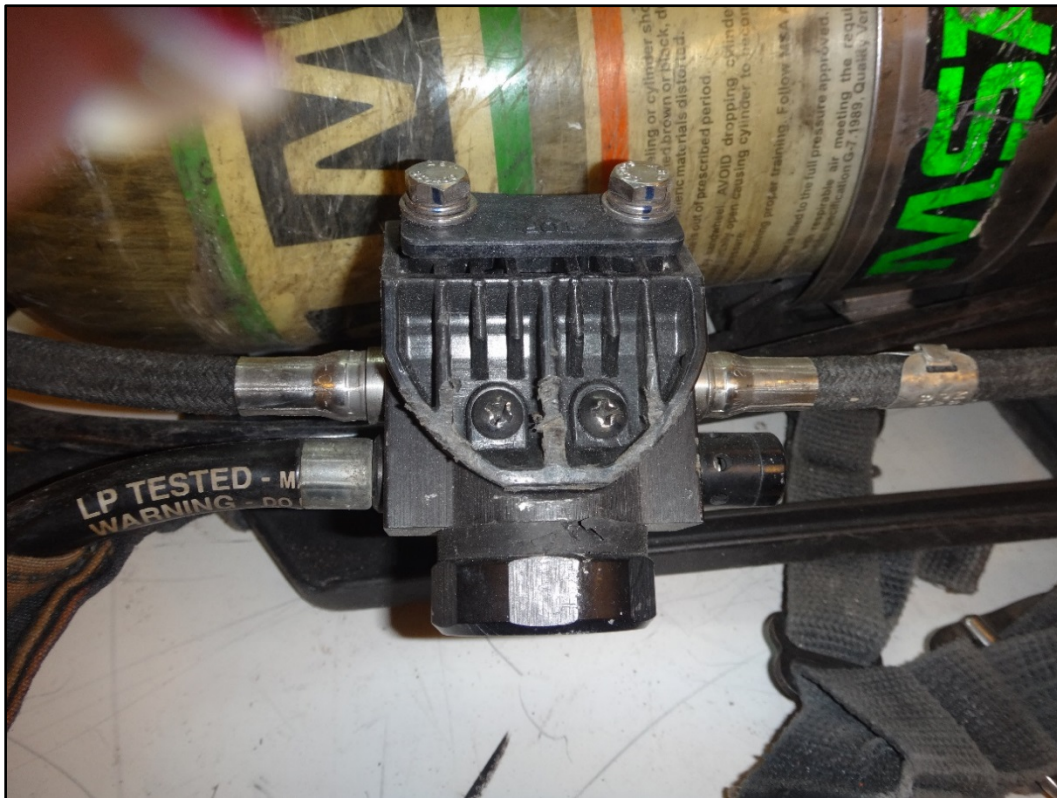
Figure 16: Pressure reducer assembly damage

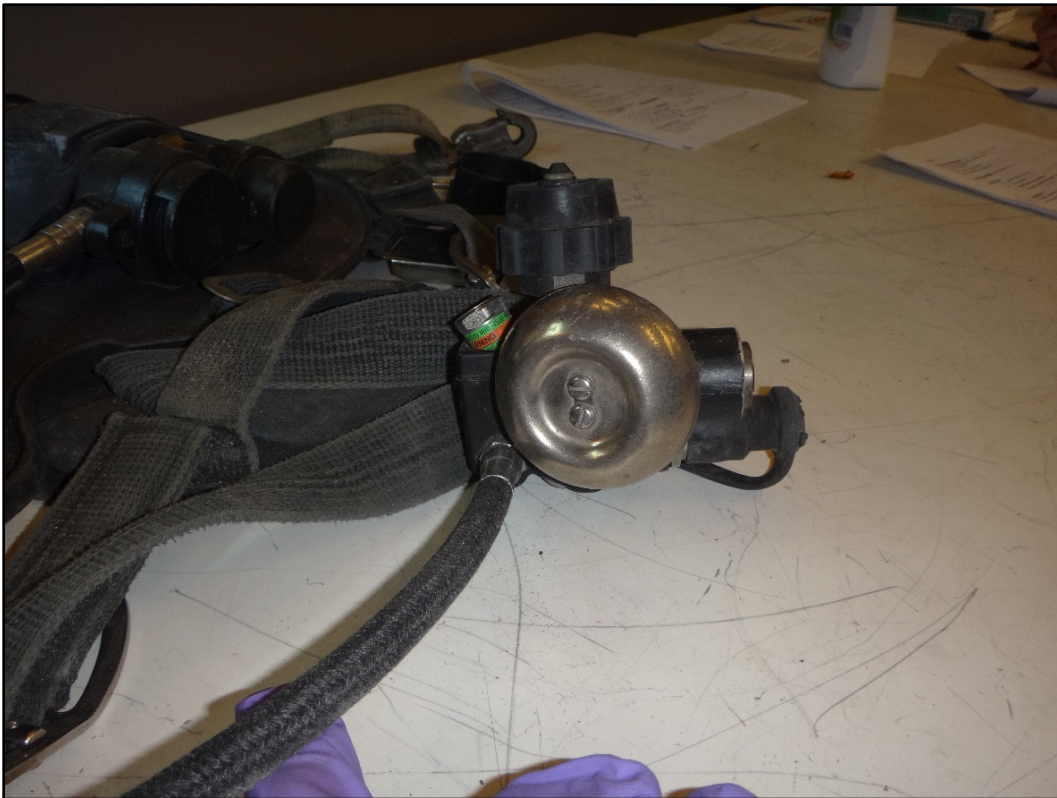
**Figure 17: High-pressure hose and cylinder attachment**

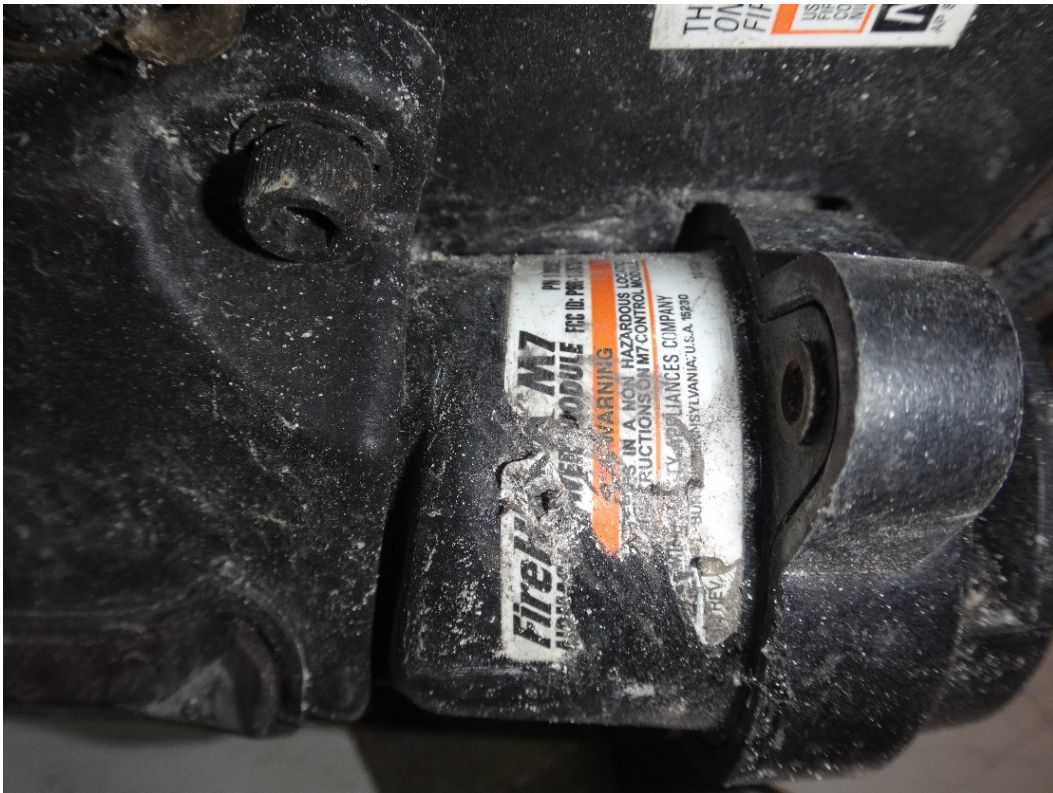
Figure 23: Damaged label on PASS control module

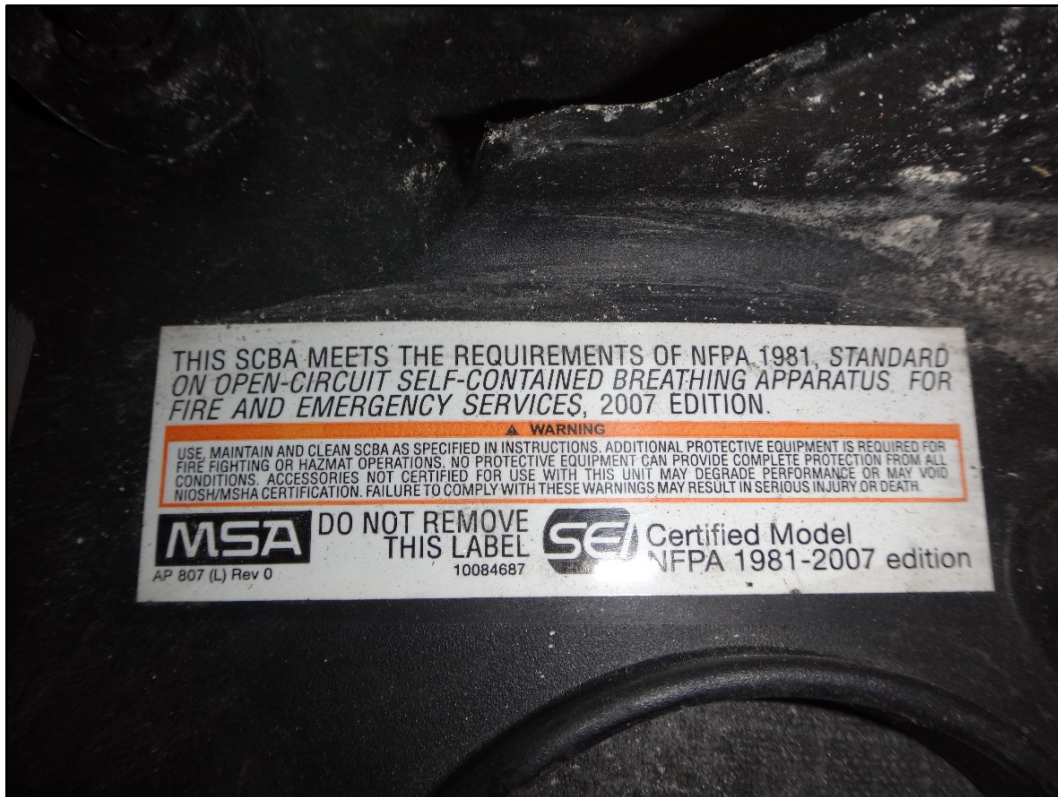
Figure 24: MSA label on pack
