# PPE CASE

## *Personal Protective Equipment Conformity Assessment Studies and Evaluations*

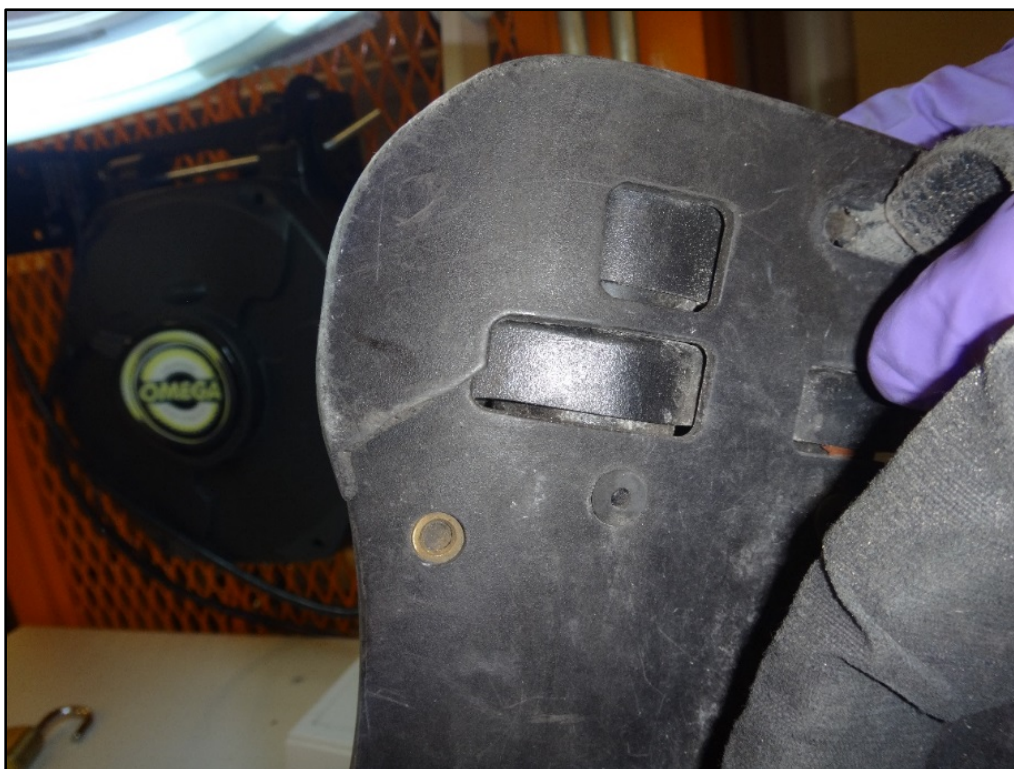
**Figure 28: Broken lumbar attachment**

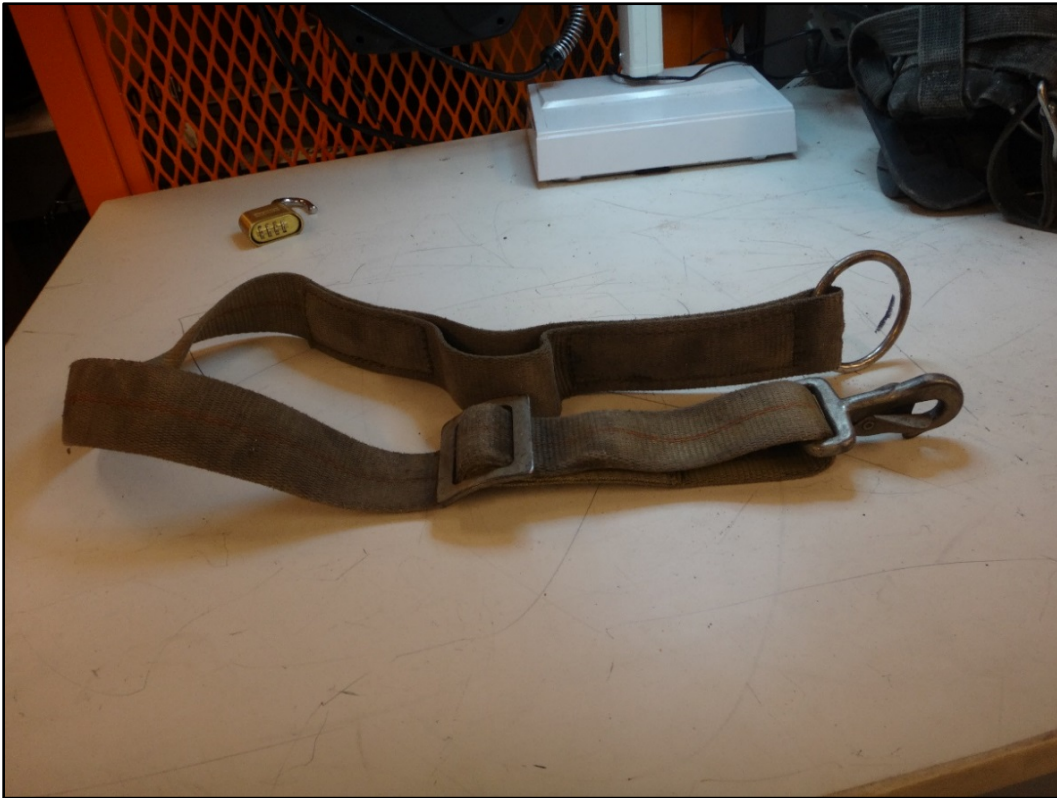
**Figure 29: Fall restraint belt**

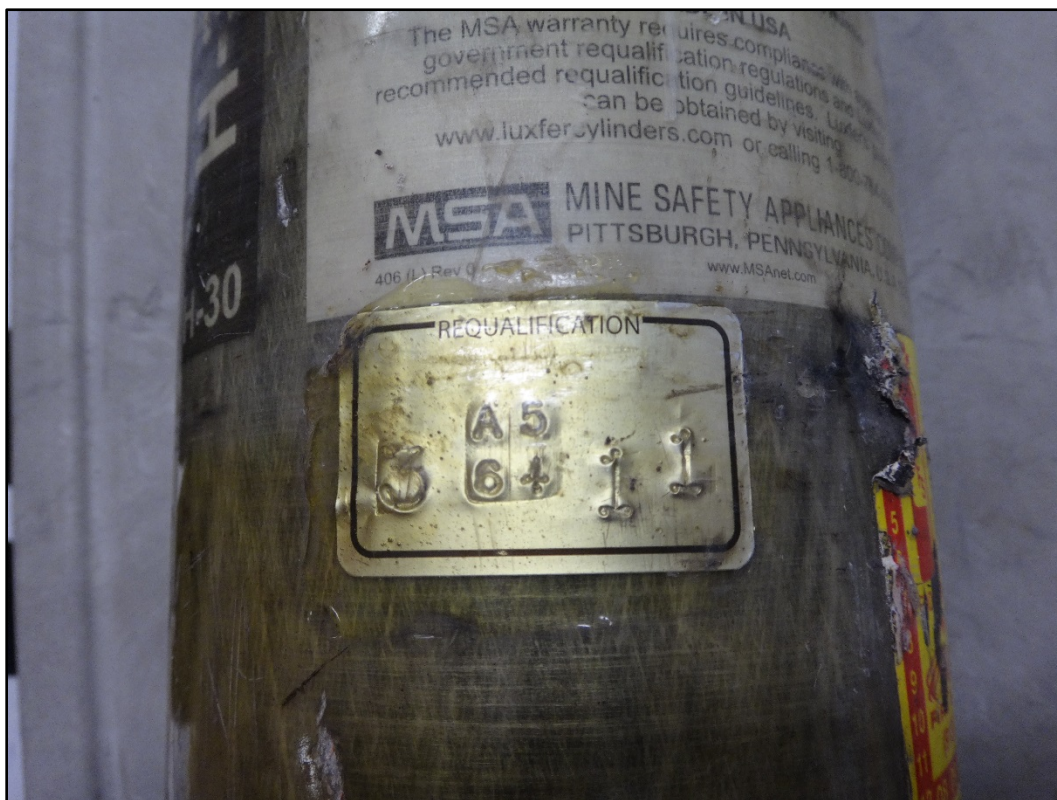
Figure 32: Hydrostatic test date

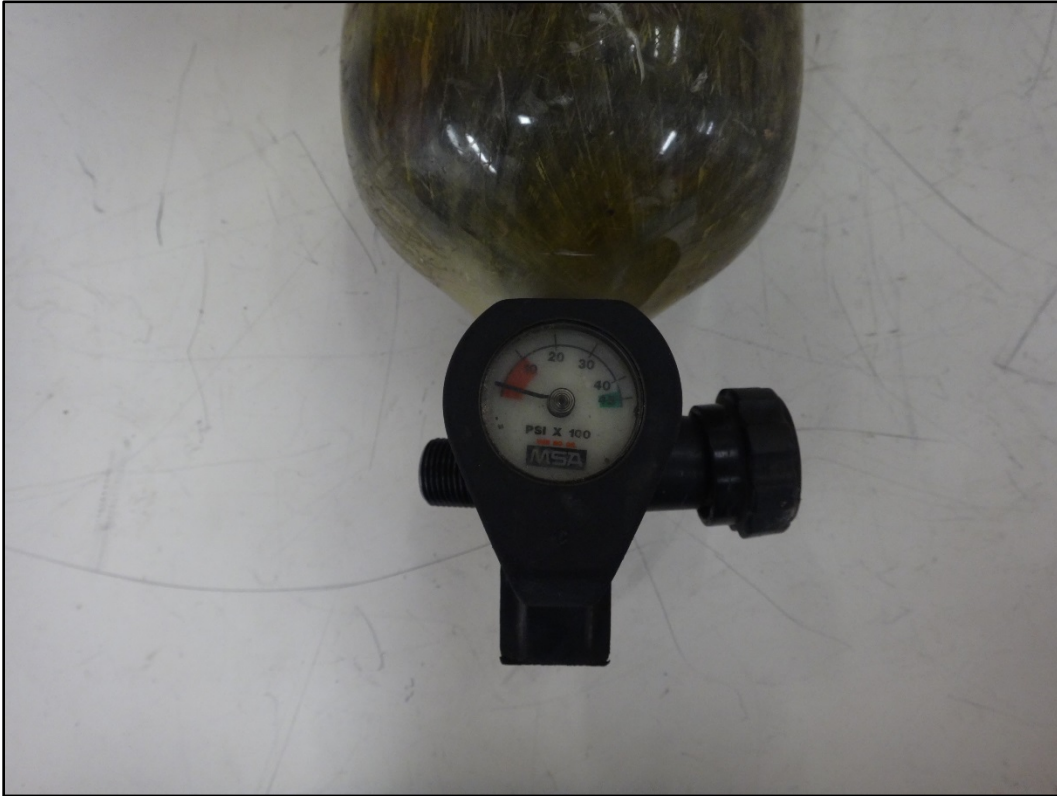
**Figure 33: Cylinder gauge**

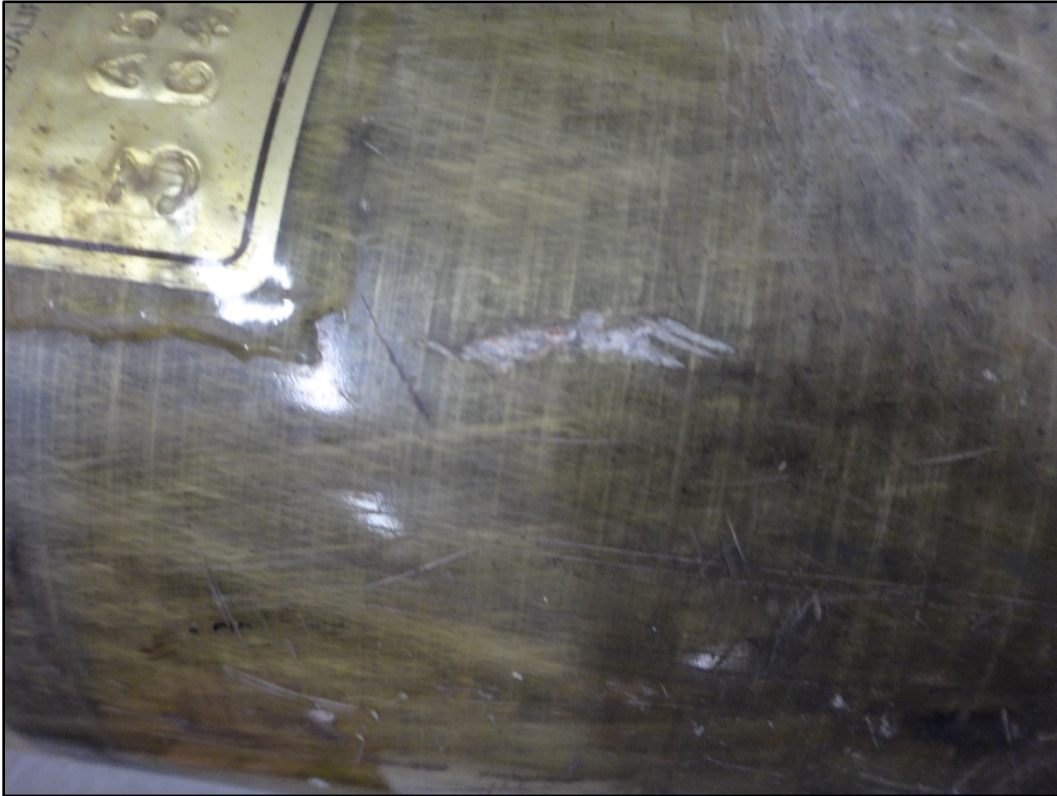
**Figure 35: Damage through clear coat/fiber wrap in cylinder**
