### Control of Paint Overspray in Autobody Repair Shops

# CONTROL OF PAINT OVERSPRAY IN AUTOBODY REPAIR SHOPS

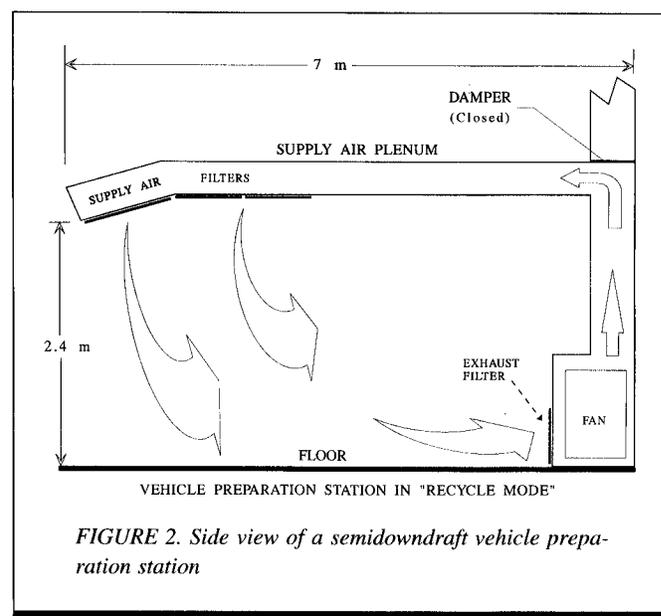
FIGURE 2. Side view of a semidowndraft vehicle preparation station

Only the semidowndraft vehicle preparation station described in Figure 2 was evaluated during this study. This station was used to do relatively small painting jobs involving autobody parts with no air recirculation. The geometric mean and geometric standard deviation for the five particulate paint overspray concentrations measured on the painter were, respectively, 2.4 and 3.5 mg/m<sup>3</sup>. Because of the limited sample size and the fact that car body parts were painted instead of cars, these concentration measurements cannot be used to compare the performance of vehicle preparation stations and the spray-painting booths listed in Table II. However, a study of airflow patterns

around the vehicle preparation station indicated it did not control paint overspray. The vehicle preparation station studied had an exhaust flow rate of 340 m<sup>3</sup>/min (12 000 ft<sup>3</sup>/min), which is a typical ventilation rate for a spray-painting booth. Observations of smoke released at the vehicle preparation station are shown in Figure 7. At distances greater than 2.1 m (7 ft) from the exhaust filters, the air velocities appeared to be too low to control paint overspray. When painting was done at the preparation station, paint overspray was observed to be dispersed throughout the vehicle preparation area.

The vehicle preparation station described did not appear to control worker exposure to air contaminants. When air was recirculated, this station did not have alarms or continuous monitors to warn of excessive aerosol or solvent concentrations caused by failure of the air-cleaning equipment or an accumulation of dust or paint overspray in the recycled air. Such alarms and monitors are recommended by ACGIH.<sup>(30)</sup> When these stations are used for painting, air is exhausted only from the back of the preparation station, and it does not flow from the supply air plenum shown in Figure 2. Also, there are no walls to contain the overspray or prevent drafts from dispersing the paint overspray throughout an autobody repair shop.

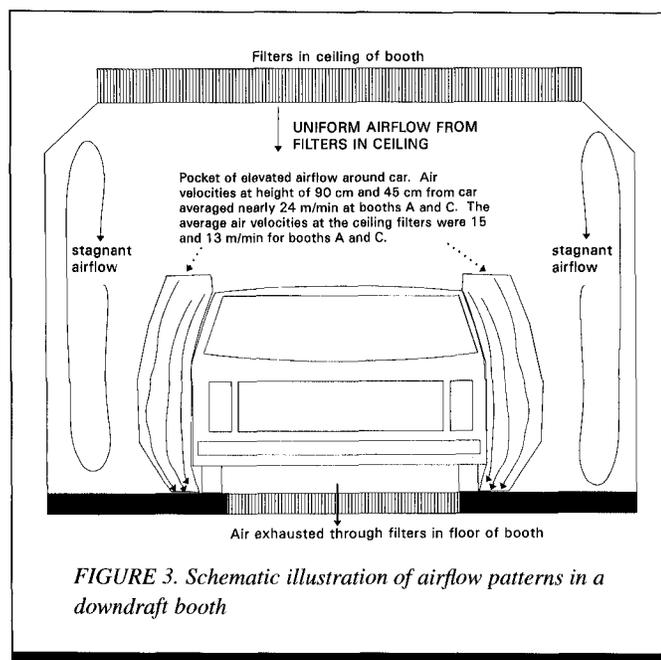
Figure 3 shows the airflow patterns in a downdraft booth. These patterns were visualized by using smoke tubes and helium-filled bubbles. The air flowed around the car at a velocity of 30–15 m/min (100–50 ft/min) into the exhaust trench located below the car. The spray-painting guns directed a jet of air toward the car. The effect of this jet on the airflow in the booth is schematically illustrated in Figure 4, which has been annotated to aid in the discussion. Figure 4 presents observations obtained while a worker simulated painting with an empty spray-painting gun. The helium bubble generator was used to disperse helium-filled bubbles into the incoming airflow (Annotation 1). The helium-filled bubbles were approximately 0.5 cm in diameter and were suspended in the air flow. Some of the bubbles were drawn toward the painter and the spray-painting gun (Annotation 2). When the jet from the spray-painting gun

impinged on the car, the bubble motion indicated that the jet appeared to split into two directions (Annotation 3). These jets forced the bubbles to move away from the painter. When the energy of the jets was dissipated, the bubbles appeared to flow toward the exhaust grates in the floor of the booth (Annotation 4). As a result of this situation, the paint overspray generally stayed away from the painter while he was painting a car body.

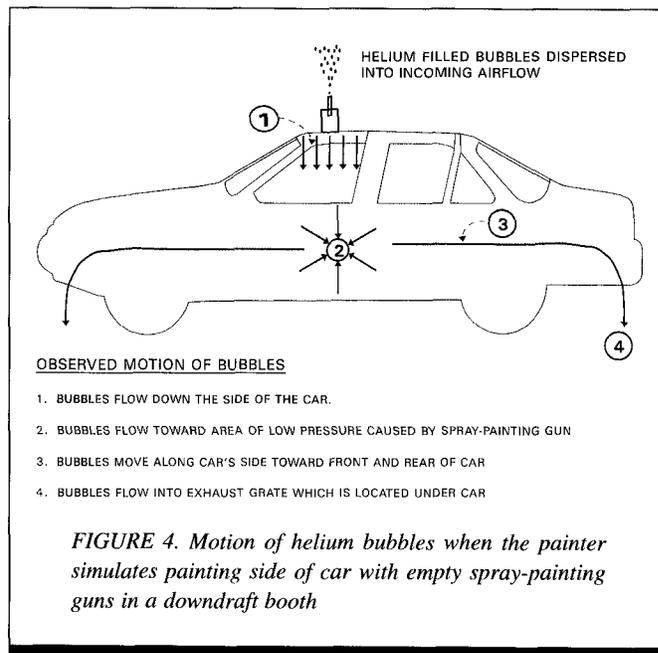
However, when car body parts were painted, as was done at Booth C, the scenario described in Figure 4 did not occur. Instead, the jet from the spray-painting gun appeared to flow around the objects being painted. The jet's energy degenerated into turbulence, which dispersed paint overspray throughout the booth. During one sampling session spray painting autobody parts resulted in a particulate overspray concentration of 18 mg/m<sup>3</sup> on the worker.

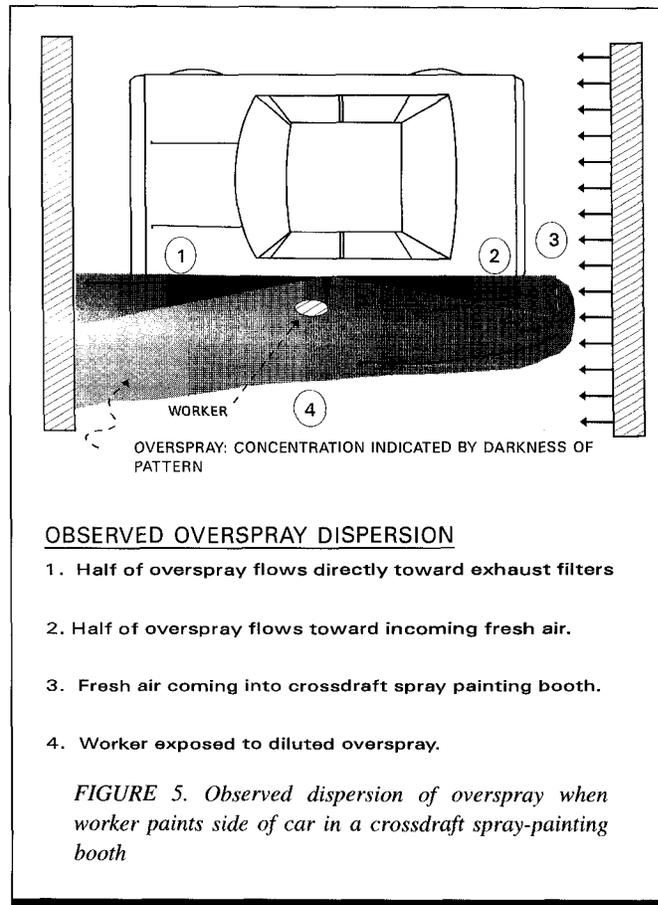
When a worker painted the side of the car in a crossdraft booth, the jet of air from the spray-painting gun was observed

to disperse overspray into the incoming airflow. These observations are schematically illustrated in Figure 5. To facilitate the discussion, this figure is annotated. One jet flowed toward the exhaust filters (Annotation 1). A second jet (Annotation 2) flowed toward the air inlet into the booth. The overspray in the second jet was dispersed into the incoming airflow (Annotation 3). This diluted overspray (Annotation 4) flowed through the worker's breathing zone as it flowed towards the exhaust filters in the back of the booth. In Booth G this air velocity was 30 m/min (100 ft/min), and in Booth H this velocity was between 20 and 3 m/min (70 to 10 ft/min). The particulate overspray concentration measured on the worker's shirt lapel (Sampling Location 1) was half the concentration measured at the back of the spray-painting booth near the exhaust filters (Sampling Location 3). This situation suggests that crossdraft booths are incapable of separating the worker from the paint overspray when the side of a car is being

repainted. Practically all painting jobs during this study involved the side of a car.

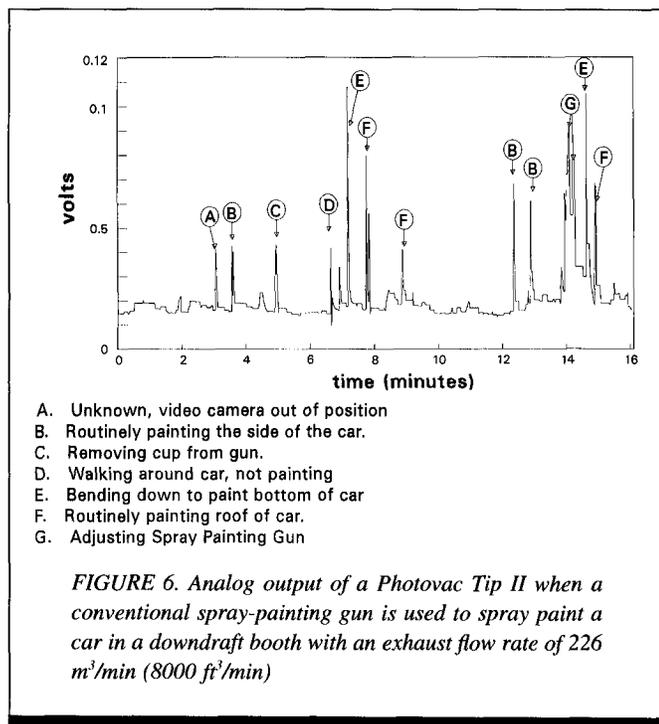
surface deflects this jet along with its induced air motion into the incoming airflow, exposure to paint overspray can occur. When real-time exposure monitoring was done in a downdraft spray-painting booth, exposure peaks did occur (as shown in Figure 6). Regardless of the source of these exposure peaks, the

data in Figure 6 indicate that downdraft booths do not provide complete control of the paint overspray. Thus, some respiratory protection may always be needed to prevent inadvertent worker exposure to paint overspray.
