FLEXIBLE ROOF DRILL FOR LOW COAL

Final Technical Report
Contractor—Ingersoll-Rand Research, Inc.

July 1979

Contract No. U.S.D.O.E. AC01-74ET12196
(formerly U.S.B.M. HO242063)

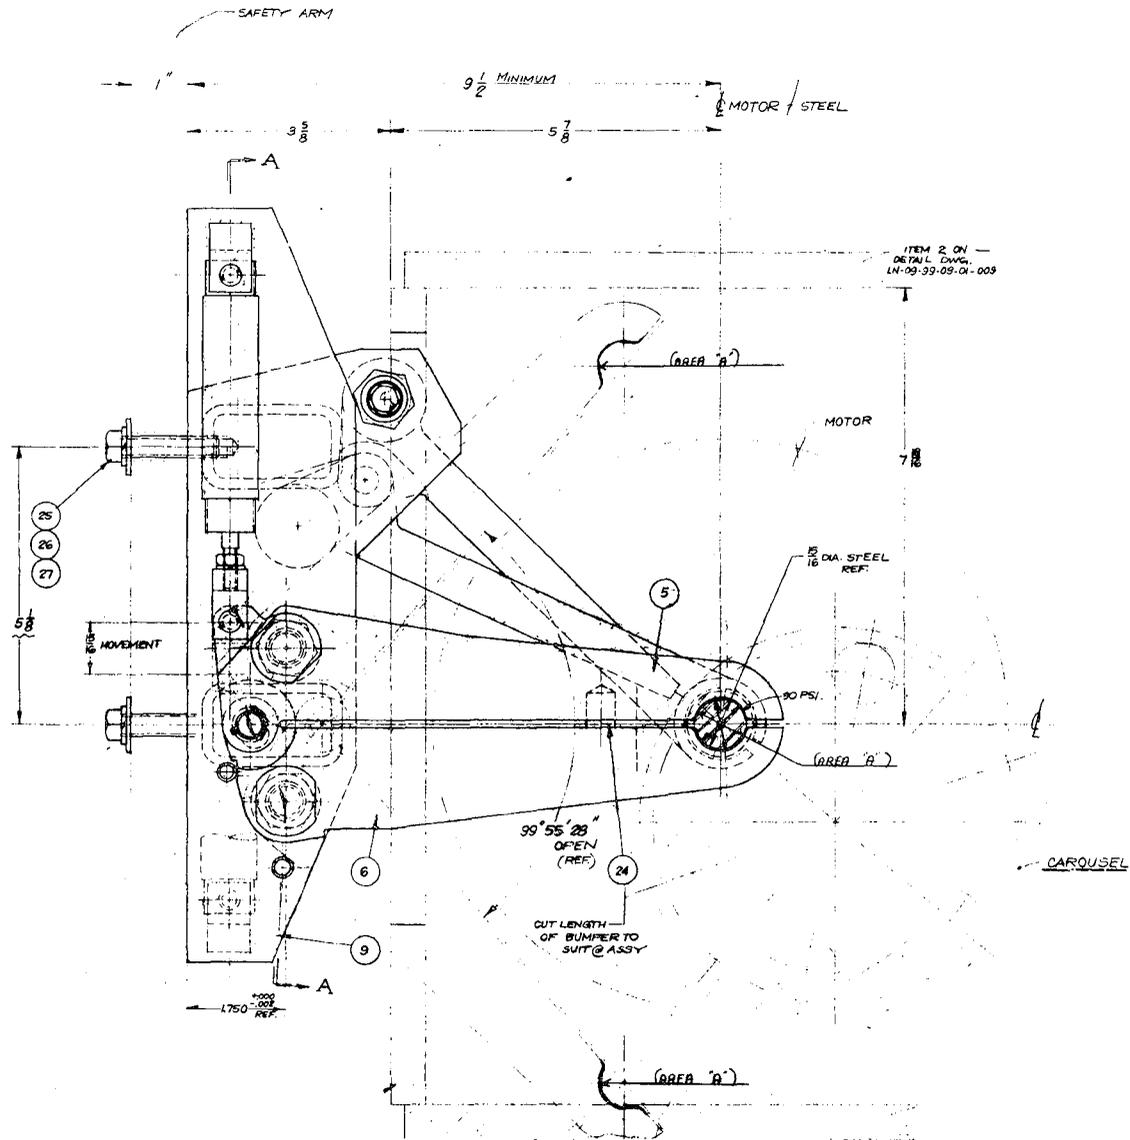
Figure 21: Upper Clamp Arms and Centralizer - Top View

When the edges are rounded off, problems are evident in the unload mode. The drill chuck engages the drill steels supported by the upper clamp arms and separates the arms before coupling can be completed. When the arms have separated, coupling becomes impossible and can be completed only through manual operation of the boom.

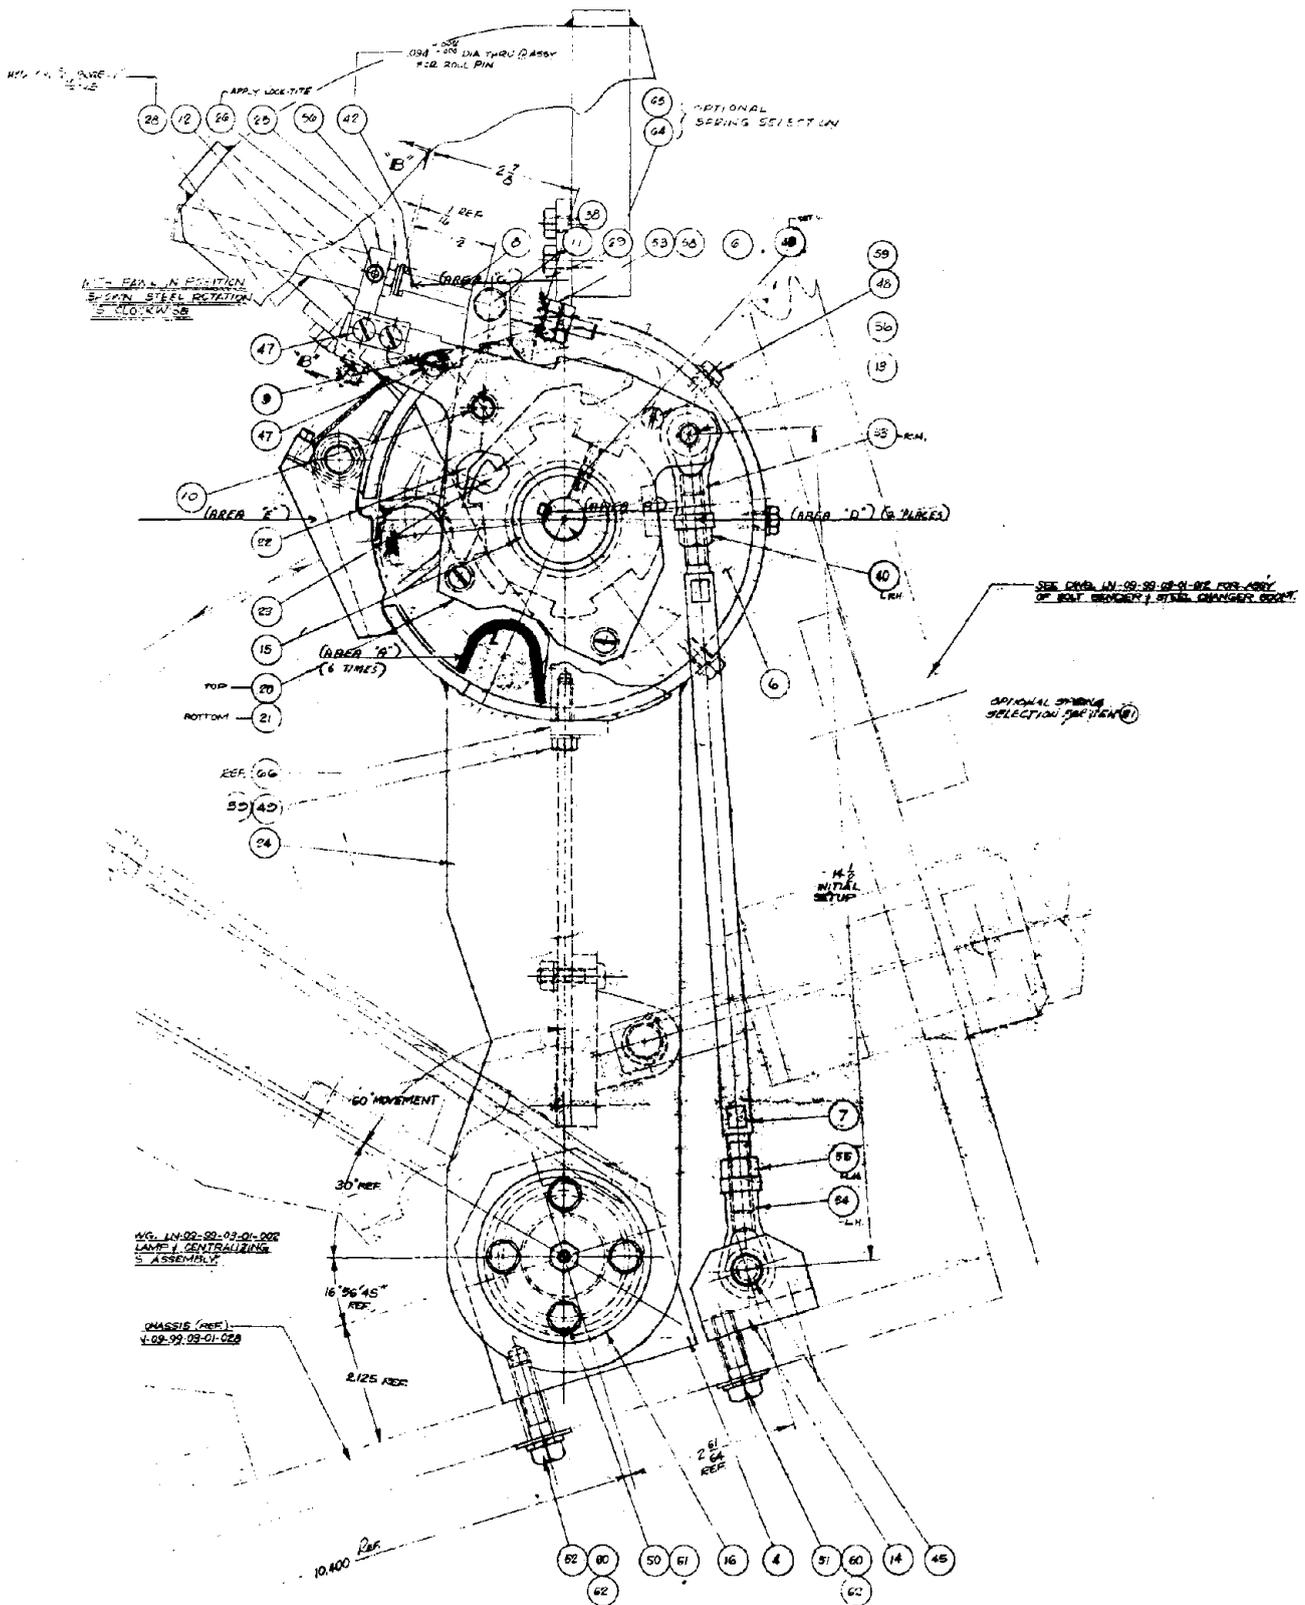
Figure 26: Carousel Ratchet Drive Assembly

hours. However, with this cylinder it was necessary to call the Ingersoll-Rand Research Center and request they procure a cylinder from the local vendor. The vendor responded by supplying a cylinder rebuilding kit within a few days. This underlies the importance of dealing with responsible vendors and the need for adequate parts supply. The actual lost time attributed to the failure of the cylinder was approximately one half day during the field trial. While the new parts were being shipped the original cylinder rod was modified so that the field trial could continue. The modifications consisted of drilling the shortened cylinder rod and pinning it to the existing bolt. The ratchet mechanism was then adjusted for proper operation.

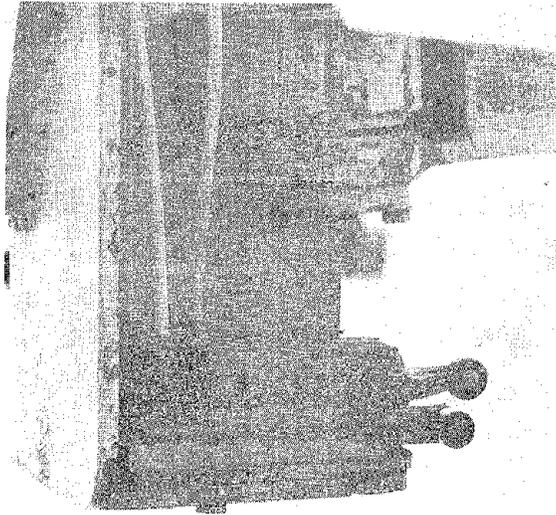
Figure 4. Modified lower limit switch.

Figures 4 and 5 show the revised lower limit switch conceived to overcome the unreliable switching noted in the field. The limit switch of Figure 4 is now mounted on a spring loaded movable block with a cam roller mounted in front. The cam roller rides on the cam shoe shown in the foreground of Figure 5. With this arrangement the limit switch is always in the same relative position to its trip lugs, regardless of the precise fore and aft location of the drill box to the chassis. The success of the slider parallelogram changes appears to have made this change somewhat redundant for its original purpose, but its inclusion simplifies the adjustment of the drill. Now, the parallelogram link can be adjusted to get the best steel coupling location and the limit switch set points are not affected.

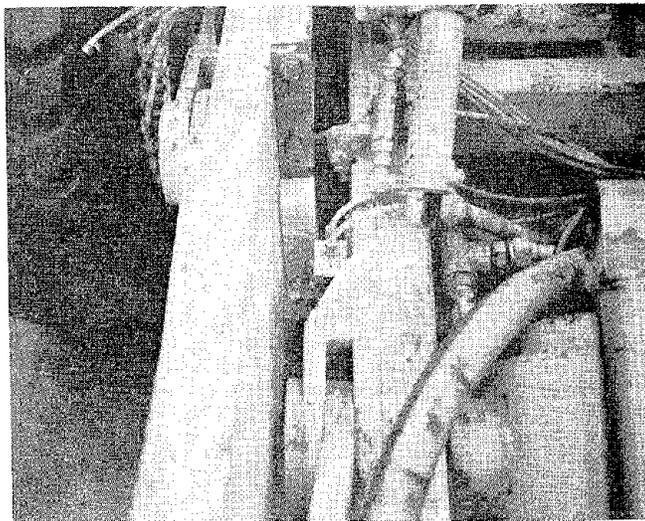
Figure 7. Revised cam for limit switch.

A third mounting problem that developed during testing concerned the limit switch which indicates that the drill box is down below the working area of the carousel. The original cam operating the switch was too short, so that it was possible to lower the drill box too much and cause a logic malfunction. A longer, stronger cam was designed to prevent this override from occurring. The result is shown in Figure 7.

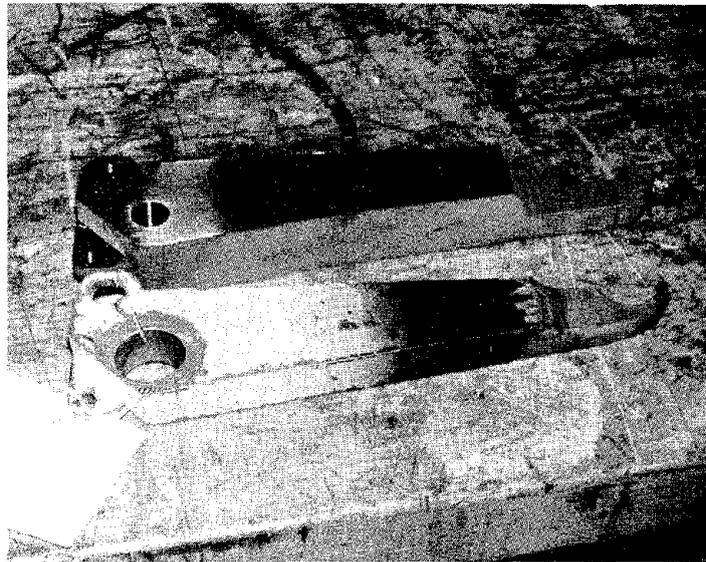
Figure 11. Upper clamp arms.

Figures 11 and 12 show the strength improvements made in the individual upper clamp and centralizer arms. Figure 11 shows the original upper clamp arm and its replacement. The failure of the original arm is evident in the cracks around the pivot hole. The new arm does away with a bushed pivot hole to gain additional bending strength around the hole. In addition, the new arm is slightly thicker for a strength improvement. Figure 12 contrasts the new larger centralizer arms with the original design. The revised centralizer arms and upper clamp arms were nitrided to improve wear resistance during drilling.

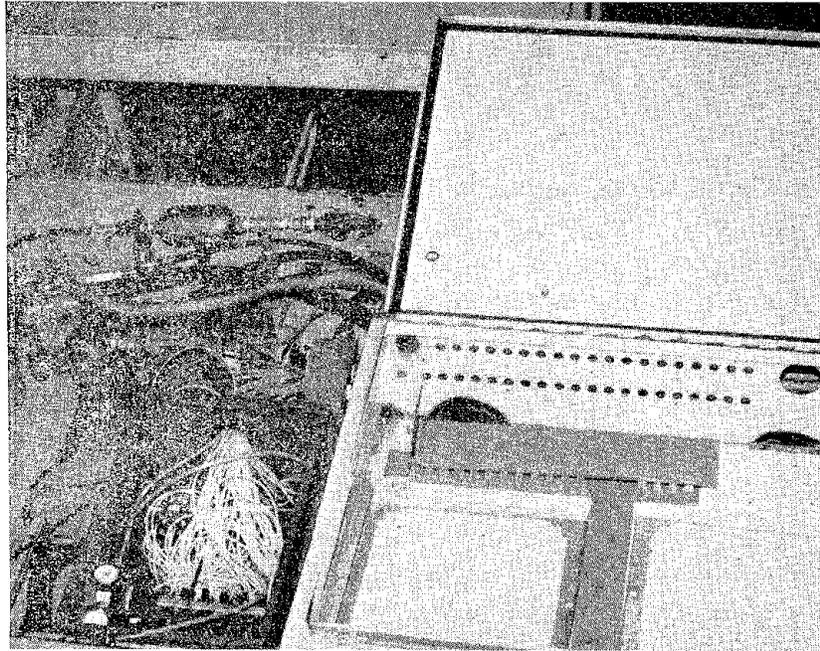
Figure 15. Packaging for the air logic.

Figure 15 shows the reduction in size which was achieved by repackaging the air logic unit. The air logic unit was originally contained in the large box sitting on the machine to the right. In the modification process, all of the logic was accomodated in the smaller box to the left. The two 11-inch square

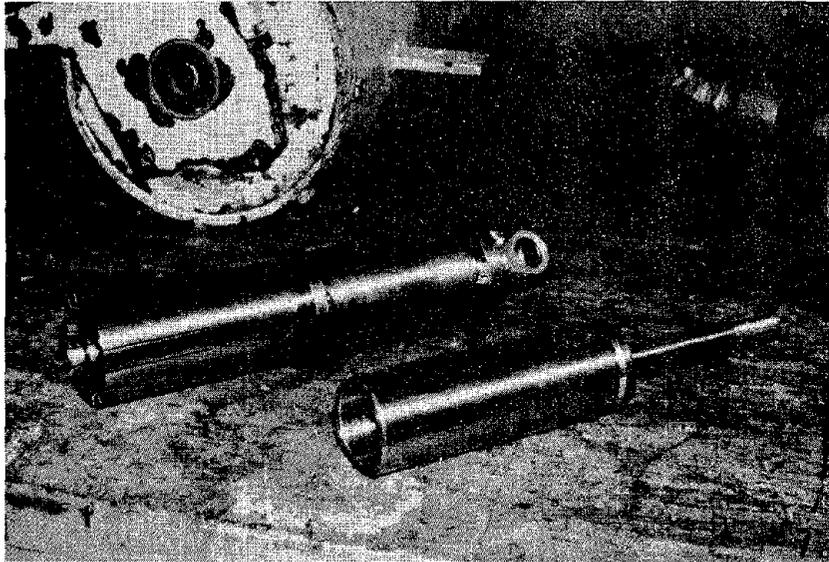
Figure 21. Linear clutch assembly.

This new assembly consists of two parts, a radial leaf spring and a piston. The radial leaf spring has knobs on the end of each leaf which seat in a groove of the piston. As an axial force is applied to the piston, the knobs are forced up out of the groove. As soon as the knobs ride on the outer surface of the piston, the axial force required to move the piston relative to the leaf spring drops to a low value. The assembly then lengthens or shortens as needed to protect the drive key. The force applied to the ratchet is limited in this instance to approximately 350 lbs. static force. In the original assembly the hydraulic cylinder driving the carousel could apply approximately 800 lbs. of force to the ratchet through the ratchet actuator link.

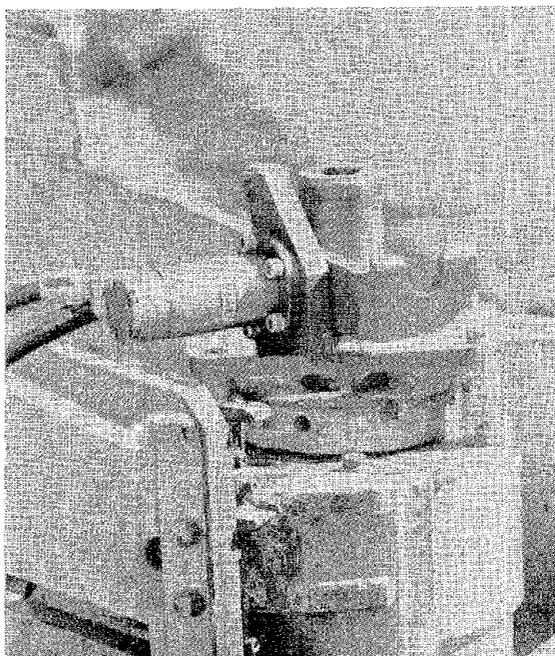
Figure 25. Revised lower clamp.

The improved clamp was derived from a design developed for DOE Contract No. ET-77-C-01-9113, a mechanical anchor bolter module. Substituting this design in Flex Drill allowed an early assessment of its reliability - valuable spinoff for the overall goal of developing a reliable, hands-off bolter. The revised lower clamp is shown in Figure 25. The concept of operation remains unchanged from the original; a fork rotates through 90 degrees to engage the groove on the drill steel when required. The strength of the parts is improved to extend the clamp's life.

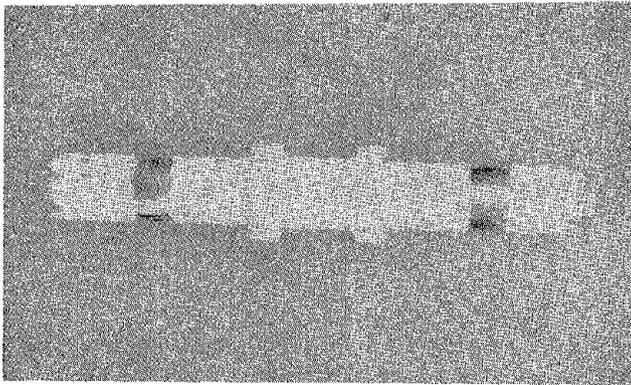
Figure 28. Current drill steel coupling.

Figure 28 shows the coupling change which evolved when the rounding-off was noticed. A larger hex driving section delays the rounding-off almost indefinitely. A second very significant change is shown in this coupling as well. The two ends of the coupling are symmetrical and can be interchanged. Now when an engaging end wears out, the coupling can be reversed, exposing a new coupling. The preferential engagement of the barrel springs necessary for reliable uncoupling is secured by shimming the spring at the permanently engaged end of the coupling. The result of this change is to reduce the effective cost of a drill coupling almost in half for any given wear life. Before, all wear occurred on a single engaging end. Now two ends can be worn out before the coupling is replaced.

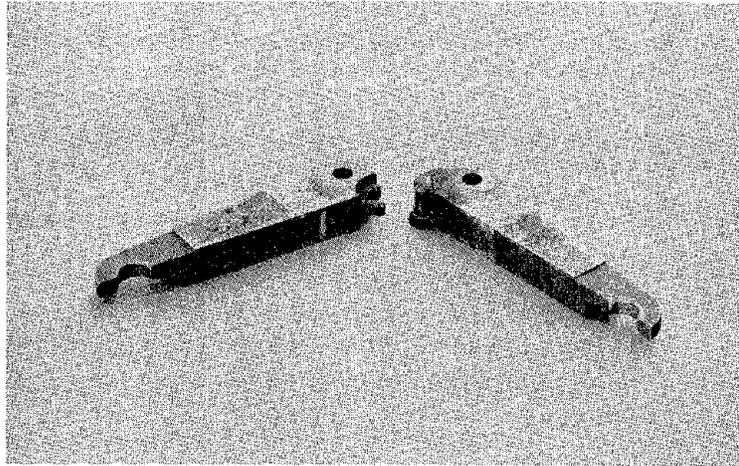
Figure 34. Upper clamp failure.

A new set of upper clamps was designed and installed during the testing. The material sections both perpendicular and parallel to the failure areas in both the leader and the follower were increased. The redesigned clamps accumulated a total of 15,324 operational cycles without a failure. The clamps were disassembled and examined at the completion of the testing. With the exception of some slight wear at the clamping areas, the leader and follower appeared to be in very good condition. There were no hairline fractures beginning to take affect as was noticed on the previous set of clamps.
