## INCIDENT FACTS

February 9, 2018

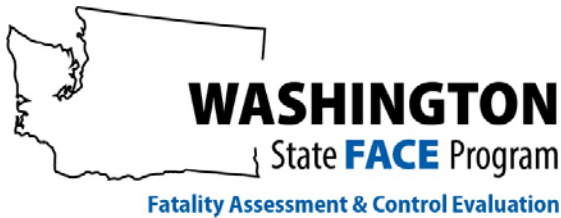
- Enforce and evaluate employee compliance with machine manufacturer's LOTO requirements when servicing or maintaining machines and equipment.
- Provide and enforce LOTO training that emphasizes the severity of the hazard of entering energized machines that have LOTO requirements.
- Implement, enforce, and evaluate a hazard reporting and response system that can document employee deviations from LOTO requirements and initiate corrective actions when they reoccur.
- Perform risk assessments with the machine manufacturer to understand or customize safety control system features, such as emergency stop (E-Stop) locations and access doors.

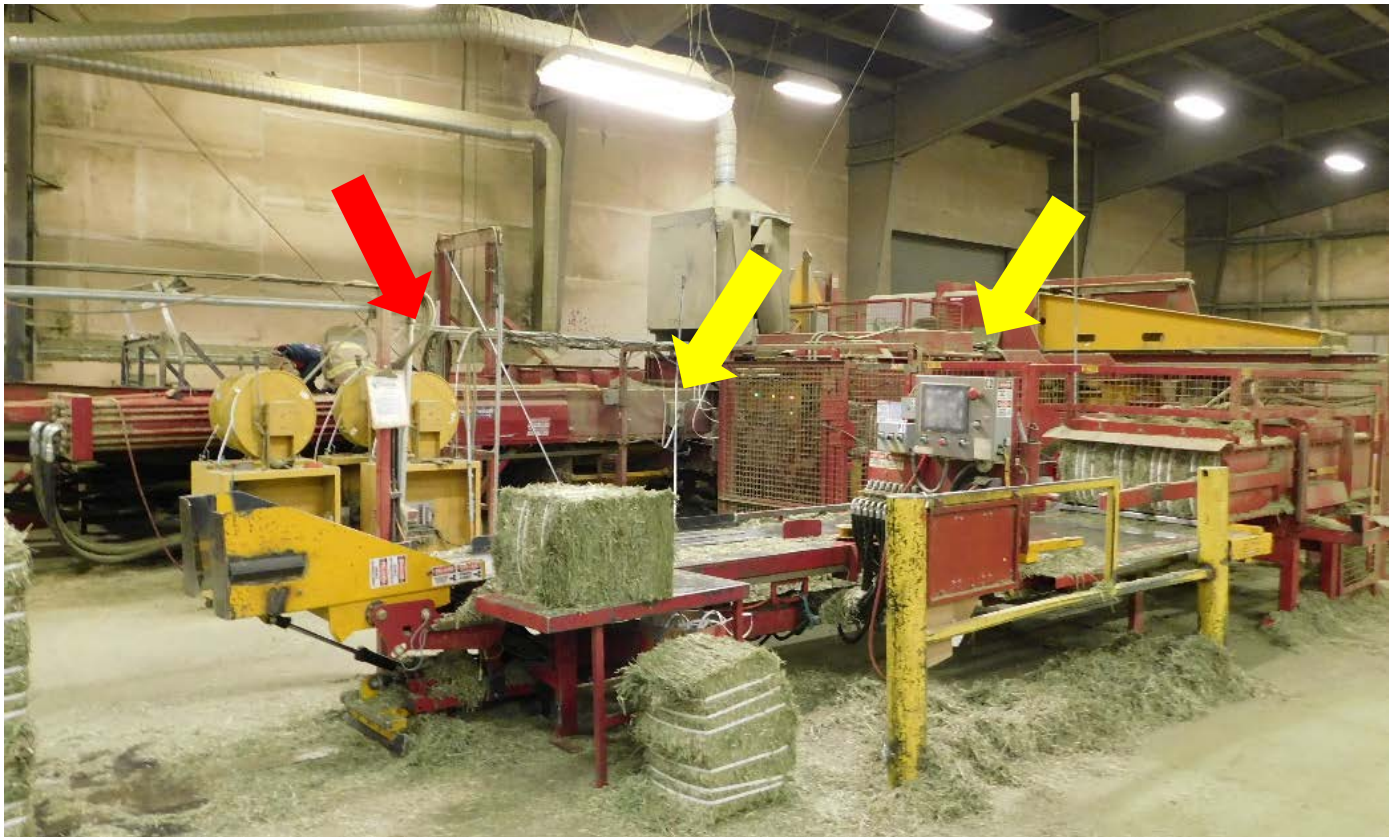
**Photo 10:** Red arrow shows the location of the guillotine where the operator was found. The yellow arrows show the locations of red emergency stop (E-Stop) buttons at the main press and operator's station.

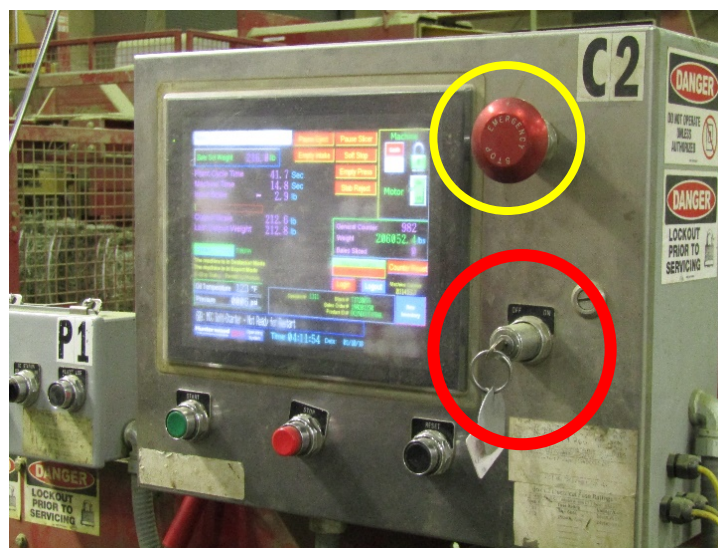
**Photo 11:** Operator's station control panel. The red circle shows the key that controls the power to the hay press. The yellow circle shows the emergency stop (E-Stop) button.

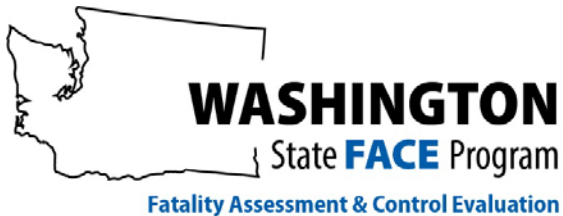
**Recommendation: Implement, enforce, and evaluate a hazard reporting and response system that can document employee deviations from LOTO requirements and initiate corrective actions when they reoccur.**

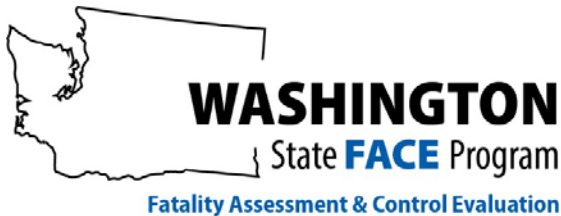
## ADDITIONAL RESOURCES
