## INCIDENT HIGHLIGHTS

July 29, 2019

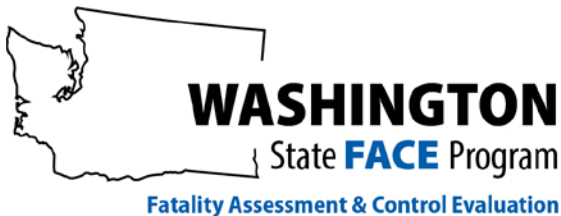
Washington FACE • PO Box 44330 • Olympia, WA 98504-4330  
1-888-66-SHARP (toll-free) or 360-902-5667

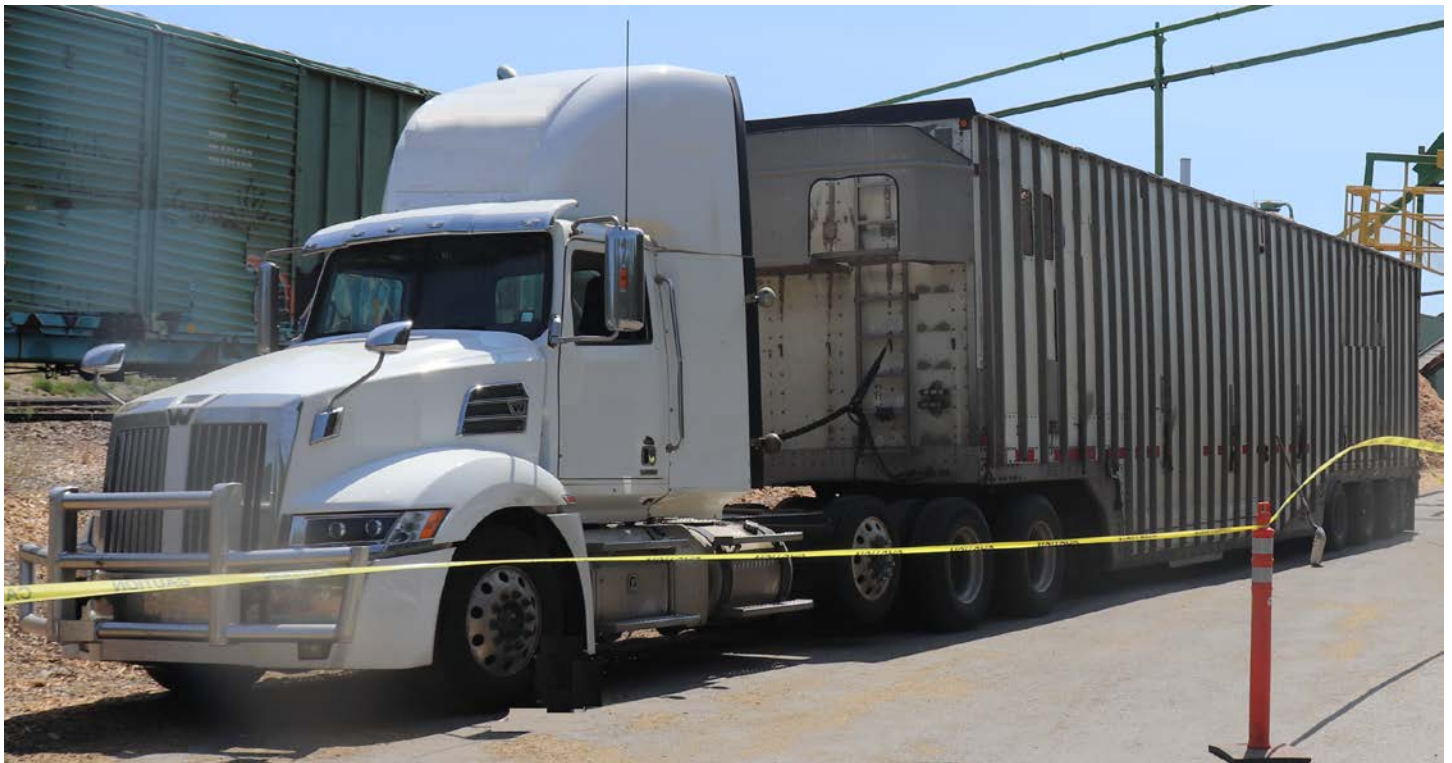
**Photo 1: The fatally injured driver operated this 2016 Western Star semi-tractor with a 2004 TYCROP high-cube, quad-axle, possum belly Super B-train chip trailer.**

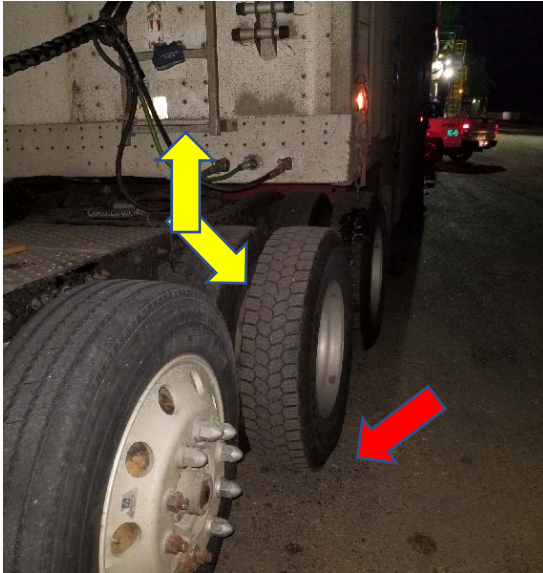
**Photo 13:** Red arrow in top left photo shows approximately where the dead driver's body was found crushed under the chip truck's left front drive tires. Yellow arrows show base of front trailer ladder and walkway between cab and trailer that the driver attempted to access as his truck rolled.

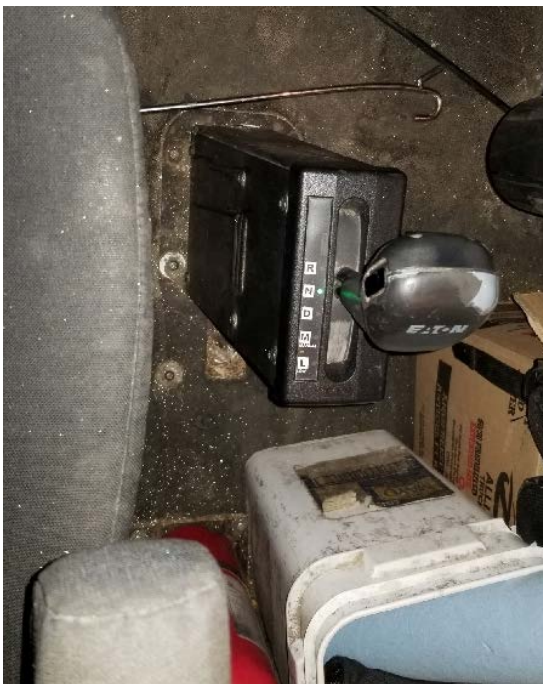
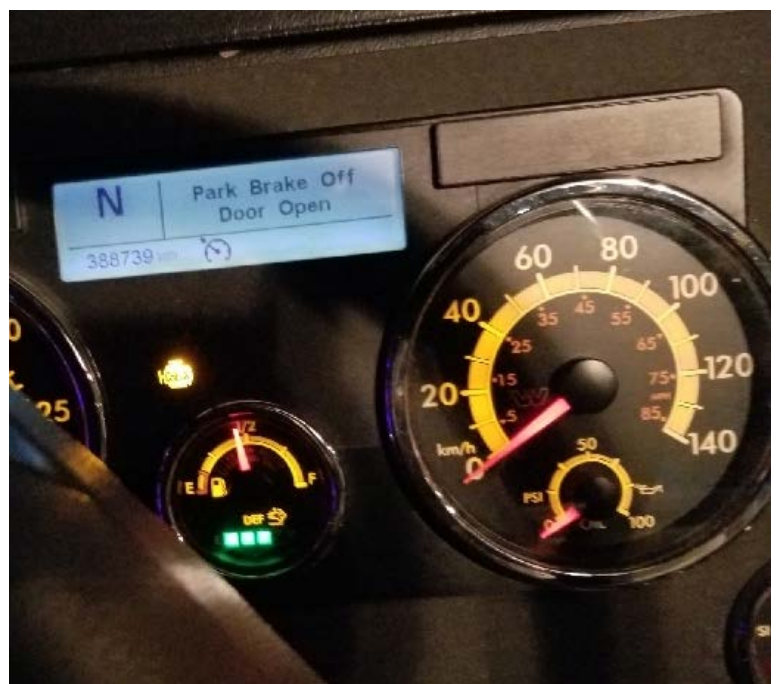
**Photos 14 and 15:** Bottom left photo shows chip truck's transmission shifter set to "N" neutral after the crushed driver was found. The transmission did not have a "P" park position. Bottom right photo shows dashboard instrument panel indicator showing that the truck's shifter was in neutral and parking brake disengaged when the incident occurred.

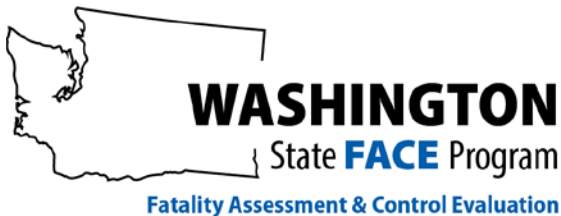
Washington FACE • PO Box 44330 • Olympia, WA 98504-4330  
1-888-66-SHARP (toll-free) or 360-902-5667

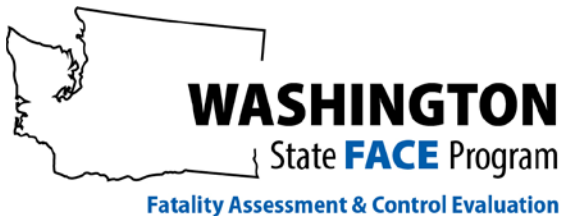
Washington FACE • PO Box 44330 • Olympia, WA 98504-4330  
1-888-66-SHARP (toll-free) or 360-902-5667

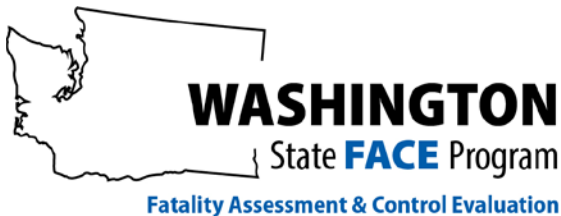
Washington FACE • PO Box 44330 • Olympia, WA 98504-4330  
1-888-66-SHARP (toll-free) or 360-902-5667

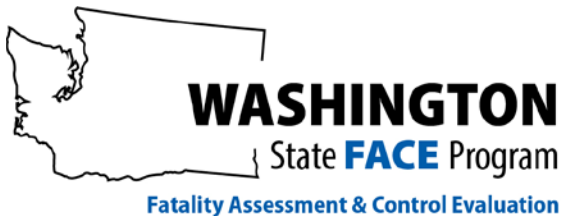
Washington FACE • PO Box 44330 • Olympia, WA 98504-4330  
1-888-66-SHARP (toll-free) or 360-902-5667
