# State FACE™ Fatality Narrative

## Technician Killed and Driver Injured in Natural Gas Vapor Cloud Explosion

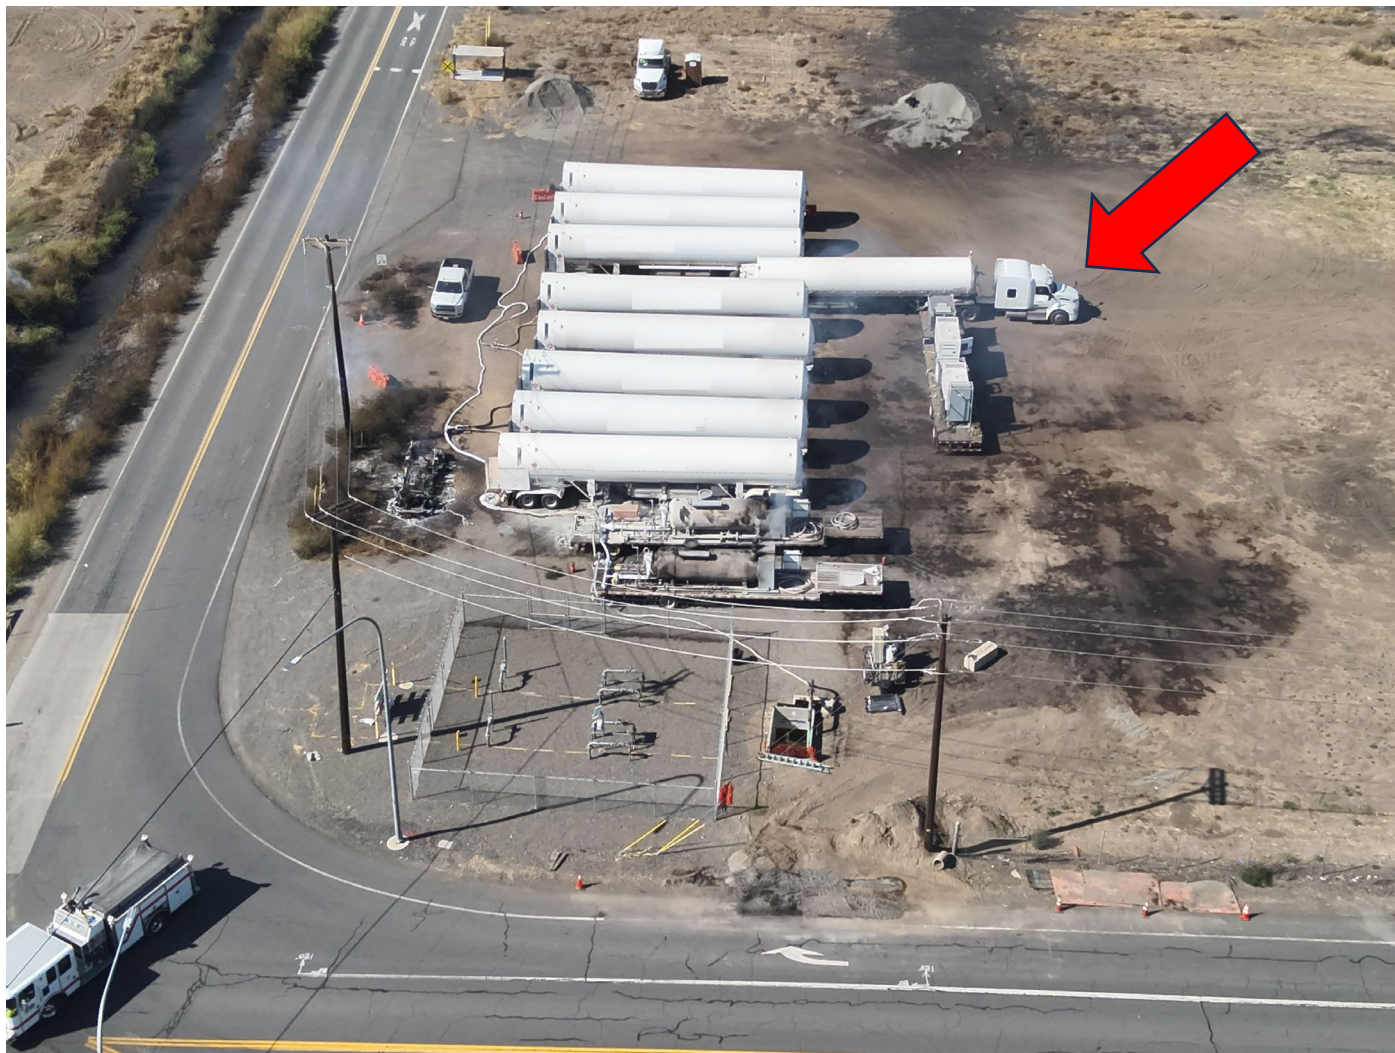
**Image 2.** Aerial view of LNG transfer station and fire damage to structures and vegetation. Arrow shows truck and transport trailer that pulled forward.

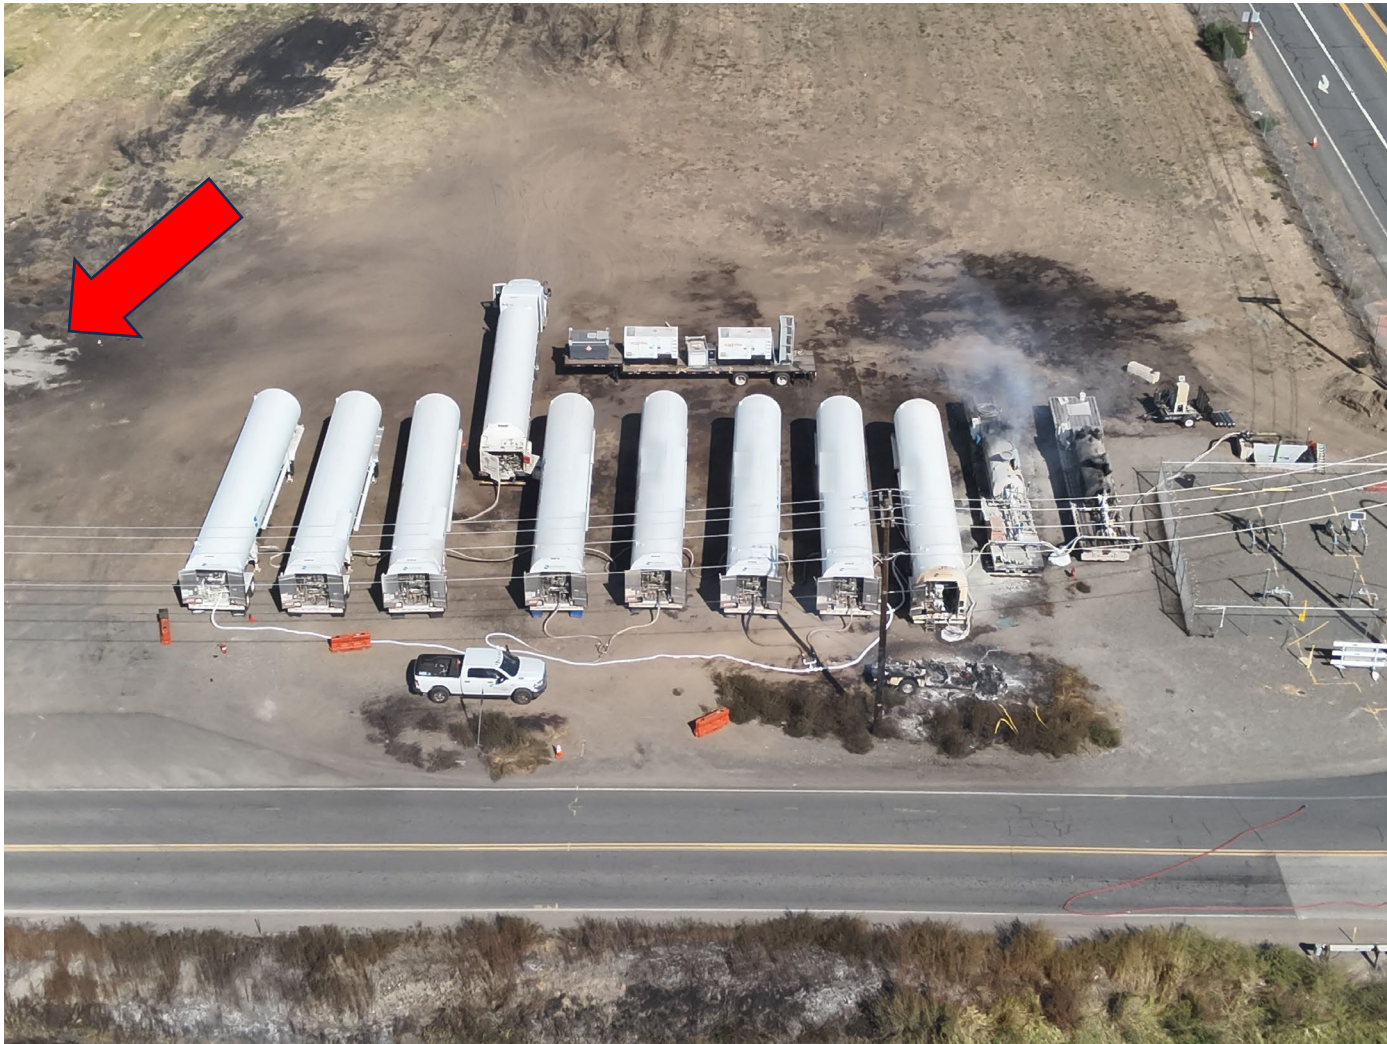
**Image 3.** Alternate aerial view of incident scene. Arrow shows muster point where the burned technician was found by his co-worker.

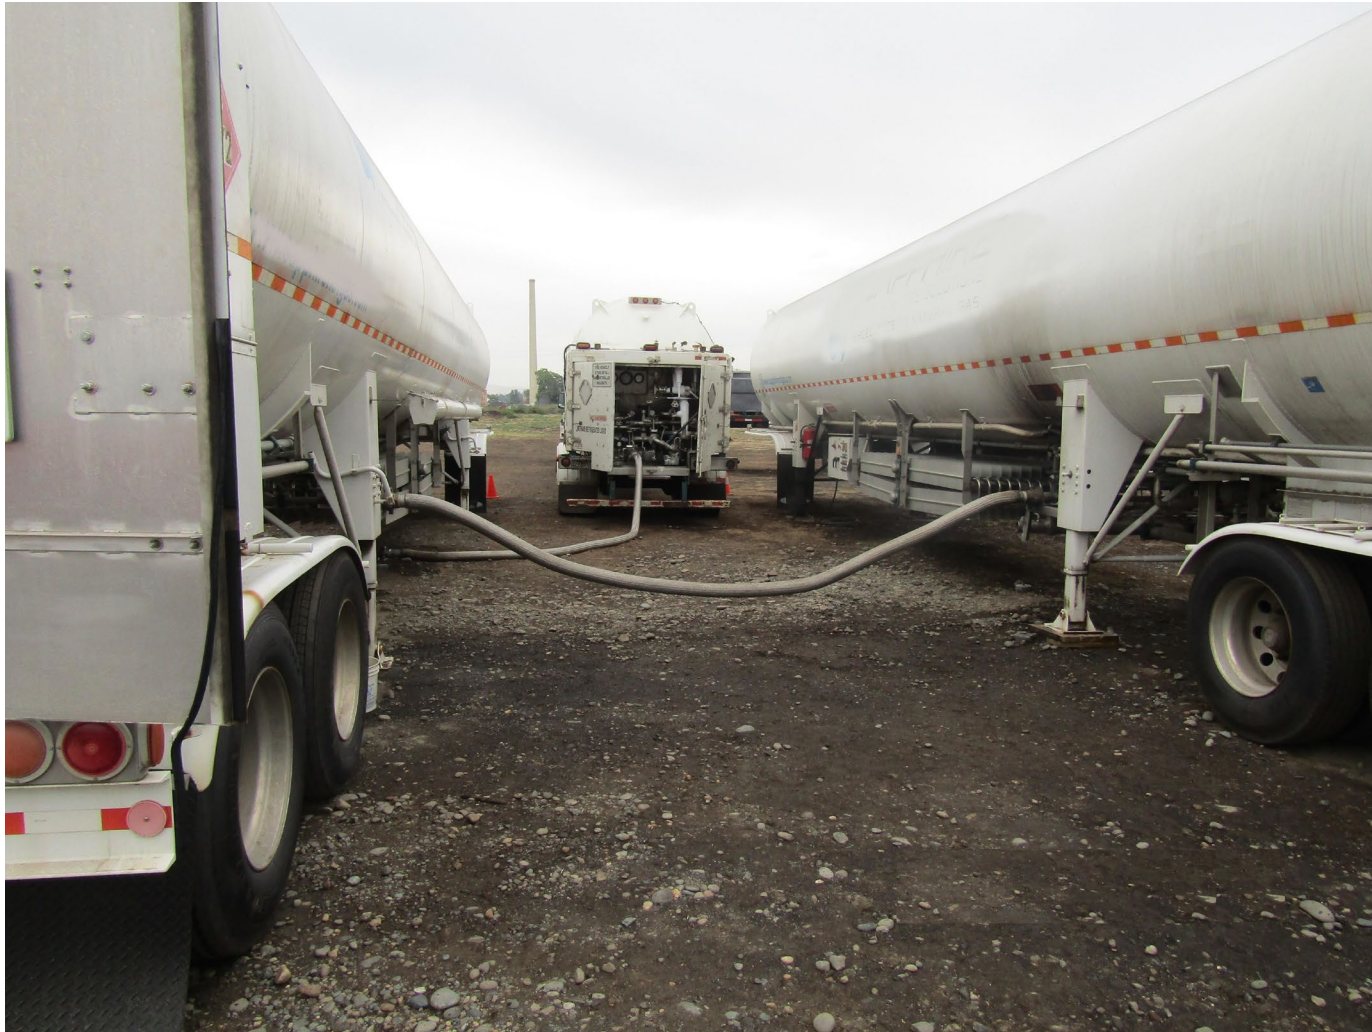
**Image 4.** Transport trailer that was pulled forward and queen storage trailers on both sides.

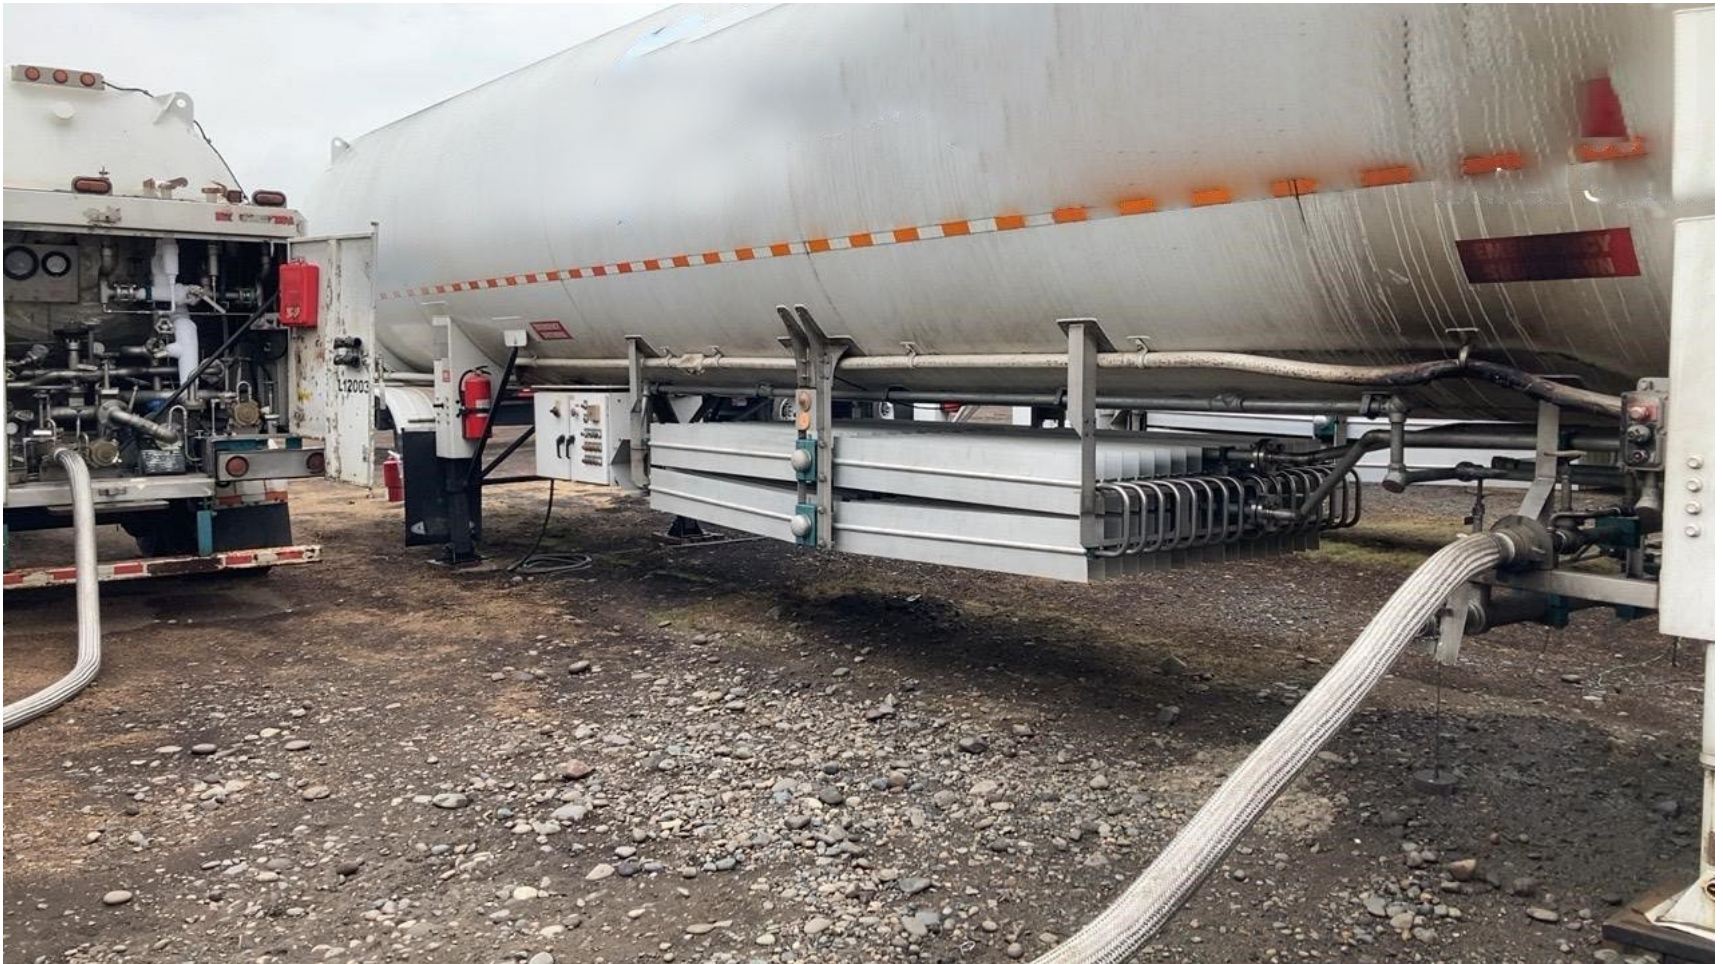
**Image 5.** Transport trailer on left and queen storage trailer on right with fire damage.

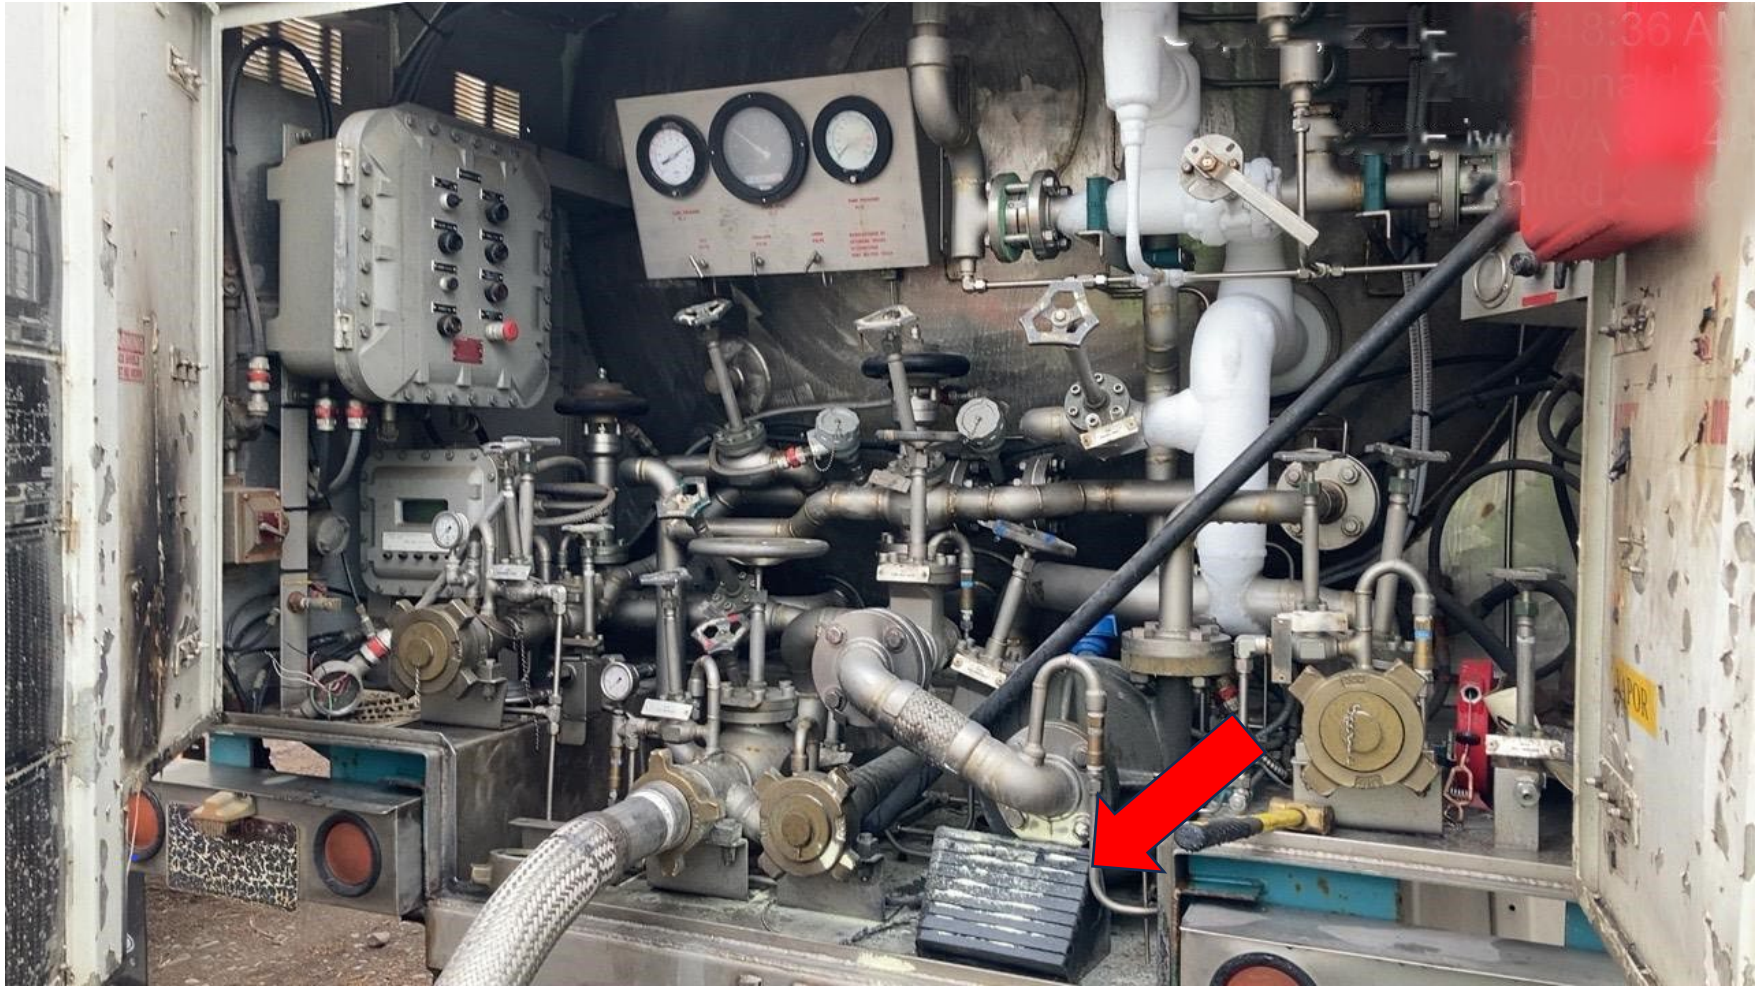
**Image 6.** Unused wheel chock in control cabinet of transport trailer.

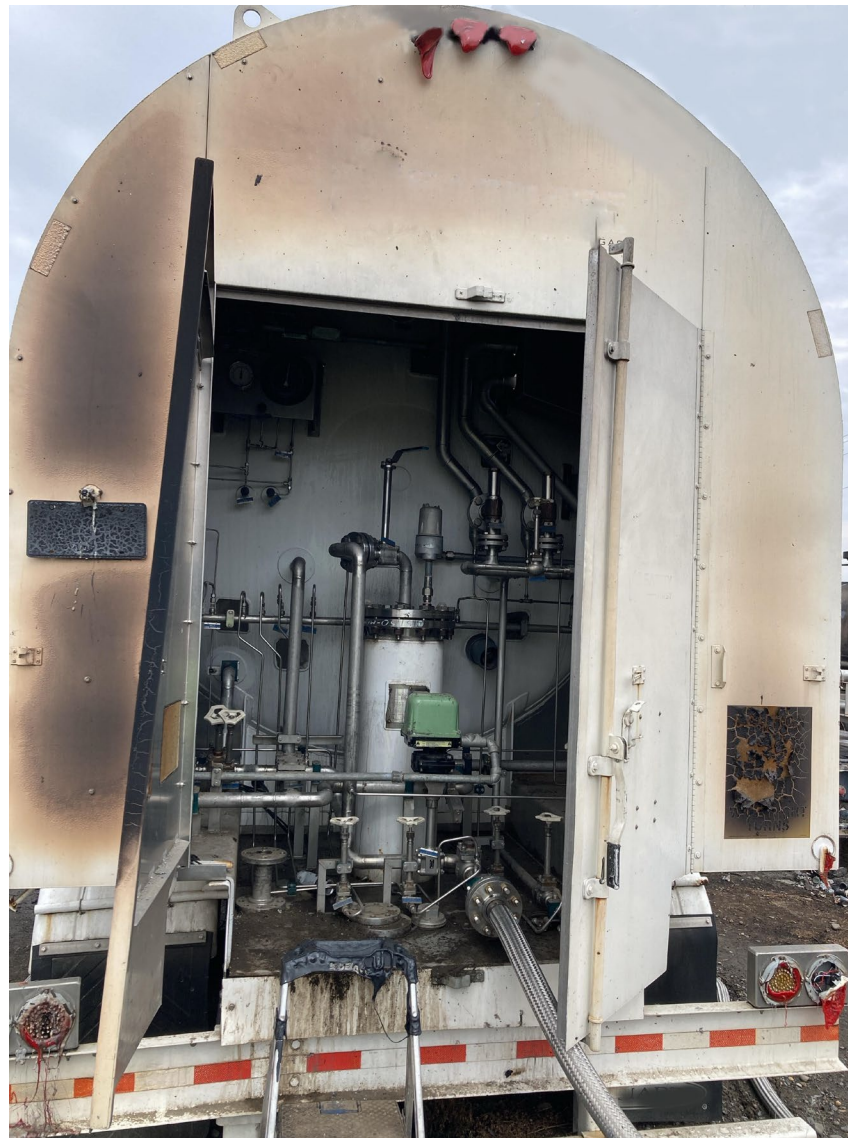
**Image 8.** Fire damage shown around control cabinet of nearby queen storage trailer.

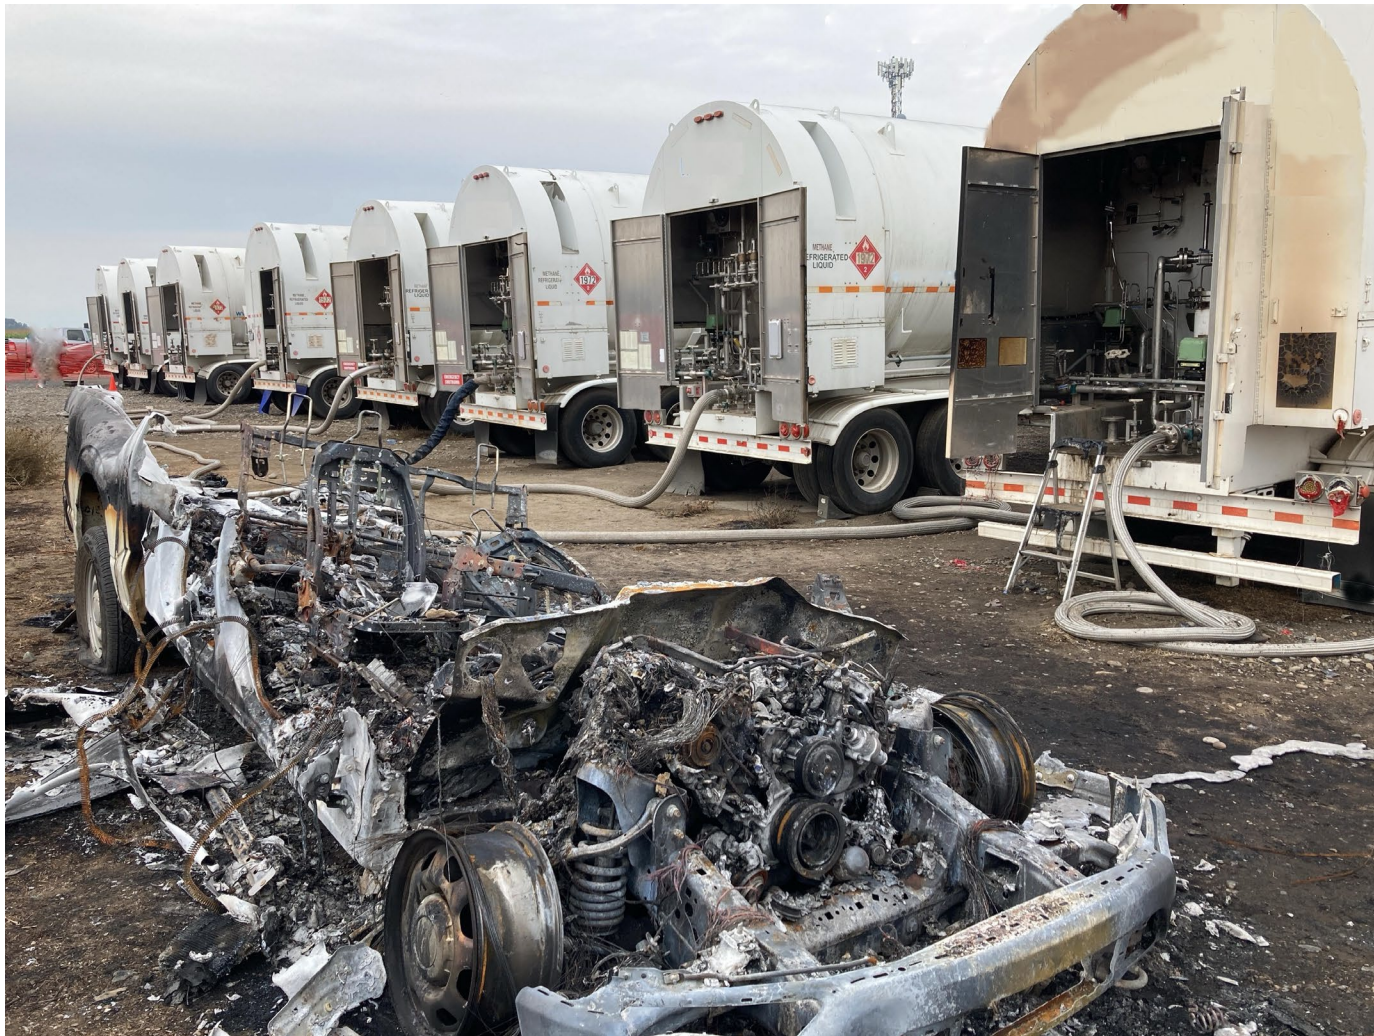
**Image 9.** Pick-up truck destroyed by fire at incident scene.
