Geologic Investigations of Underground Coal Mining Problems

RI 8022

Bureau of Mines Report of Investigations/1975

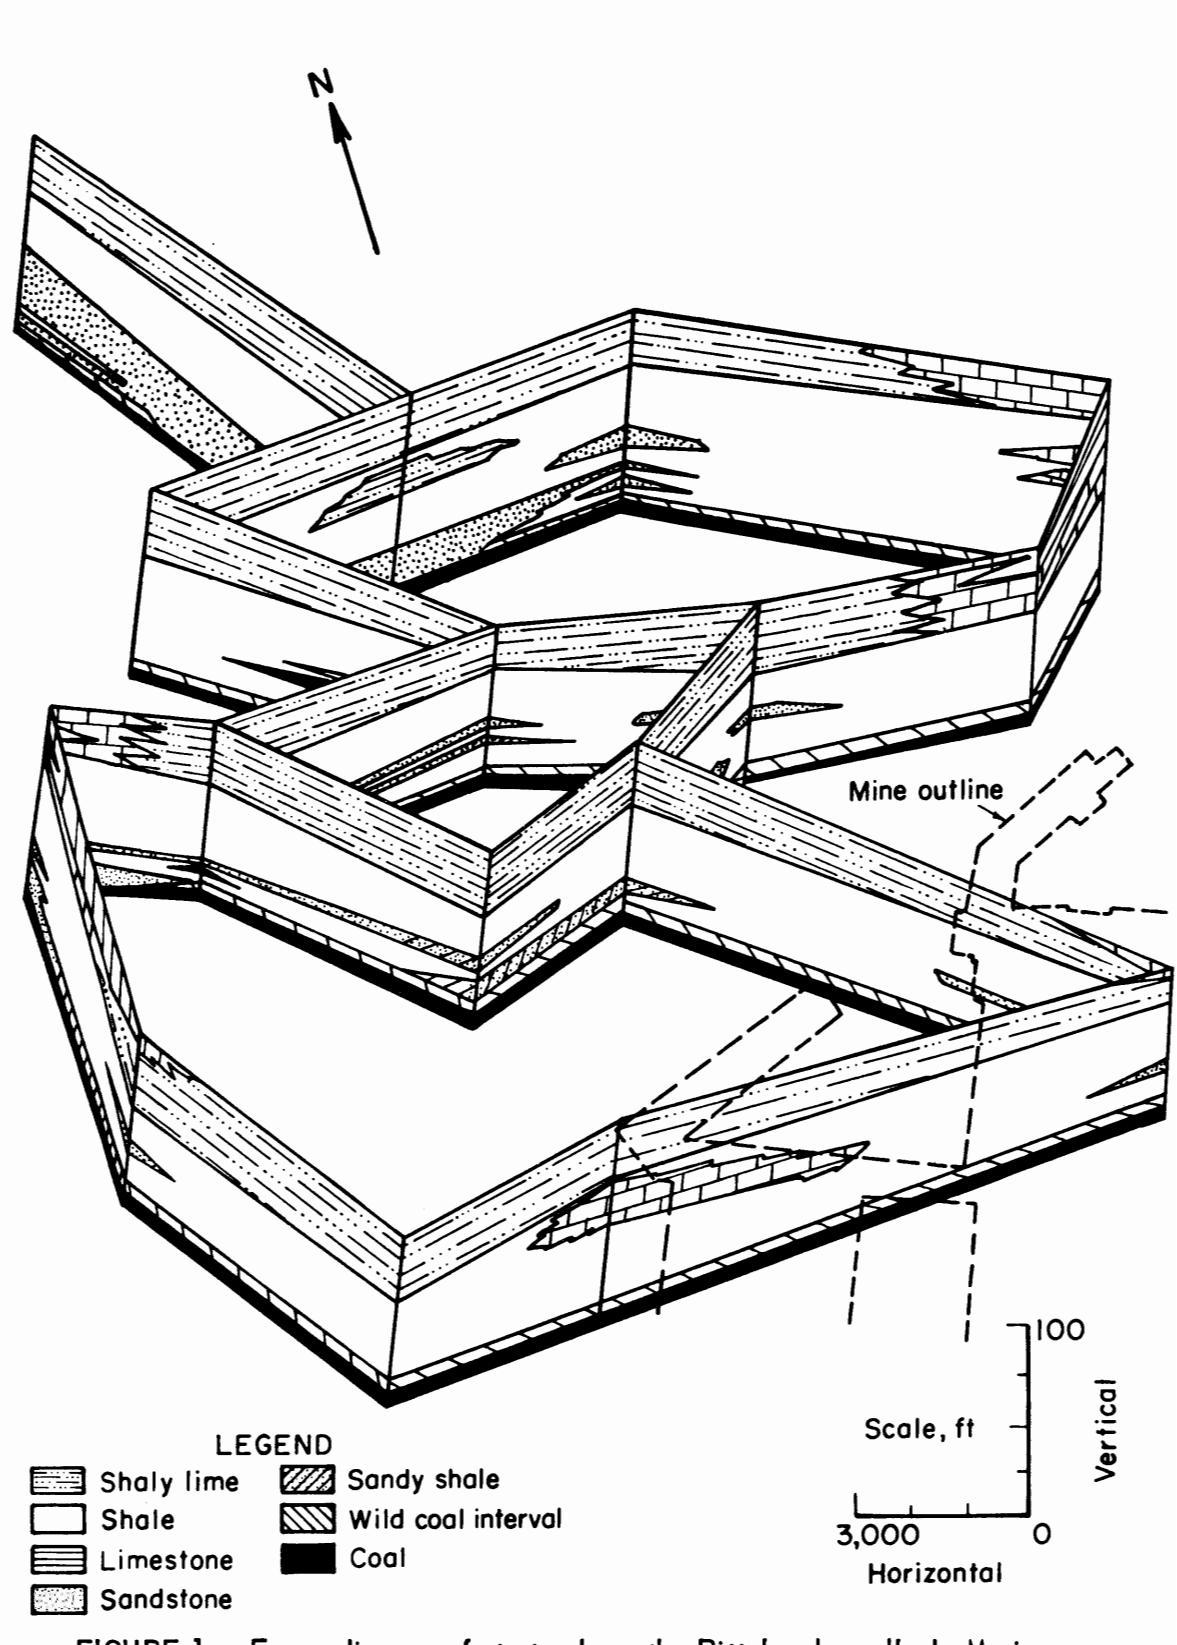
FIGURE 1. - Fence diagram of strata above the Pittsburgh coalbed, Marianna No. 58 mine.

A panel (see glossary) or fence diagram (fig. 1) and a structure map (fig. 2) of the property were prepared. A topographic map was overlayed on the mine map to correlate the

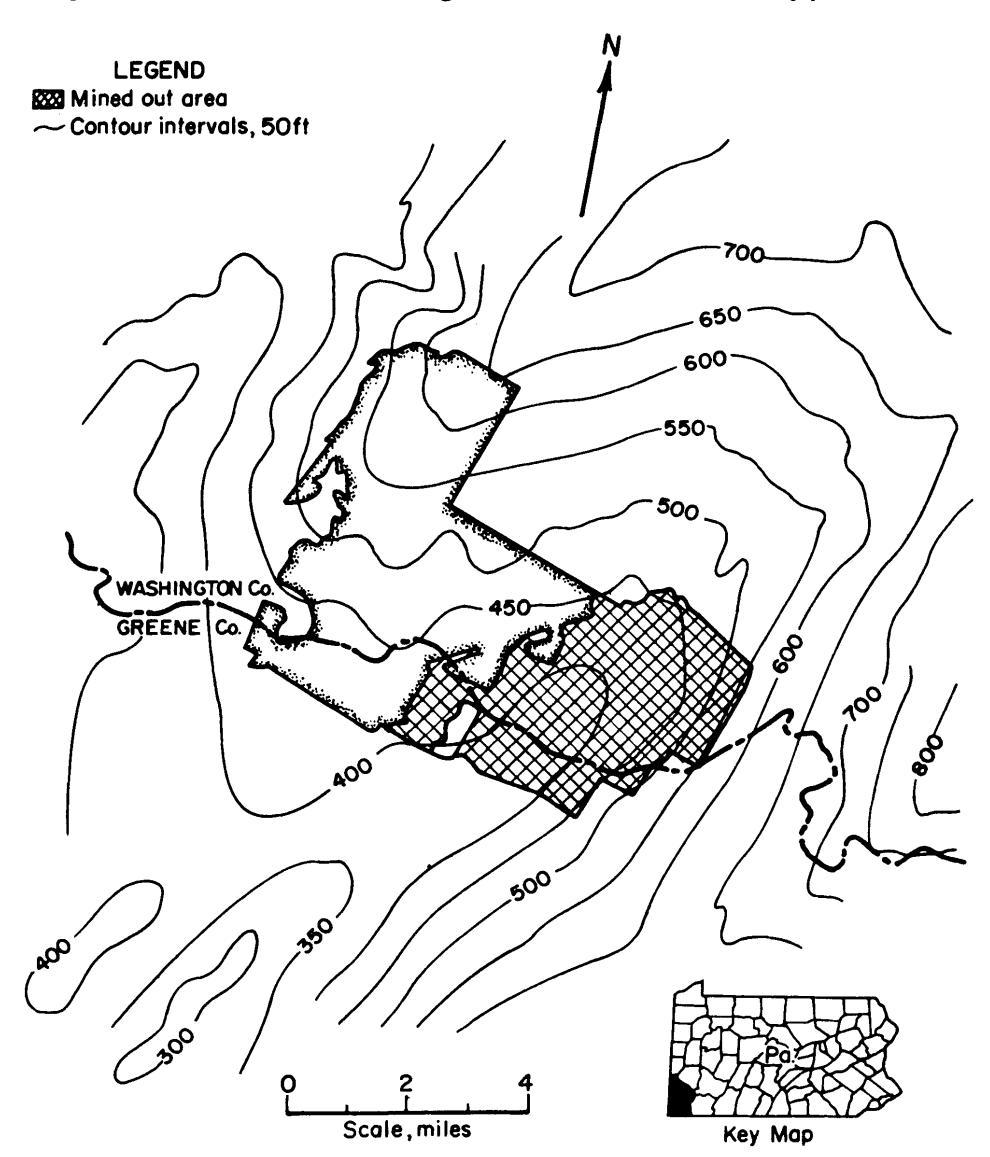
FIGURE 2. - Structure drawn on base of the Pittsburgh coalbed, Marianna No. 58 mine.

topography over the mine with problems encountered underground. A number of falls seem to aline with and occur under streams in the area. Because most streams form along zones of weakness, it was felt that this zone parallel to the stream would be a problem whenever it was encountered (fig. 3). Research currently underway further supports this idea. Another zone of falls associated with abnormally high gas emissions was found where the cover changed abruptly from 300 to 700 feet. This was attributed tentatively to differential overburden pressures.

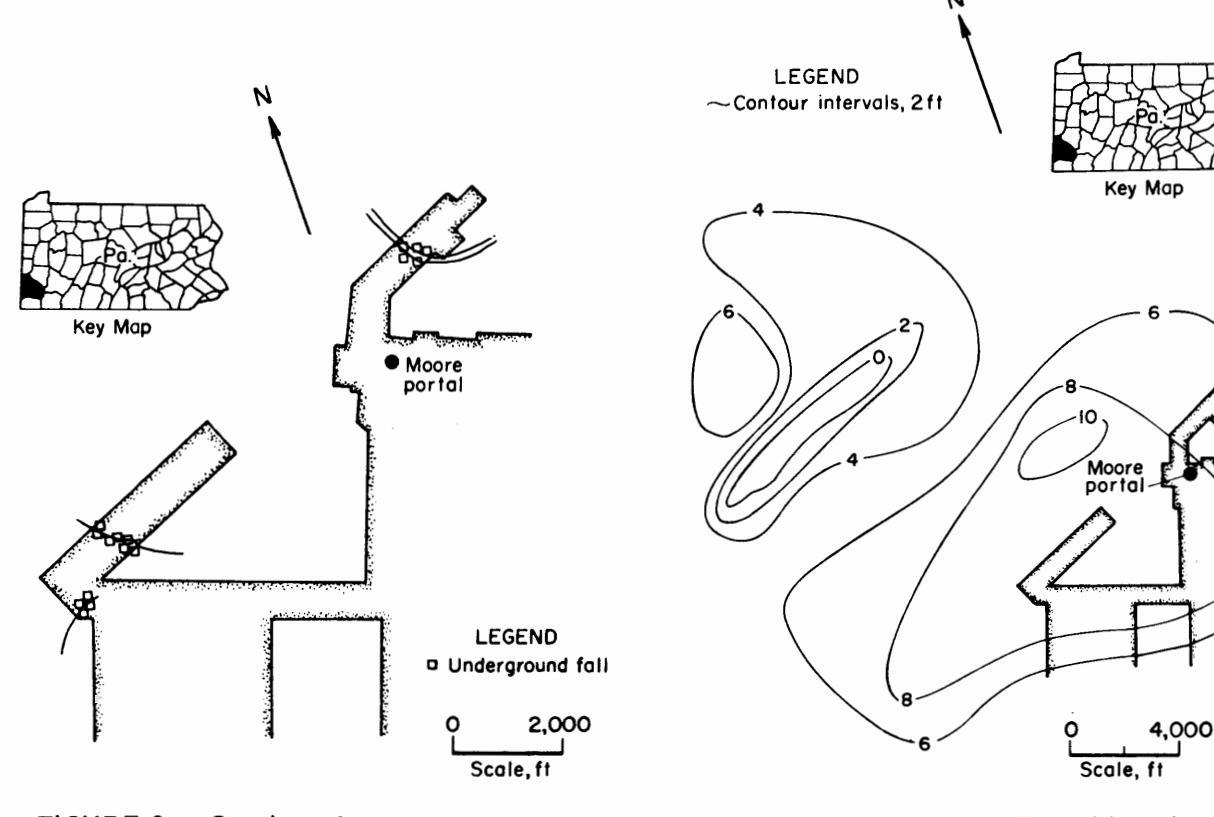
- FIGURE 3. Overlay of mine streams on surface related to underground falls.
- FIGURE 4. Isopach of the wild coal interval over the Pittsburgh coalbed in the Marianna No. 58 mine.

The major problem throughout the mine was the wild coal interval formed by alternating thin bands of claystone and coal that overlay the coal. The interval ranged in thickness from 1 to 9 feet and could not support itself. The company was using roof bolts with a minimum length of 6 feet and a standard length of 7 feet; these were adequate where the wild coal was less than 6 feet thick. An isopach map of the wild coal interval (fig. 4) showed where this unit is greater than 6 feet thick; longer roof bolts would be needed in these areas.

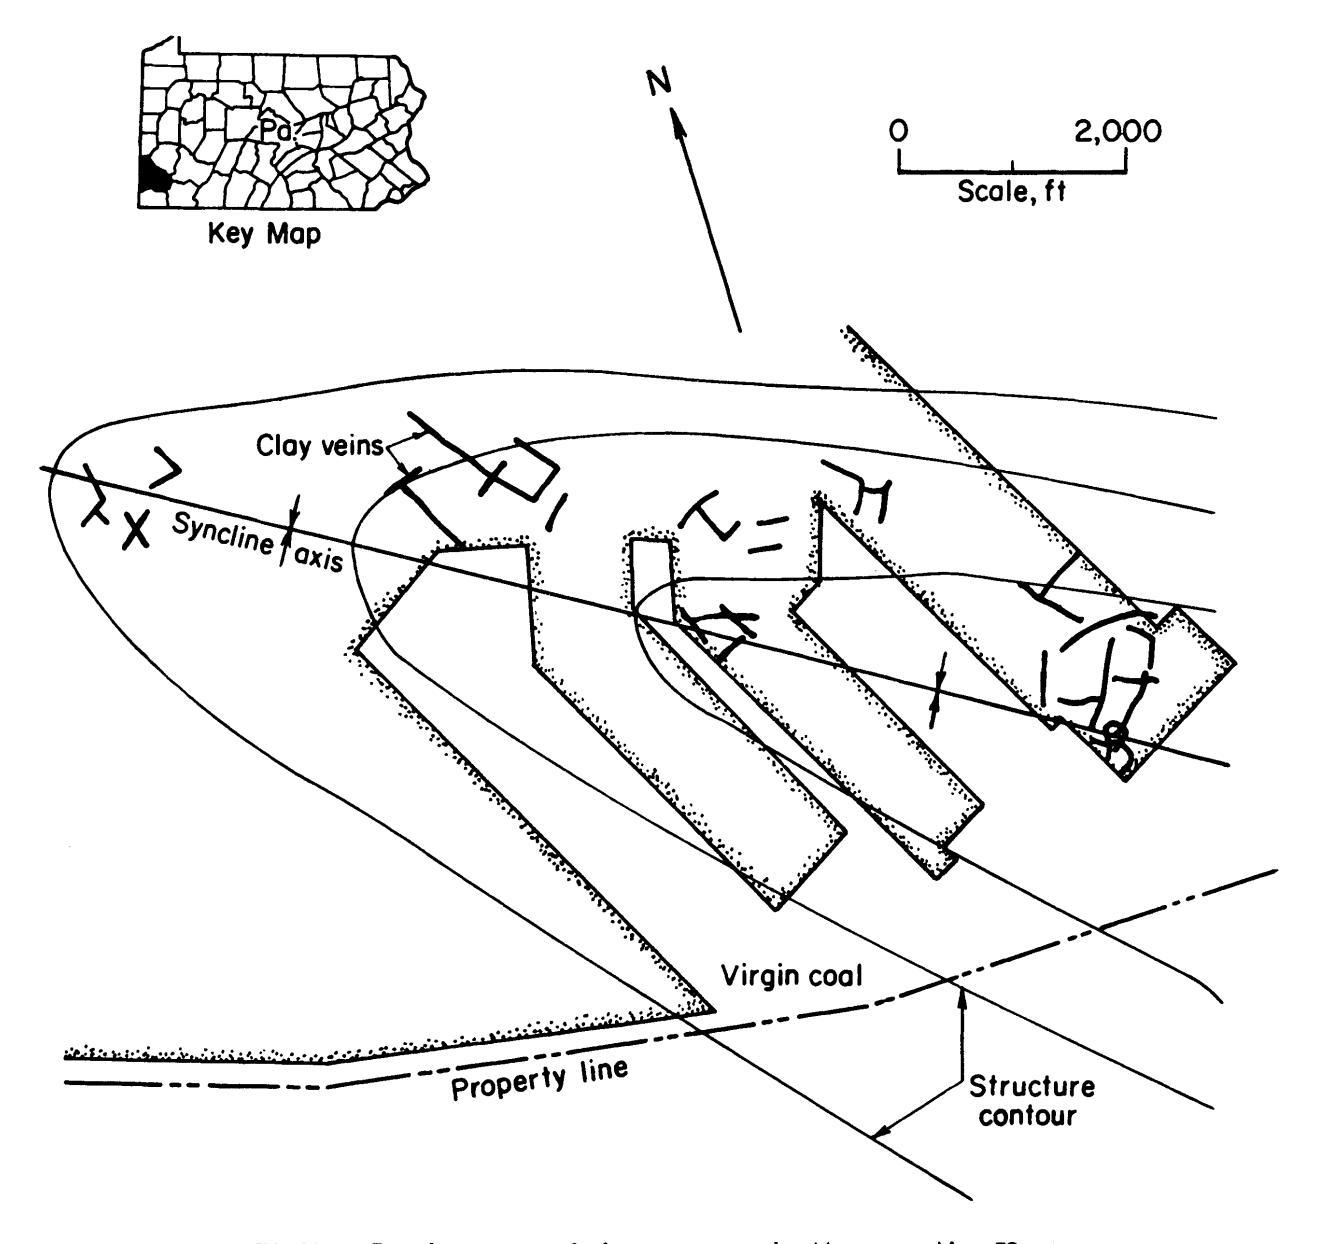
FIGURE 5. - Location of clay veins in the Marianna No. 58 mine.

A section affected by clay veins was carefully mapped. Comparison with a structure map of the area revealed the presence of a syncline with the clay veins located along its axis (fig. 5). As some of the mine entries had

already passed through the axis and were now encountering few clay veins, it was anticipated that when mining approached the axis of this syncline the occurrence of clay veins would increase.

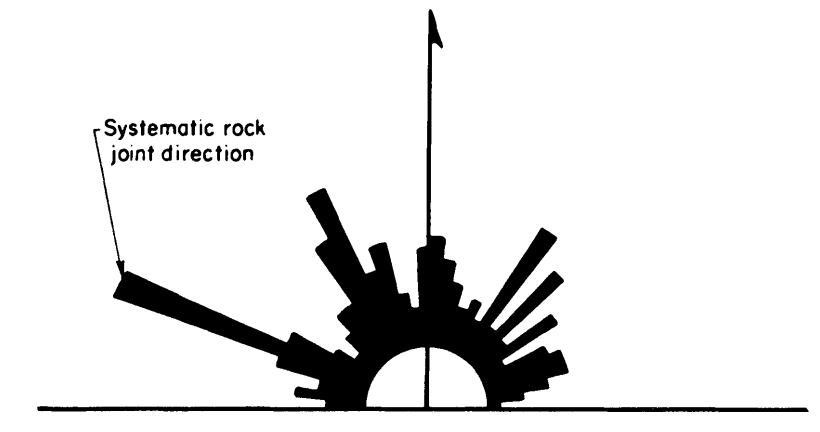
FIGURE 6. - Surface joint data above the Marianna No. 58 mine.

Joints were measured on the surface (fig. 6) to evaluate correlations between the principal fracture directions underground and those on the surface. Correlation was excellent.

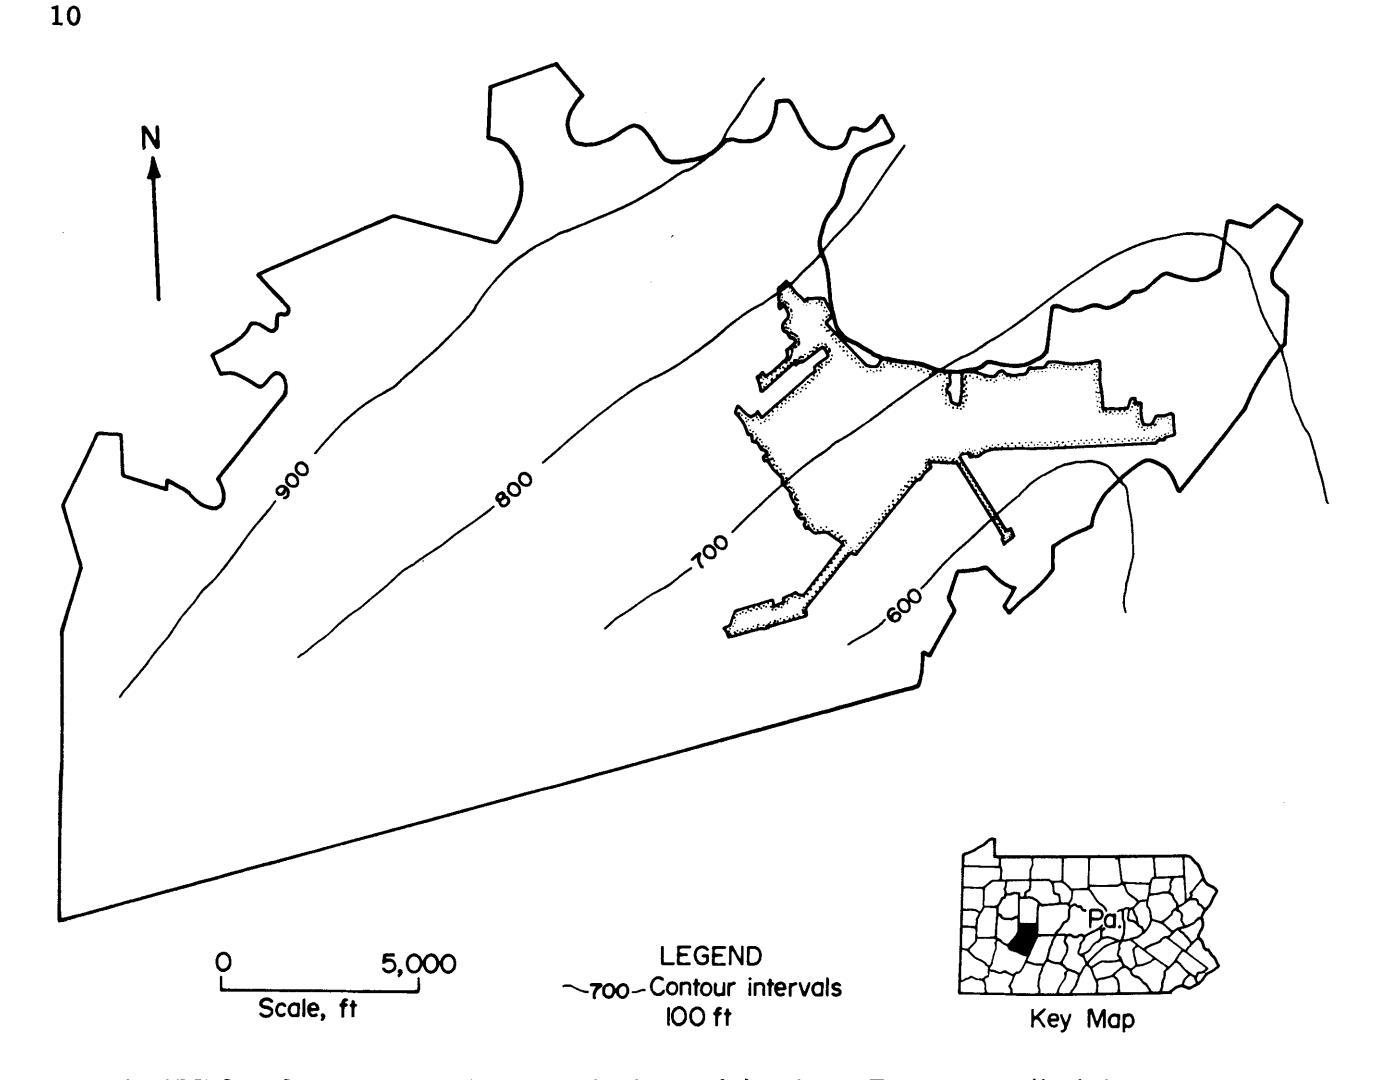
FIGURE 9. - Structure map drawn on the base of the Upper Freeport coalbed, Lucerne No. 6 mine.

A structure map (fig. 9) of the base of the Upper Freeport seam, drawn from corehole data, shows a synclinal structure with axis bearing approximately N30°E and passing through the easternmost section of the mine. The largest part of the mine workings and reserves lies in the western limb of the syncline. The data points were too widely spaced to determine more than the gross structure of this area.

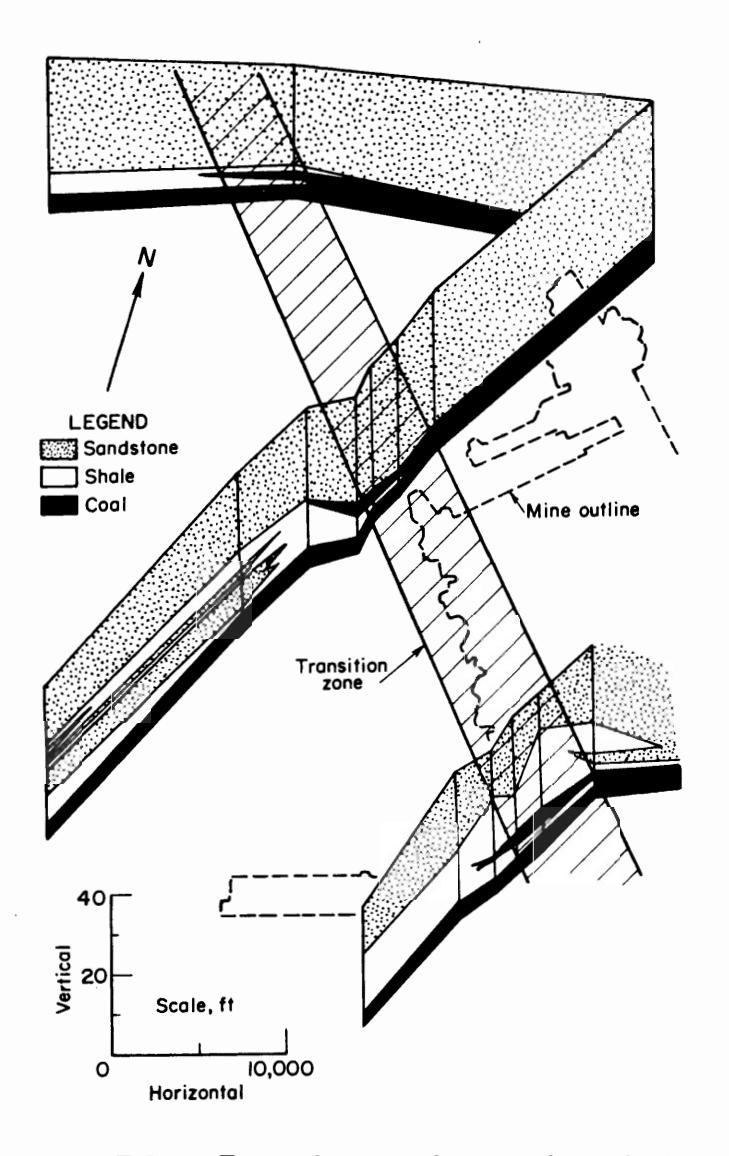
FIGURE 10. - Fence diagram of strata above the Upper Freeport coalbed, Lucerne No. 6 mine.

zone is N30°W. This is illustrated by the fence diagram (fig. 10) constructed from the core log descriptions of the first 40 feet of rock above the coal. Within this interval, sandstone is present throughout almost the entire area. This sandstone is separated from the coal locally by shales and sandy shales. Its large lateral extension makes it a probable water and gas reservoir. Thick sandstone directly overlying coal often exhibits deformations due to compaction which appears locally to be thrust faults, but this was not the case here. The core logs were examined for records of broken rock, but they yielded no pattern indicative of possible fault zones.

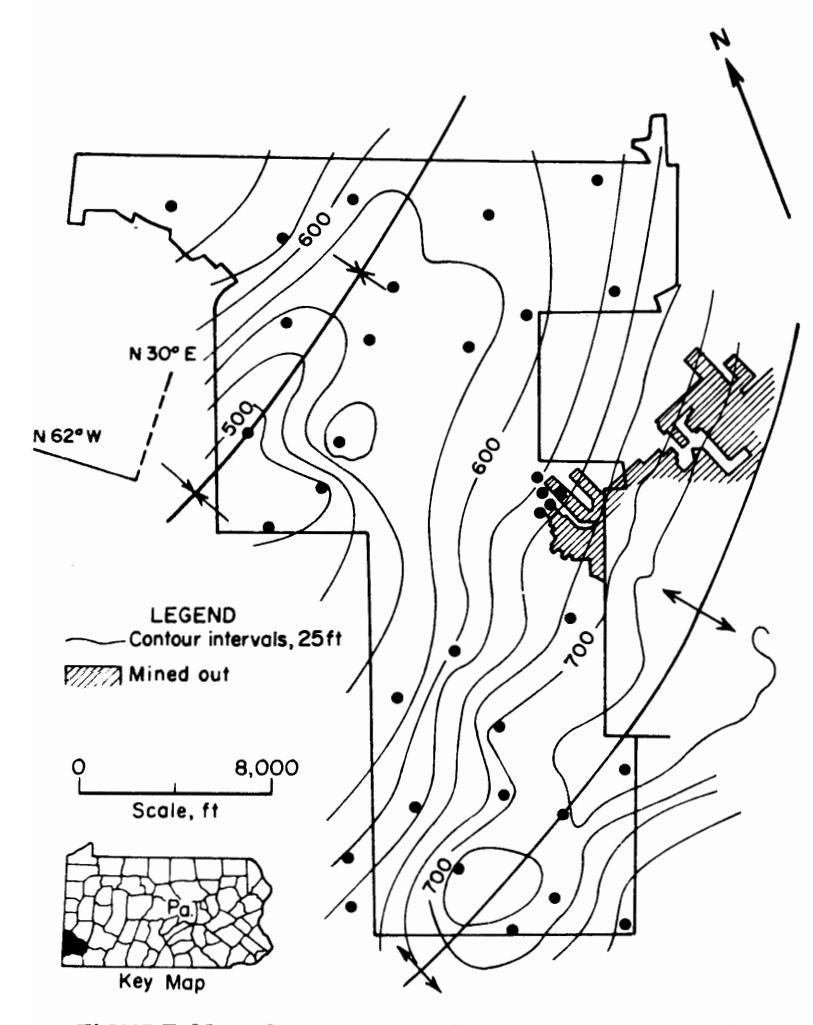
FIGURE 11. - Structure map drawn on the base of the Pittsburgh coalbed at Somerset No. 60 mine.

that mining is preceding down the northwest flank of the Amity anticline towards a syncline (fig. 11). Water is reportedly accumulating at the face of entries being driven to the northwest. This condition may be expected as long as the entries dip into the working face. Once they advance on the axis of the syncline, the floor will dip away from the face and water should no longer accumulate there.

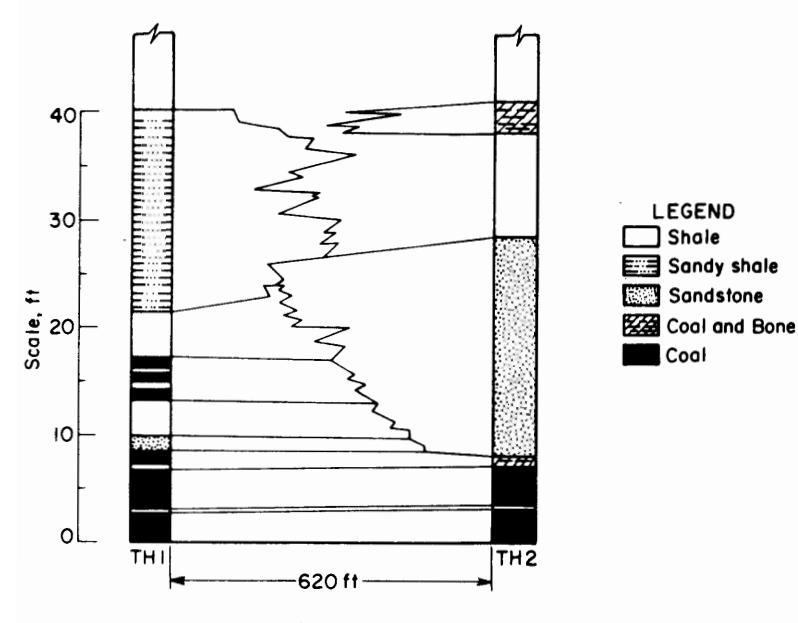
FIGURE 13. - Lithologic change between drill holes TH1 and TH2.

holes TH1 and TH2 (fig. 13) drilled 620 feet apart. The change in lithology is due to stream erosion of strata that were originally deposited over the coalbed in the same way as in the northern part of the area. Subsequently, sand was deposited in these erosion channels. The depth of erosion varied from place to place so that the coal is only removed locally. The thinner the interval between the coalbed and the overlying sandstone, the greater the probability that erosion will affect the coalbed. A map based on present drill hole data shows areas where cutouts may be expected (fig. 14).

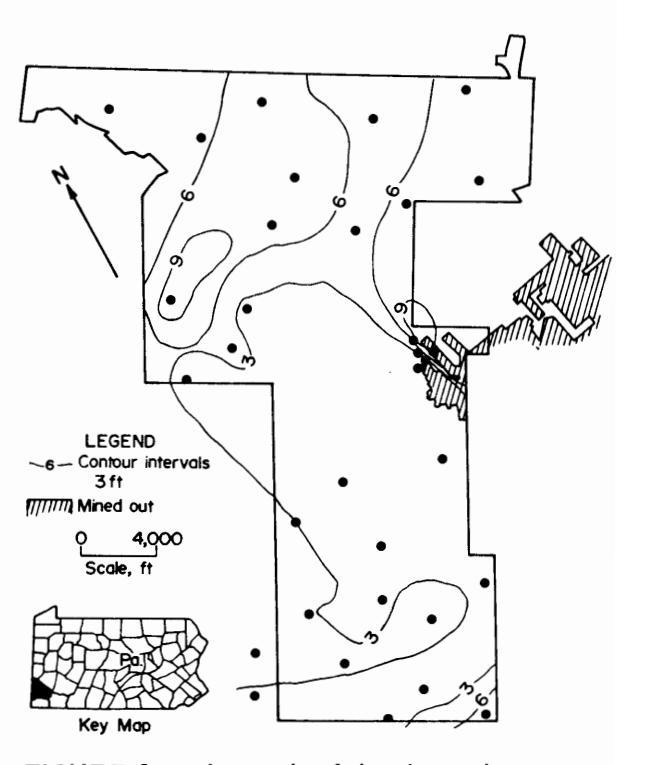
FIGURE 15. - Isopach of the draw slate unit above the Pittsburgh coalbed, Somerset No. 60 mine.

Overlying the main bench (mined portion) of the Pittsburgh coalbed is an interval of variable thickness composed of alternating slickensided claystones and coals (fig. 15). The interval has very little strength and can fall, causing gas emissions as well as haulage

problems. Most mines prefer to anchor roof bolts in the more competent rock above this interval. Figure 15 can be used in a general way to determine the minimum length of bolt that would be necessary to bolt through the interval in any given area.

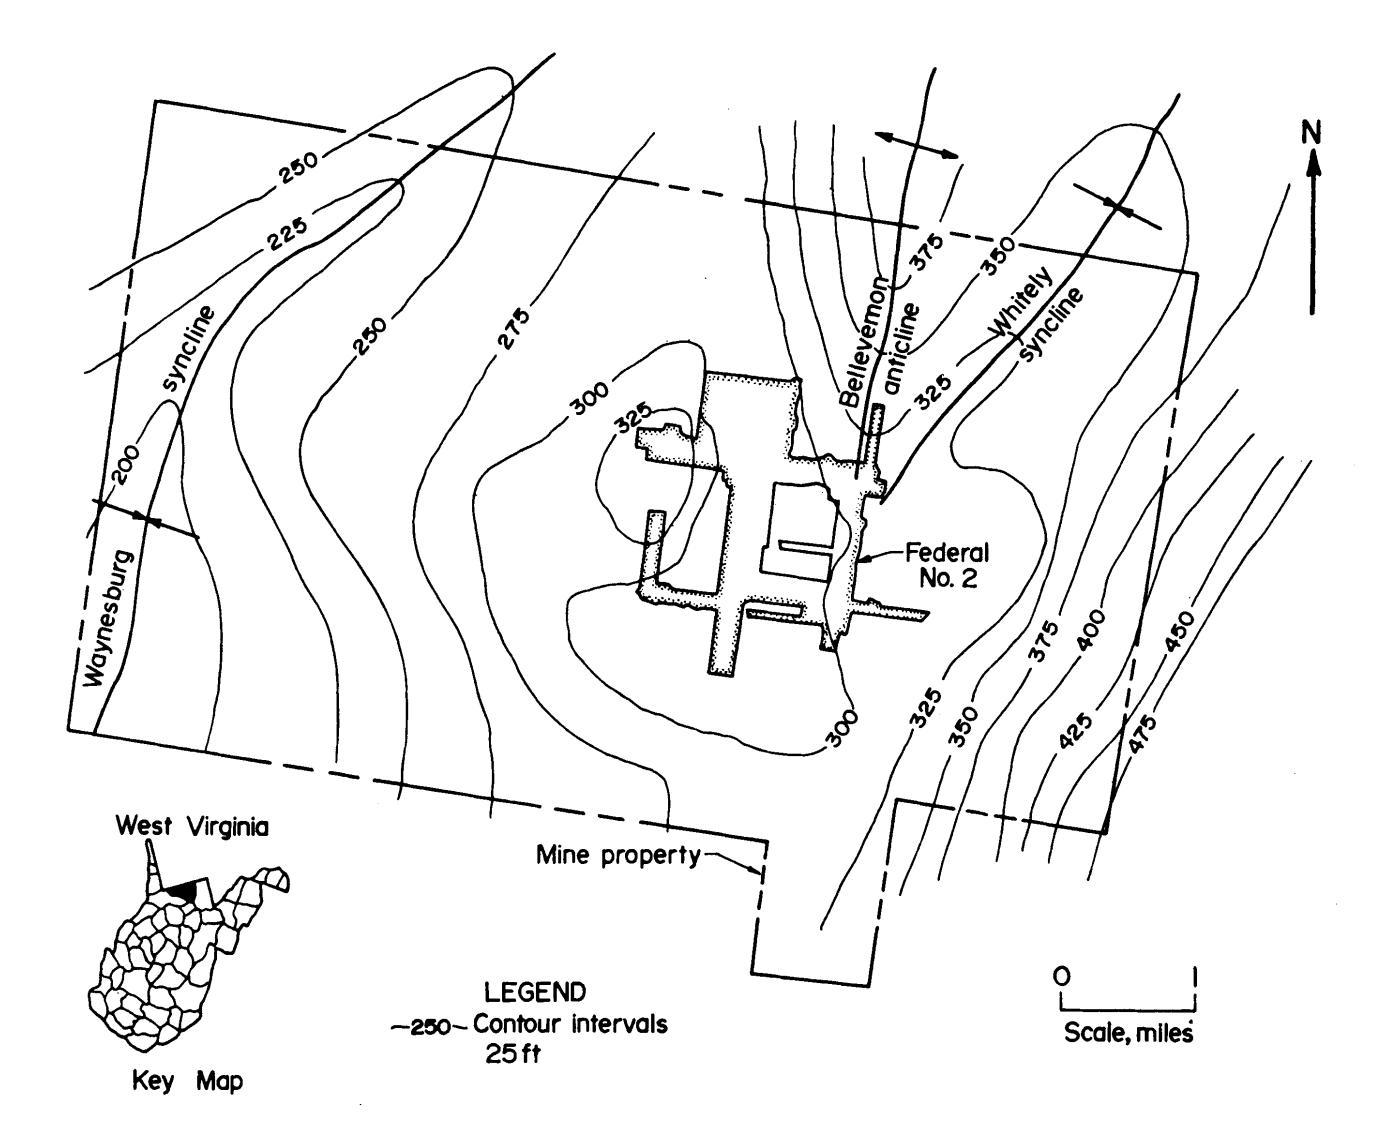
FIGURE 17. - Structure map drawn on the base of the Pittsburgh coalbed, Federal No. 2 mine.

A structure map (fig. 17) shows the axis of the Waynesburg syncline passing through the western extremity of the mine property. The Pittsburgh coalbed dips generally westnorthwest towards the axis. The Belle Vernon anticline and the Whitely syncline are well developed northeast of the mine area. In the central portion of the mine property, there is a local upwarping which interrupts the gentle westerly dip.

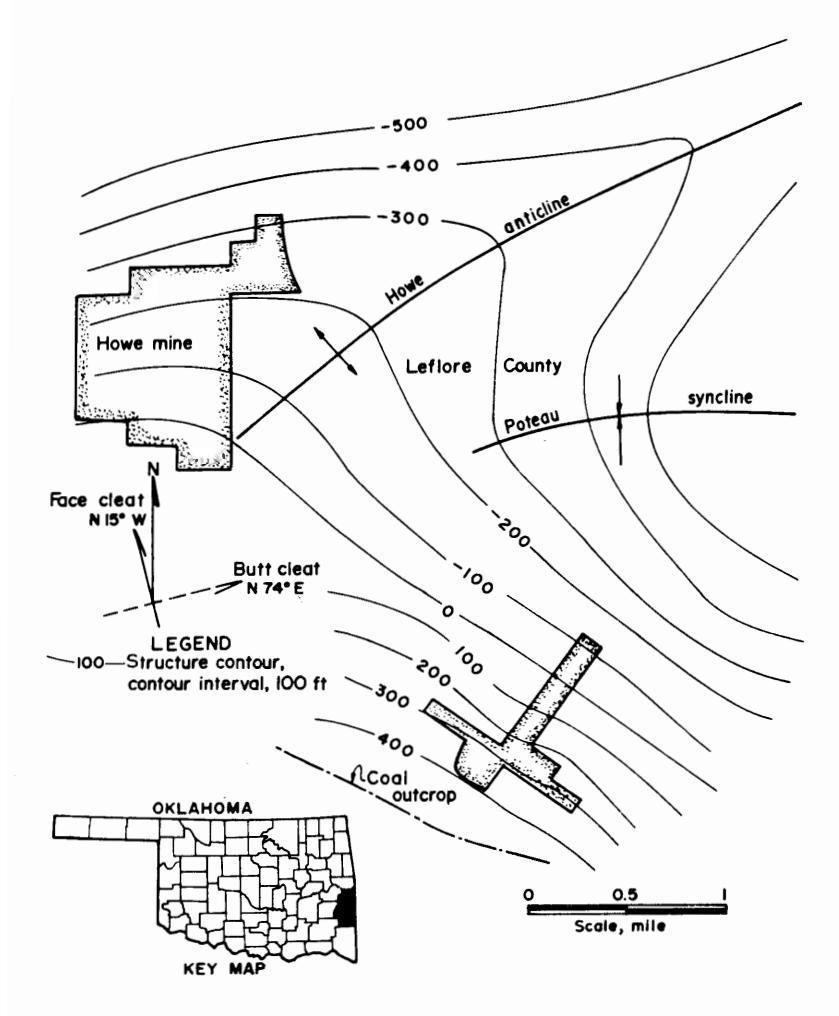
FIGURE 18. - Structure map drawn on the base of the Lower Hartshorne coalbed, Howe mine.

The mine is located 6 miles south of Poteau, La Flore County, Okla. It is on the south side of the Arkoma Basin, which is described as a synclinorium. Figure 18 shows the generalized structure of the Lower Hartshorne coalbed and the two major structures present in the area--the Howe anticline and Poteau syncline--with the cleat orientations. The Hartshorne coalbed consists of an upper bench averaging about 32 inches in thickness, below which there is a shale parting up to 24 inches thick, followed by several thin layers of usually impure coal laminated with black, carbonaceous shale.

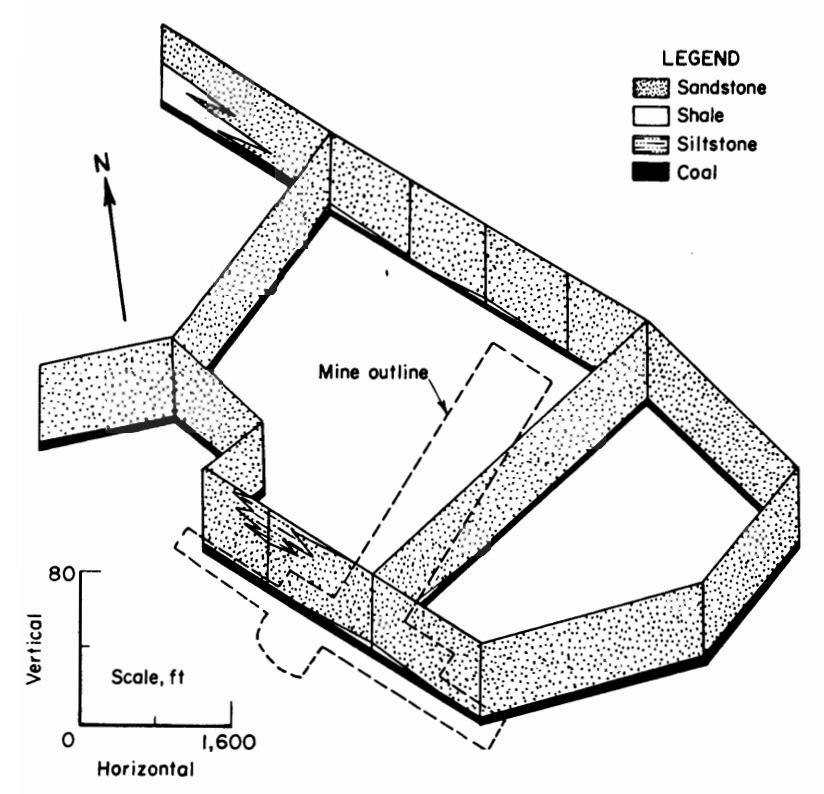
FIGURE 19. - Fence diagram of the strata above the Lower Hartshorne coalbed, Howemine.

A panel diagram (fig. 19) constructed from core logs of the test holes drilled by the company shows that the immediate roof over most of the property is sandstone. According to Bureau research, the absence of shale between the coal and sandstone greatly increases the probability of sandstone channels.

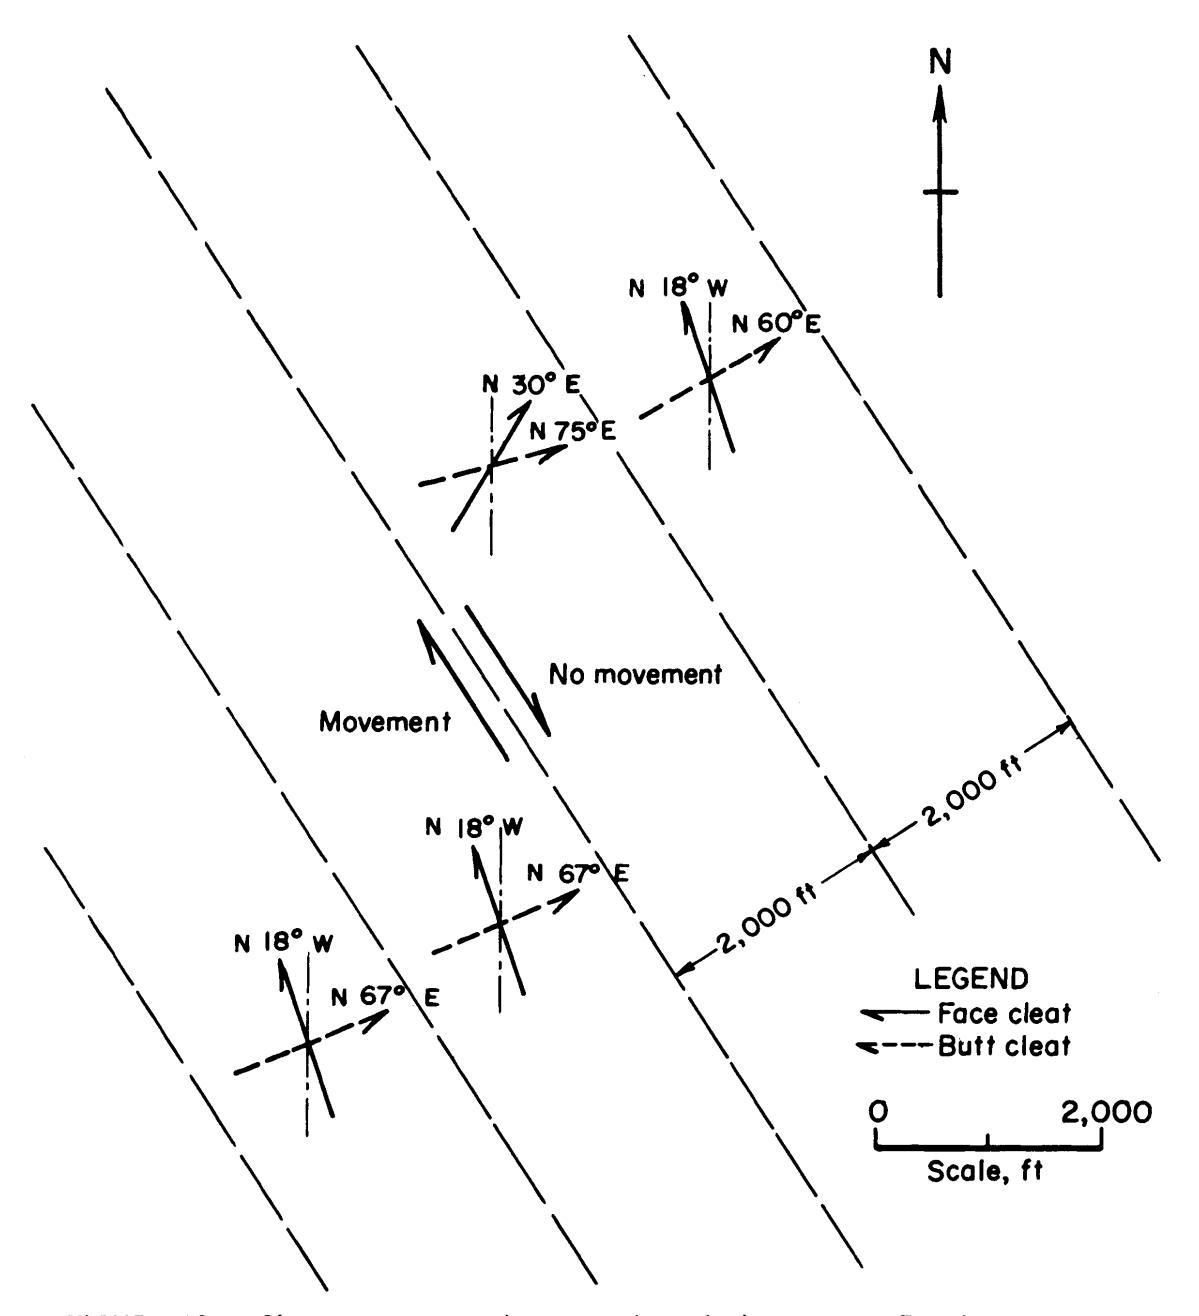
FIGURE 21. - Cleat rotation in relation to shear fault, Beatrice-Pocahontas mine.

Cleat measurements showed face cleat trending N18°W and butt cleat trending N67°E. On the northeast side of the fault, a rotation of the cleat (fig. 21) indicated that this side had acted as a buttress against which the southwest block moved.

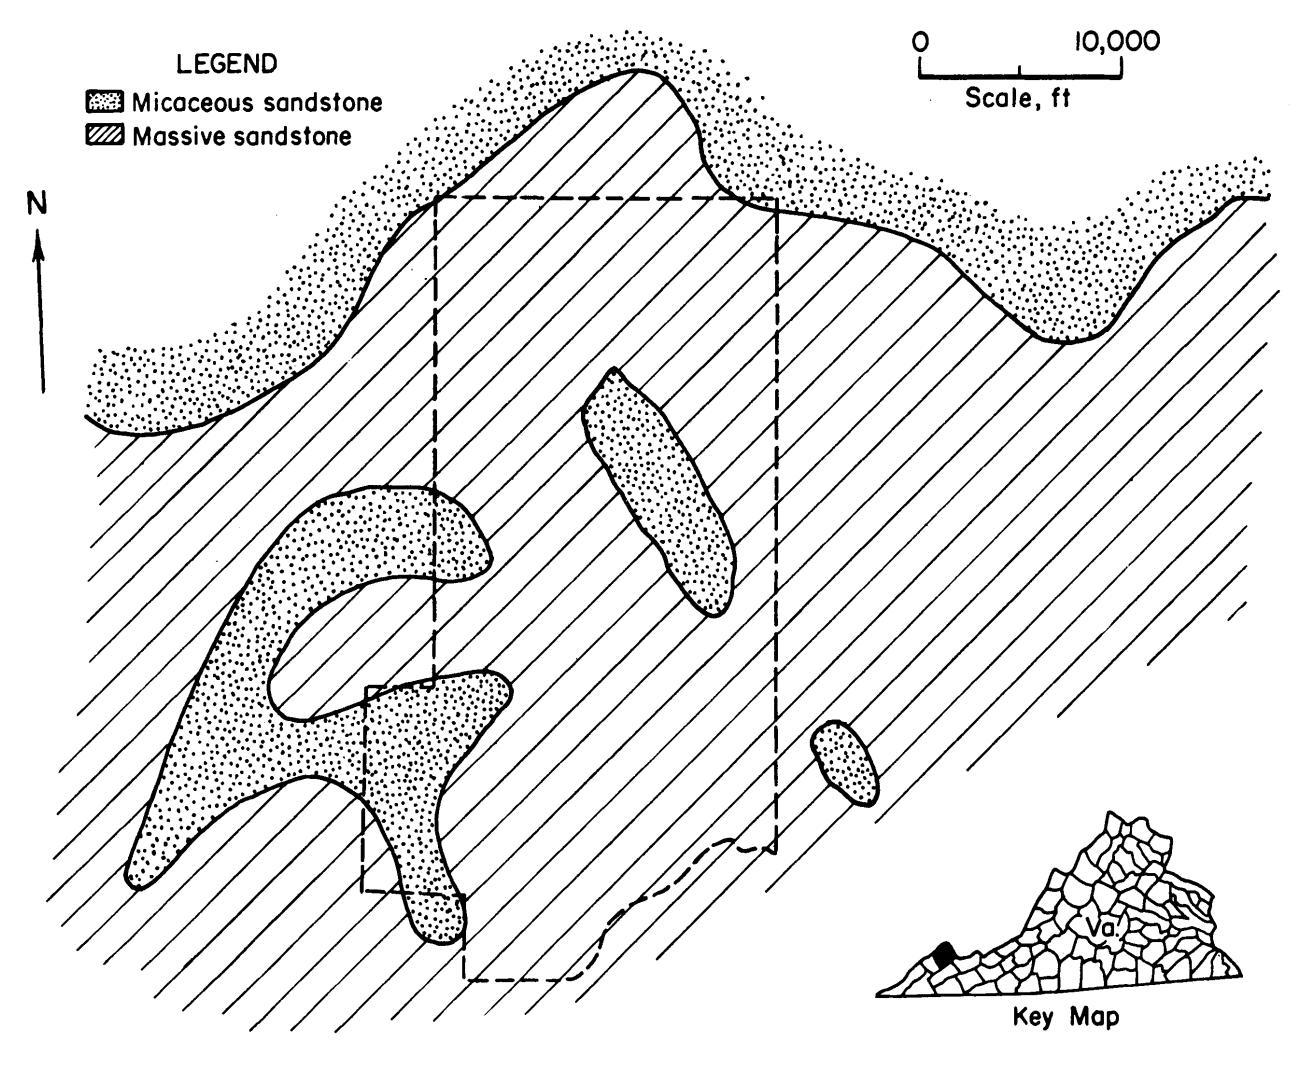
FIGURE 24. - Nature of sandstone above Pocahontas No. 3 coalbed, Beatrice-Pocahontas mine.

During the survey, it was noted that washouts occurred with massive sands, and a majority of the falls observed had micaceous sands composing the fall unit. A map of the type of sandstone (massive or micaceous) found above the coal (fig. 24) should anticipate such problems and make it possible to modify mining techniques before problem zones are encountered.

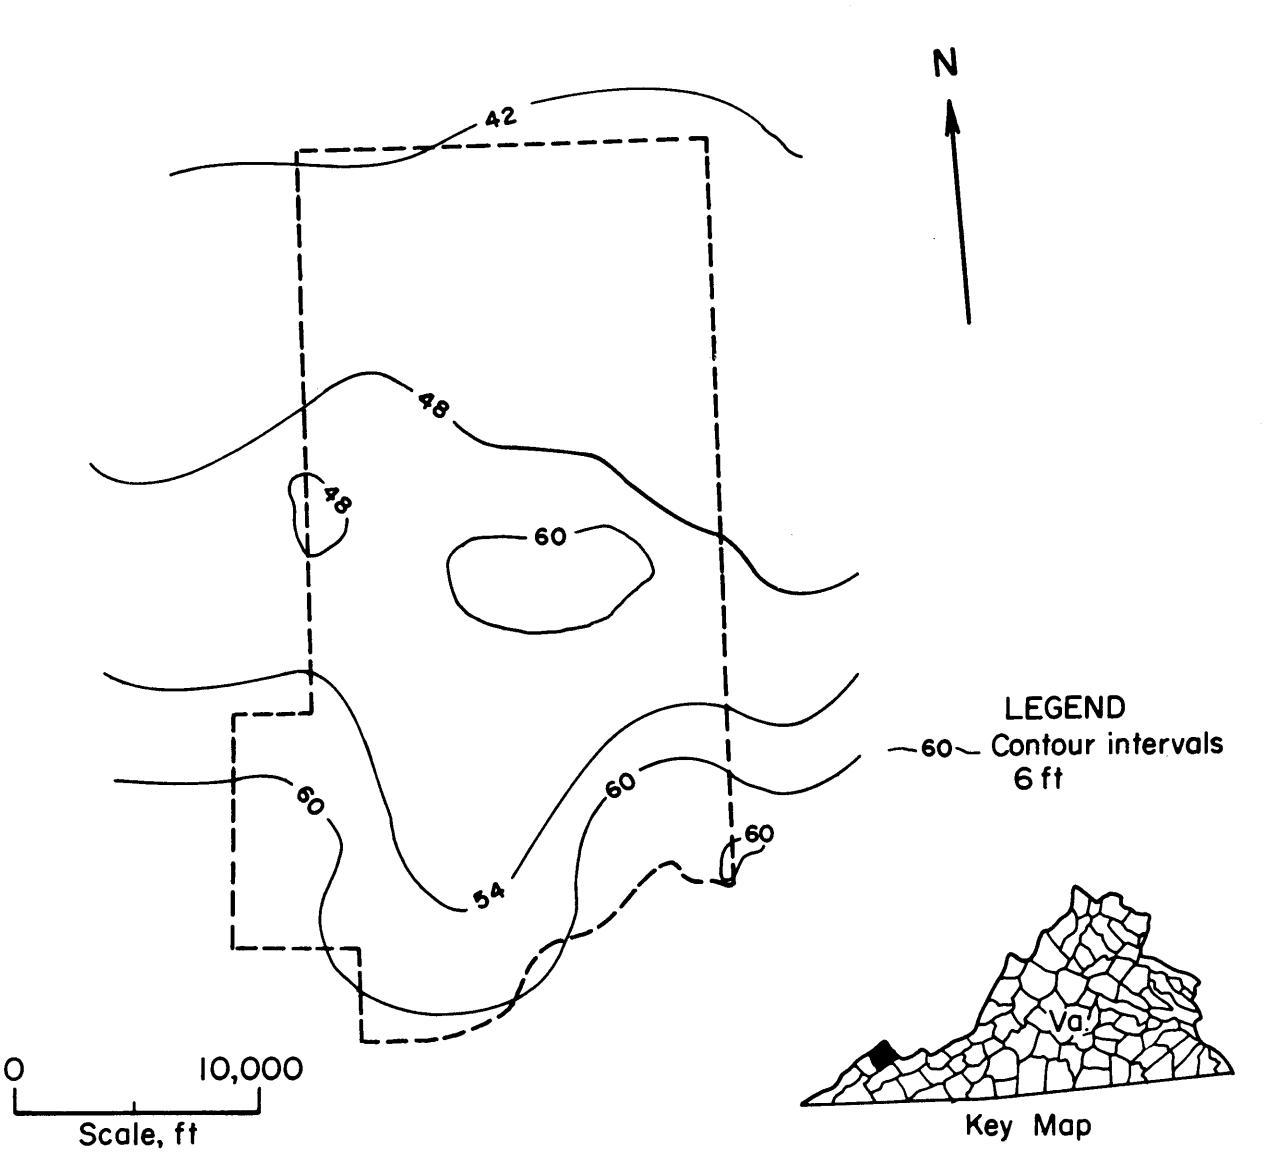
FIGURE 25. - Isopach of Pocahontas No. 3 coalbed (inches), Beatrice-Pocahontas mine.

An isopach map (fig. 25) of the coal thickness was prepared to determine if any washouts could be located. A second isopach from the coal to the sandstone above (fig. 26) was constructed to determine if the roof falls and gas content correlated with proximity to the sands and as an additional aid in locating washouts and channels.

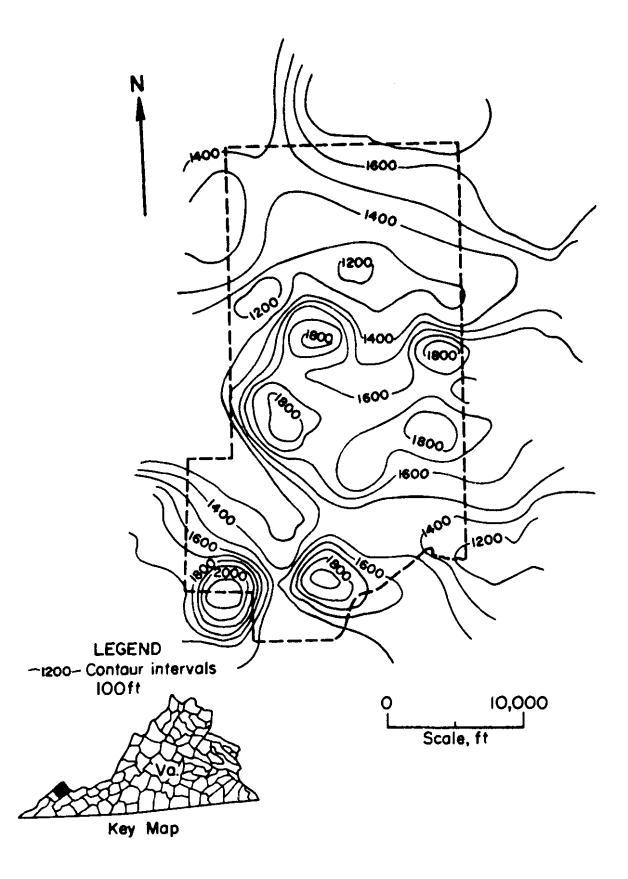
FIGURE 27. - Overburden isopach map of interval from Pocahontas No. 3 coalbed to surface, Beatrice-Pocahontas mine.

Finally an overburden isopach (fig. 27) was drawn to verify a Bureau of Mines theory that relates the amount of gas to the thickness of the overburden.
