Effects of Hydraulic Stimulation on Coalbeds and Associated Strata

Report of Investigations 8260

By Curtis H. Elder

BUREAU OF MINES

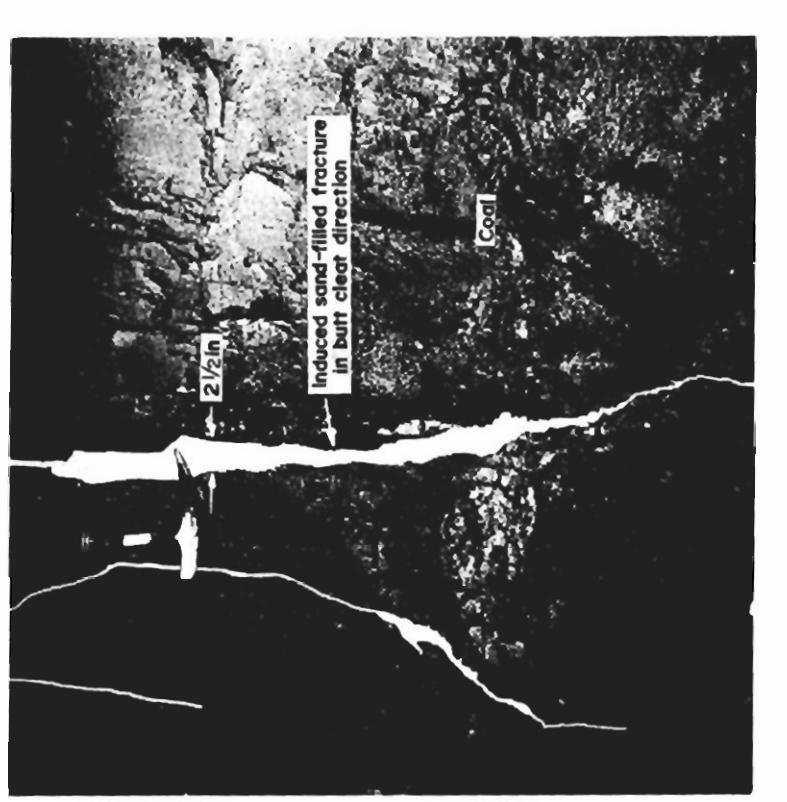
On June 12, 1974, the induced fractures were intercepted by mining. Twenty feet of vertical sand-propped fracture was mapped along the face cleat direction west of the borehole. The sand-filled fracture ranged from oneeighth to one-half inch in width, extending from the draw slate at the top of the coalbed to the mine floor. There was no evidence that the fracture extended into the roof or floor rock (figs. 4-6). Wide vertical fractures were propagated to the north of the borehole along the butt cleat direction. These fractures were 1/2 to 2-1/2 inches in width and were packed with the propping sand (figs. 7-8). They extended from the base of the draw slate to the floor. Again, no evidence was found to indicate that the induced fractures along the butt cleat direction penetrated the roof (fig. 9) or floor rock.

FIGURE 8. - Detail of induced fracture in middle of Pittsburgh coalbed at maximum width.

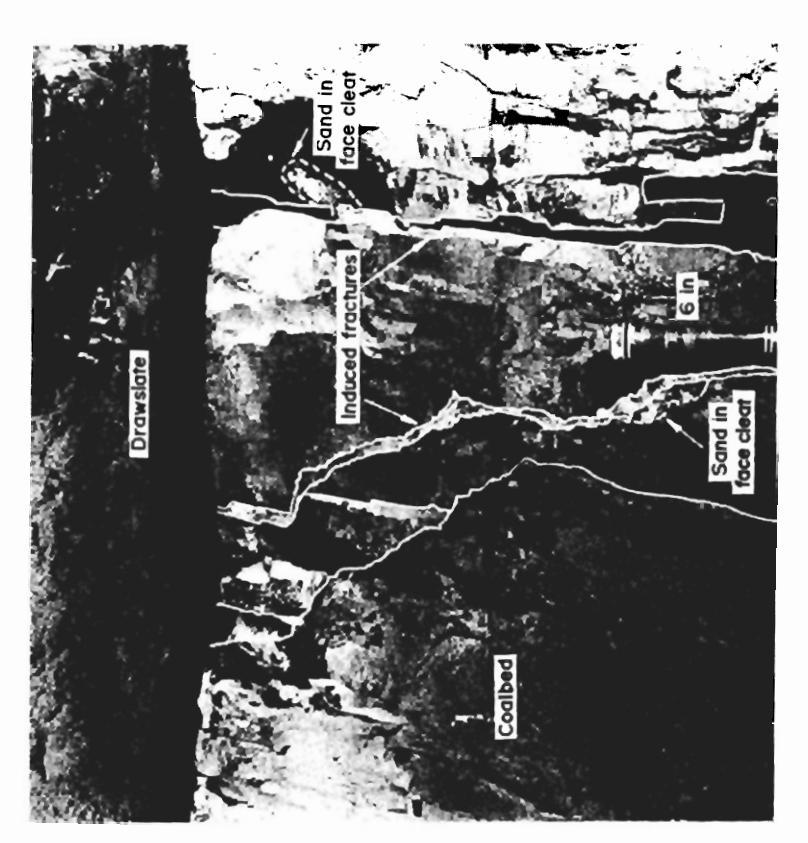
FIGURE 9. - Detail of induced fracture terminating at draw slate or rock strata overlying coalbed. The fracture does not penetrate overburden rock.

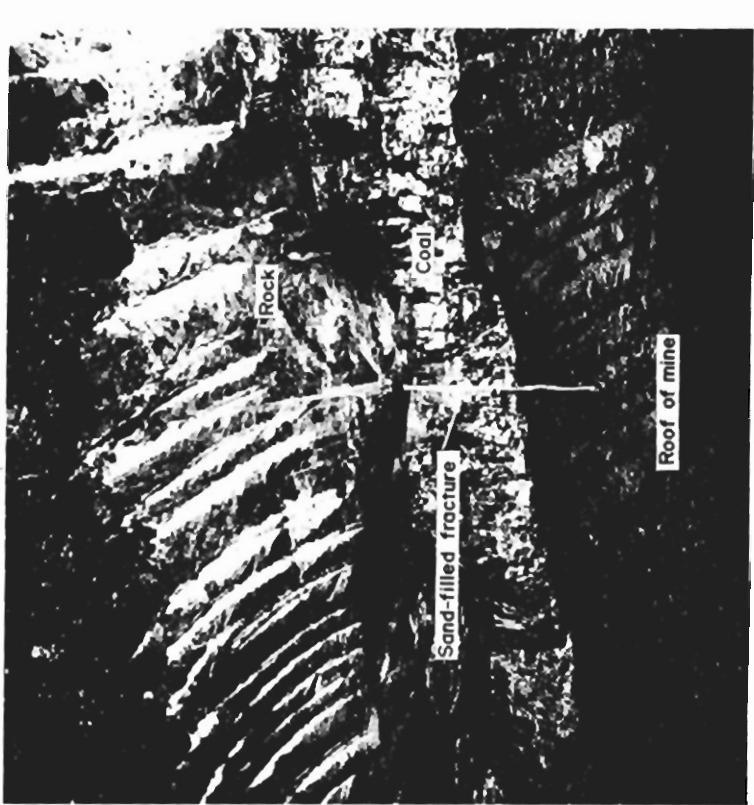
The fracture could be readily traced across the entries of the roof coal. It ranged from one-eighth to three-eighths inch in width, averaging approximately one-quarter inch (figs. 15-18). The sand-propped fracture did not extend into the roof or floor. The roof coal and rock remained stable in all the entries intersecting the fracture. Mining developed normally through the stimulated areas. Mine engineers noted a reduction in gas emission into the mine in the test area resulting from a long period of degasification prior to mining. Approximately 61 cu ft of fracture volume was created which was filled with sand. Sixty-four cubic feet of sand was used during the treatment. The 3-cu-ft difference can be attributed to sand that settled in the borehole. The excess sand was removed from the borehole immediately after treatment.

FIGURE 16. - Detcil of induced fractures in roof coal and termination of fracture at rock strata overlying coalbed at point A on figure 13.
