REPORT OF INVESTIGATIONS/1988

Anticollision Systems for Large Mine-Haulage Trucks

By Russell E. Griffin

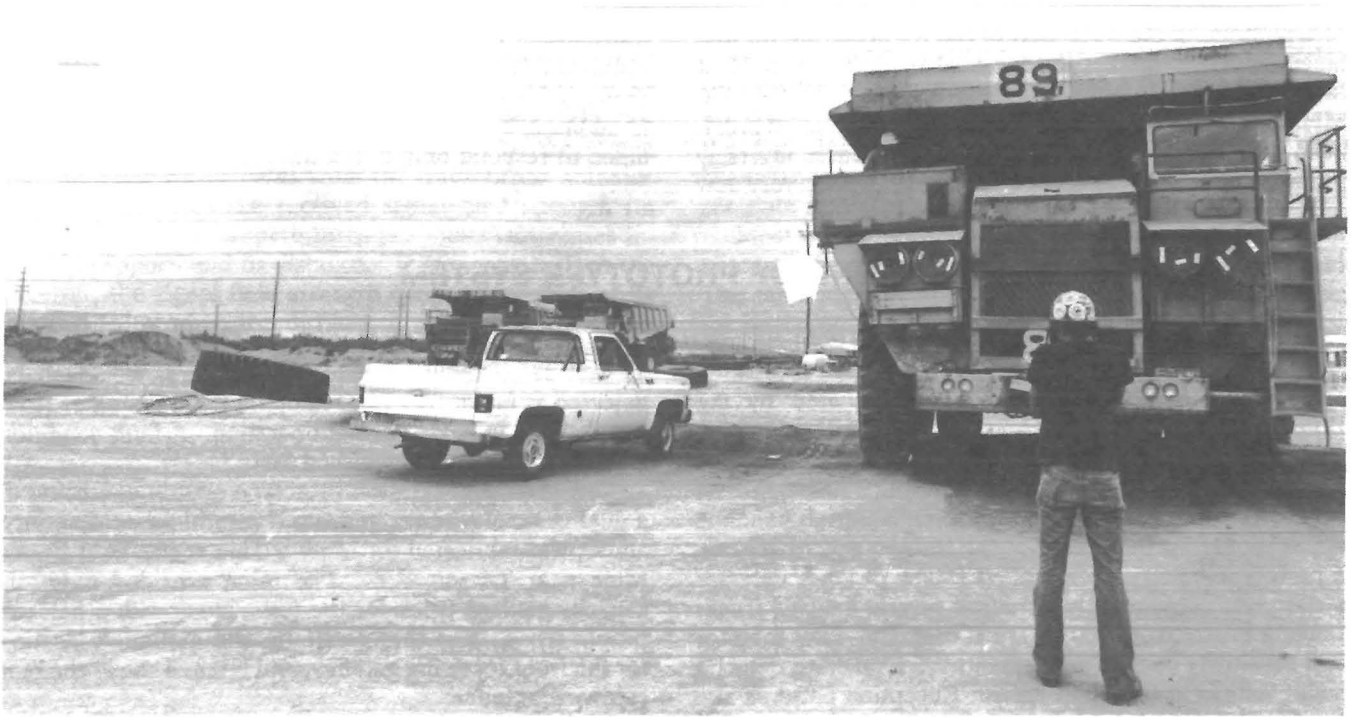
Figure 3.—Mounting location of front receiving antenna for Telemotive system.

One second-generation prototype system consisting of a dual-channel receiver and two transmitters, as described above, was fabricated for in-pit testing at the Twin Buttes Mine near Tucson, AZ. The mine provided a 120-st-capacity haulage truck for the tests, along with a half-ton pickup truck. Figure 3 illustrates the mounting location for the front receiving antenna, and figure 4 shows the rear receiving antenna.

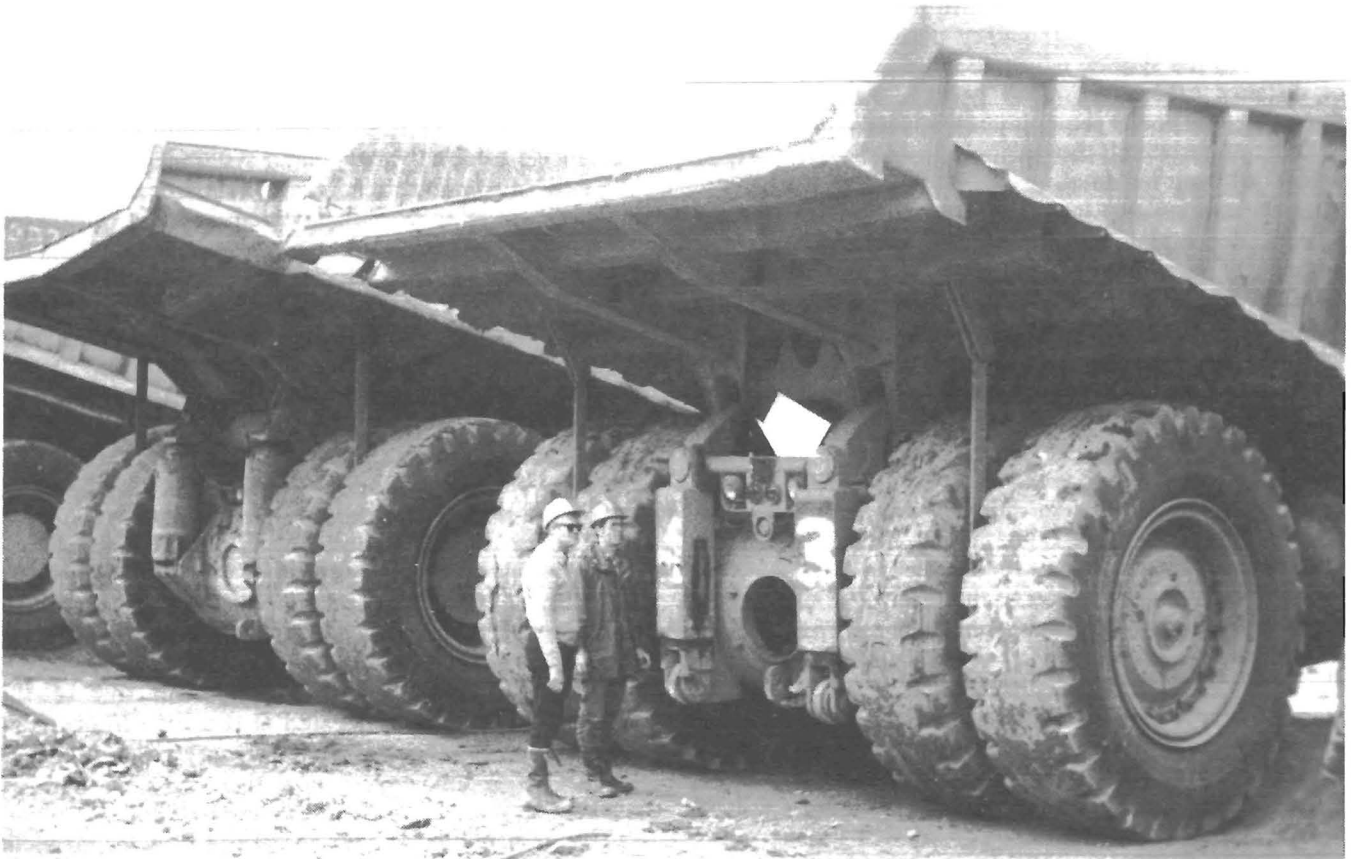
Figure 4.—Mounting location of rear receiving antenna for Telemotive system.

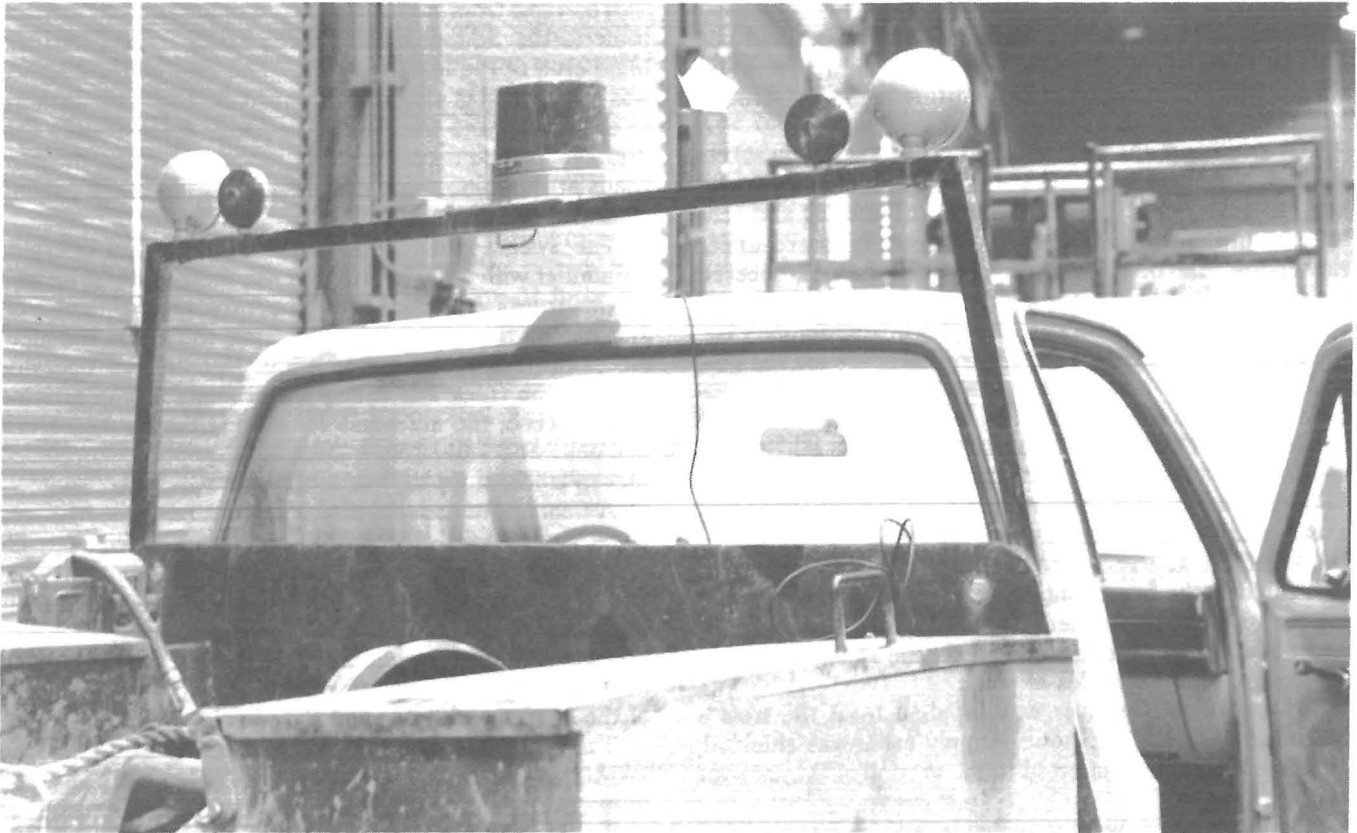
Figure 5.—Transmitter antenna mounted for Telemotive system.

The transmitter antennas were left with magnetic mounting bases for ease of changing vehicles (fig. 5).

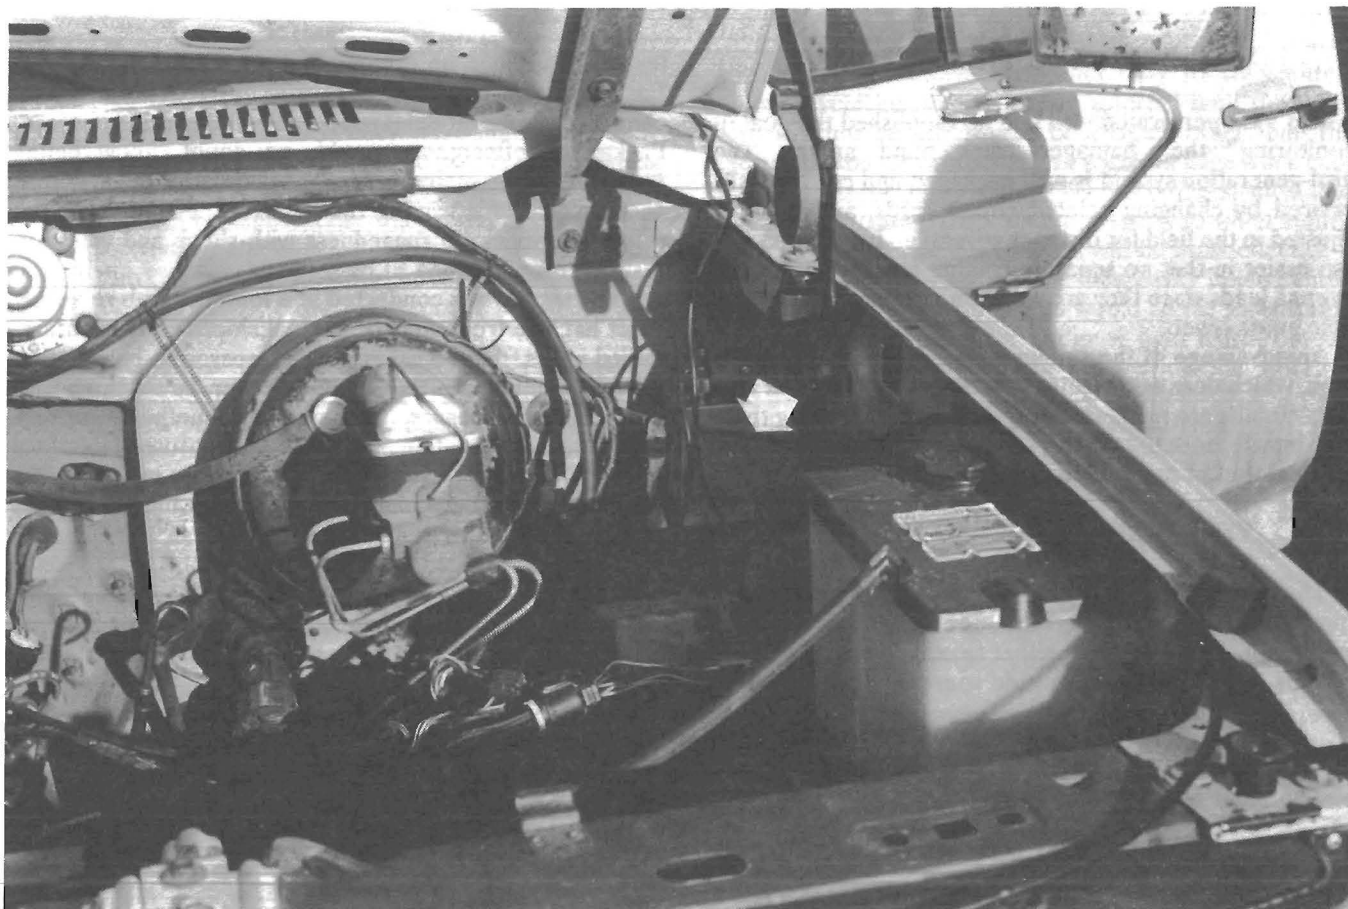
Figure 8.—Transmitter location for Motorola system.

A mine utility pickup truck was also provided, and the system transmitter was installed on the engine compartment firewall, with electrical connection to an accessory terminal on the fuse block under the dash. The antenna was mounted on a magnetic base and placed on the roof of the truck with the lead coming down along the left corner past, under the hood, onto the transmitter connection (fig. 8).
