**Report of Investigations 9495**

# A Field Trial for Sealing Abandoned Mine Shafts and Adits With Lightweight Concrete

By E. H. Skinner and L. A. Beckett

**BUREAU OF MINES**

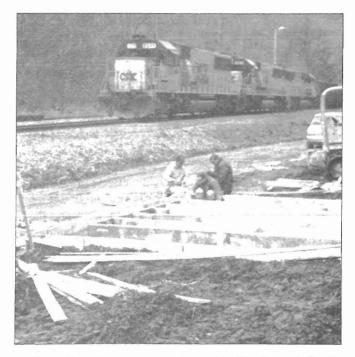
Figure 5.—Railroad and county road traffic along shaft site. Shaft cover is being prepared as safety precaution.

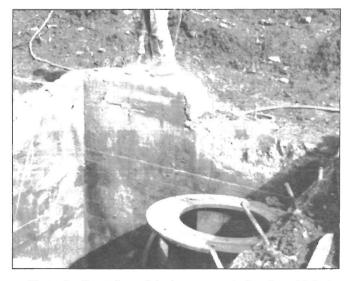
Figure 8.—Removing original concrete shaft collar with jackhammer.

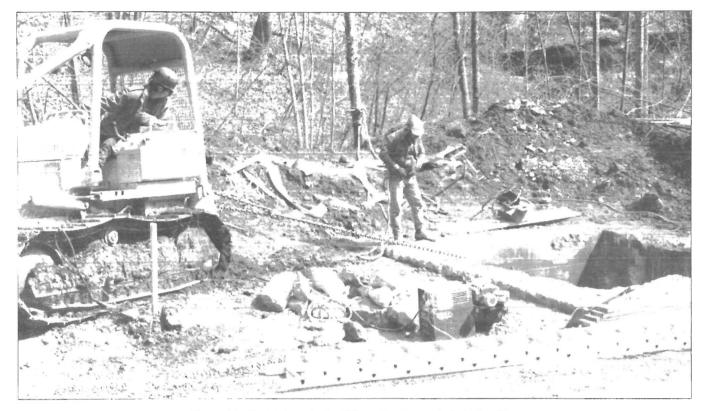
Figure 10.-Removing shaft utilities after removal of shaft collar.

Removal of shaft utilities was done in two stages: the removal of surface equipment and debris, and the cutting away of pump lines and shafting within the shaft to a depth of approximately 12 ft below the collar. No materials were salvaged. Removing the shaft utility lines was completed in conjunction with the removal of the concrete collar (fig. 10) and was extremely hazardous.

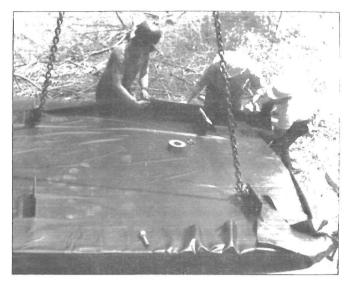
Figure 12.—Applying geomembrane covering to shaft platform.

The platform was painted in the field with two coats of corrosion-resistant, industrial-grade paint before wrapping with Hypalon geomembrane. The Hypalon fabric was supplied in one large sheet for the bottom wrap and a smaller sheet for the top wrap. Strips of Hypalon were used to seal the joints between the platform and the shaft walls. Manufacturer-approved glue was used on all joints (fig. 12). Wrapping and sealing the platform with geomembrane in the field was considered very successfu! (fig. 13).

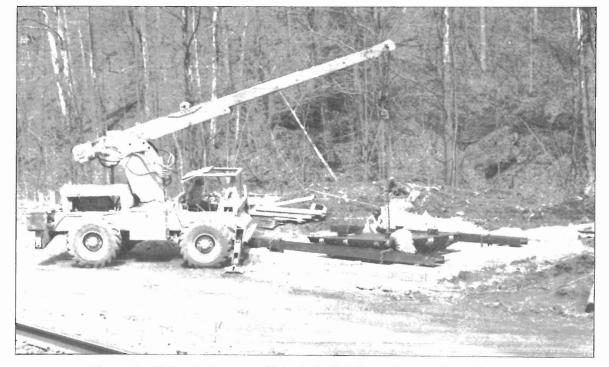
Figure 15.-Platform being lowered into shaft. Note beams in place alongside shaft.

After covering the platform with the geomembrane, the platform was moved to the shaft, the tie-rods and chain were attached, and the entire assembly was lowered into the shaft without incident (fig. 15). Adjusting the chain positions on the beams, so that the weight became equally distributed, completed the installation. Within the shaft,

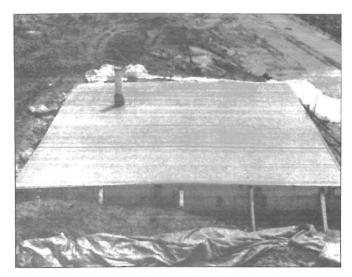
Figure 24.-Completed shaft capping of reinforced concrete.

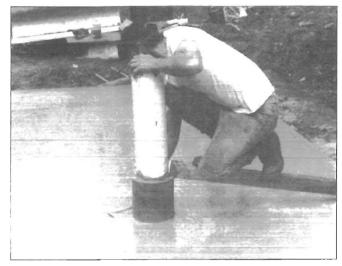
Figure 26.—Hand-packing grout between protective steel casing and vent tube.
