Report of Investigations 9429

**Bending Fatigue Tests 2 and 3 on 2-Inch
6×25 Fiber Core Wire Rope**

By J. R. Bartels, W. M. McKewan, and A. J. Miscoe

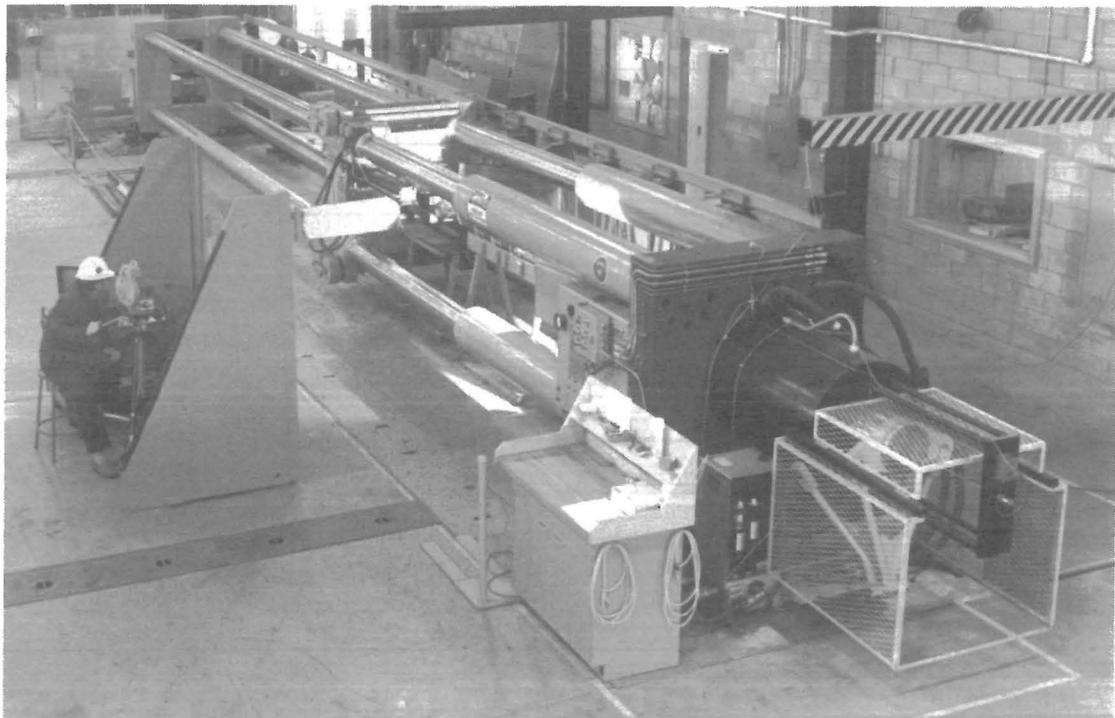
Figure 6.—Tensile and axial fatigue testing machine.

The second major piece of equipment in the laboratory is the tensile and axial fatigue testing machine shown in figure 6.

The tensile and axial fatigue testing machine was used to measure the actual breaking strengths of the new rope and the degraded rope samples from the bending fatigue test. The performance of this machine was reported in a previous publication.⁶

This hydraulically actuated machine is in a horizontal position rather than the usual vertical position to reduce vertical height requirements and for ease of access. The load is applied through a closed-loop servohydraulic system. The controllable parameters are displacement of the actuator, load applied to the specimen, and torque generated by the specimen as the axial load is applied. The system specifications are listed in table 2.
