REPORT OF INVESTIGATIONS/1995

Field Evaluation of Cable Bolts for Coal Mine Roof Support

By John P. McDonnell, Stephen C. Tadolini, and Paul E. DiGrado

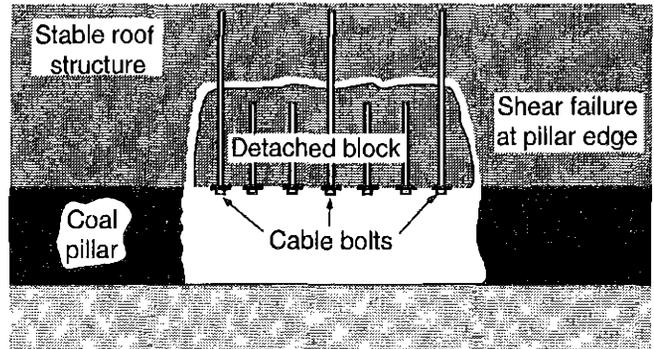
Figure 1

Detached block failure supported by cables.

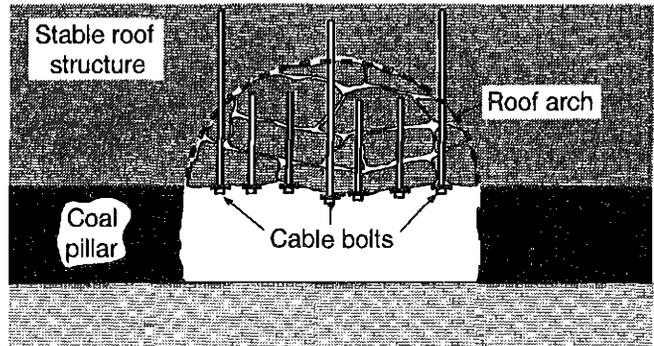
Figure 2

Formation of pressure arch of failed mine roof material.

This method is conservative since it is more likely that the coal pillars will provide additional support to the detached roof structure, forcing the formation of a pressure arch of the failed material. As shown in figure 2, the cables must be capable of supporting only the material within the boundaries of the pressure arch. The height of the arch can be correlated to the vertical and horizontal stresses acting in the immediate roof and is believed to increase as the in situ horizontal stress increases. A generally used criterion for determining the height of the pressure arch is that the failure height is 0.5 to 2.0 times the mined seam height, varying with the direction and magnitude of the stress field (11). The weight of the material within the arch can be estimated with respect to the opening width and the height of the arch by the following equation:

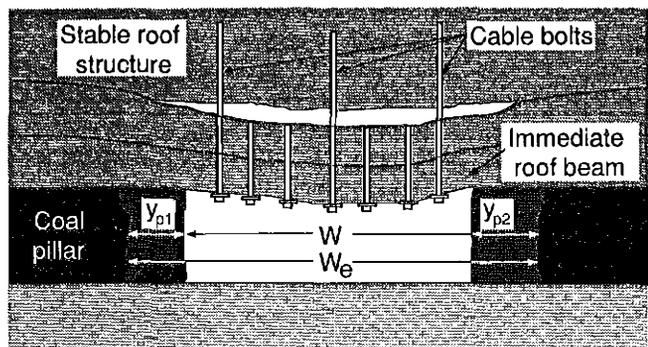
Figure 3

Formation of yield zone in coal pillars. (W_e = effective width of opening; y_{p1} = yield zone for pillar 1; y_{p2} = yield zone for pillar 2; W = mined width of opening.)

The behavior of the pillar under different loading conditions determines W_e , shown in figure 3. Wilson defines the depth of the yield zone as the depth at which the coal strength in the entire pillar is exceeded by the loads imposed; therefore, Wilson's equations can be used to estimate the depth of this yield zone for rigid roof-floor conditions (equation 3) and yielding roof-floor conditions (equation 4) (12).

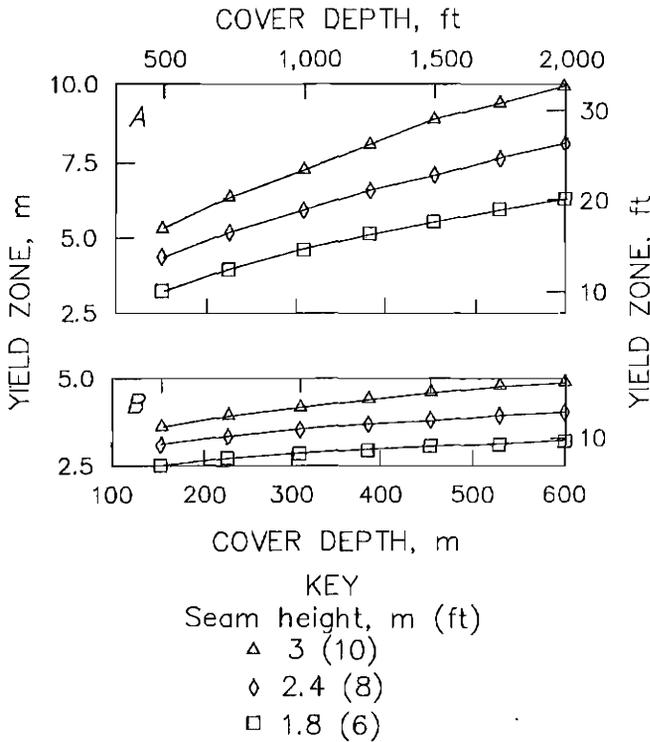
Figure 4

Design chart to determine yield zone width in coal pillars. A, Yielding roof; B, rigid roof.

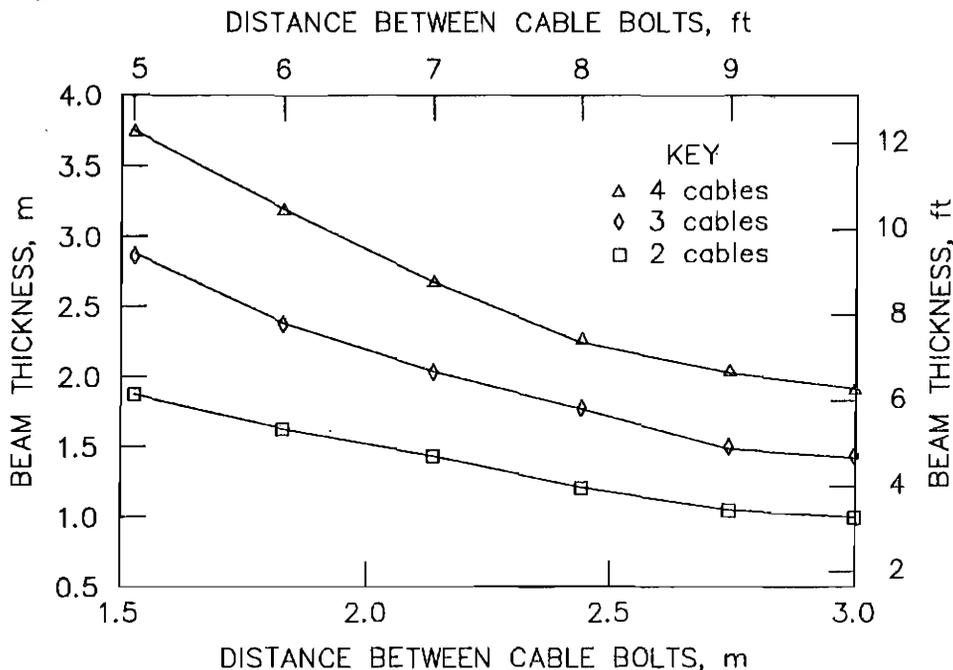
Cable support design chart, where effective width of opening (W_c) = 7.6 m (25 ft) and rock density (γ) = 2,403 kg/m³ (150 lb/ft³). For example, a 2.1-m (7-ft) cable bolt spacing along entry could support 1.4, 2.0, and 2.7 m (4.5, 6.7, and 8.9 ft) of separated material using two, three, and four cables, respectively.

Figure 5 shows a design chart calculated for two, three, and four cables installed for W_c of 7.6 m (25 ft) and a material weighing 2,403 kg/m³ (150 lb/ft³). For example, drawing a line up from the x-axis, spacing distance along the entry to the cable number line, and going left from that point to the y-axis indicates the thickness of a failed beam member that can be entirely supported with the installed cables. In the example, two, three, and four cables spaced across the width, at 2.1-m (7-ft) spacing along the entry, would have the capacity to support 1.4, 2.0, and 2.7 m (4.5, 6.7, and 8.9 ft) of separated material, respectively.

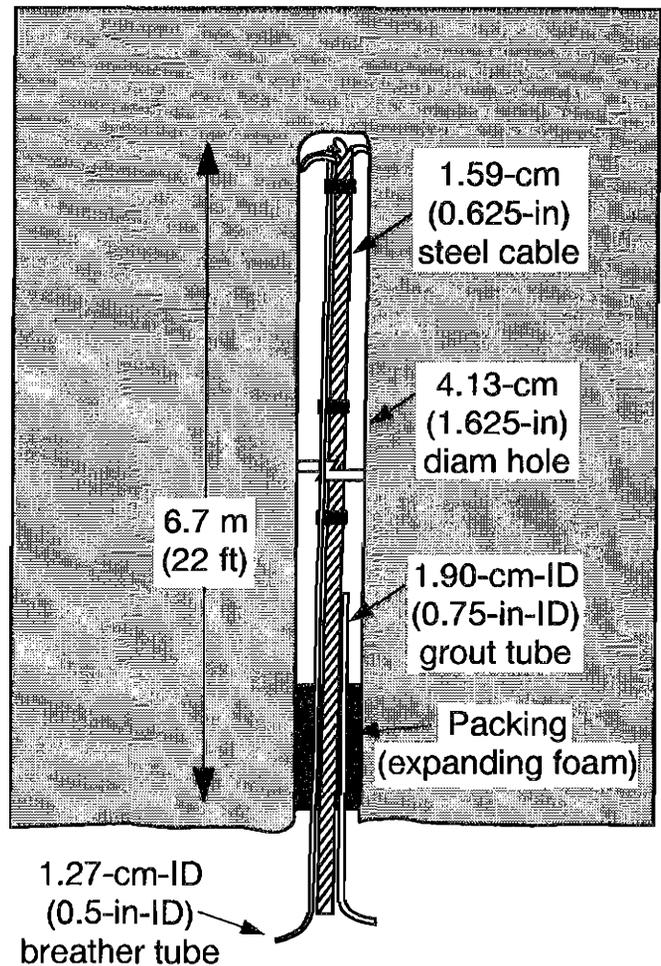
Figure 6

Components of concrete-grouted cable support. (ID = inside diameter.)

A completed cement installation and the required components, without the bearing plate and the cable grips, are shown in figure 6.

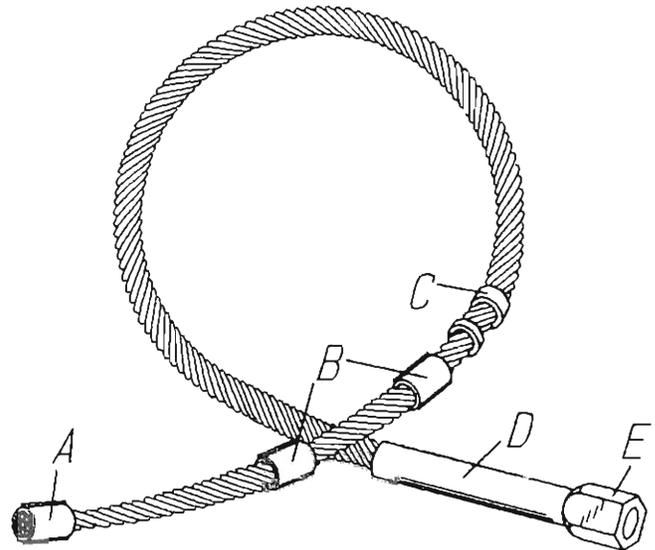
Figure 7

Specific components of resin-grouted cable bolt. A, Swaged-on fitting to tie all cable strands together; B, swaged-on buttons for additional anchorages; C, short button to hold plastic seal in place; D, cable stiffener rod; E, installation head or cable nut.

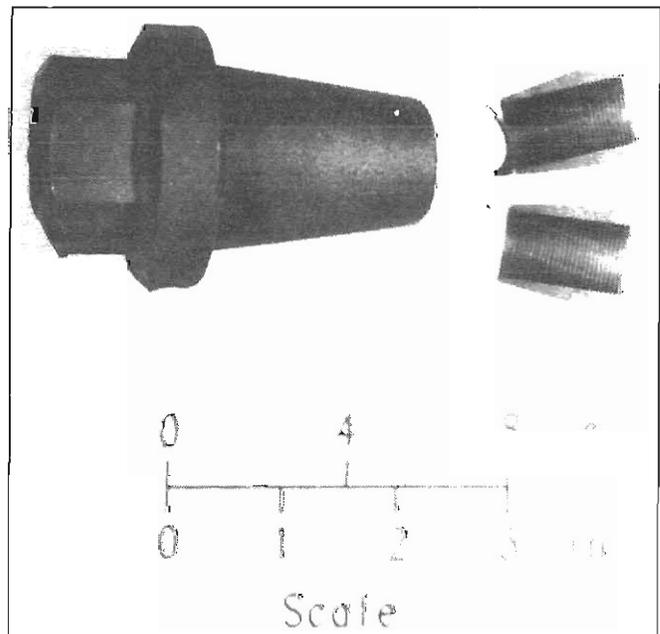
Figure 8

Tensionable nut for resin-grouted cable bolt.

Several variations of this system are becoming available. One system of particular interest allows tension to be applied to the cable after the resin has cured. This component is shown in figure 8. High degrees of tension may be

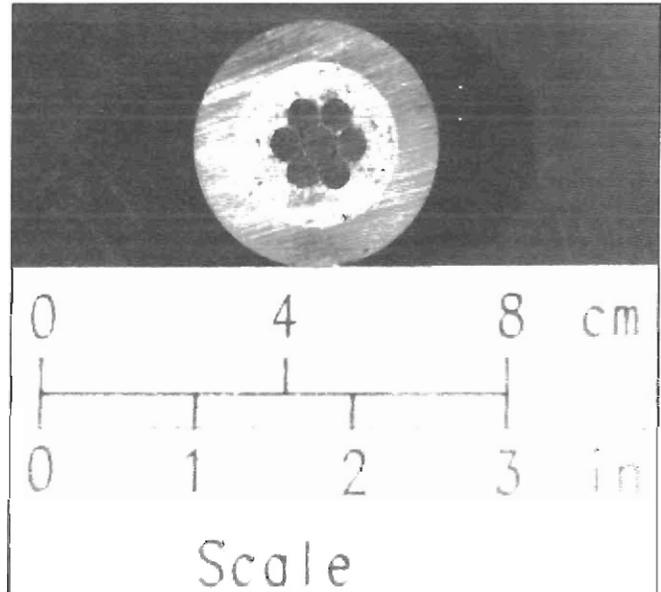
Figure 9

Cross section of 1.52-cm (0.60-in) diam cable installed in 2.5-cm (1-in) diam hole.

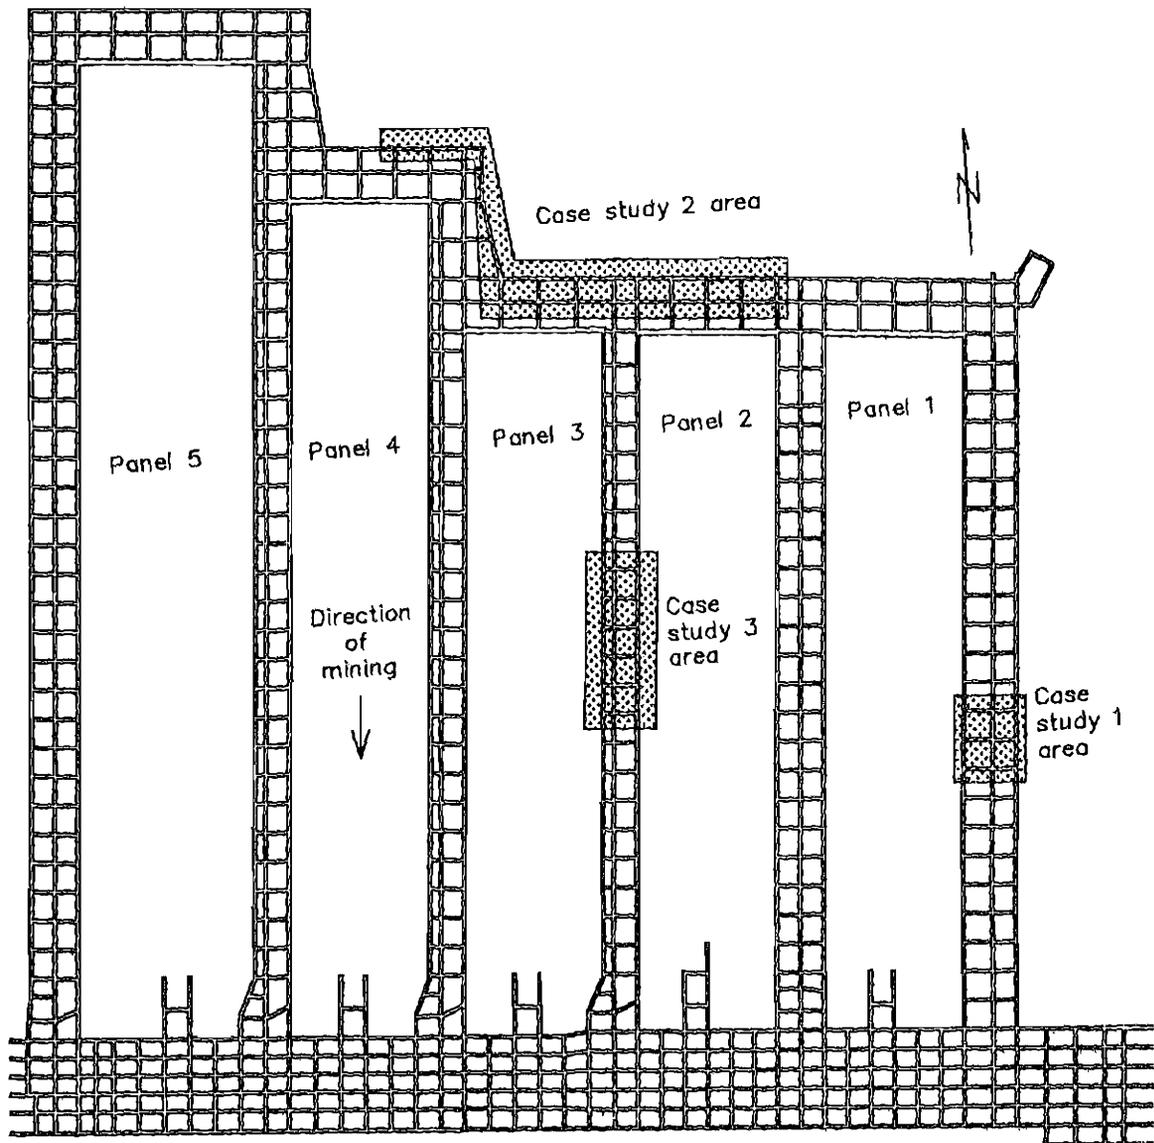
Figure 10

General mine layout showing case study locations.

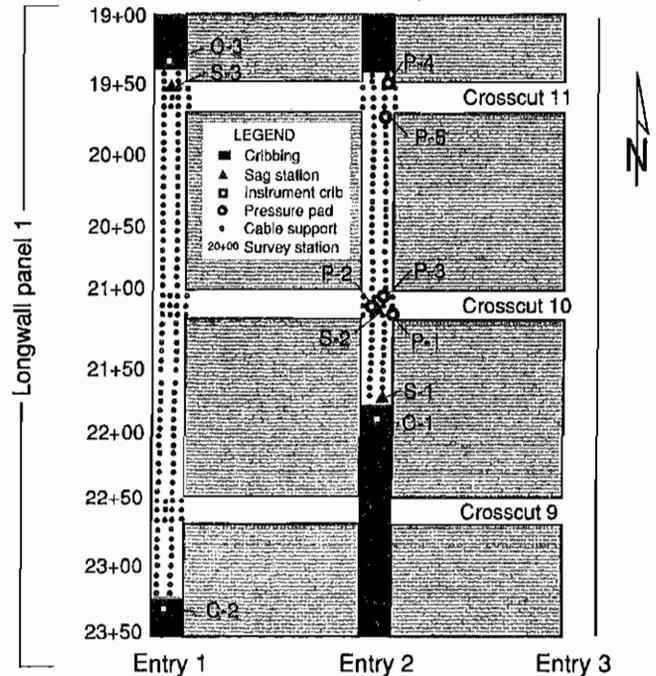
Figure 11

Gate roads showing cement-grouted cable test area and instrumentation layout at a Western U.S. underground longwall mine.

76.2 m (250 ft) of the second entry, longwall bleeder entry 2, was supported with 5.5-m (18-ft) long cables installed on a 2.1-m (7-ft) spacing, as shown in figure 11. The difference in cable length was attributed to the different loading conditions that the supports would be subjected to as the panel was extracted. The primary support system in the area, installed on initial development, was 1.8-m (6-ft), full-column, resin-grouted bolts on a 1.5-m (5-ft) pattern installed with pans and complete wire meshing.

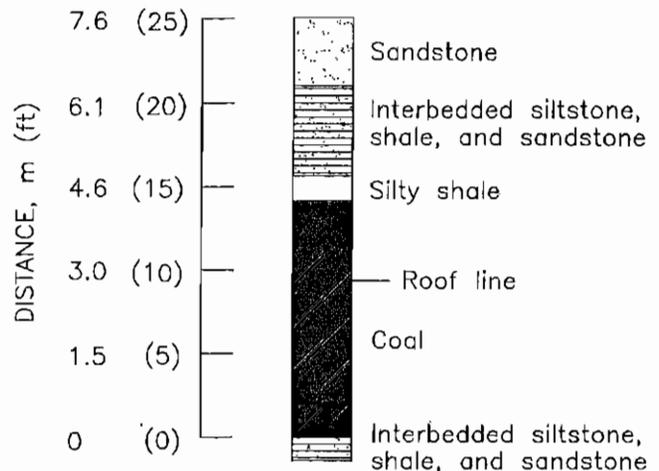
Figure 12

Geological column from test area.

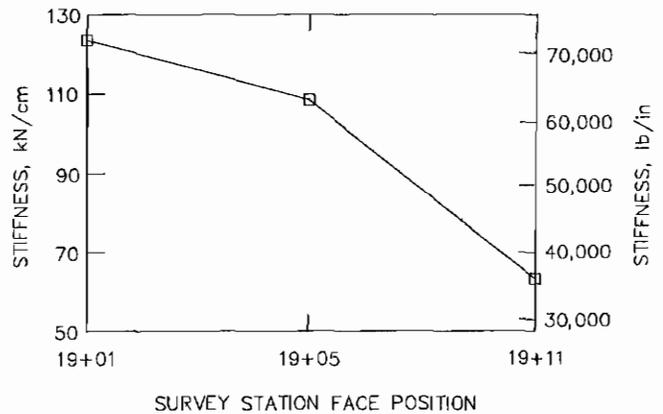
Figure 13

Crib stiffness at different intervals of face advance.

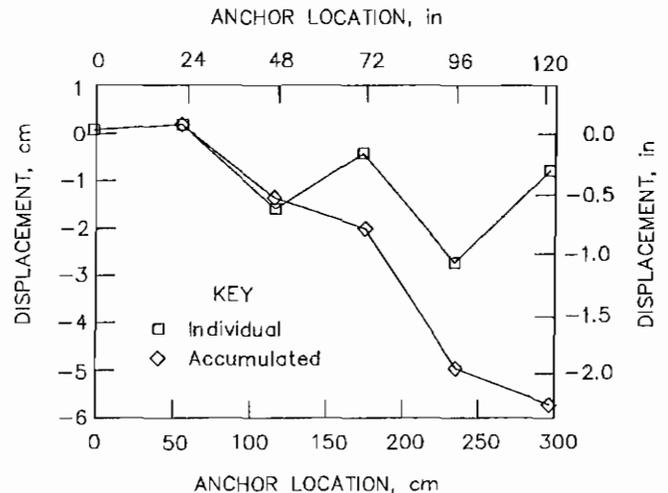
Figure 14

Individual and accumulated roof anchor displacements.

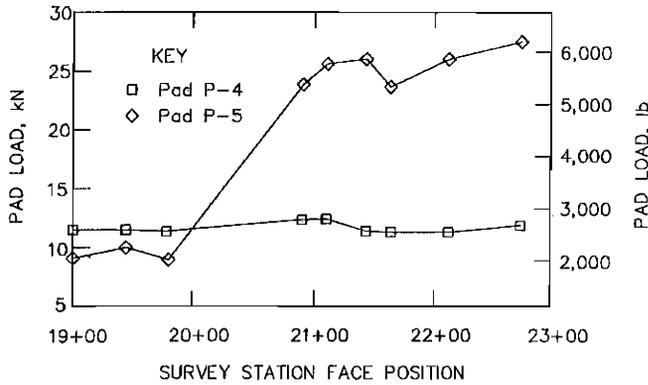
Figure 15

Pressure pad loading behavior with face advance in crosscut 11.

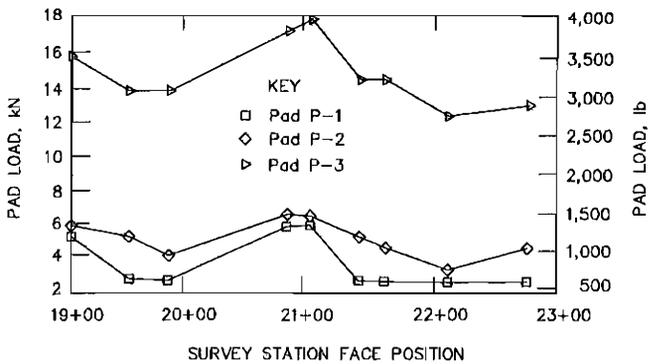
Figure 16

Pressure pad loading behavior with face advance in crosscut 10.

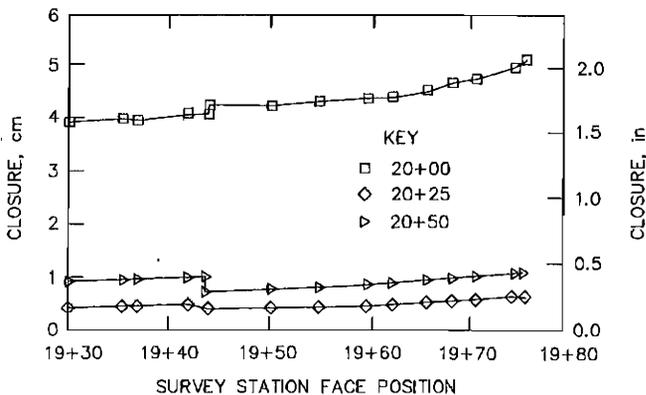
Figure 17

Entry closure and roof response.

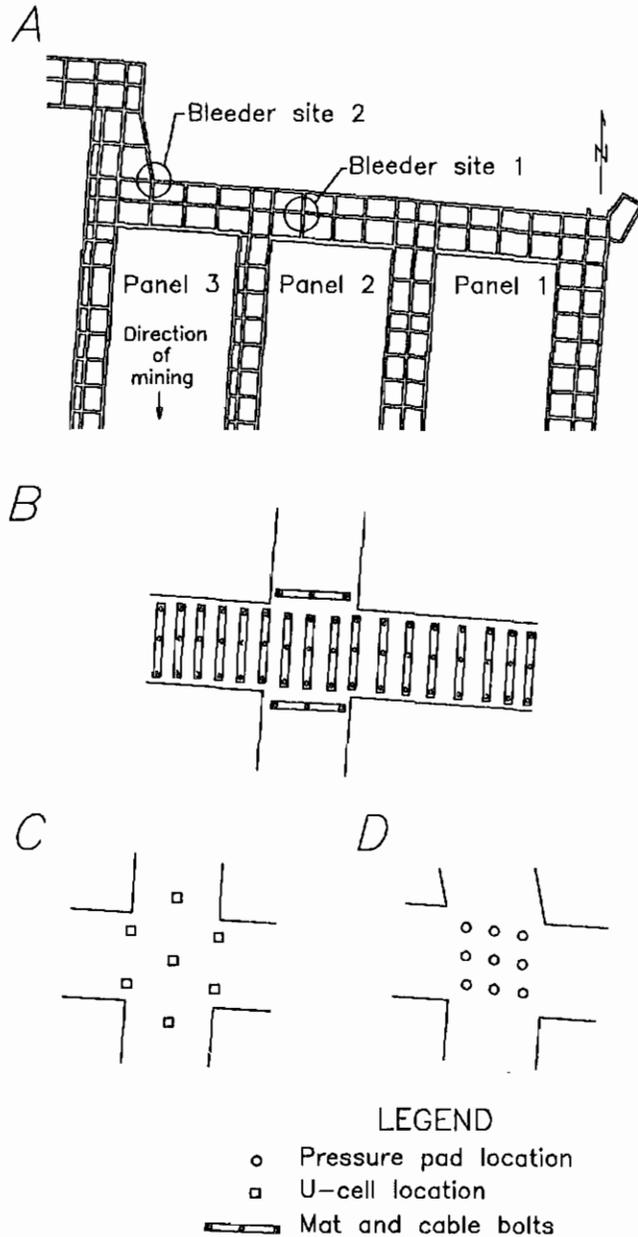
Figure 18

Bleeder entry configuration and resin-grouted cable test area.
A, Location of bleeder sites; B, general layout of cable bolt supports in bleeder entries; C, bleeder site 1 detail; D, bleeder site 2 detail.

generalized summary of the immediate roof in the area included about 0.8 m (2.5 ft) of top coal overlain by about 0.5 m (1.5 ft) of a silty shale. The roof above the silty shale grades vertically into interbedded units of siltstone, shale, and sandstone. This unit coarsens upwards in grain size, and the top portion consists of sandstone. The test area location is shown in figure 18.

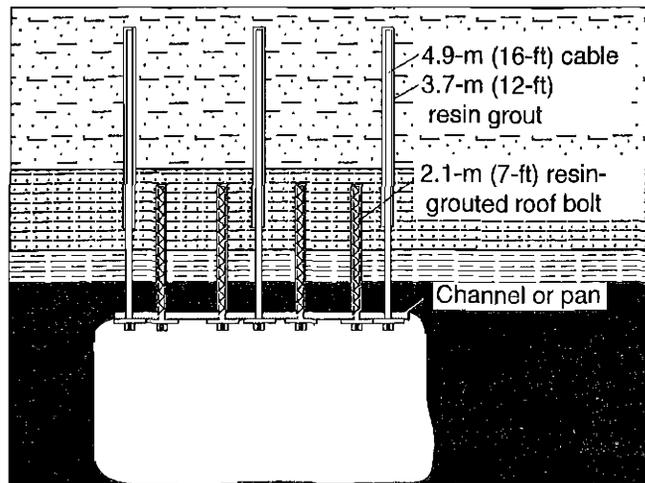
Figure 19

Cross section of test area showing primary and cable support spacing and resin grout lengths.

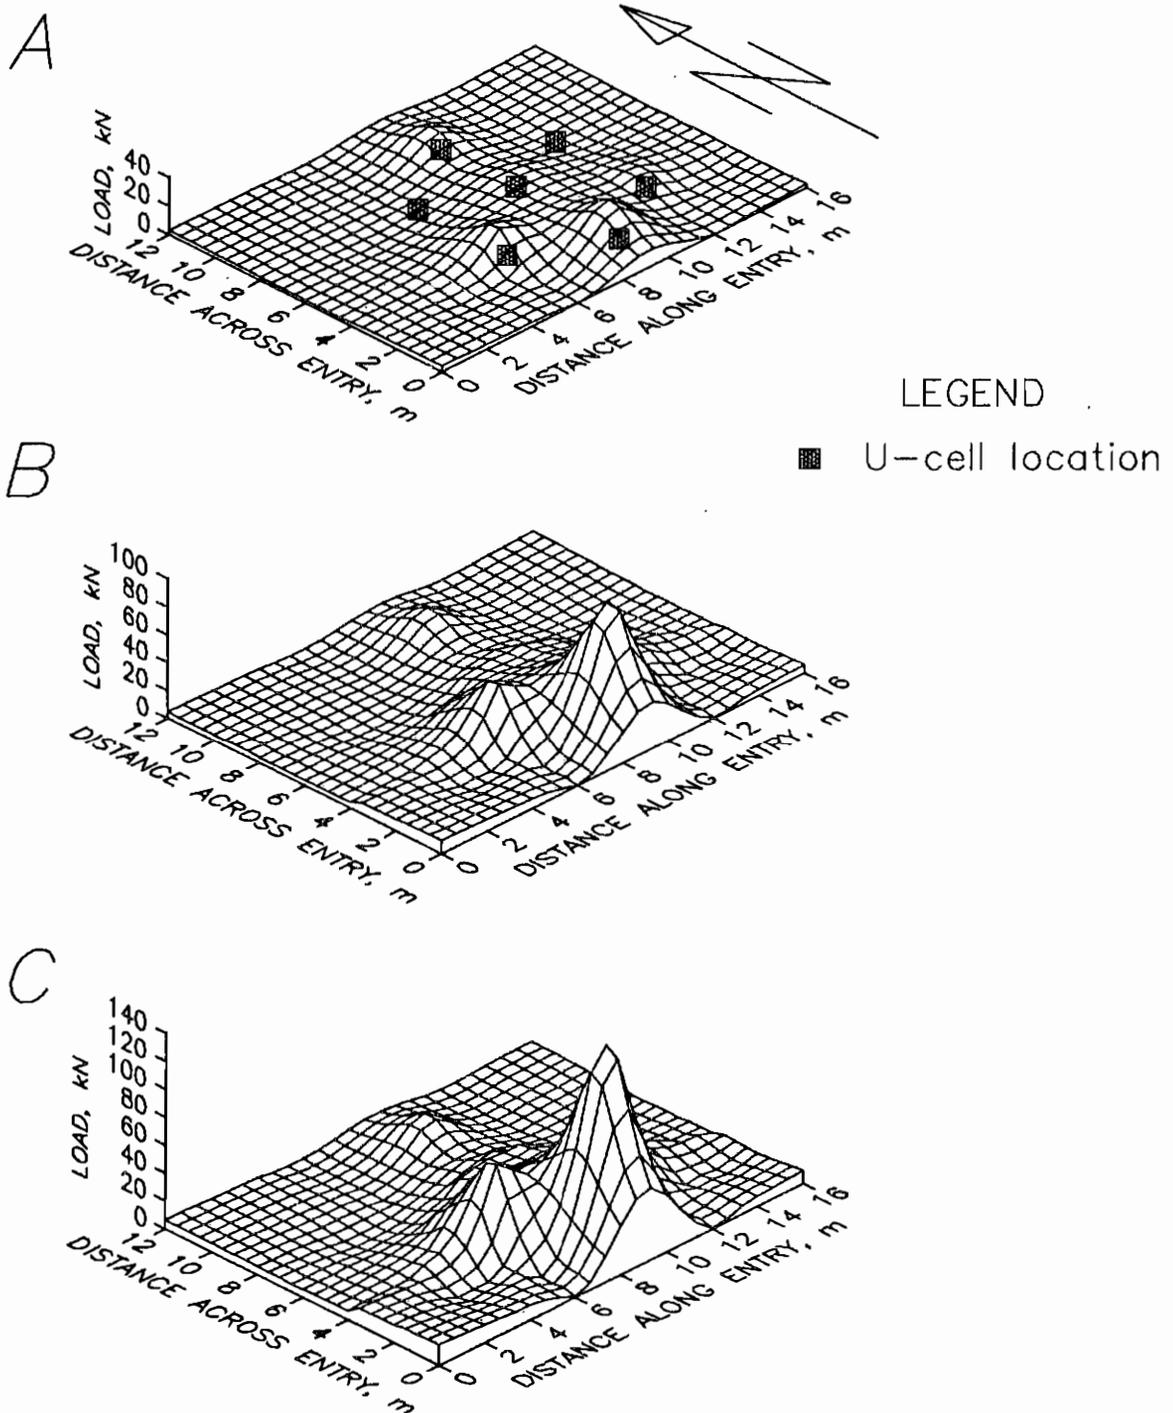
Figure 20

Bleeder site 1 profiles during panels 2 and 3 mining. A, Panel 2 face position 0+00 with U-cell instrument locations; B, panel 2 face position 11+05; C, panel 3 face position 11+98.

individual cables ranged from 14.7 to 149.0 kN (3,295 to 33,500 lbf), averaging 18.8 kN (4,225 lbf) for the seven hydraulic U-cells. Differential sag stations placed in the roof indicated very little separation in the interface between the shale and sandstone. The entire bleeder entry behind panel 2 remained extremely stable, with no roof falls and very little signs of roof spalling or separation. Additional recorded cable loads varied throughout the entire panel 2 bleeder area, with higher readings mostly related to geologic features that occurred in the cable-supported area.

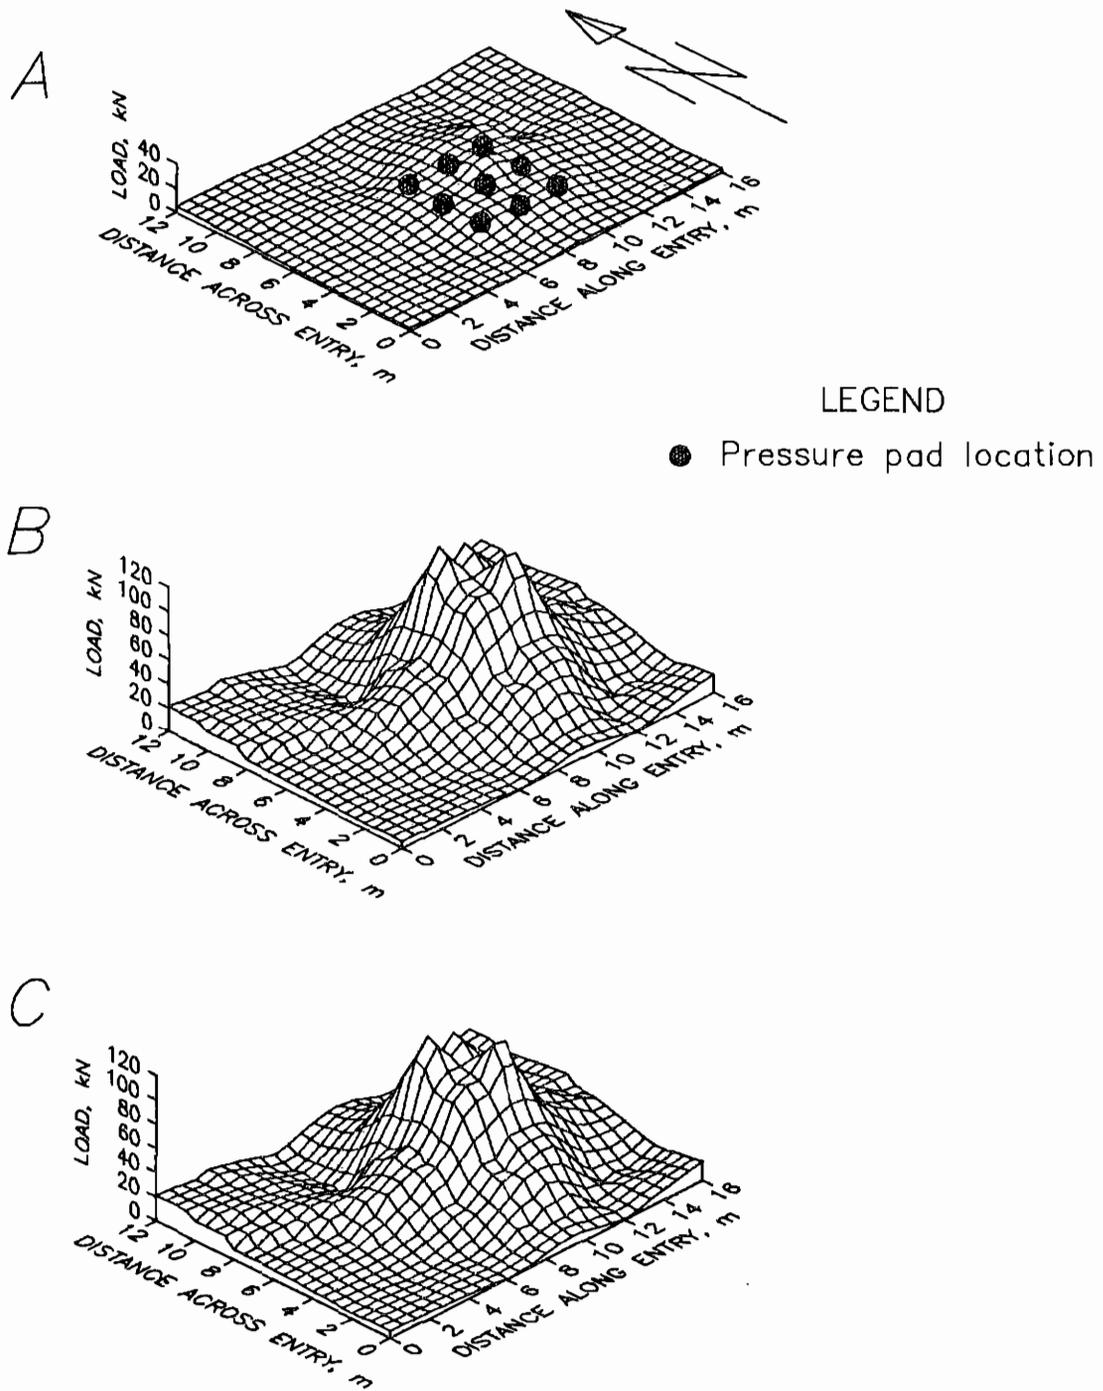
Figure 21

Bleeder site 2 profiles during panel 3 mining. A, Panel 3 face position 0+00 with pressure pad instrument locations; B, panel 3 face position 3+00; C, panel 3 face position 11+98.

The behavior in bleeder site 2 area was very similar to the behavior of bleeder site 1. The main difference was that loading on the test area occurred shortly after panel 3 started mining and then stabilized as if the system had reached equilibrium, with the cable supports experiencing no additional load increases. The initial cable loads and the subsequent loads recorded when the panel 3 face had been extracted to approximately 91 m (300 ft) and 365 m (1,198 ft) are shown in figure 21. The pillars in this area showed more rib sloughage and spalling than the area behind panel 2. However, the roof remained competent with no visual signs or recorded loads that would indicate unanticipated separation. The loads measured on the eight Goodyear pressure pads in bleeder site 2 ranged from 18.0 to 119.2 kN (4,120 to 26,800 lbf) and averaged 73.8 kN (16,600 lbf). Subsequent measurements recorded in the panel 3 bleeder entry system showed little or no cable bolt load increase as panel 3 was extracted. The results from both bleeder test areas demonstrated the effectiveness of cable supports as an alternative to other forms of secondary support. Ground conditions remained good in the bleeder entry during the mining of two complete longwall panels, and none of the cable loads exceeded 50% of failure strength. The vast majority of the cables did not exceed 10% of the ultimate cable load capacity.

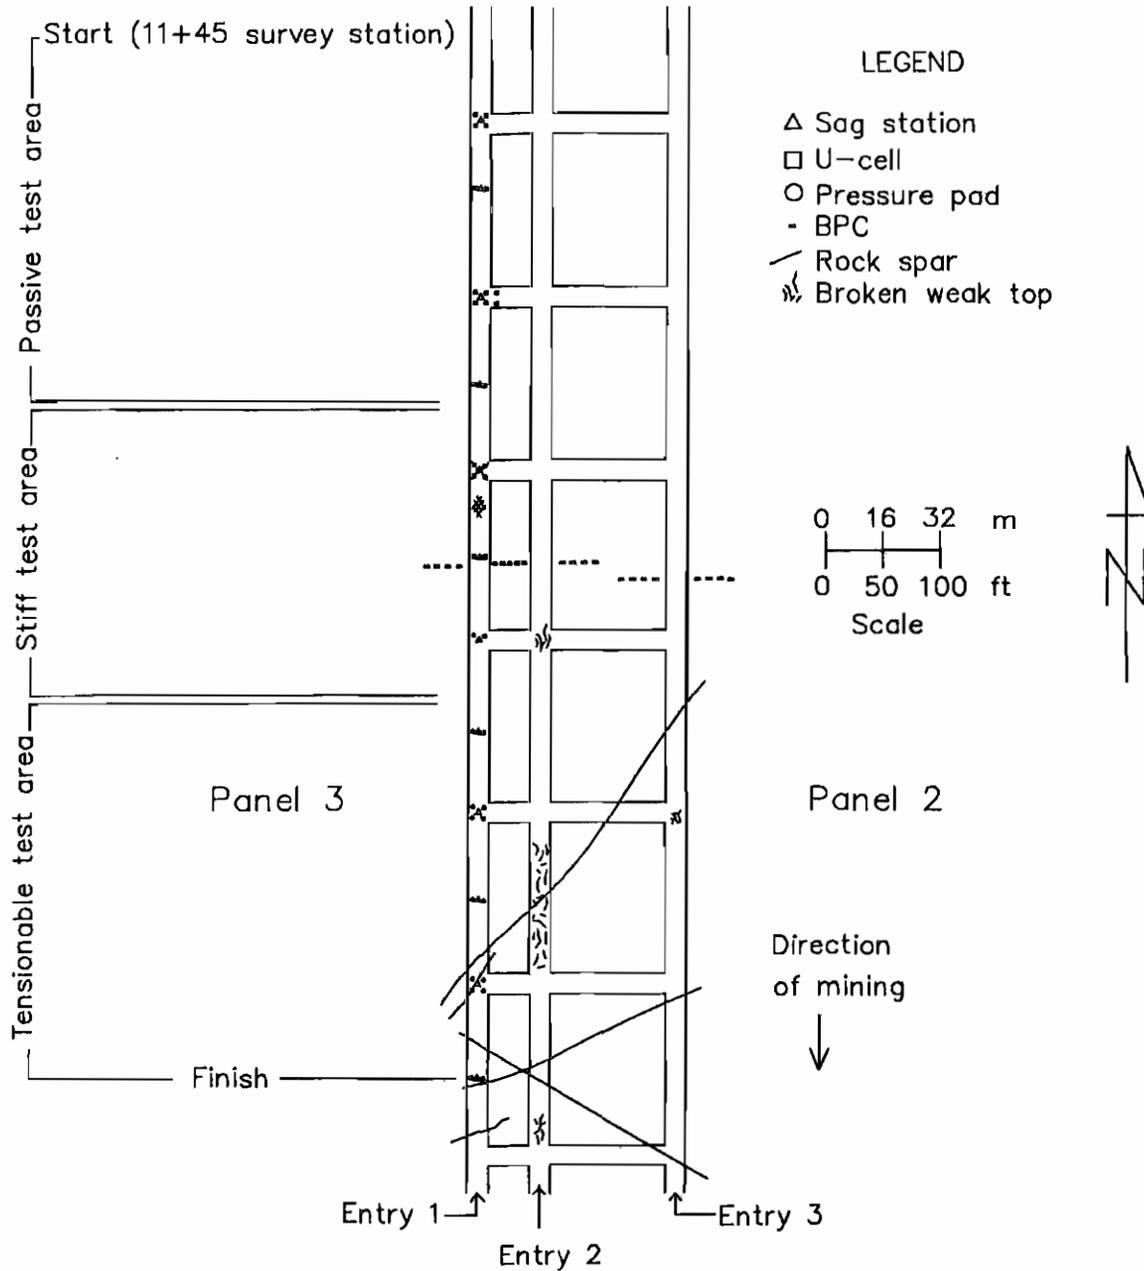
Figure 22

Case study 3 test area examining three different types of resin-grouted cable supports and respective instrumentation types and locations.

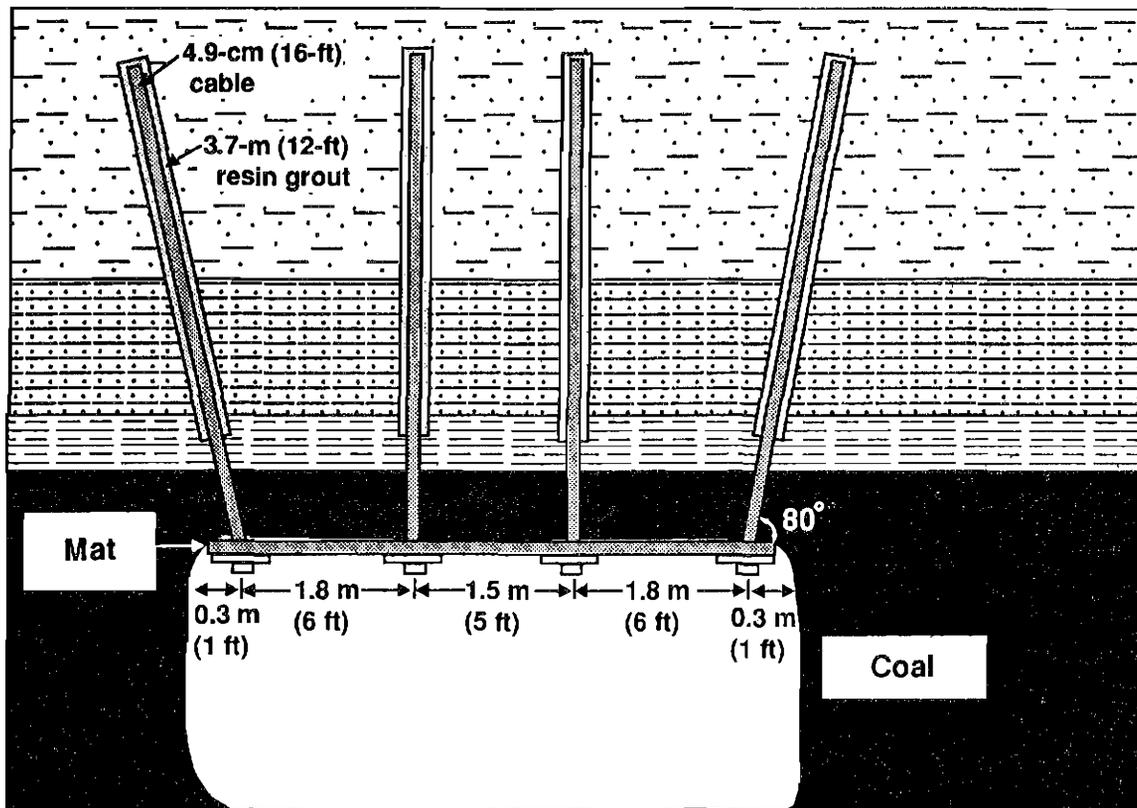
Figure 23

Generalized cross section of cable spacing and lengths used in gate road test areas.

All of the cable systems were installed with 15.2- by 15.2-cm (6- by 6-in) bearing plates and Monster Mats.⁷ The mats provide excellent mine roof support between the cables and maintain any failed material in place. Mats also help prevent unraveling, rotation of failed blocks, or progressive-type failures. The cables were placed four across the 5.7-m (19-ft) wide opening at a row spacing of 1.5 m (5 ft). The cables at the ends, dictated by the holes in the mats, were installed as close to the pillar and panel edges as possible and angled at approximately 80° from horizontal. A cross section of the cable pattern is shown in figure 23.

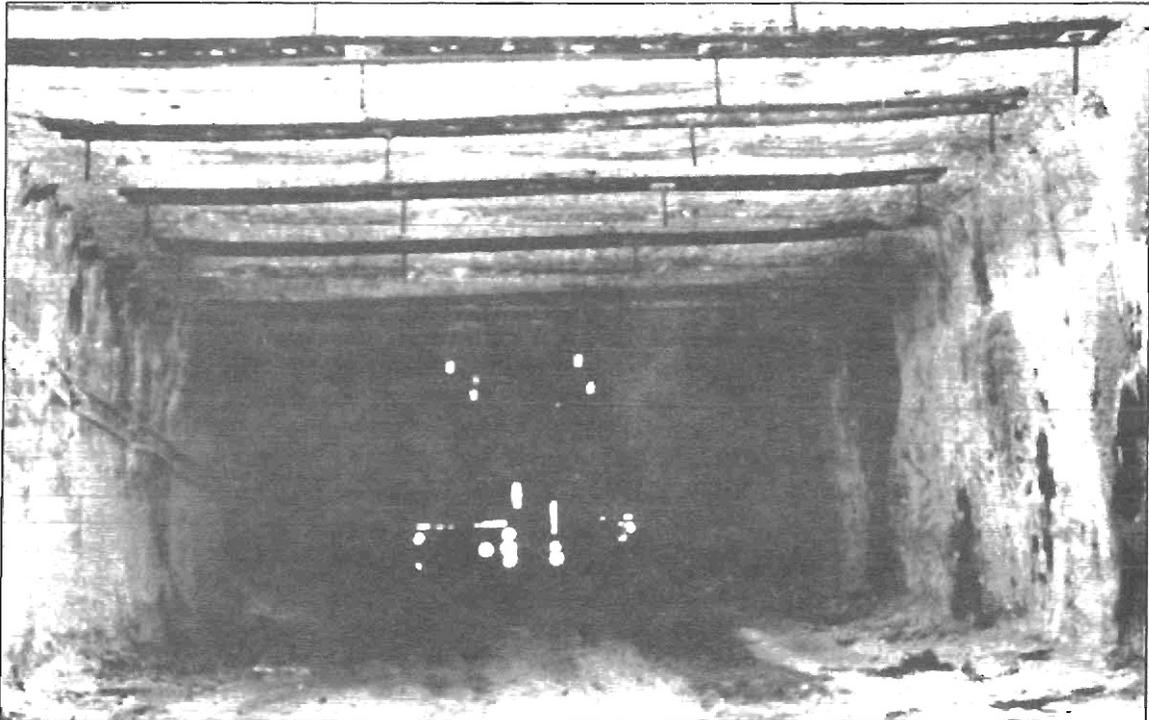
Resin-grouted cable test area immediately after cable support installation (before first panel mining).

sloughage caused by increased pillar loading, the areas were extremely stable, and no roof control problems were noted. Figure 24 shows the resin-grouted cable test area after installation. Figure 25 shows the cable test area after panel 2 mining and prior to panel 3 mining.

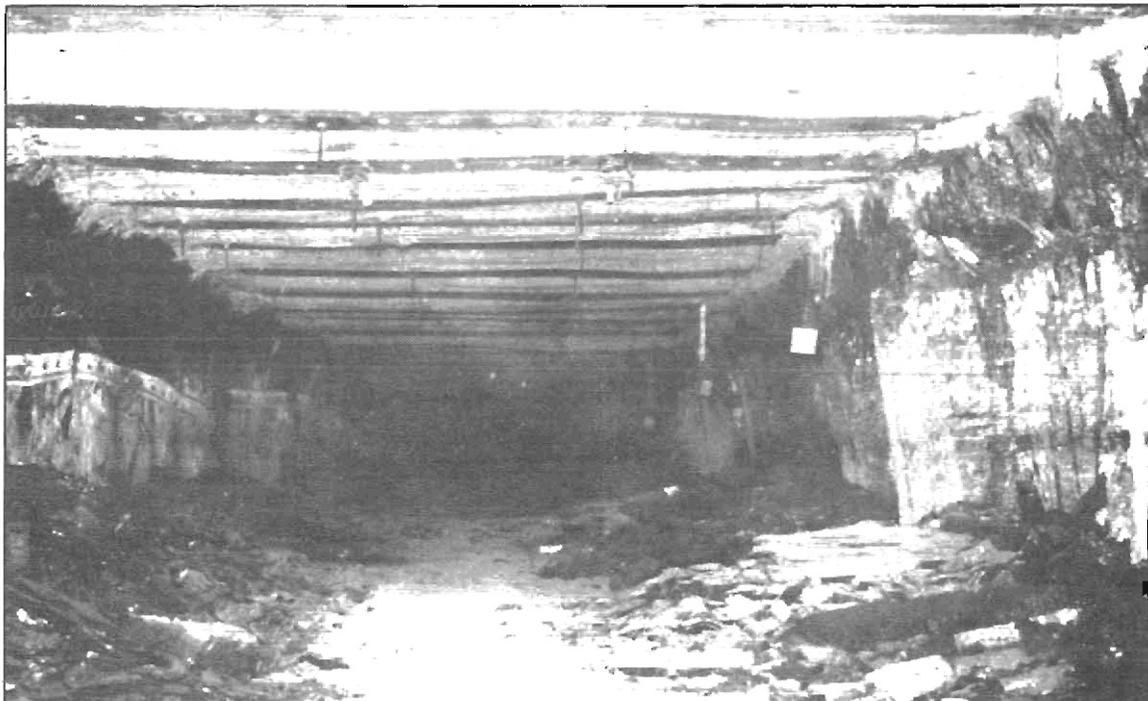
Figure 25

Resin-grouted cable test area after first panel passed test area and loads were redistributed onto pillars and next panel.

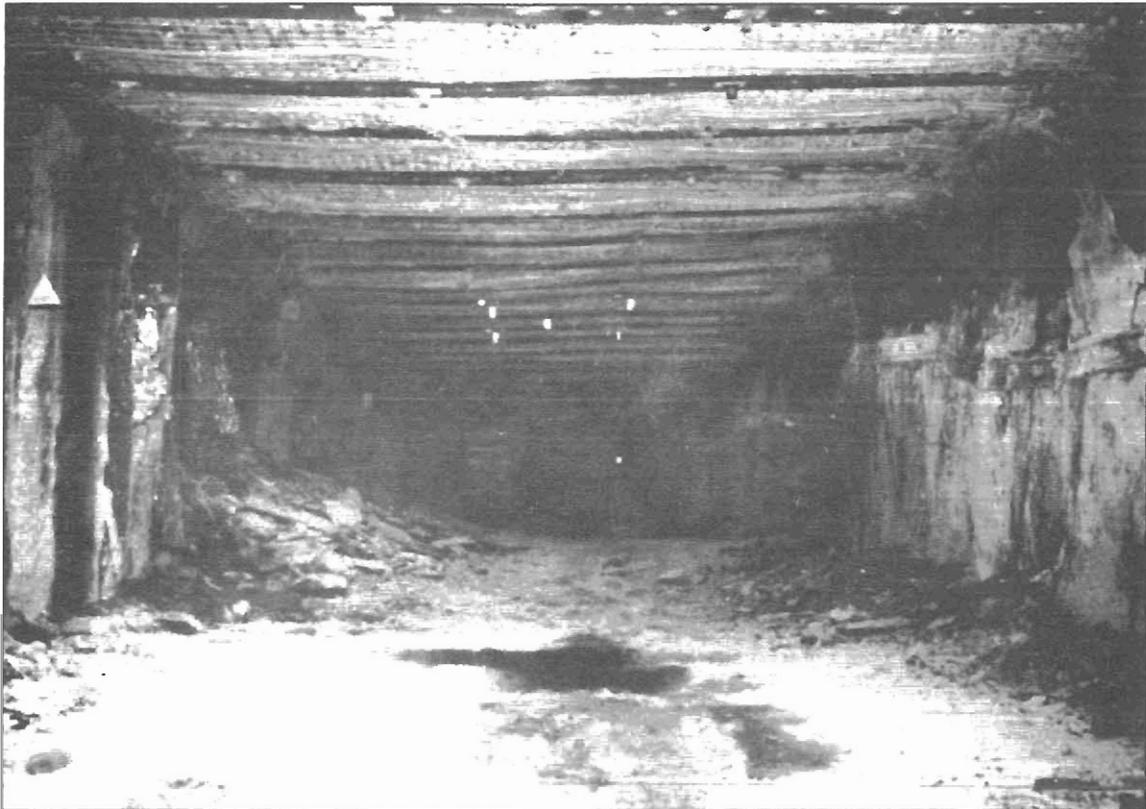
Figure 26

Resin-grouted cable test area when panel 3 face was 243.8 m (800 ft) in by test area.

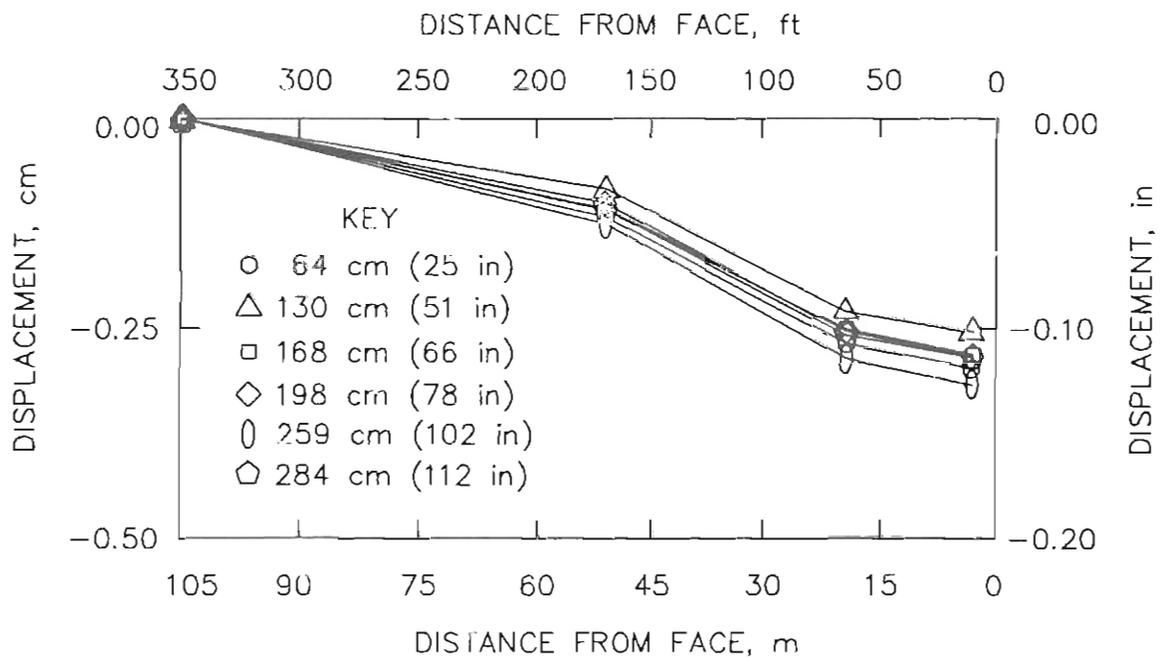
Figure 27

Results from differential sag station being located in first intersection of passive test area.

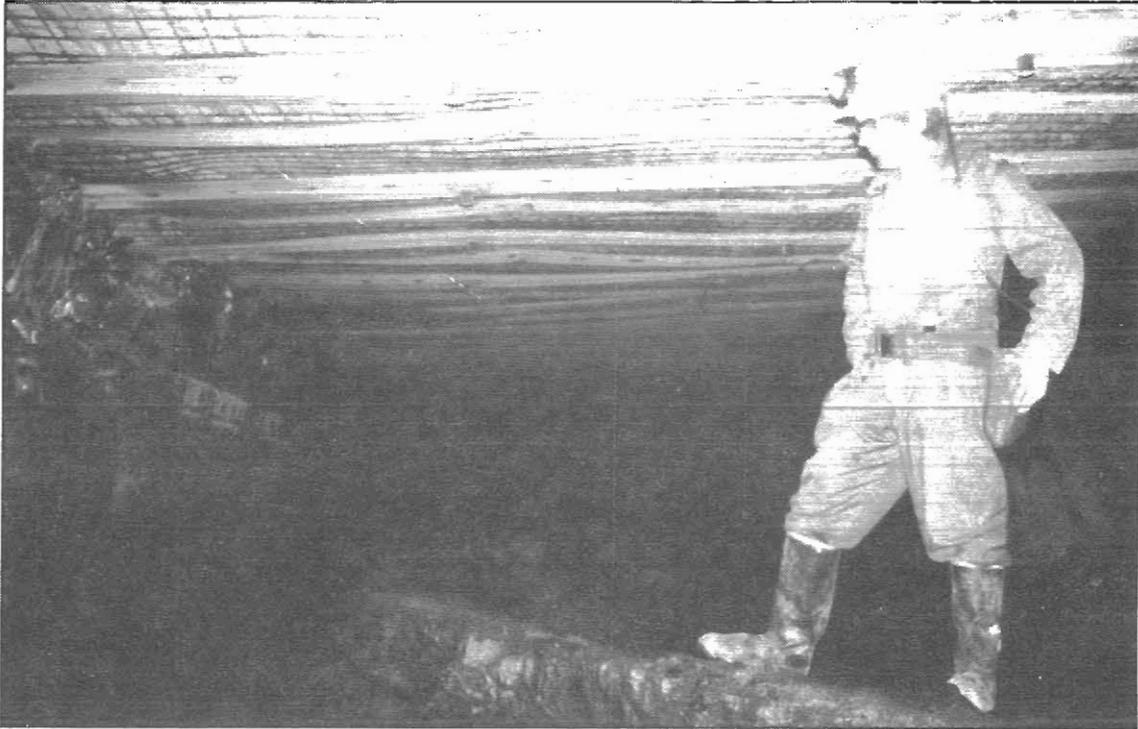
Figure 28

Floor heave in passive support system test area.

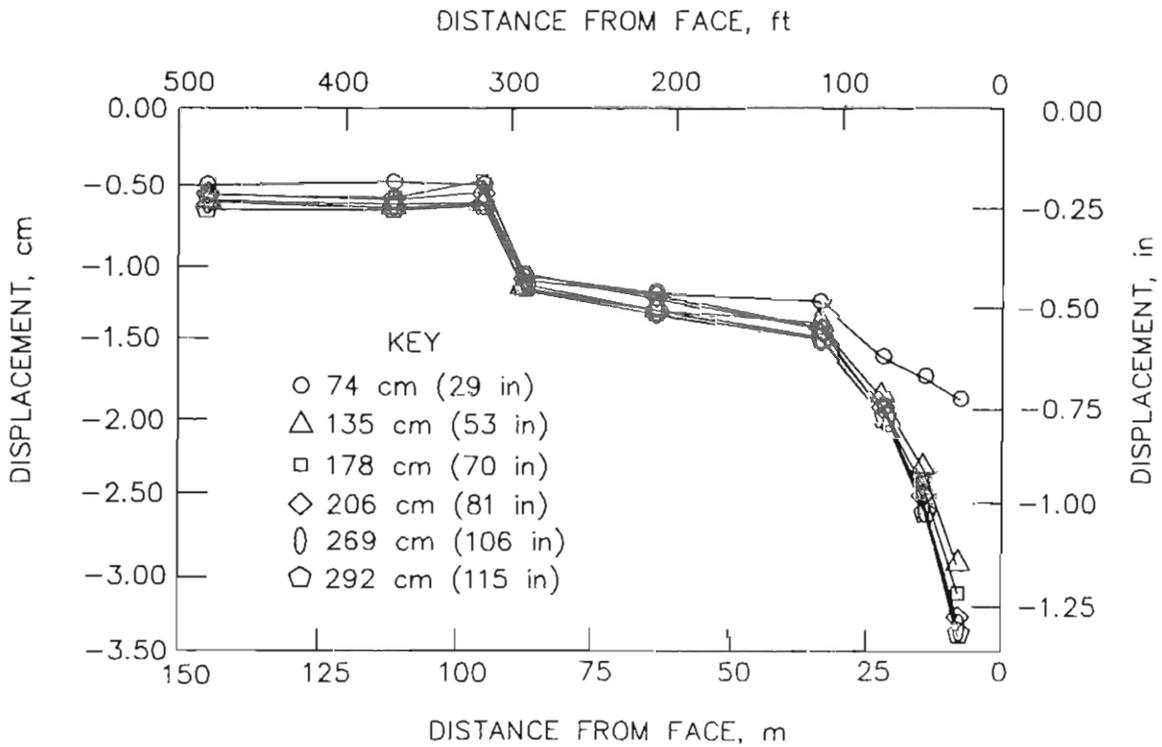
Figure 29

Results from differential sag station being located in first intersection of stiff support system test area.

The differential sag stations indicated that a minor separation occurred between the first and second extensometer anchors, which would have placed it between the coal and clay-shale interface. Typical roof behavior, shown in figure 29, as observed from a sag station located in the first intersection, indicated that a slight separation also occurred between the 135- and 178-cm (53- and 70-in) anchors. The yield pillar and panel sloughed as the forward abutment of panel 3 approached within 91.4 m (300 ft), as shown in figure 30. Similar to the first test area (passive area), floor heave forced the floor to within 1.8 m (6 ft) of the roof, starting approximately in the middle of the entry and propagating toward the yield pillar, indicating a stiff panel edge transferring stress into the floor. The stiff test area was mined through without problems, and the roof remained intact until the panel was well past the support system. Figure 31 shows the caving profile of the roof as it remains standing approximately 30.5 m (100 ft) behind the panel 3 longwall face, shown on the left side of the photograph.

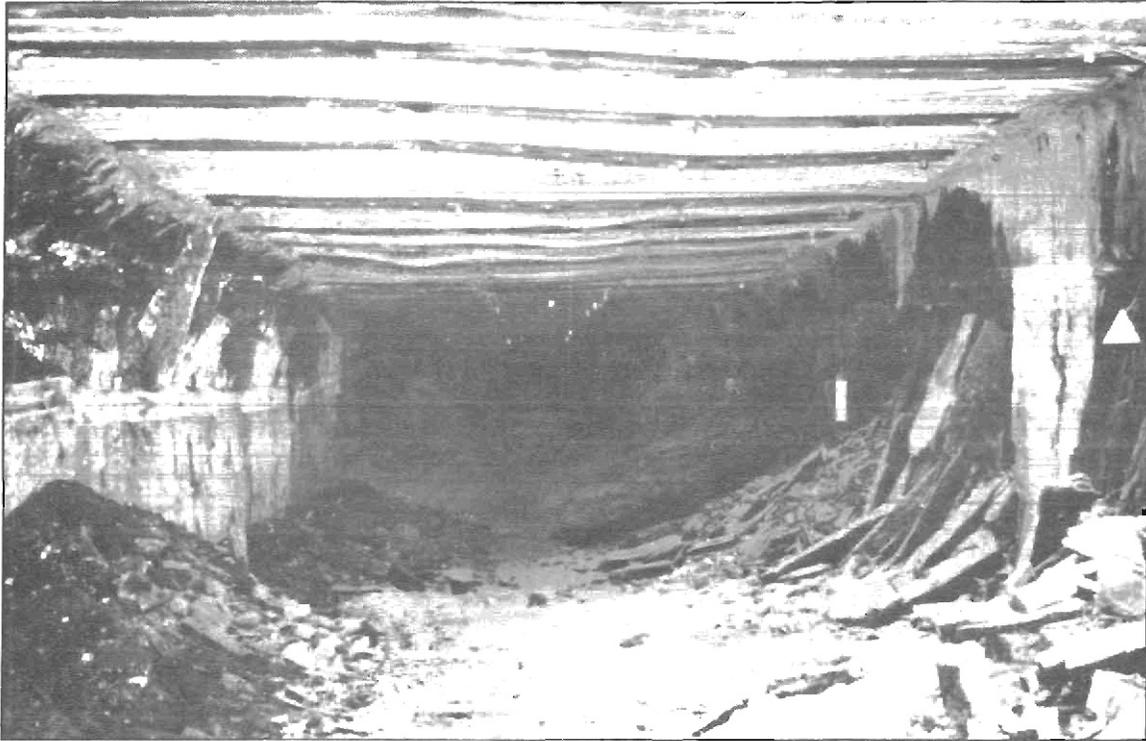
Figure 30

Stiff support system test area condition during panel 3 mining.
