REPORT OF INVESTIGATIONS/1995

Field Evaluation of Cable Bolts for Coal Mine Roof Support

By John P. McDonnell, Stephen C. Tadolini, and Paul E. DiGrado

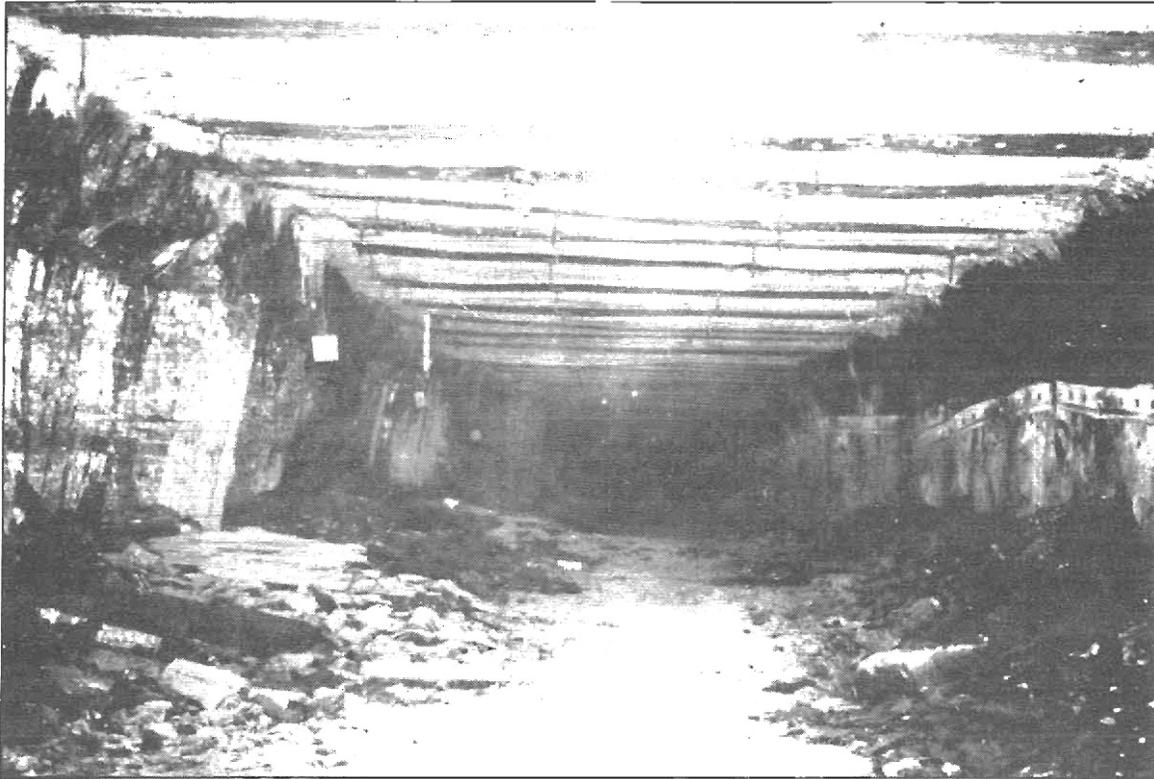
Figure 32

Tensionable support system test area condition during panel 3 mining.

The tensionable support system test area provided the most difficult test conditions because the zone with cables contained several geologic features that created roof instability prior to panel extraction. A zone containing rock spars and sedimentary dikes had disrupted the continuity of the immediate roof, weakening it. Additionally, the discontinuities may have been associated with a changing roof lithology. The mine roof was heavily fractured in the areas traversed by rock spars and dikes. This roof condition resulted in some heavy loading almost immediately after panel 2 had mined past the site. In one specific area, approximately 3 m (9.9 ft) long and 5.5 m (18 ft) wide, the cables were loaded to 142.3 kN (32,000 lbf) and the roof appeared broken and fractured. Unfortunately, the differential sag station installed in the area was lost because of the broken roof. Calculating the roof separation height based on pressure pad loads, suggests that the loads measured on the cable supports could be the result of the roof separating at a height of about 3.7 to 4.0 m (12 to 13 ft). However, the cables, combined with primary support, Monster Mats,⁸ and wire mesh, kept the immediate roof in place. The average loads on the instrumented cables at the conclusion of panel 2 mining ranged from 18.2 to 151.2 kN (4,100 to 34,000 lbf) and averaged 50.7 kN (11,400 lbf) for the 12 instrumented cables. The tensionable cable support area, when the panel 3 face is approximately 152.4 m (500 ft) inby, is shown in figure 32.

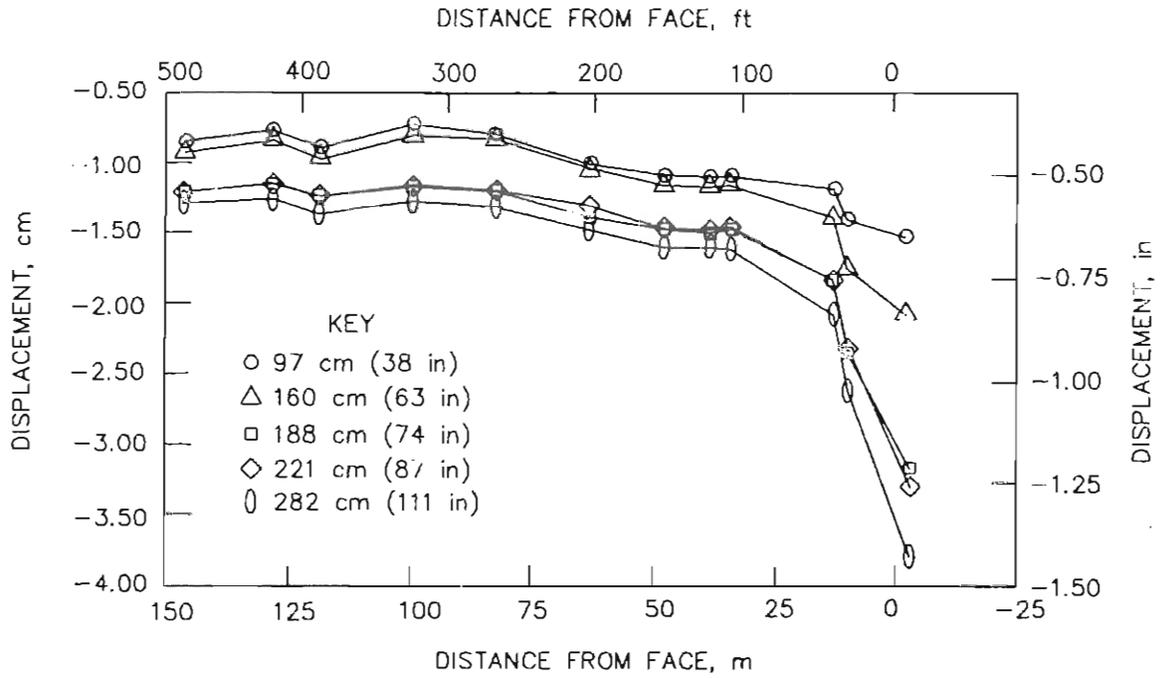
Figure 33

Results from differential sag station being located in second intersection of tensionable support system test area.

The differential sag station results, shown in figure 33, are from the sag station located in the second intersection of the tensionable support system test area. The results indicate four distinct separations between the instrumented levels, with a major separation forming between the 160- and 188-cm (63- and 74-in) anchors in the roof. The roof below this level separated approximately 2.54 cm (1 in) when the face was approximately 9.4 m (31 ft) from the station. The separations occurred between geological interfaces, with the largest at the expected level. However, the cables maintained the immediate roof, which permitted reading the sag station when the face was 2.1 m (7 ft) past the station. The major separation had a displacement of approximately 1.3 cm (0.5 in), and two minor separations occurred between the 221- and 282-cm (87- and 111-in) anchors.

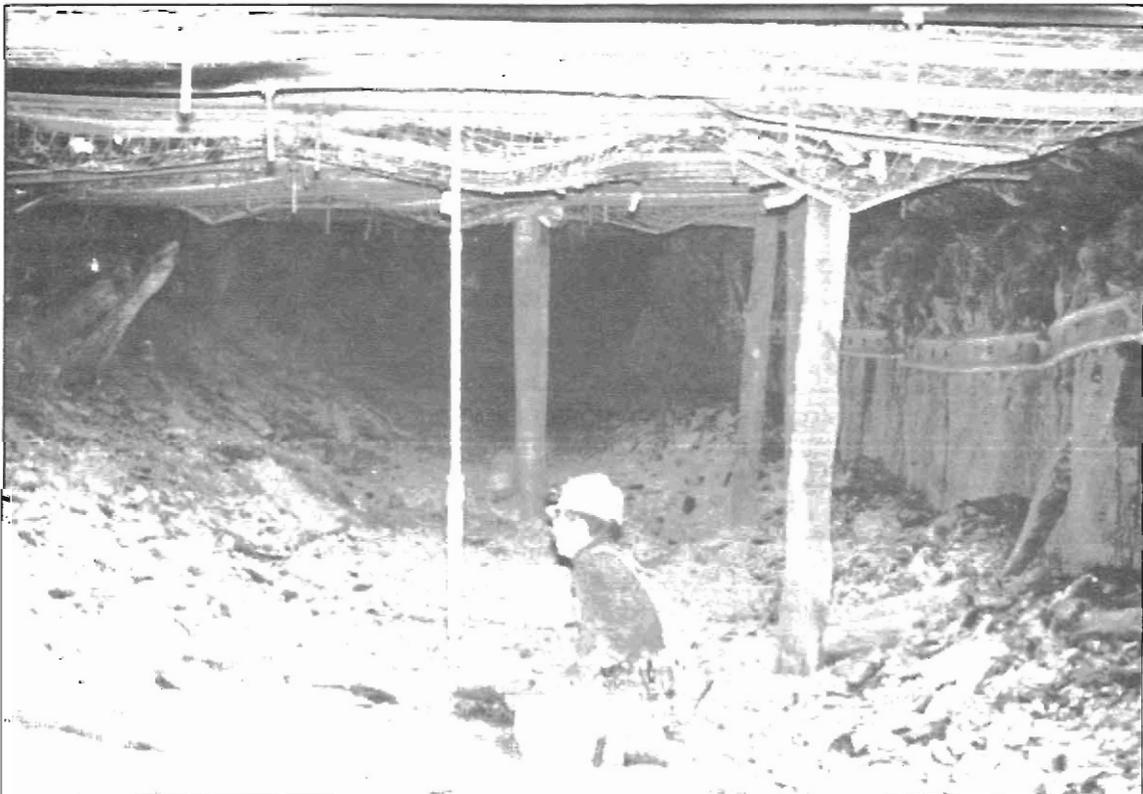
Figure 34

Closure-rate instrumentation and condition of tensionable support system test area.

Floor heave also occurred in the tensionable support system test section with rates similar to the previous two areas. Closure instrumentation and the general condition of the test area when the face was approximately 45.7 m (150 ft) in by are shown in figure 34. As shown, if the cables failed or appeared to have taken considerable load, a timber post was placed adjacent to the cable. Additionally, some cable nuts appeared to be slipping under heavy load, preventing all seven strands from actively resisting movement. The area was mined through without incident, and a total of nine timber posts were set in the areas subjected

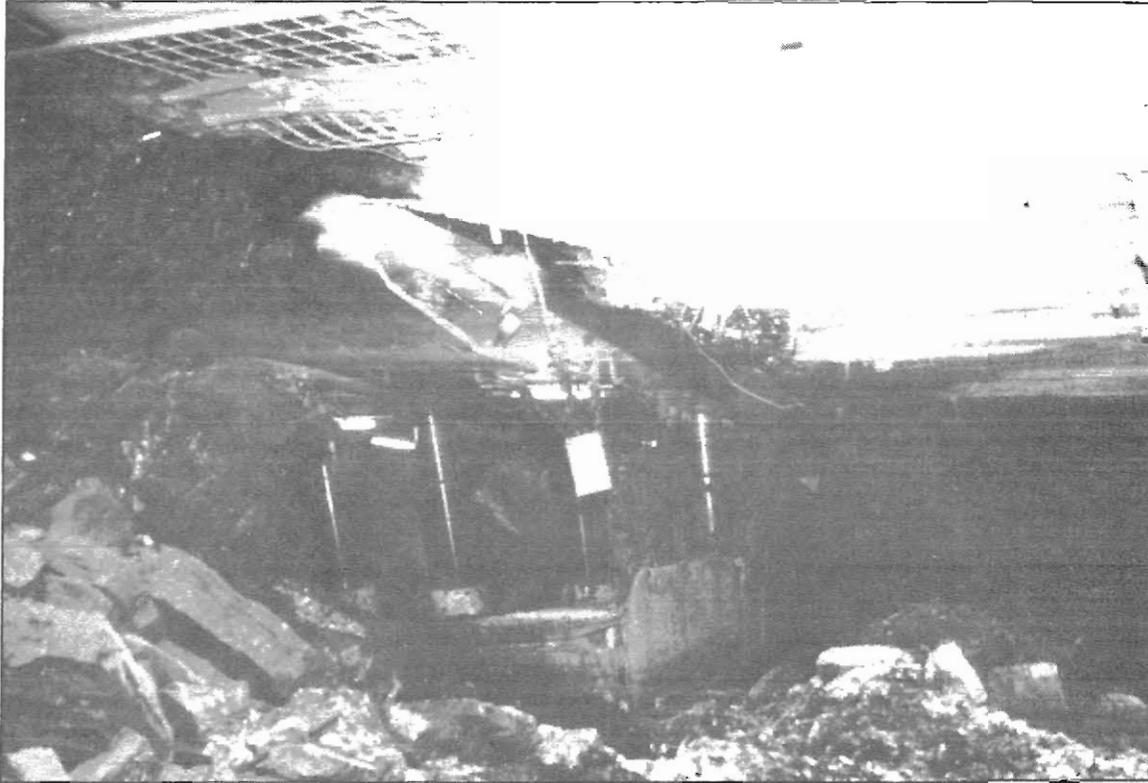
Figure 35

Roof integrity and stability of tensionable support system test area.

to high loading. These areas were usually associated with the geological features as described earlier. The face and the integrity of the immediate roof are shown in figure 35. This type of roof condition, encountered throughout the entire test area, provided a safe and accessible travelway and maintained the ventilation airway.

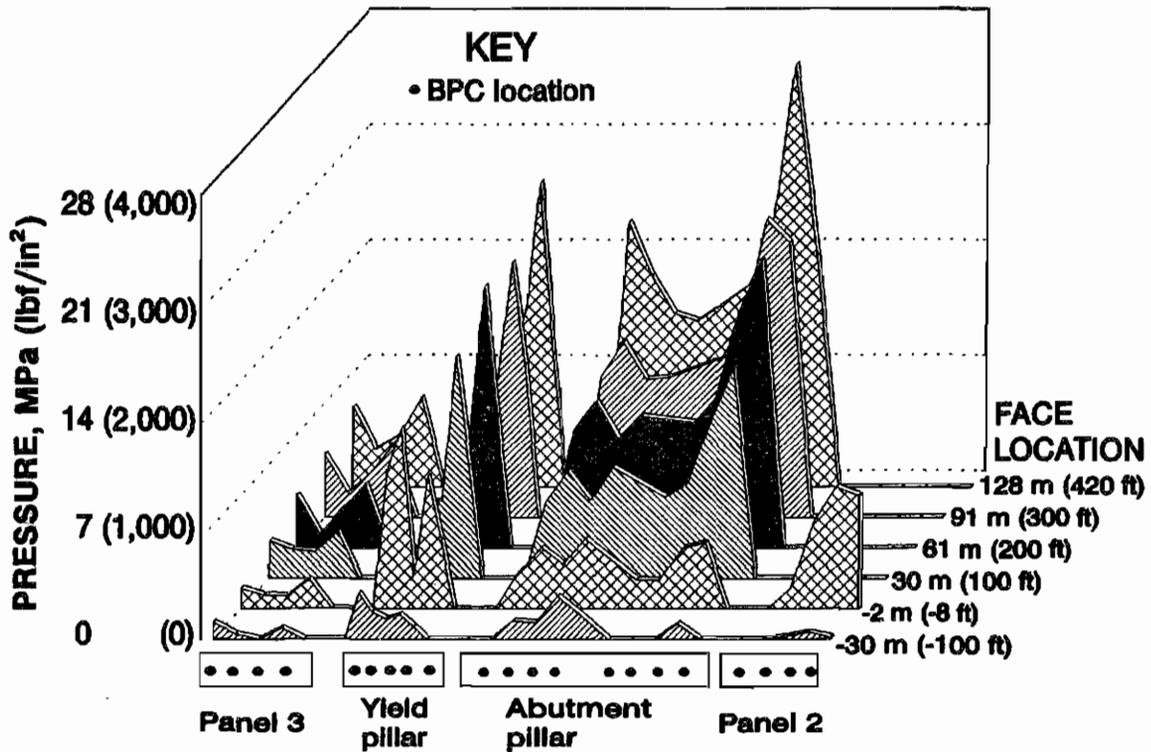
Figure 36

Pillar and panel loading during panel 2 extraction.

The forward abutment pressures during panel 2 mining were characterized by monitoring vertical pressure in the longwall panel 2 headgate, as shown in figure 36. For the purposes of discussion, the BPC pressure changes from equilibrium pressure are presented. All pressure cell data are plotted versus distance from the cell location to the active mining face. The onset of the forward stress abutment was first observed when the panel 2 face was approximately 30.5 m (100 ft) inby the BPC locations. A minus sign (-) indicates the panel face was inby the cells. An increased rate of cell pressure rise on the panel was observed when the face was 2.4 m (8 ft) inby the pressure cells, resulting in an average increase of 6.5 MPa (940 lbf/in²). At this time, the abutment pillar, adjacent to the panel, experienced an average increase of 3.0 MPa (435 lbf/in²). The yield pillar, adjacent to panel 3, realized an increased average cell pressure of 6.6 MPa (965 lbf/in²), with the major stress concentration occurring adjacent to entry 1 on the panel 3 side. Panel 3 cells experienced a minor loading change of about 1.2 MPa (170 lbf/in²) as panel 2 was mined through the instrumentation site.

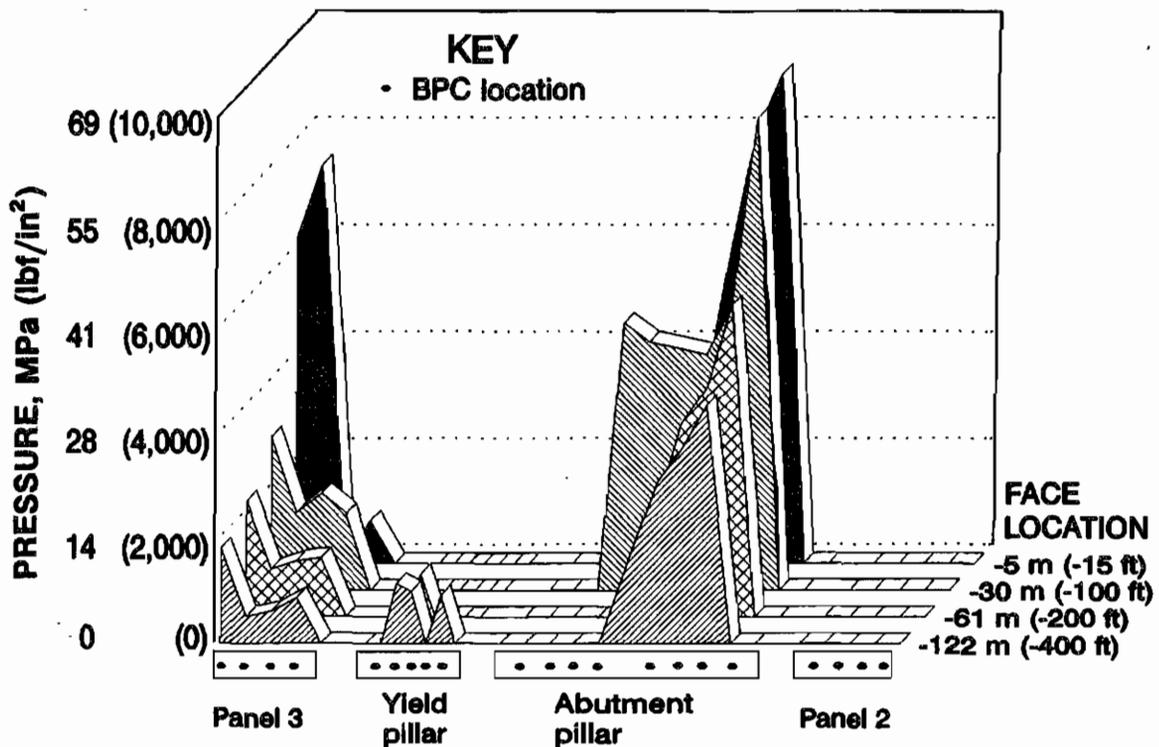
Figure 37

Pillar and panel loading during panel 3 extraction.

The analysis of the data started again after panel 2 was completed and the panel 3 face had mined to a position approximately 121.9 m (400 ft) inby the instrumentation, as shown in figure 37. At this point, the abutment pillar edge adjacent to entry 2 had yielded to the cell established 19.2 m (63 ft) inside the pillar from entry 2. The abutment pillar had also yielded about 3.0 m (10 ft) from entry 3 next to previously mined panel 2. The yield pillar remained intact with the exception of the outer 3.6 m (12 ft) of the pillar on the entry 2 side. This area, heavily loaded during panel 2 extraction, had yielded by the time the panel 3 face approached the site. When the panel 3 face was 61.0 m (200 ft) inby the instrumentation, the yield pillar core lost pressure. Even though the yield pillar appeared to be intact with only minor sloughage, the instrumentation indicated that the yield pillar loading had decreased. Load from the yield pillar was transferring to panel 3 and the core of the abutment pillar. The abutment pillar and panel 3 experienced increased load.
