REPORT OF INVESTIGATIONS/1994

Full-Scale Evaluation of the Strength and Deformation of Grout Column Supports for Mine Subsidence Abatement

By Thomas M. Barczak and David F. Gearhart

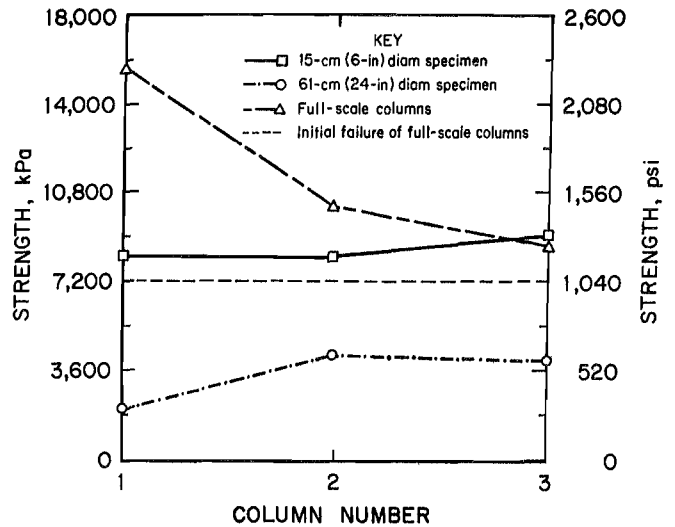
Figure 13.—Small-scale cylinder strength tests of grout samples used for MRS column construction.

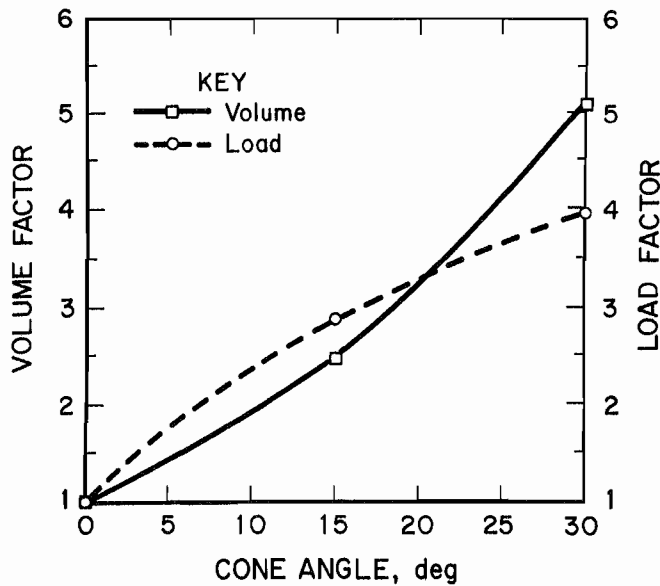
Figure 15.—Relationship between material volume and specimen strength for small-scale cone specimens as a function of cone angle.

The maximum load sustained by each cone specimen is shown in figure 14, and the relationship between material volume and specimen strength is shown in figure 15 as a function of the cone angle. A 30° cone angle specimen provided nearly 400 pct greater strength than a cylindrical

specimen. However, the strength improvement provided by the cone geometry diminishes nonlinearly with increasing cone angles. This strength improvement is also gained at the expense of rapidly increasing material volume as shown in figure 15. A specimen with a 30° cone angle has nearly three times the volume of a specimen with 15° cone angle, but less than twice the load capacity.

Figure 15 showed a 350- to 400-pct increase in capacity for small-scale cones with a 15-cm (6-in) diameter top surface area and a 20° to 30° cone angle as compared with a cylindrical specimen with the same top surface area. The relationship between load and cone angle is nonlinear with the strength improvement diminished as the cone increases in cross-sectional area at larger cone angles. However, this increase in capacity due to the cone geometry was not fully realized in the full-scale grout columns. Full-scale grout columns provided a strength increase of about 75 pct in relation to the material strength measured from 61-cm (24-in) diameter specimens or a 5 pct increase in capacity in relation to material strength measures from 15-cm (6-in) diameter specimens. Failure of the columns to reach the expected level of strength is attributed to the presence of cold joints formed by the sodium silicate and the asymmetrical shape of the structure.

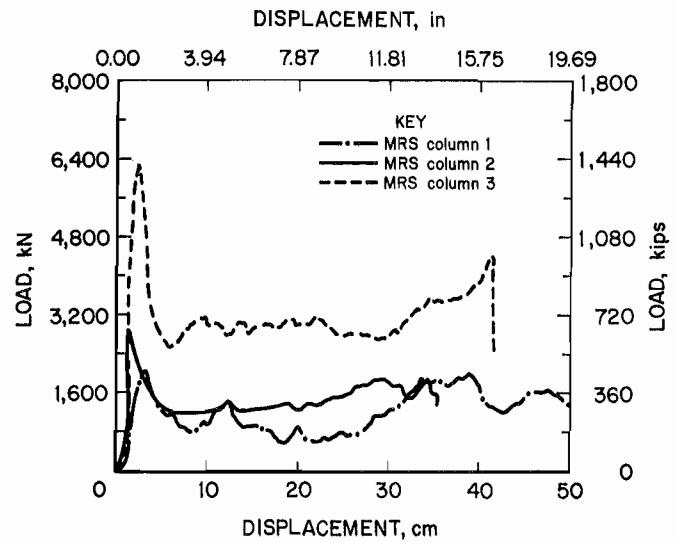
Figure 16.—Initial failure of MRS columns.

Columns constructed in the MRS avoided the problem of an uneven bottom surface, which degraded the performance of the columns constructed at the SAIL. The MRS columns were also constructed against an artificial roof to provide roof contact and a measurable top surface area. Unlike the columns formed at the SAIL without roof contact, the MRS columns exhibited a high initial stiffness as they developed significant resistance with little displacement as shown in figure 16. All columns began to fail as the top surface stress approached 7,241 kPa (1,050 psi). After the initial failure, the stiffness of the support structure decreased slightly (see figure 17), while the load capacity continued to increase with increasing convergence. Maximum load occurred when localized failures (cracks) coalesced to fracture the specimen from top to bottom.

A significant increase in load capacity after first failure was noted in the first column because of the increased area caused by crushing of the top surface. The increase

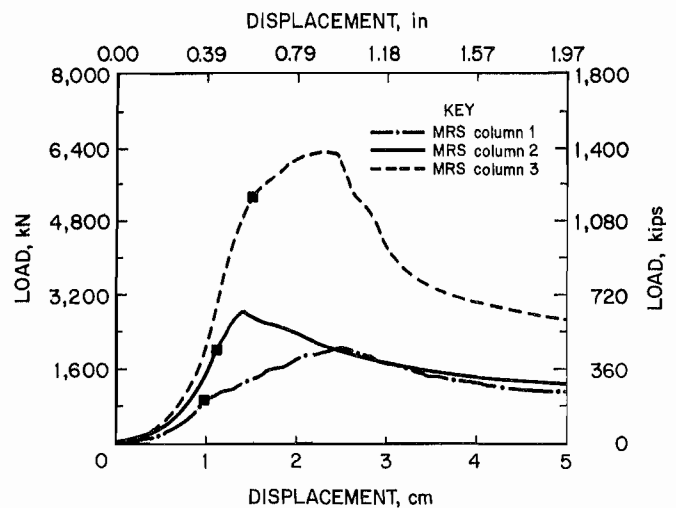
Figure 17.—Decreased stiffness of grout column after first failure. Boxed data points indicate point of initial failure of the grout column.

in load in the other two columns after first failure was less than that observed in the first column. Maximum load capacities of 2,002, 2,847, and 6,338 kN (450, 640, and 1,425 kips) were observed for columns 1, 2, and 3 as referenced in table 2. These maximum capacities were attained at less than 2.5 cm (1 in) of displacement. Load resistance after reaching the maximum capacity was reduced by about 50 pct as the columns split through their cross section and crushed from the continued displacement.

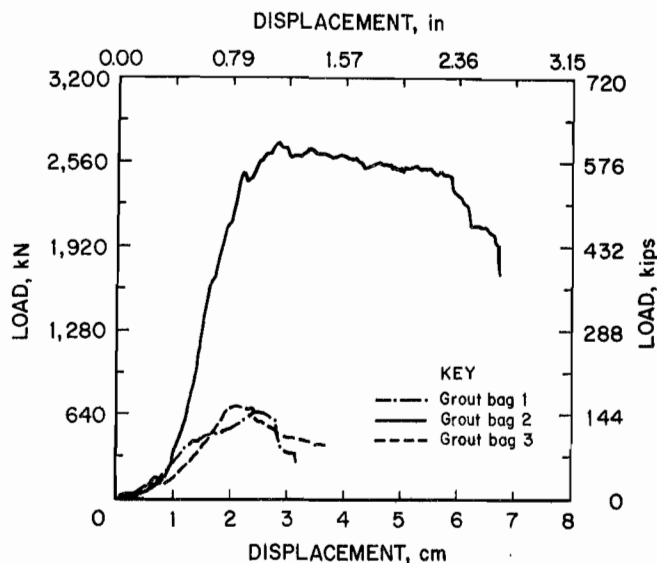
Figure 18.—Load-deformation response of grout bag columns.

Test results of the three grout bag columns as referenced in table 3 are shown in figure 18. Column 2 provided a maximum load capacity of nearly 2,669 kN (600 kips) with approximately 1.1 m³ (1.4 yd³) of material. This compares with the 2,002- and 2,847-kN (450- and 640-kip) load capacity of the two full-scale MRS grout columns, which contained 2.3 and 3.1 m³ (3 and 4 yd³) of sodium silicate grout. These results demonstrate the potential for substantial material and cost savings using grout bags for containment during column formation. However,

the other two grout bag columns were unstable and provided only 667 kN (150 kips) of load capacity, demonstrating the need for further research in bag design to improve the utilization of this technology.

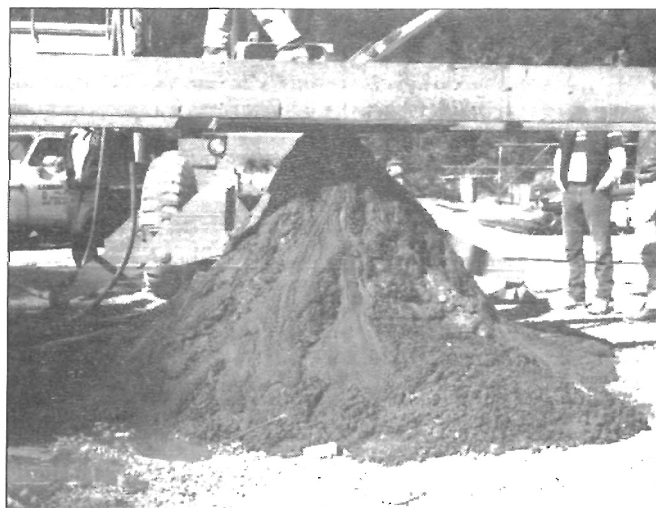
Figure 20.—Layering of grout caused by sodium silicate.

The use of sodium silicate enables a structure to be formed in a water-filled environment that may not be formed otherwise. However, there are some deficiencies associated with this sodium silicate technology. Inadequate mixing of the sodium silicate with the cementitious grout produces pockets or layers of sodium silicate gel that reduce the load capacity of the support structure. During column construction, grout flows through the path of least resistance and down a small area on the side of the cone. As this section of the cone builds, increased resistance diverts the grout flow to a different area where the grout has already set, and the newly placed grout does not fully react with the previously placed material. The resultant layering, as shown in figure 20, also creates planes of

weakness in the structure that reduce the load capacity of the column. This layering during column formation also creates an asymmetrical structure where the side surfaces of the cone are not smooth or continuous. Depressions in the side of the columns create stress concentrations that cause localized failures that reduce the overall capacity of the grout column. The sodium silicate accelerates the setting time for the grout, which is advantageous for column construction, but the accelerated setting time also increases the tendency for plugging. In abandoned mine applications where the grout is pumped from the surface, plugging is an important consideration to grout placement.

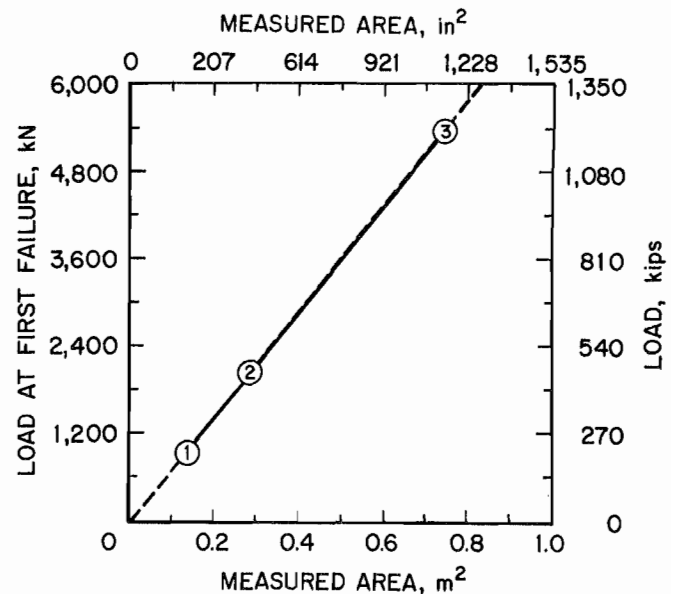
Figure 21.—Initial failure of MRS grout columns as a function of roof contact area. Circled numbers identify columns.

Roof contact area largely determines the capacity and stiffness of grout columns. As shown in figure 21, the initial failure of the grout columns tested in the MRS is linearly related to the roof contact area. Hence, the capacity of the support is directly related to the area of roof contact established during column construction. The material strength achieved in the full-scale column can be determined from the slope of the load versus contact area plot. For the MRS columns depicted in figure 21, the material strength was 7,241 kPa (1,050 psi).
