Geotechnical Aspects of Roof and Pillar Stability in a Georgia Talc Mine

By Noel N. Moebs and Gary P. Sames

Report of Investigations 9404

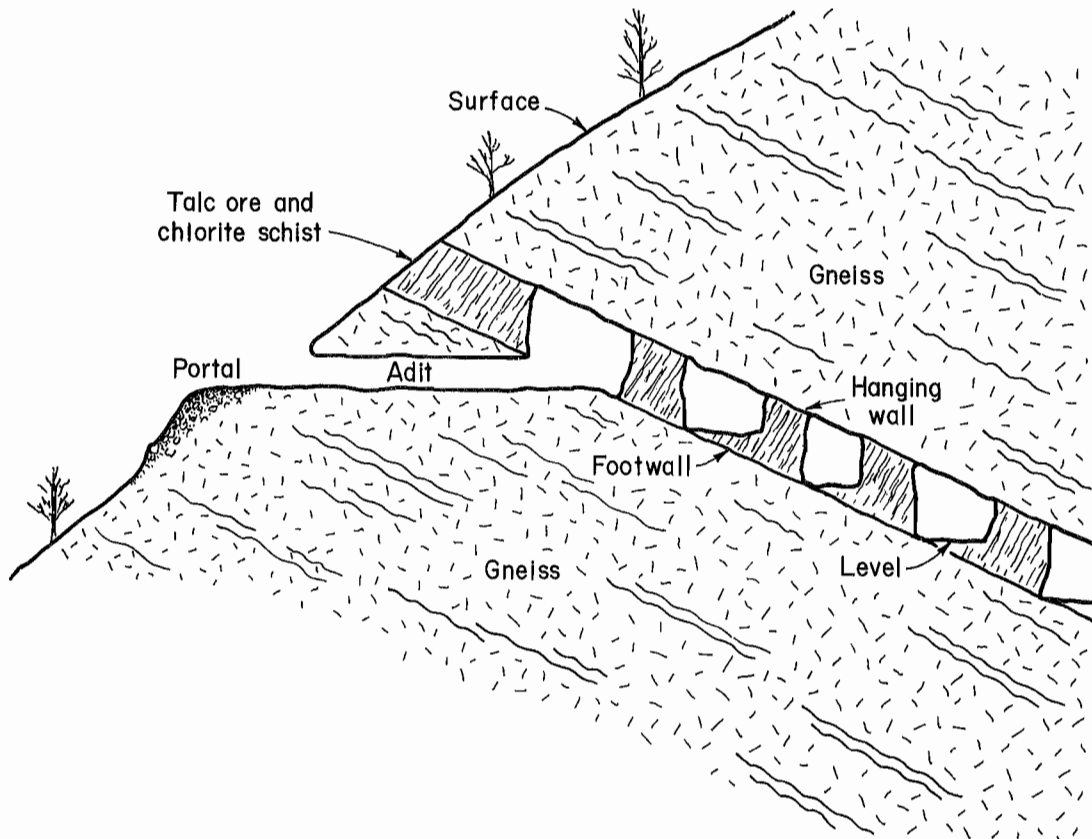
Figure 2.—Typical method of developing an underground talc mine in northwest Georgia.

Mines are developed in a somewhat random manner in that no uniform pillar plan is followed. This method of extraction can best be termed either "room-and-pillar" or "open stope" mining. Generally, oversized pillars containing good grade ore are later split or reduced in size.

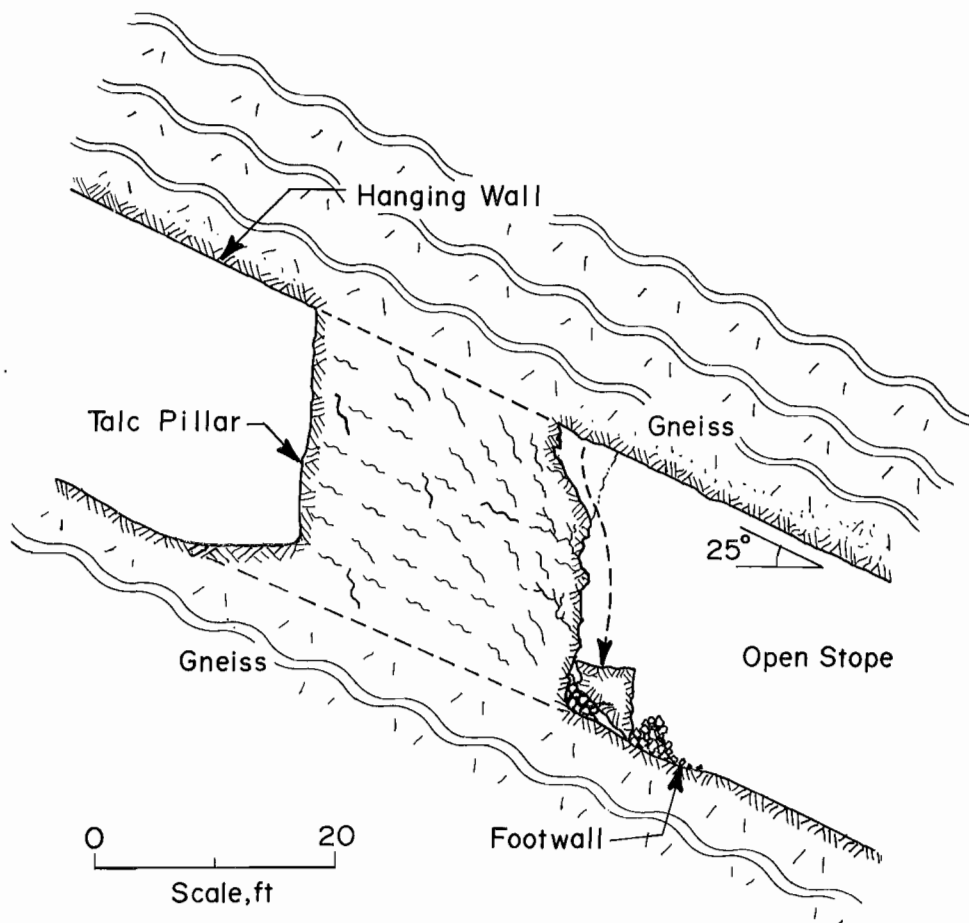
Figure 3.—Schematic of incipient pillar failure.

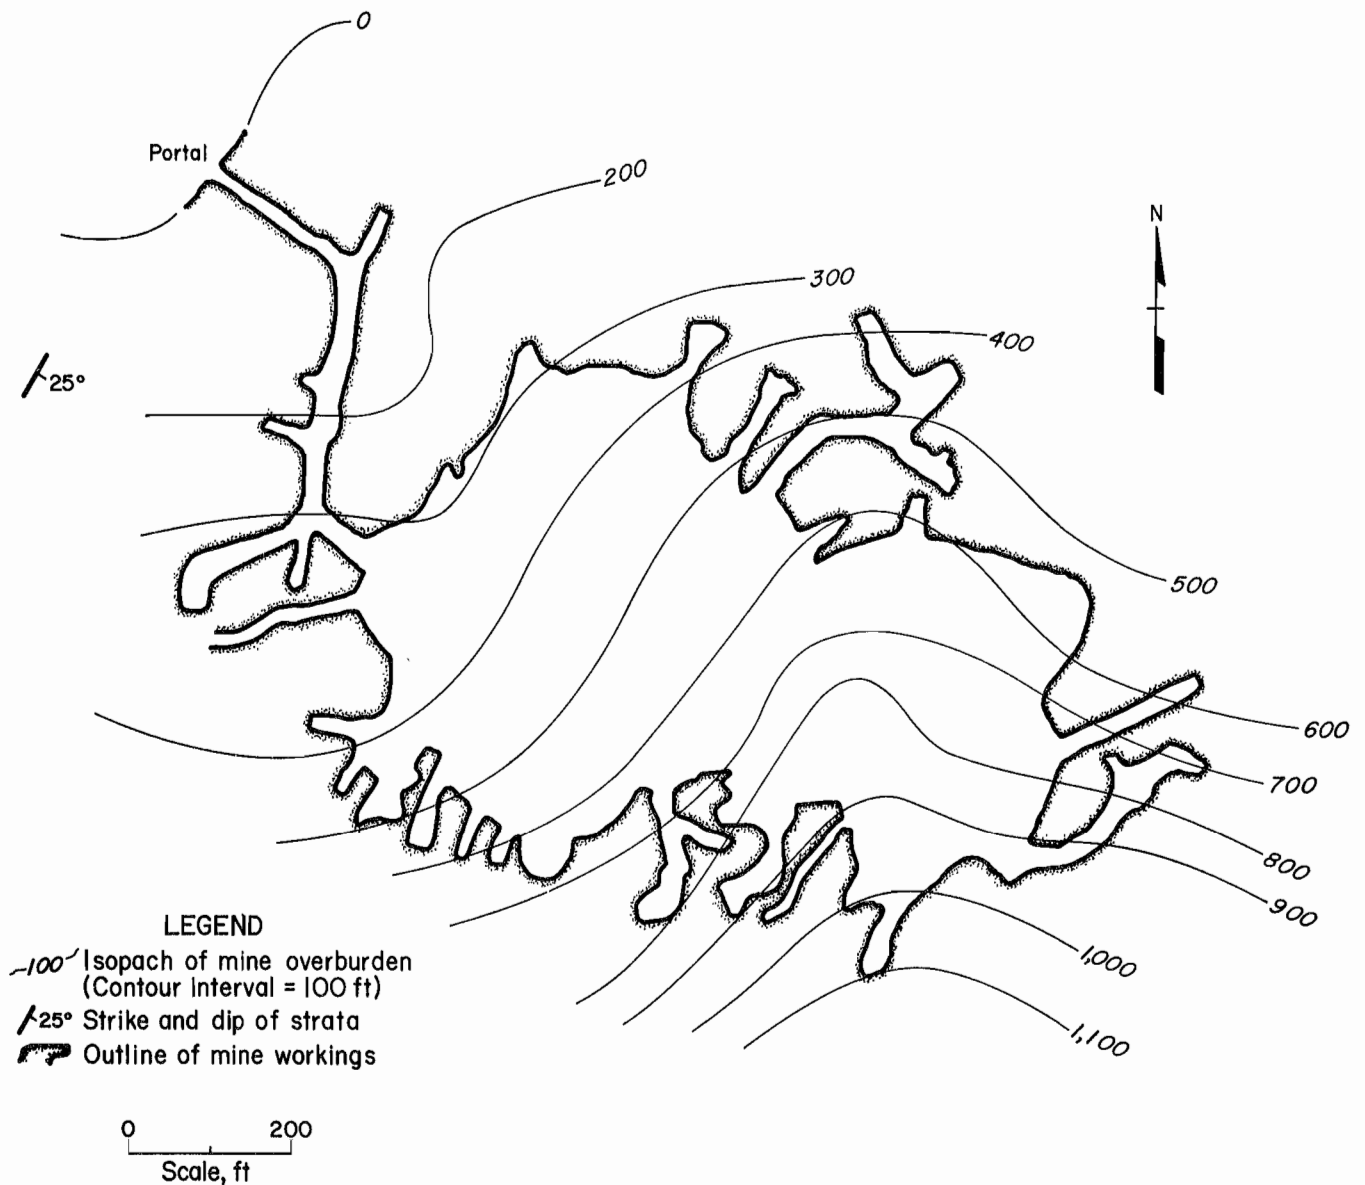
Figure 4.—Isopach map of mine overburden.

was resumed from the upper levels. By 1989, production was coming from several different levels of the mine. The mine now extends over an area of about 800 by 1,200 ft and has reached a depth of 1,100 ft below the surface (fig. 4).

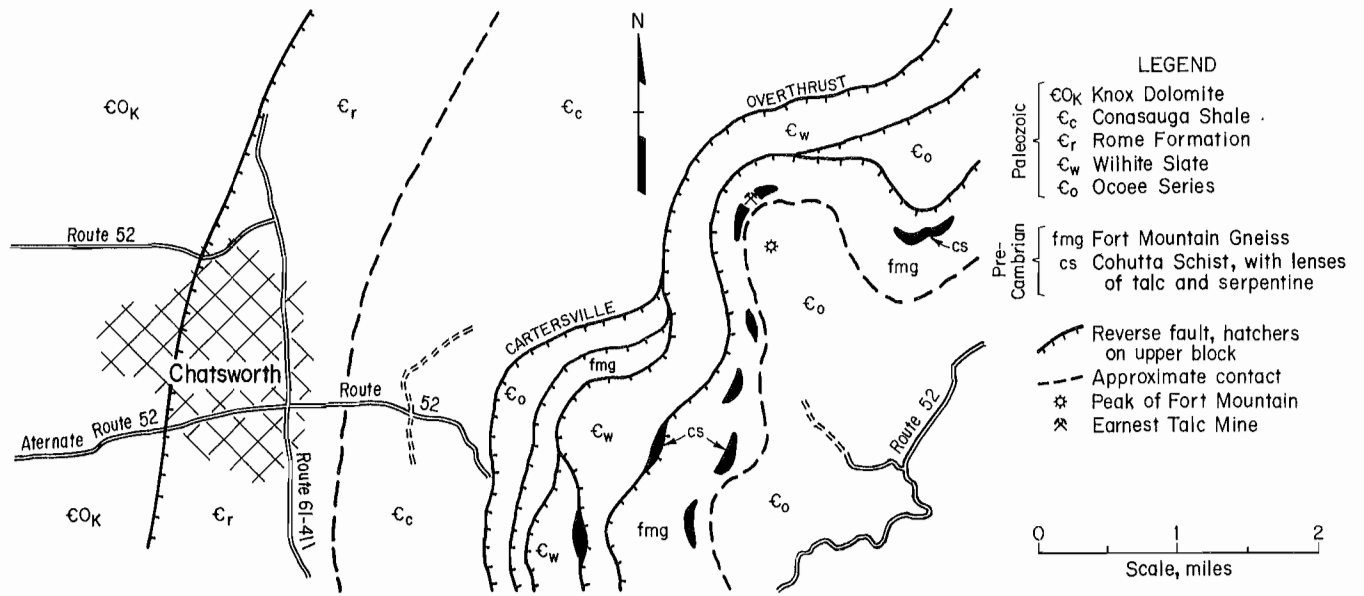
Figure 6.—Fault structures in talc district of northwest Georgia.

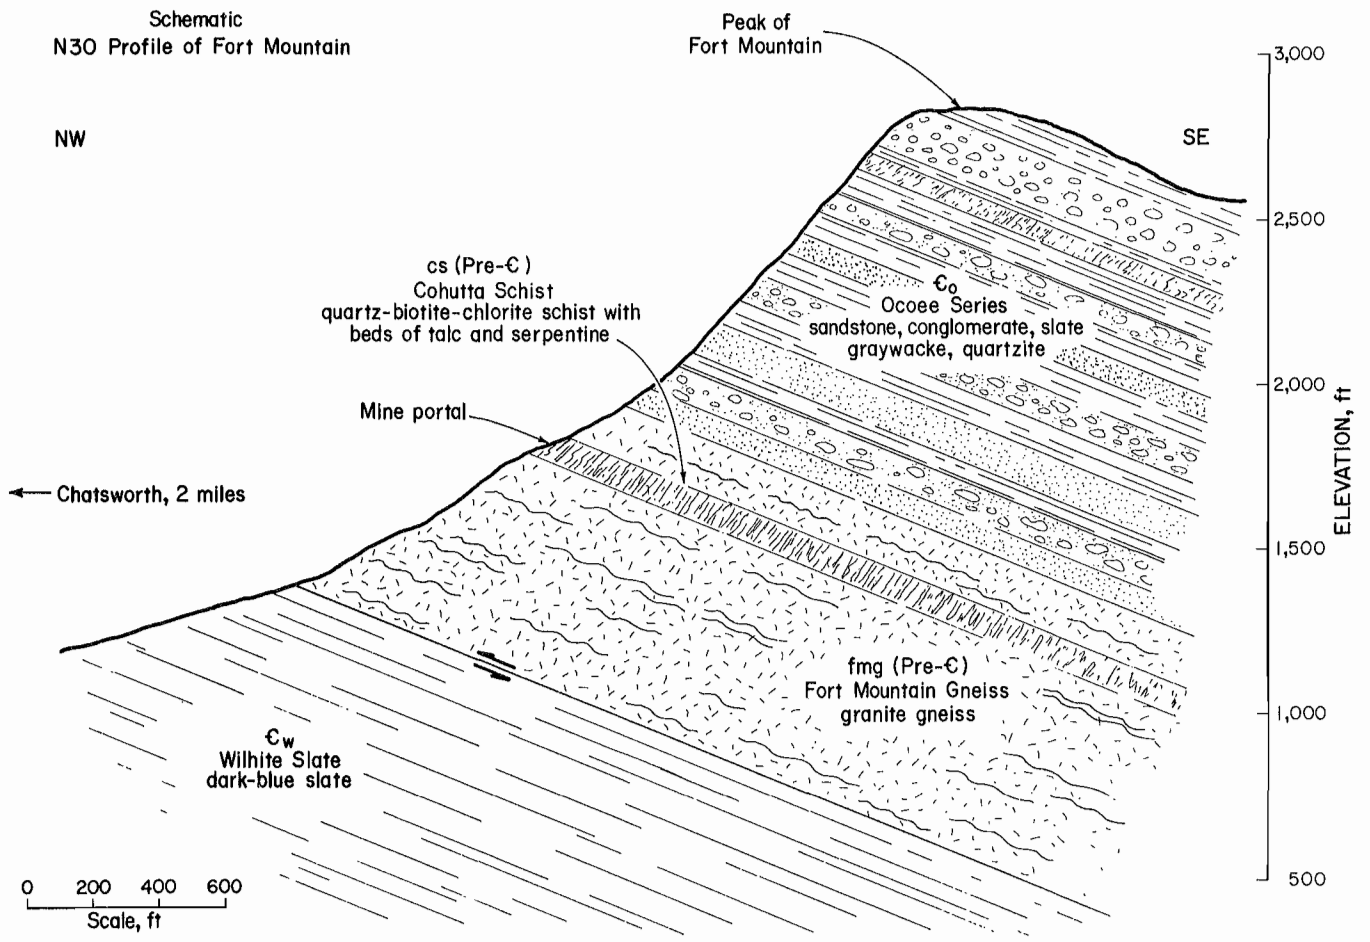
Figure 7.—Profile of Fort Mountain thrust block.

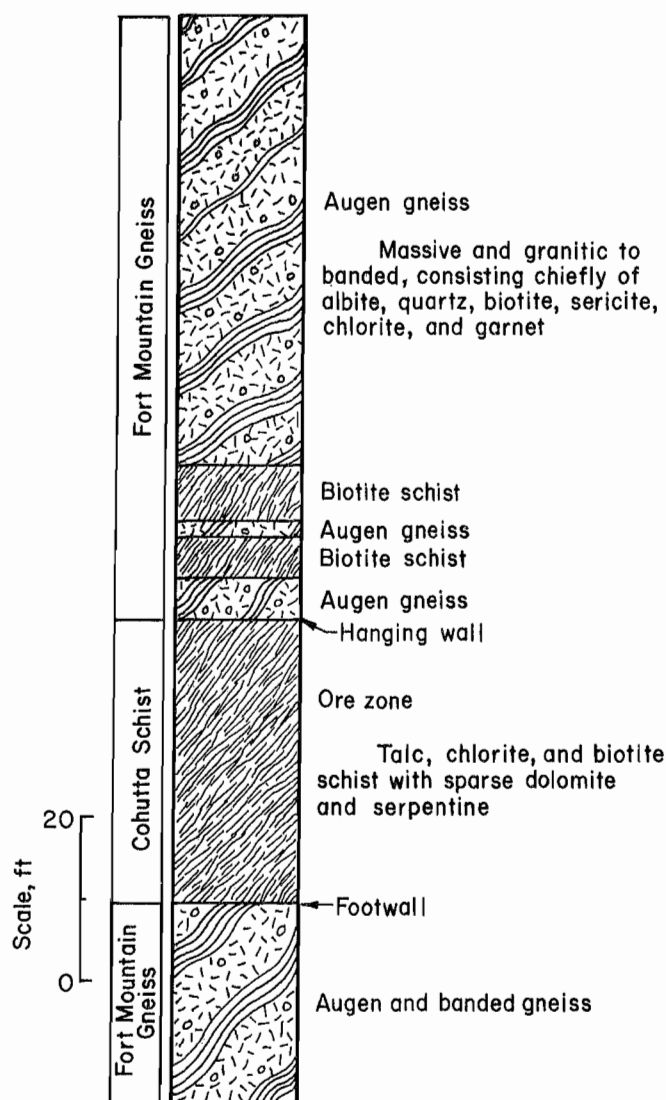
Figure 8.—Generalized stratigraphic column of talc district.

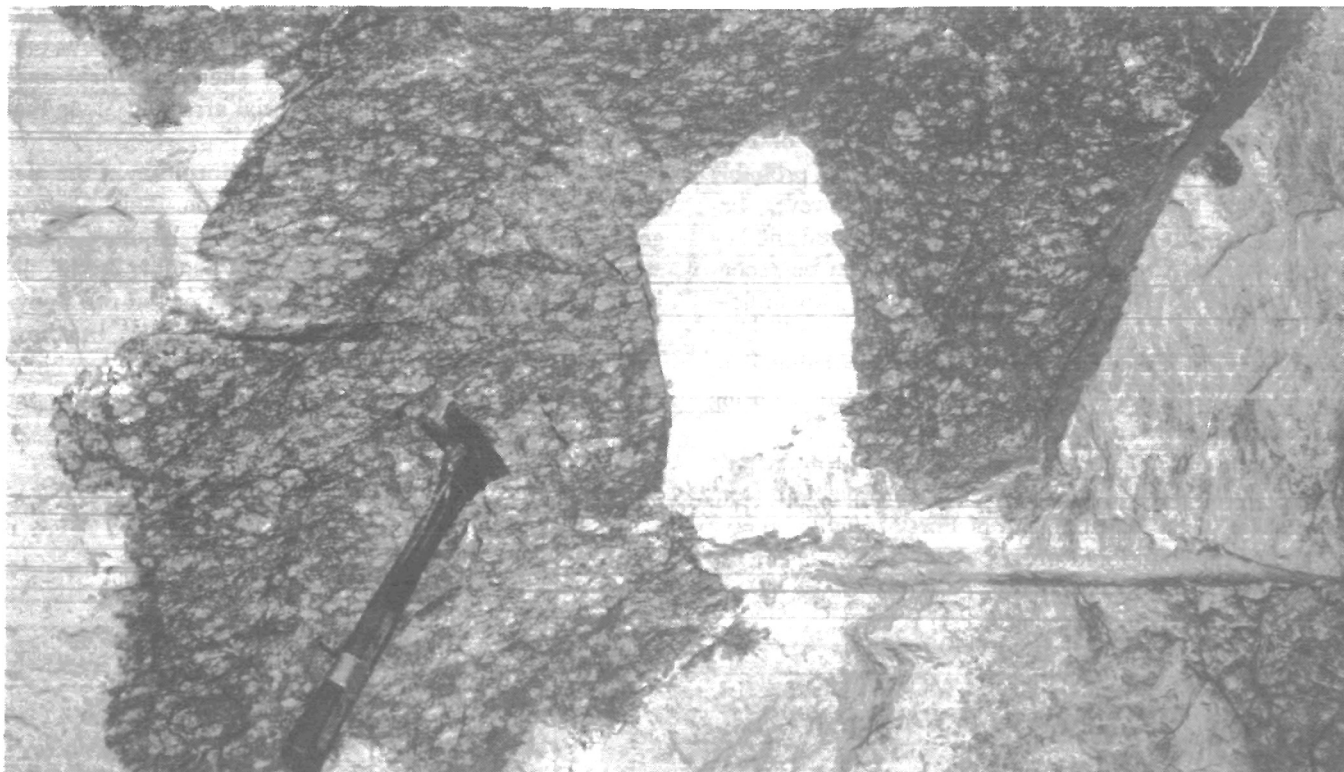
Figure 9.—Augen gneiss in Earnest Mine hanging wall.

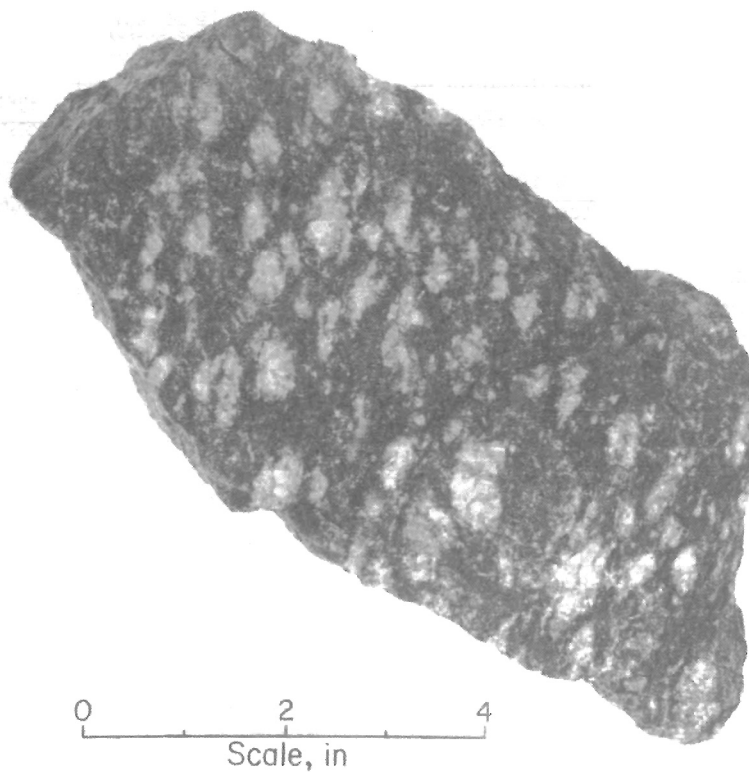
Figure 10.—Texture of hanging wall augen gneiss.

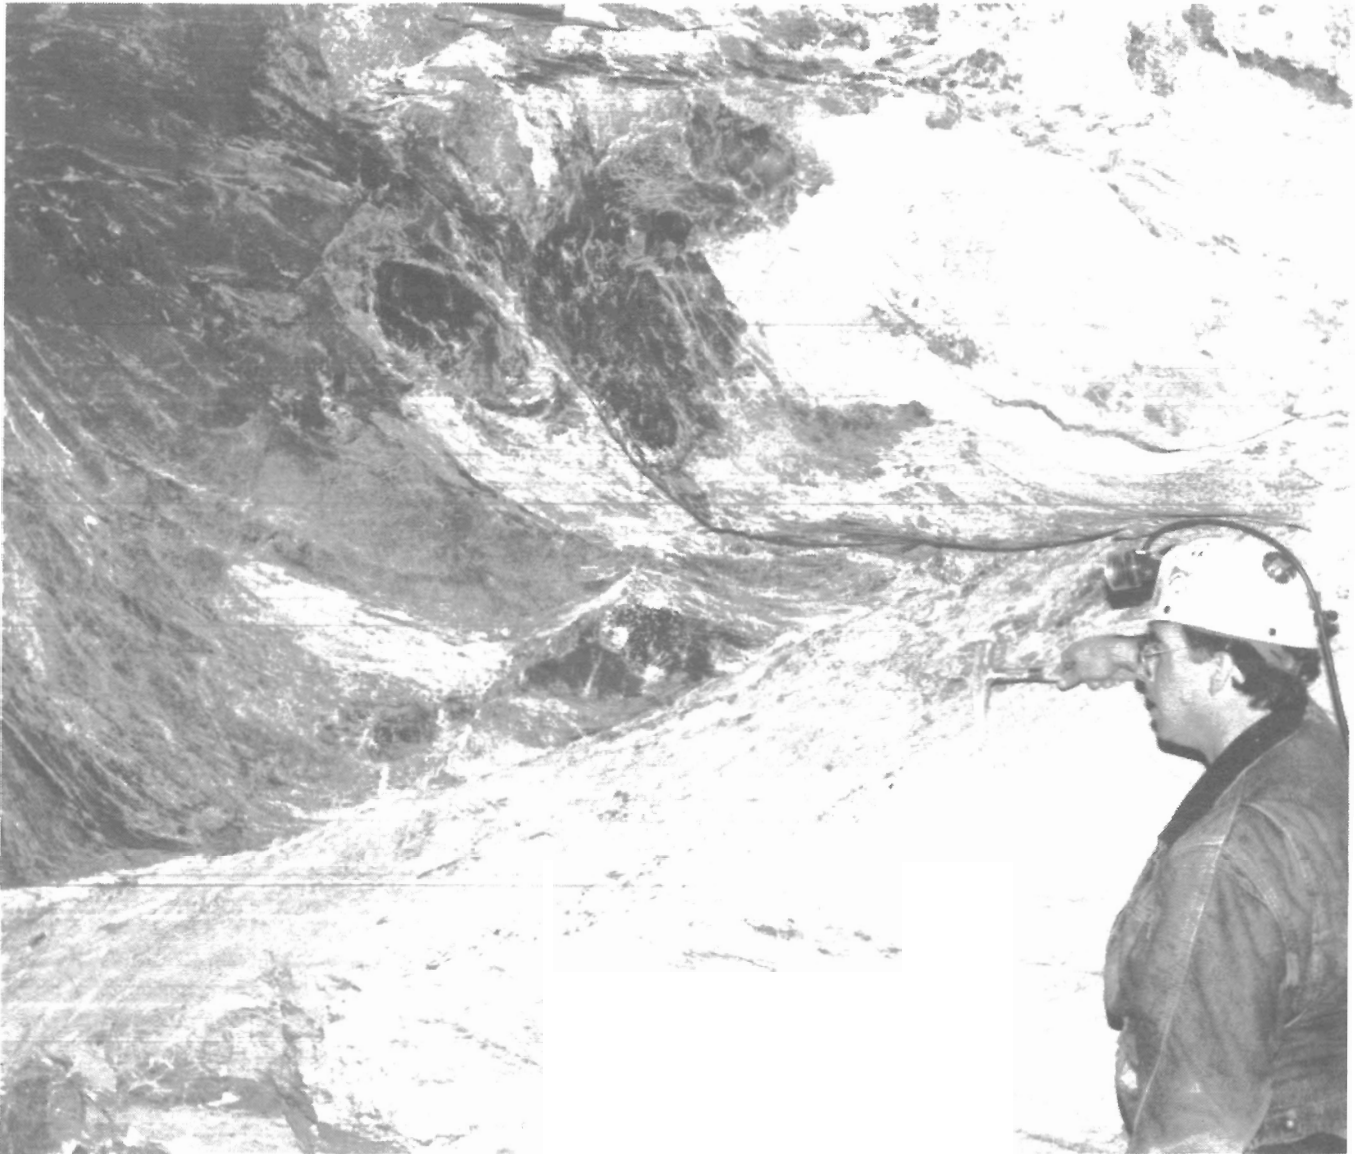
Figure 11.—Roof roll in hanging wall schist of Earnest Mine.

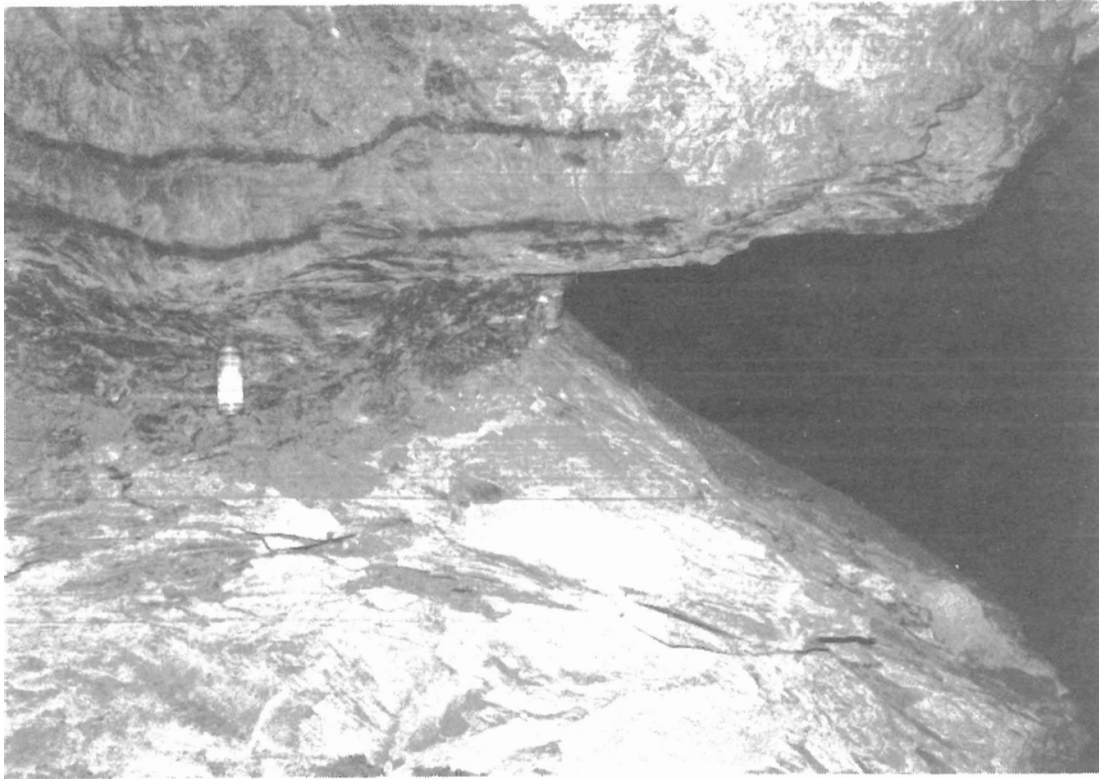
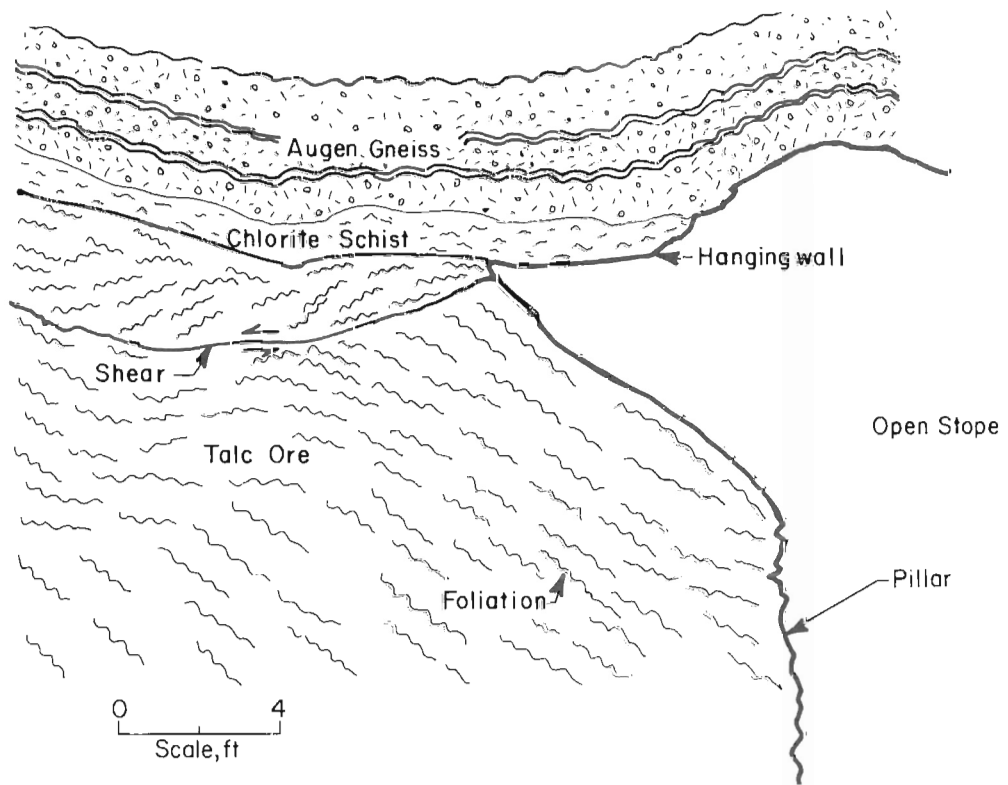
Figure 12.—Photograph (above) and sketch (below) illustrating structure in hanging wall.

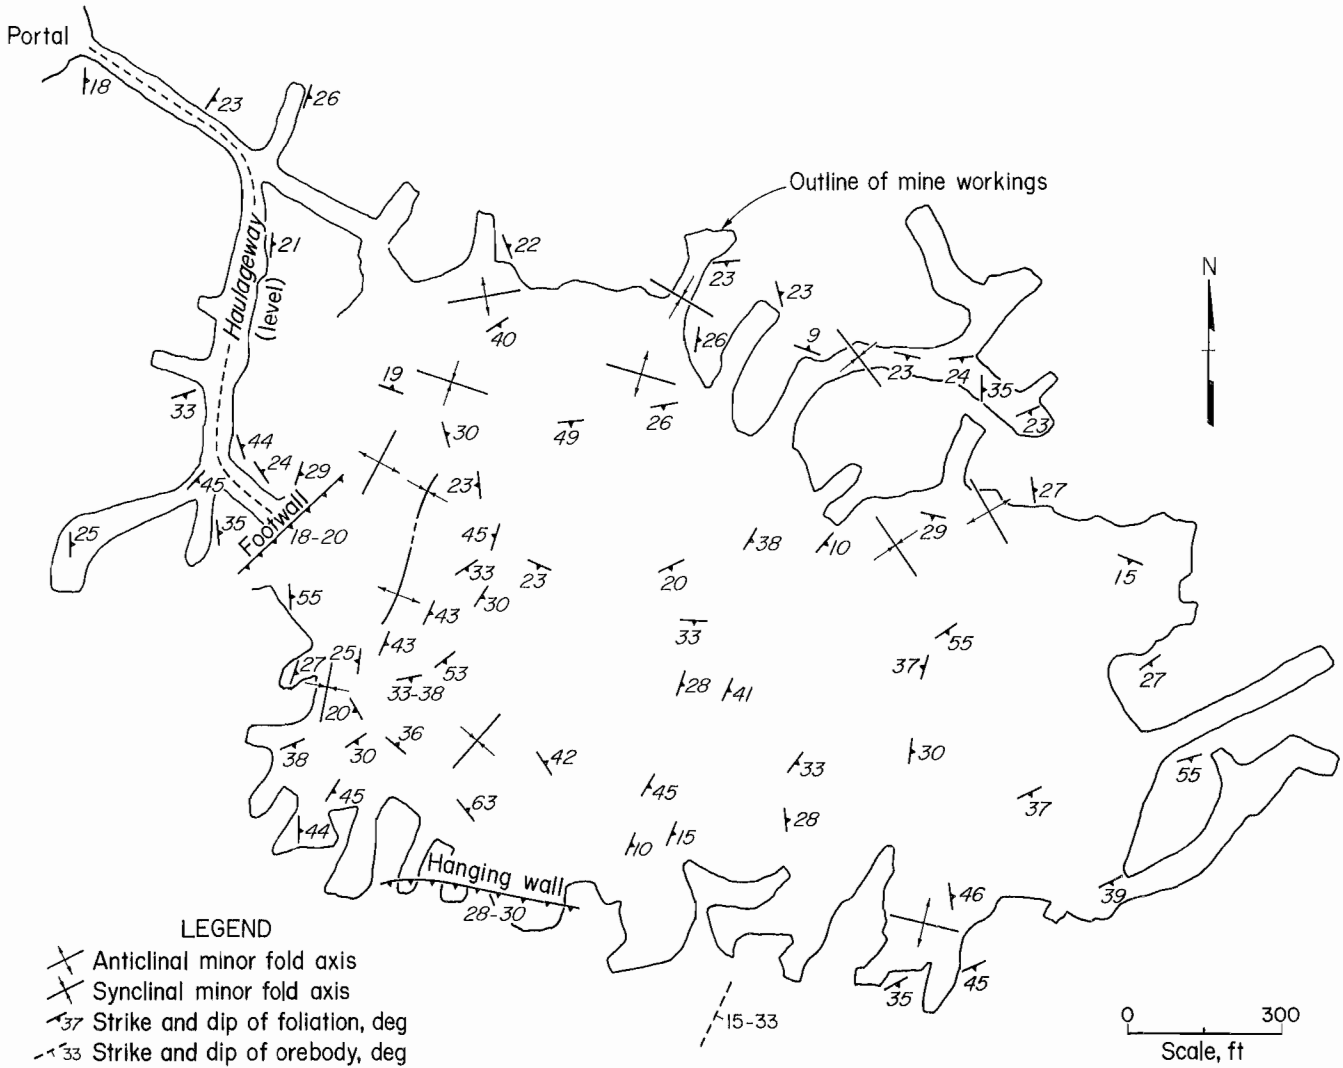
Figure 13.—Minor structures in talc ore body.

The intense deformation and metamorphism of the ore has resulted in strongly developed foliation. This foliation generally is parallel to the thin textural banding. The structural attitudes of the foliation and banding are highly irregular as a result of the deformation of the ore body. Small-scale drag folds, crenulations, slickensides, boudins, and flexural folds are common throughout the ore body (fig. 13). Jointing is only very locally developed.

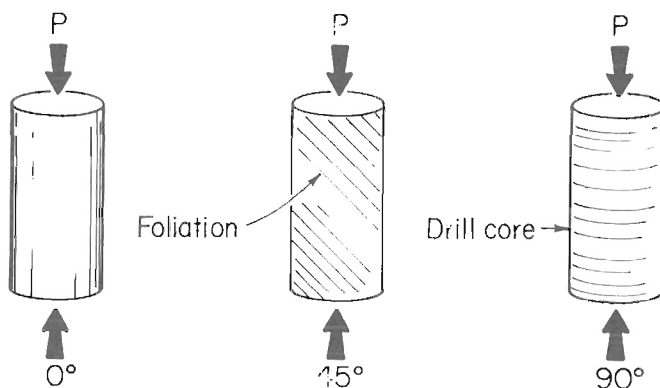
Figure 14.—Relation of applied load to foliation in drill core. Core diameter, 1.25 in; P indicates direction of applied load.

To examine the effect of foliation orientation on the strength of talc pillars, a simple laboratory testing program was conducted on 23 talc cores with three foliation orientations relative to the specimen axis (fig. 14). In the first group, foliation was parallel (0° to 15°) to the core specimen axis and loading axis; in the second group, foliation was 45° (30° to 55°) to the specimen axis and loading axis; and in the third group, foliation was perpendicular (75° to 90°) to the specimen axis and loading axis.

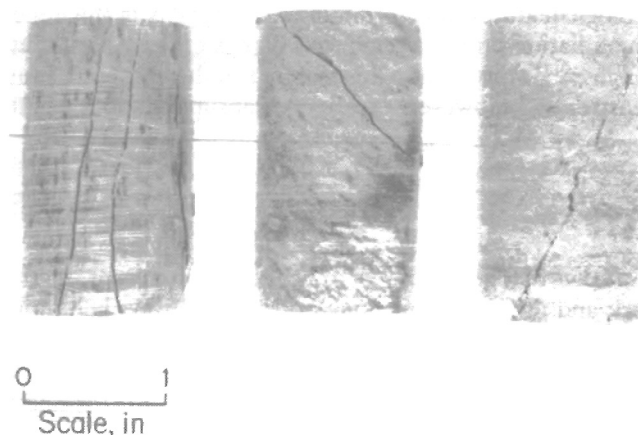
Figure 15.—Failure patterns (fractures) and orientation of foliation in cores of talc ore.

foliation. Those in the second group (45° to foliation) failed in shear along the preexisting weakness planes (foliation). Those in the third group (perpendicular to foliation) failed by classical shear fracture that went through the intact material and was oriented at about 30° to the loading axis.

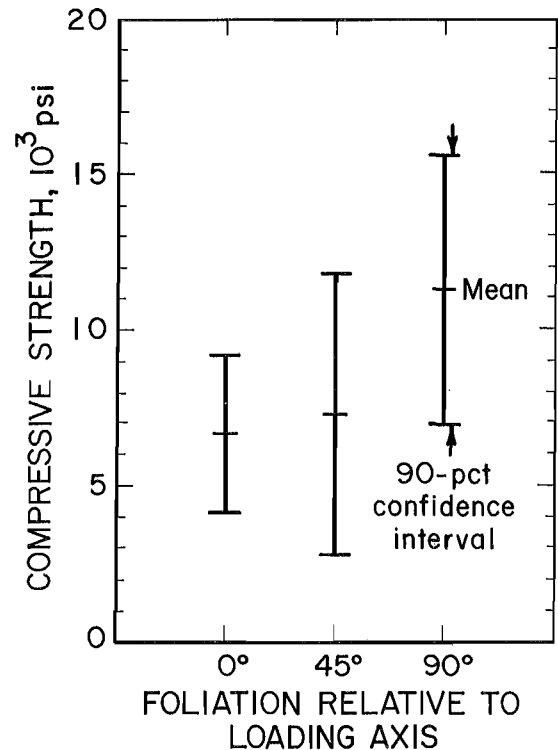
Figure 16.—Compressive strength of talc ore relative to orientation of foliation.

Figure 16 shows the compressive strength data for the three orientation groups. The middle line indicates the mean for that group, and the upper and lower lines define a 90-pct confidence level for that mean.⁴

Summarizing the above foliation effect on talc strength, the talc strength when the specimen is loaded perpendicular to foliation averages 12,000 psi for a 1.25-in-diam core specimen. Strength decreases to an average of 8,000 psi when the specimen is loaded at 45° to foliation, and continues to decrease to an average of 6,000 psi when the specimen is loaded parallel to foliation. These results indicate that a foliation orientation parallel to the loading direction can result in a 50-pct strength reduction, approximately. A strong caution is warranted in that this interpretation is based on small-scale laboratory specimens. The full-scale strength of talc pillars is still largely unknown; however, based on these laboratory observations it is reasonable to expect that the strength of a full-scale talc pillar may also decrease when foliation is inclined or parallel to the loading direction.

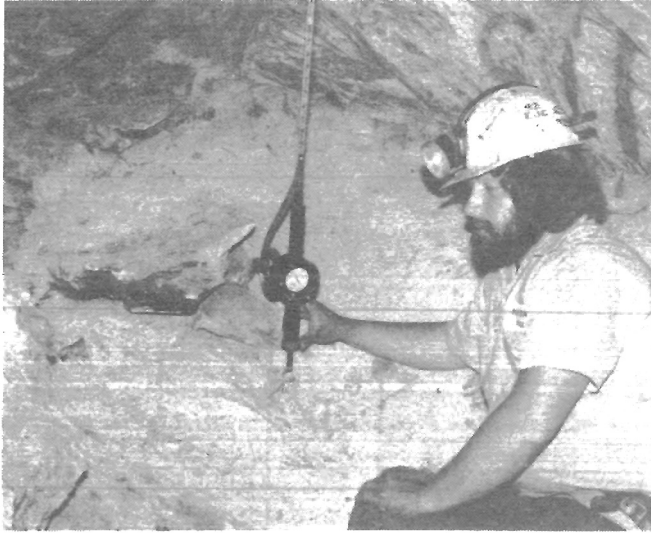
Figure 17.—Measurement of roof convergence with tape extensometer.

A tape extensometer consists of a steel engineer's tape, a dial-tensioning mechanism, and two snaphooks (fig. 17).

Anchoring stations usually are short 3/8-in-diam expansion bolts with eyebolts for connection to the instrument.

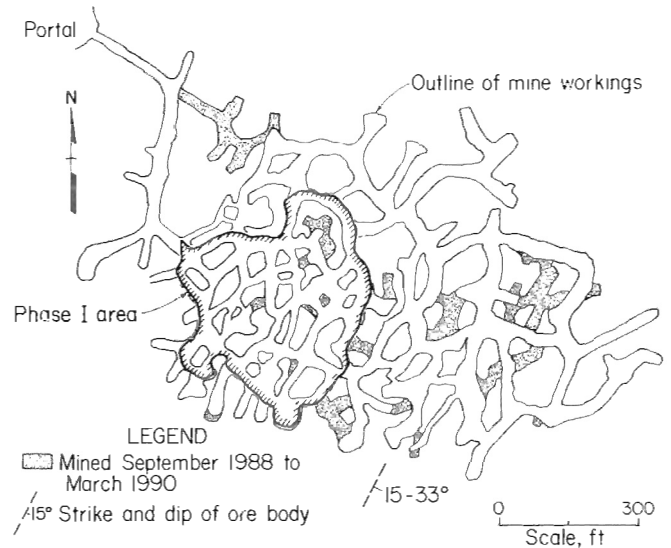
Figure 18.—Outline of phase I study area in Earnest Mine.

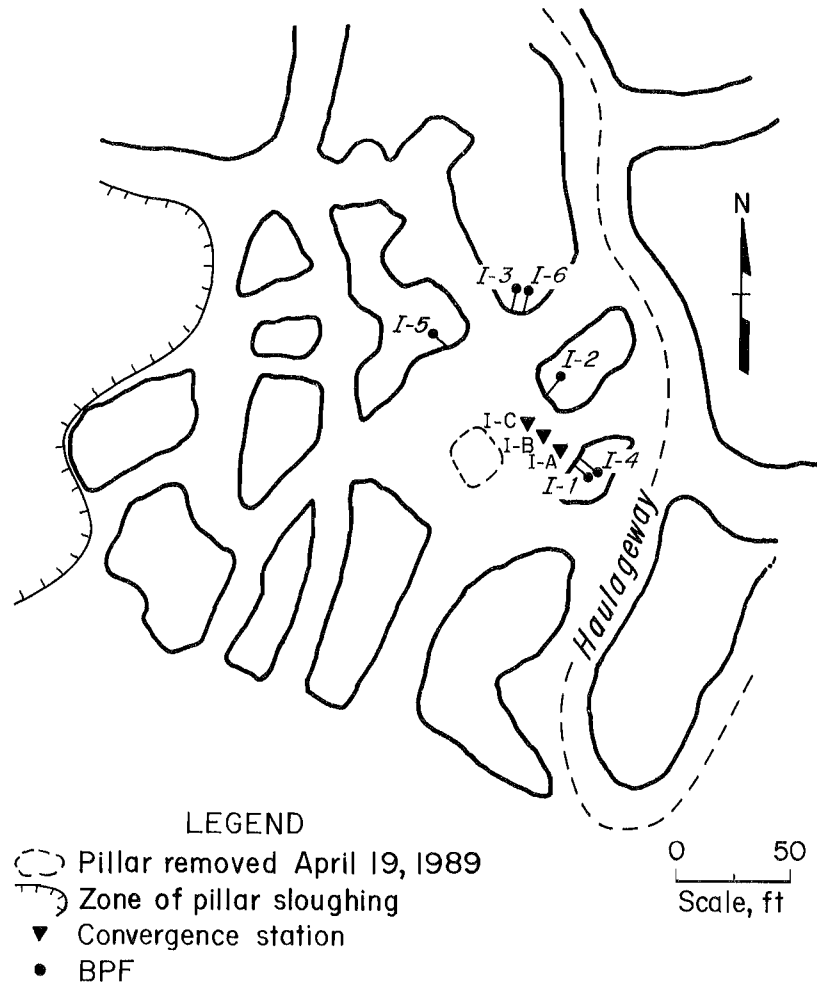
Figure 19.—Location of phase I instrumentation. (BPF = borehole platened flatjack.)

The BPF's were installed in pillars adjacent to a small pillar that was scheduled for removal (fig. 19). This location is under about 550 ft of overburden. Figure 20 shows that virtually no changes in pillar loading were detected after removal of the small pillar and no significant changes occurred throughout the remainder of the period, although additional mining was conducted in the vicinity (fig. 21).

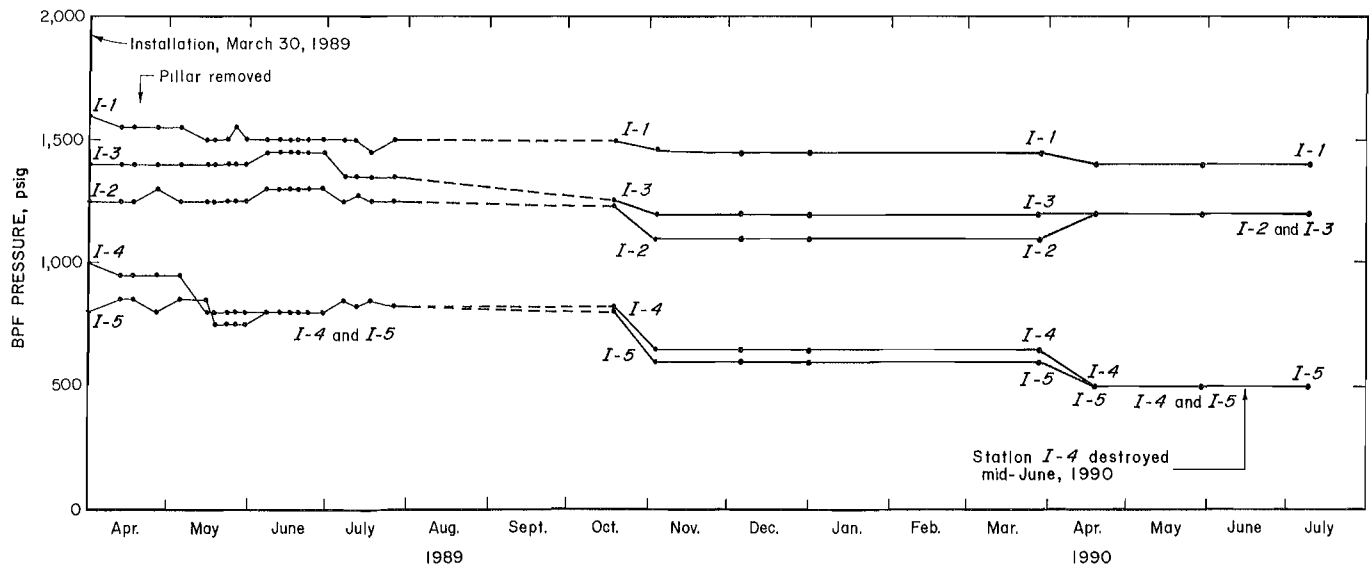
Figure 20.—Phase I pillar loading. No measurements taken during period of August-October 1989. (BPF = borehole platened flatjack.)

A small unexplained pressure loss is indicated for all BPF's from October to November 1989 (fig. 20).

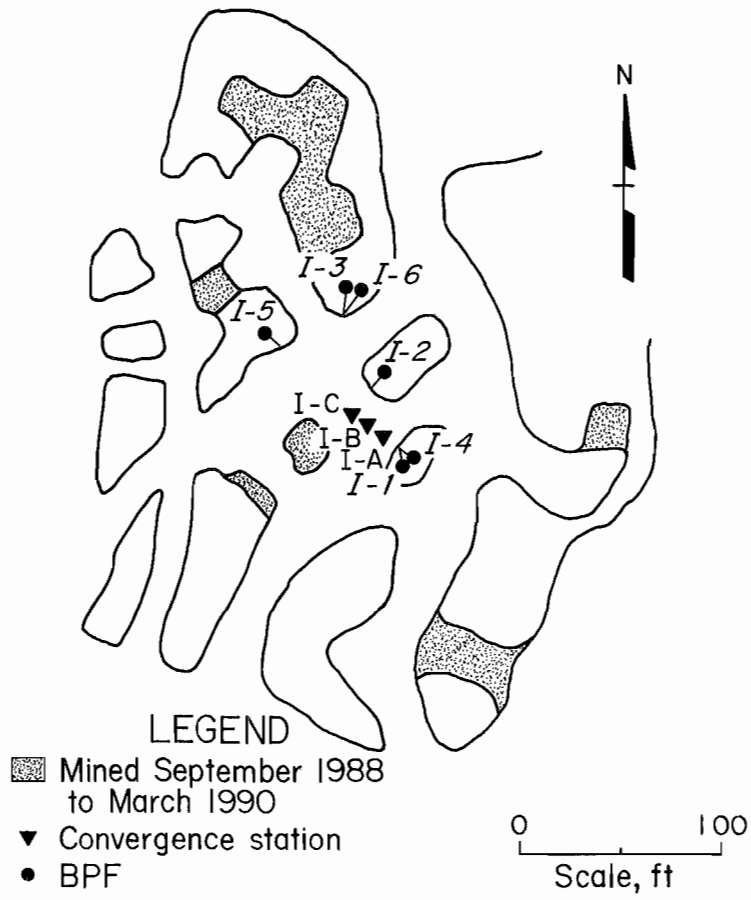
Figure 21.—Ore extraction in phase I area.

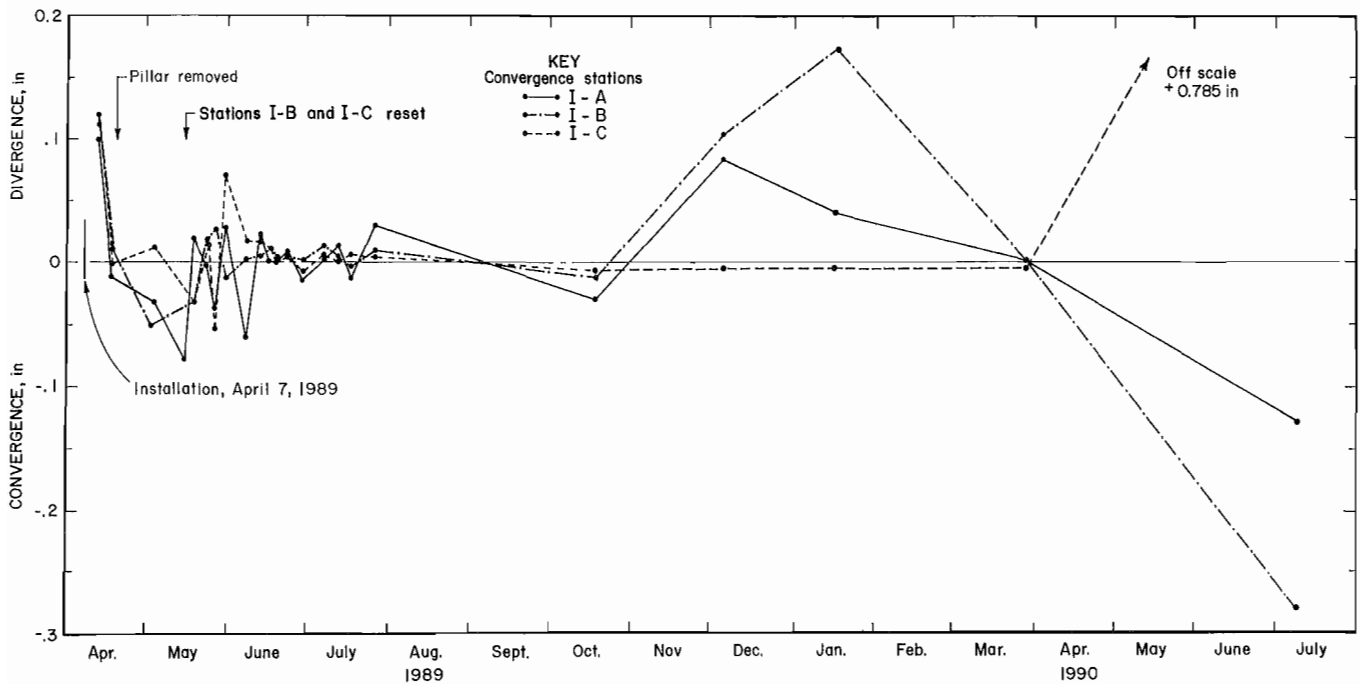
Figure 22.—Phase I roof convergence.

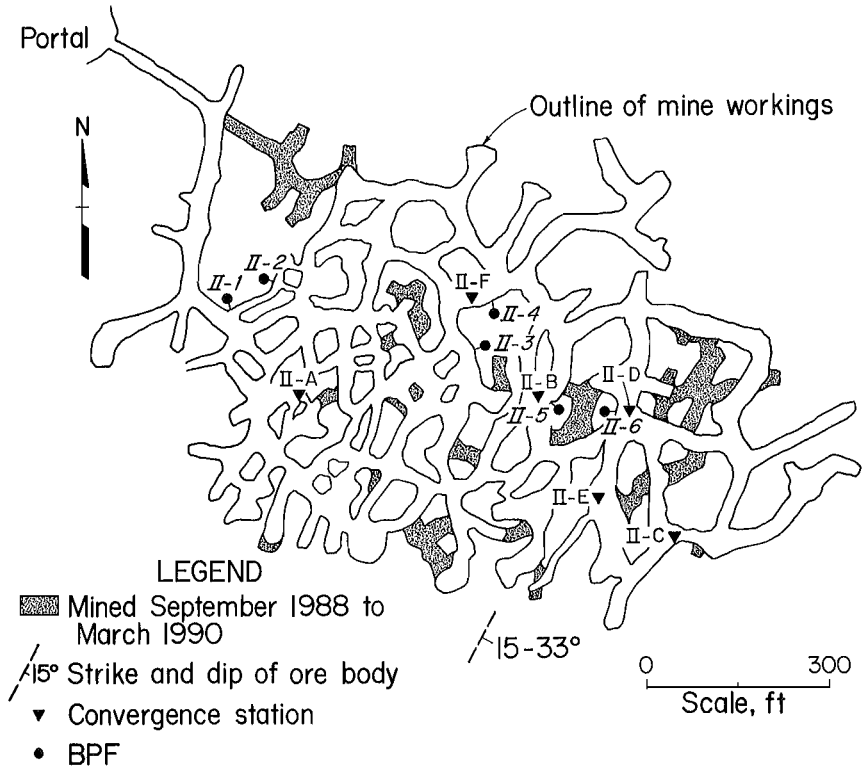
Figure 23.—Location of phase II instrumentation.

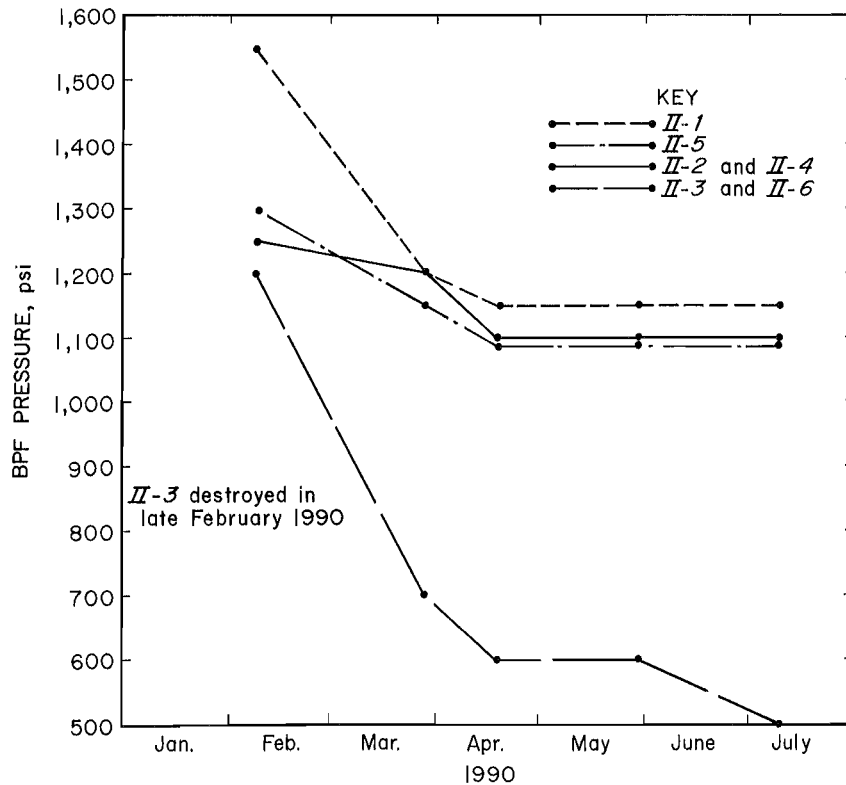
Figure 24.—Phase II pillar loading.

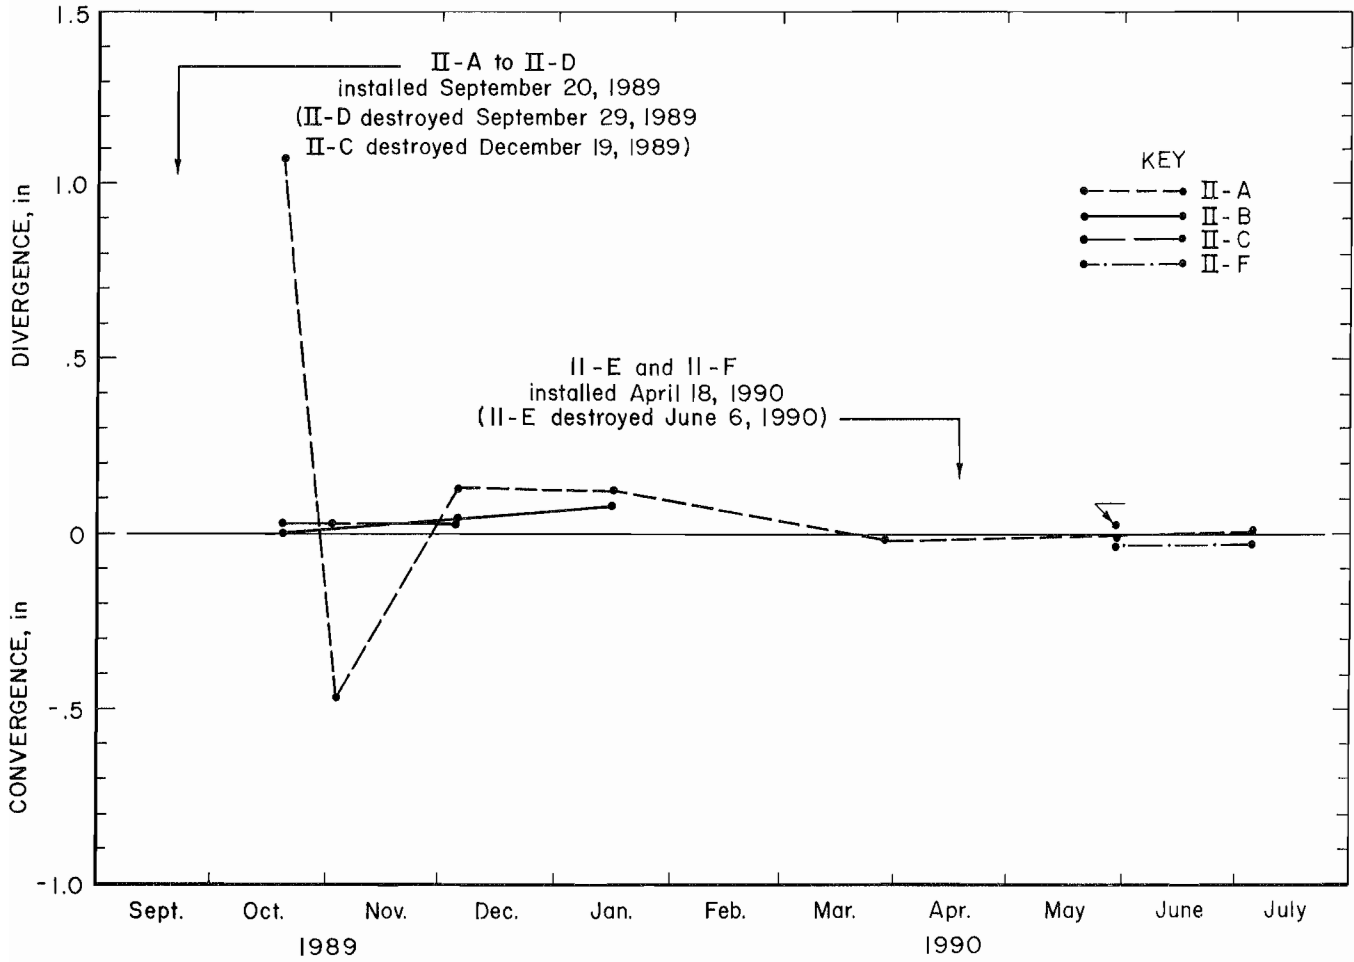
Figure 25.—Phase II roof convergence.

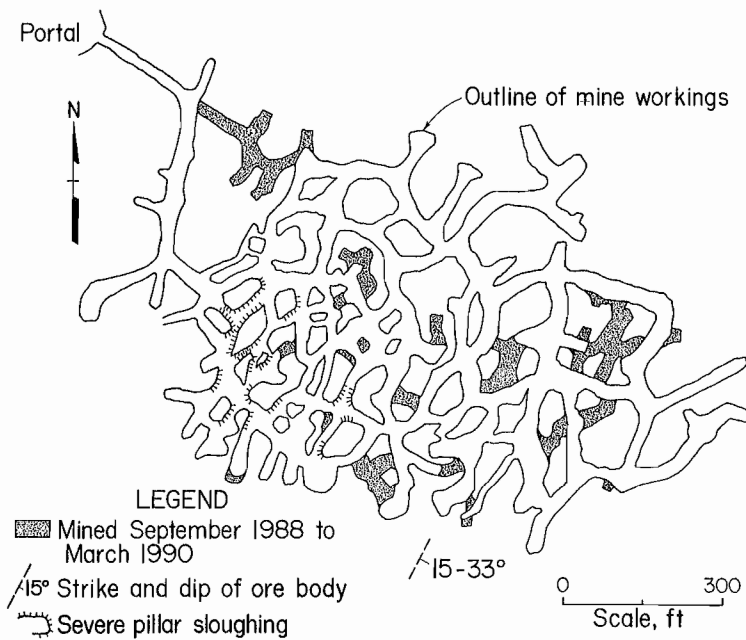
Figure 26.—Areas of severe pillar sloughing in Earnest Mine.
