Geotechnical Aspects of Roof and Pillar Stability in a Georgia Talc Mine

By Noel N. Moebs and Gary P. Sames

Report of Investigations 9404

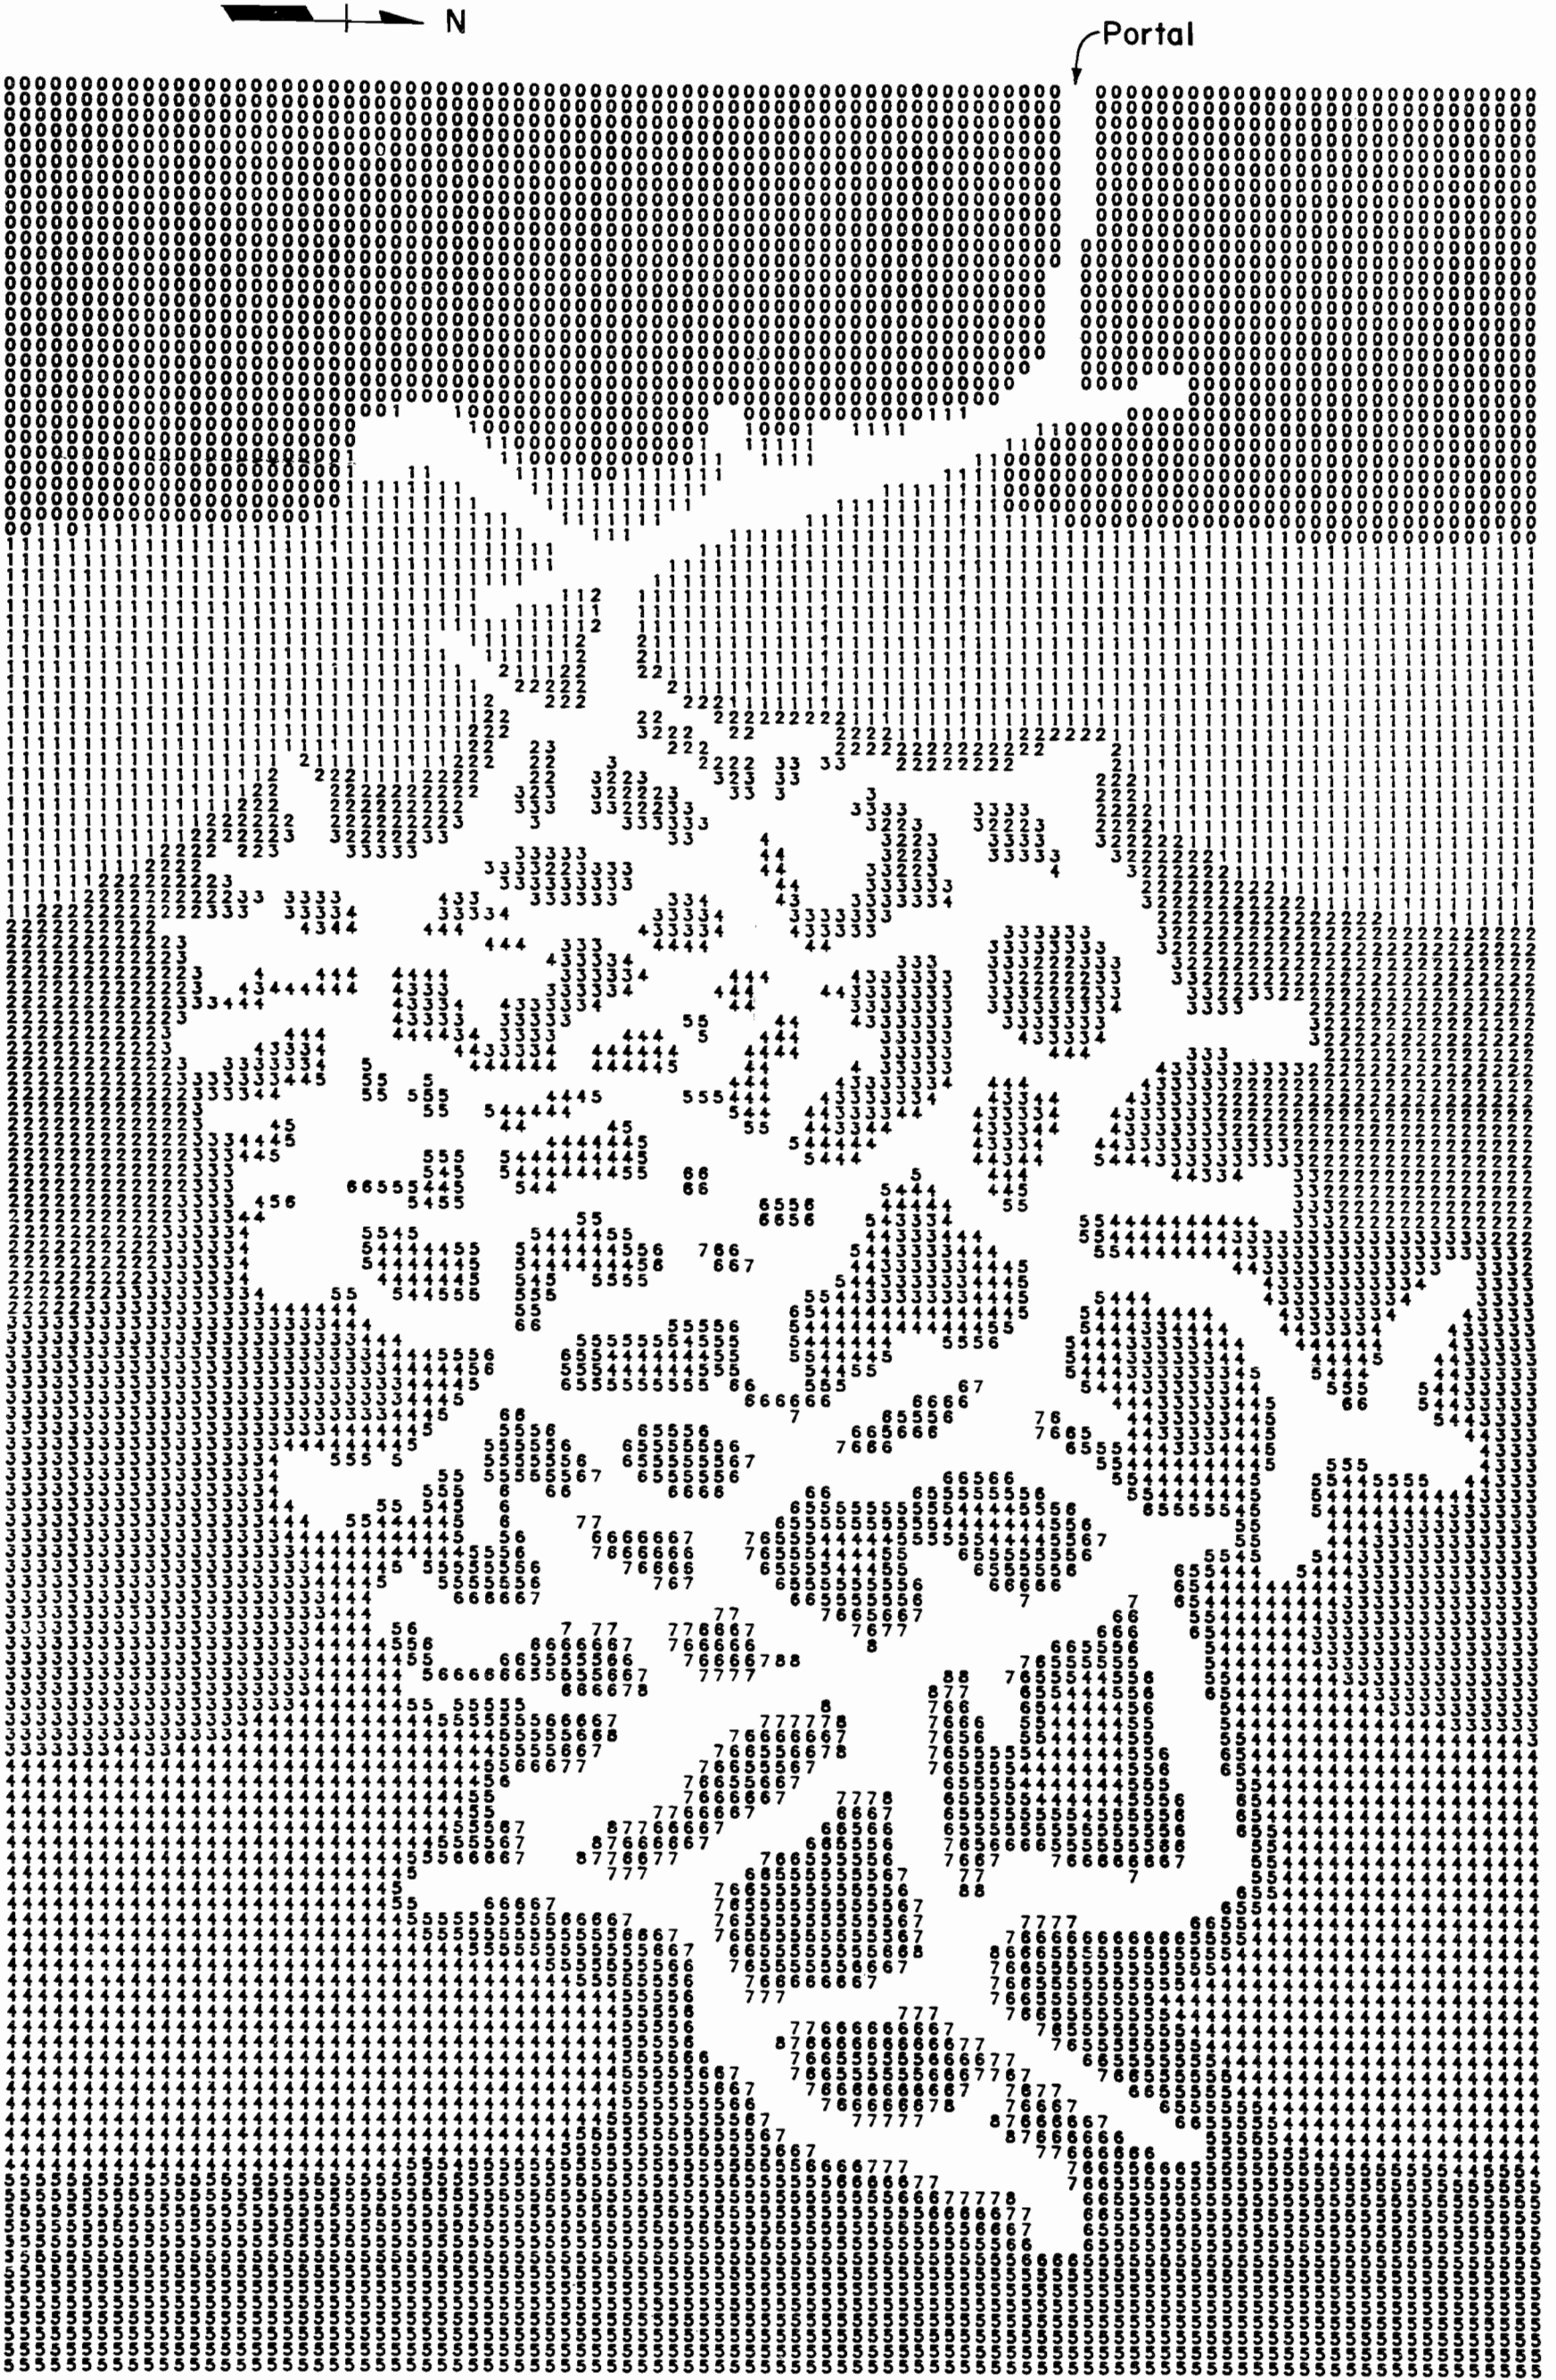
Total vertical stress, psi

The MULSIM/BM model of the mine was used to make stress calculations at two steps in the mine development. These two steps correspond with the beginning and end of the study period. The calculated stress results from the two steps are shown in figures 27 and 28, and the changes in stress between the two steps caused by mining of the indicated areas are shown in figure 29. These results clearly indicate the increasing stress with distance down dip. The highest stress indicated in the model is 2,500 psi, which is fairly close to the 2,600- to 3,200-psi laboratory strength of the talc ore. However, this peak

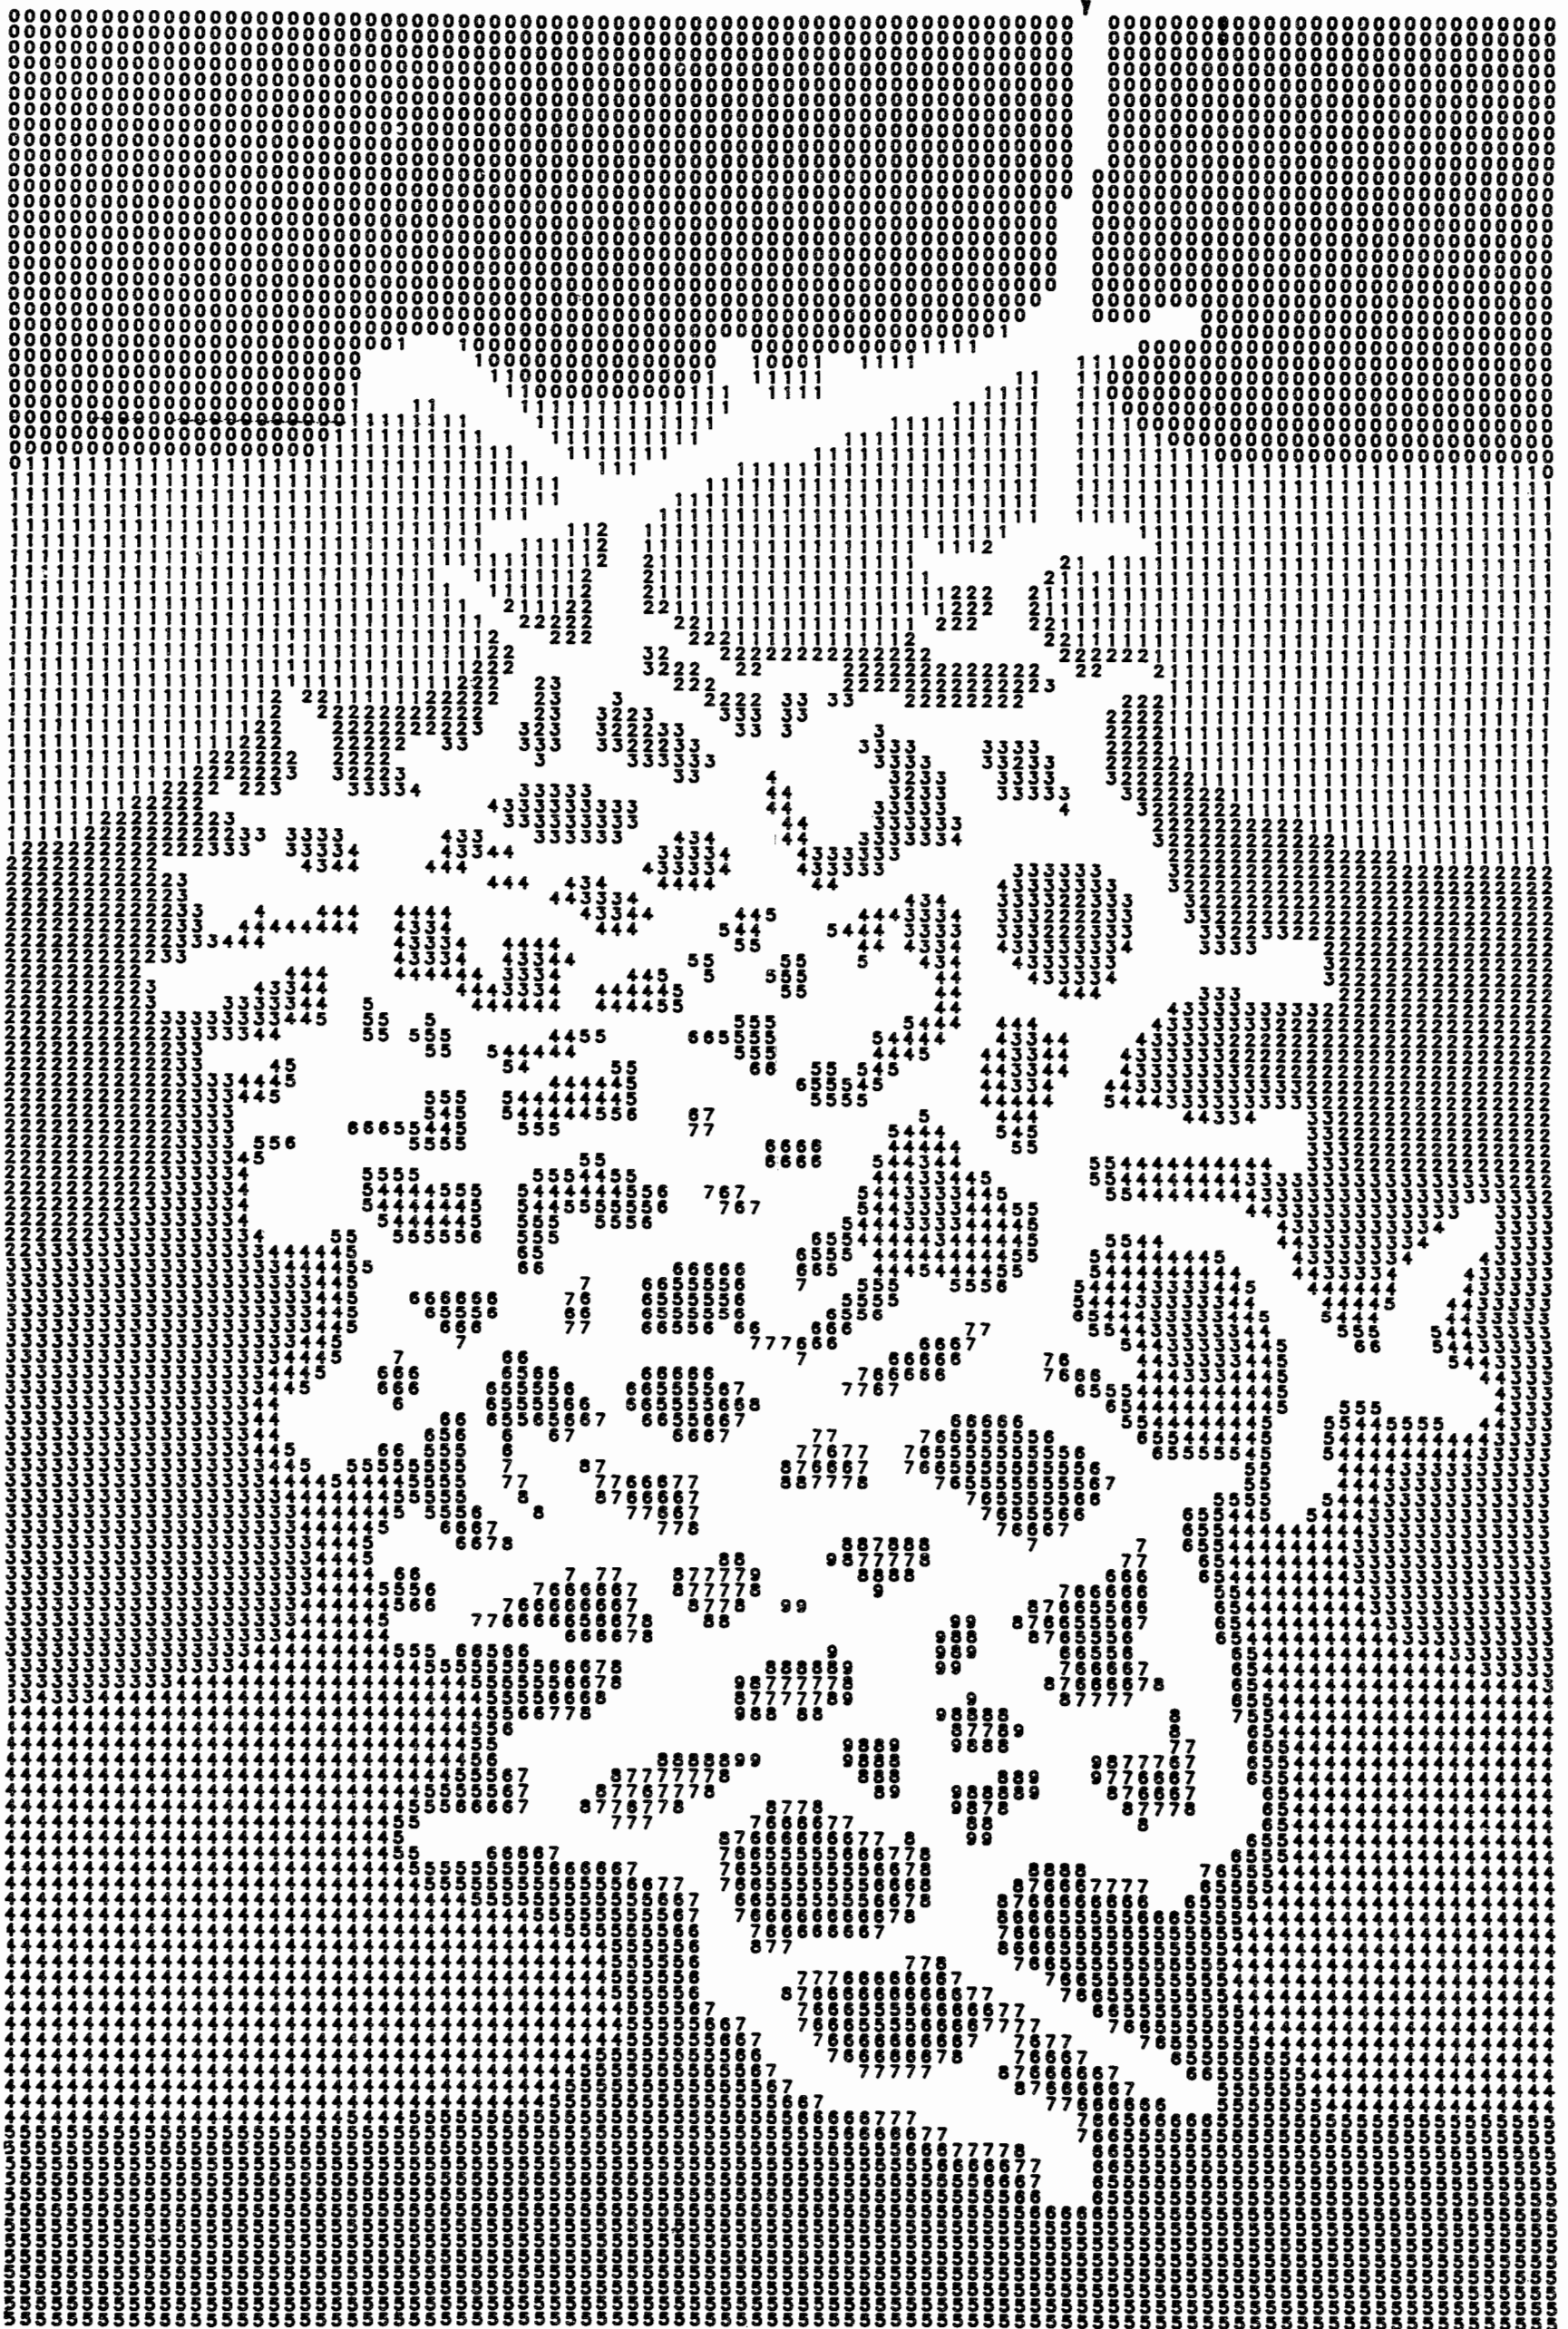
Figure 28.—Vertical stress at end of study period.

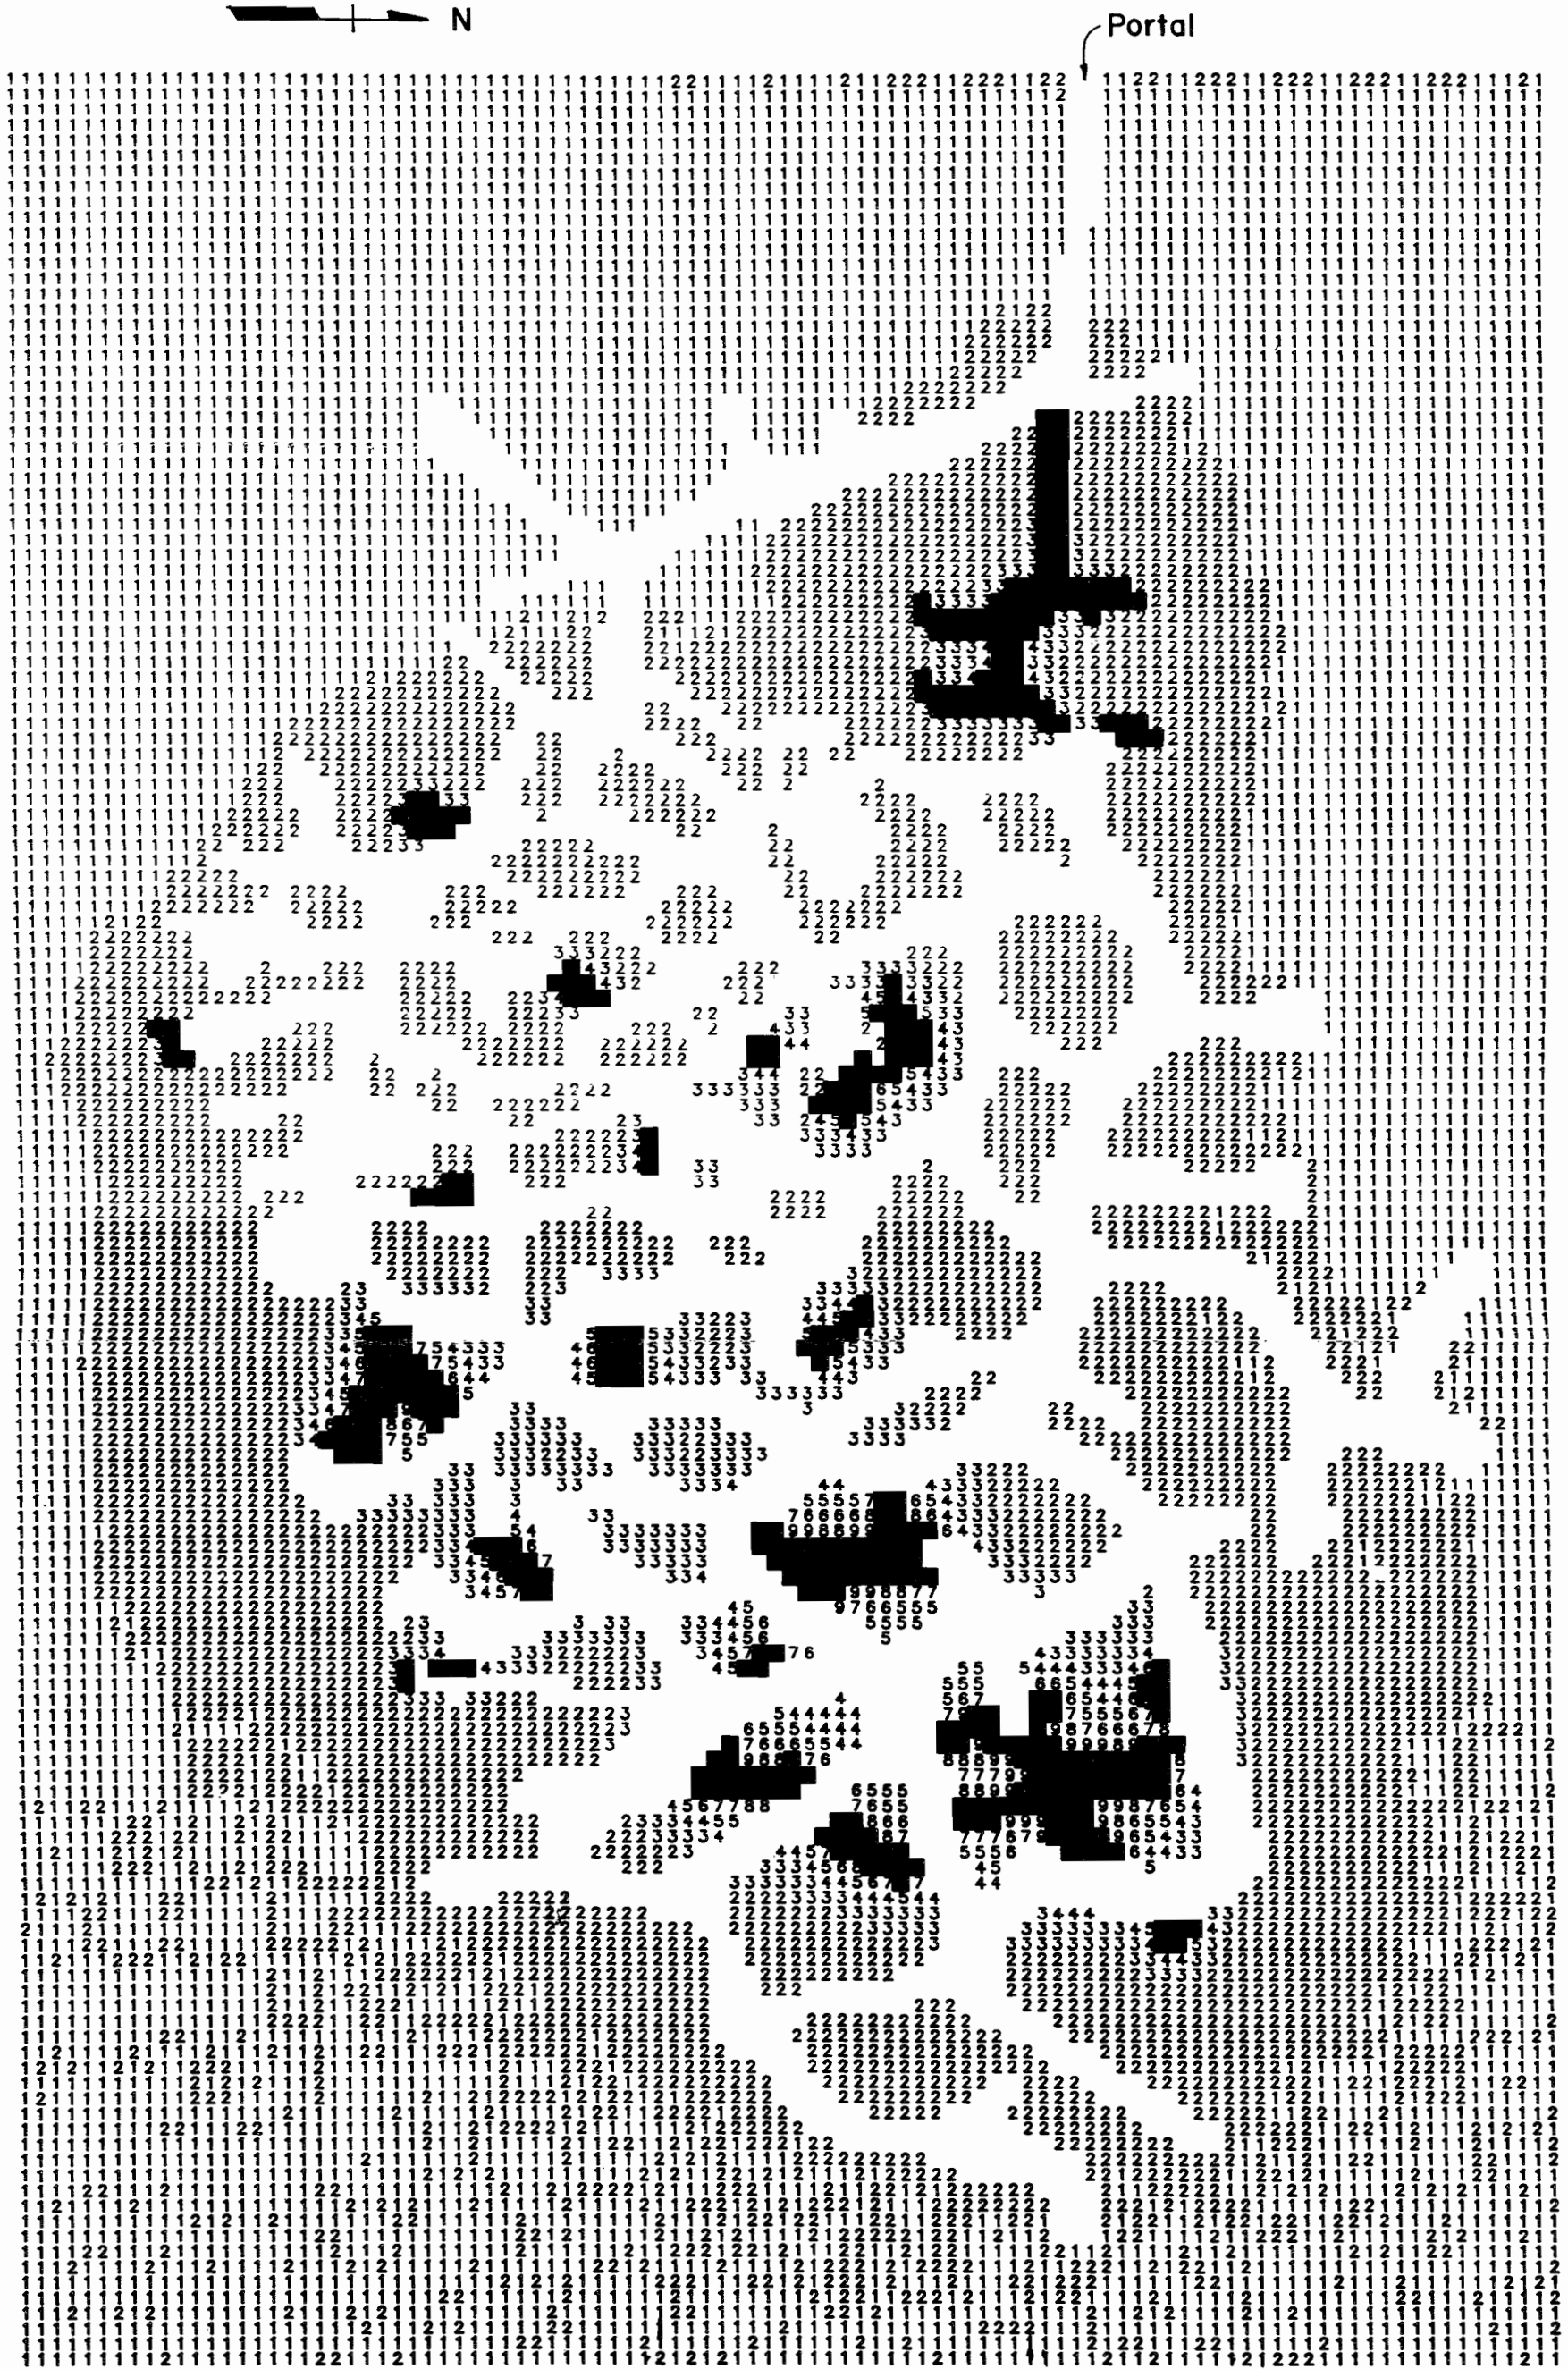
LEGEND
Stress change, psi

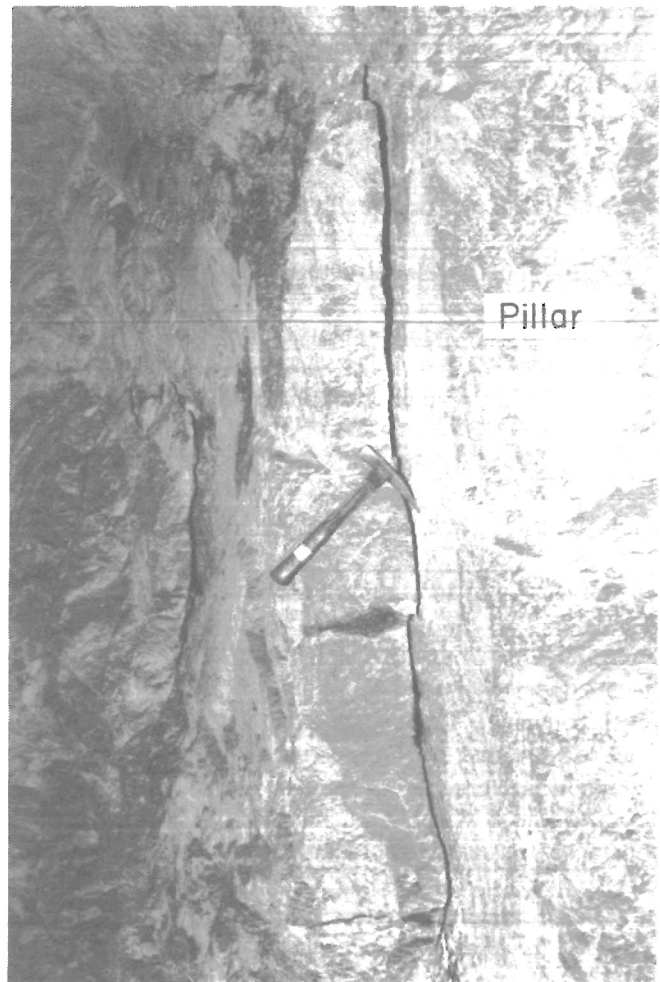
Figure 30.—Pillar sloughing fracture (hammer point) cutting across talc ore foliation.

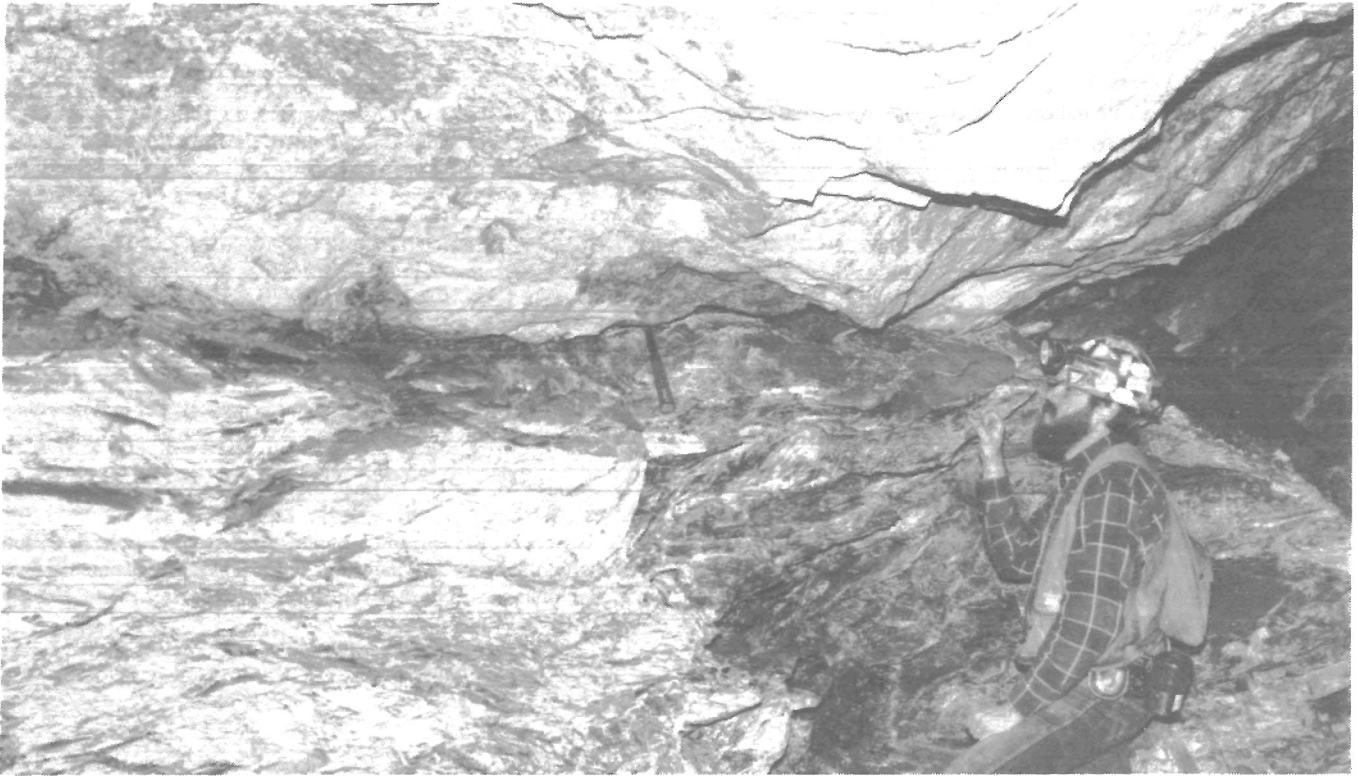
Figure 31.—Separation of pillar top from hanging wall (hammer at plane of separation).

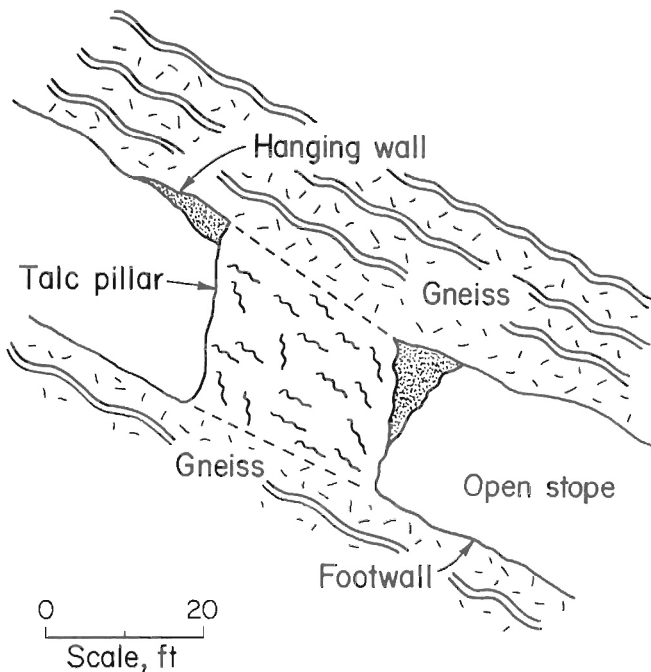
Figure 32.—Overhang of talc ore adjacent to pillar top.
