Bureau of Mines Report of Investigations/1983

A Ball-on-Block Impact-Spalling Wear Test and Results on Several Iron Alloys

By R. Blickensderfer and B. L. Forkner

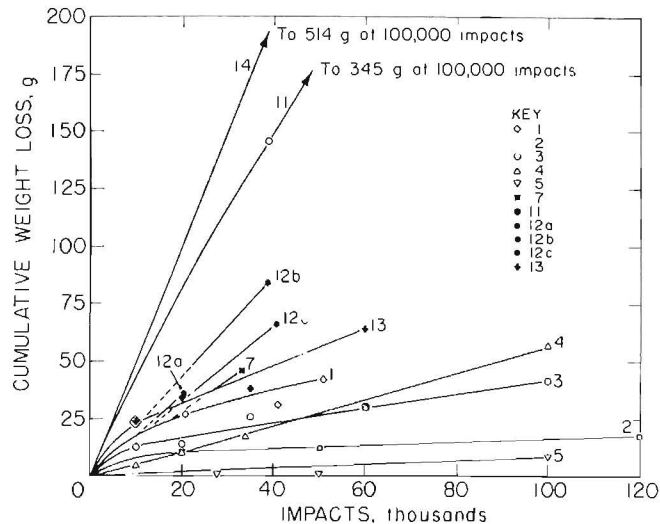
FIGURE 4. - Wear rates of test blocks.

maximum spalling. The rates at which blocks lost weight are shown by the slopes of the curves in figure 4. The rates of weight loss decreased for several alloys as the test progressed. For example, the high Cr-Mo white cast iron, (block 13), lost weight very slowly beyond 20,000 impacts.

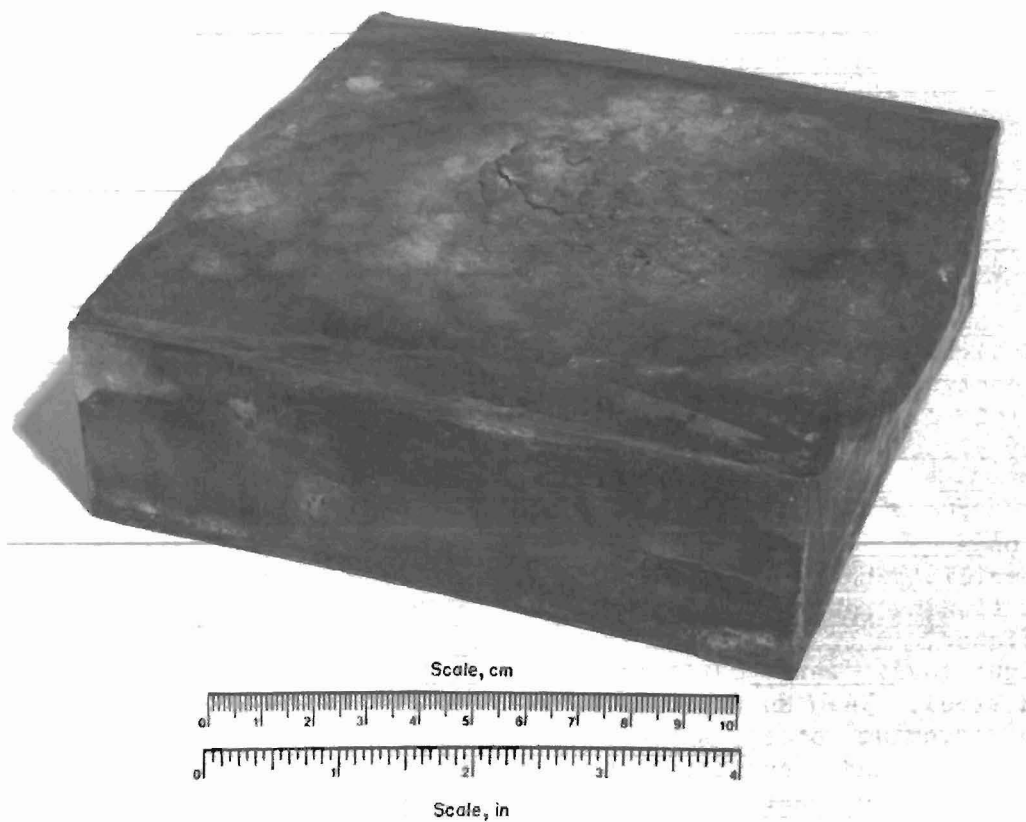
FIGURE 6. - Flaking of a test block. Mild steel (block 1) after 50,000 impacts.

Flaking occurred after repeated impacts on the surface of the test blocks that were no harder than HB 555 and did not spall or break. As the result of repeated plastic deformation of the surface regions, flakes formed and eventually separated from the surface. This flaking closely resembles the threshold mechanism of flake formation reported by Brown and Edington (6) for erosion caused by solid-particle impacts. Partially formed flakes in the mild-steel block are shown in figure 6. The dark lines in the region of impact are not cracks but shadows of flakes that are separating from the surface. Flakes were generally less than 0.1 in across and very thin. Examination of the flakes by electron microscopy revealed that the edges could be penetrated by electrons, which indicated a thickness on the order of 10^{-6} in.

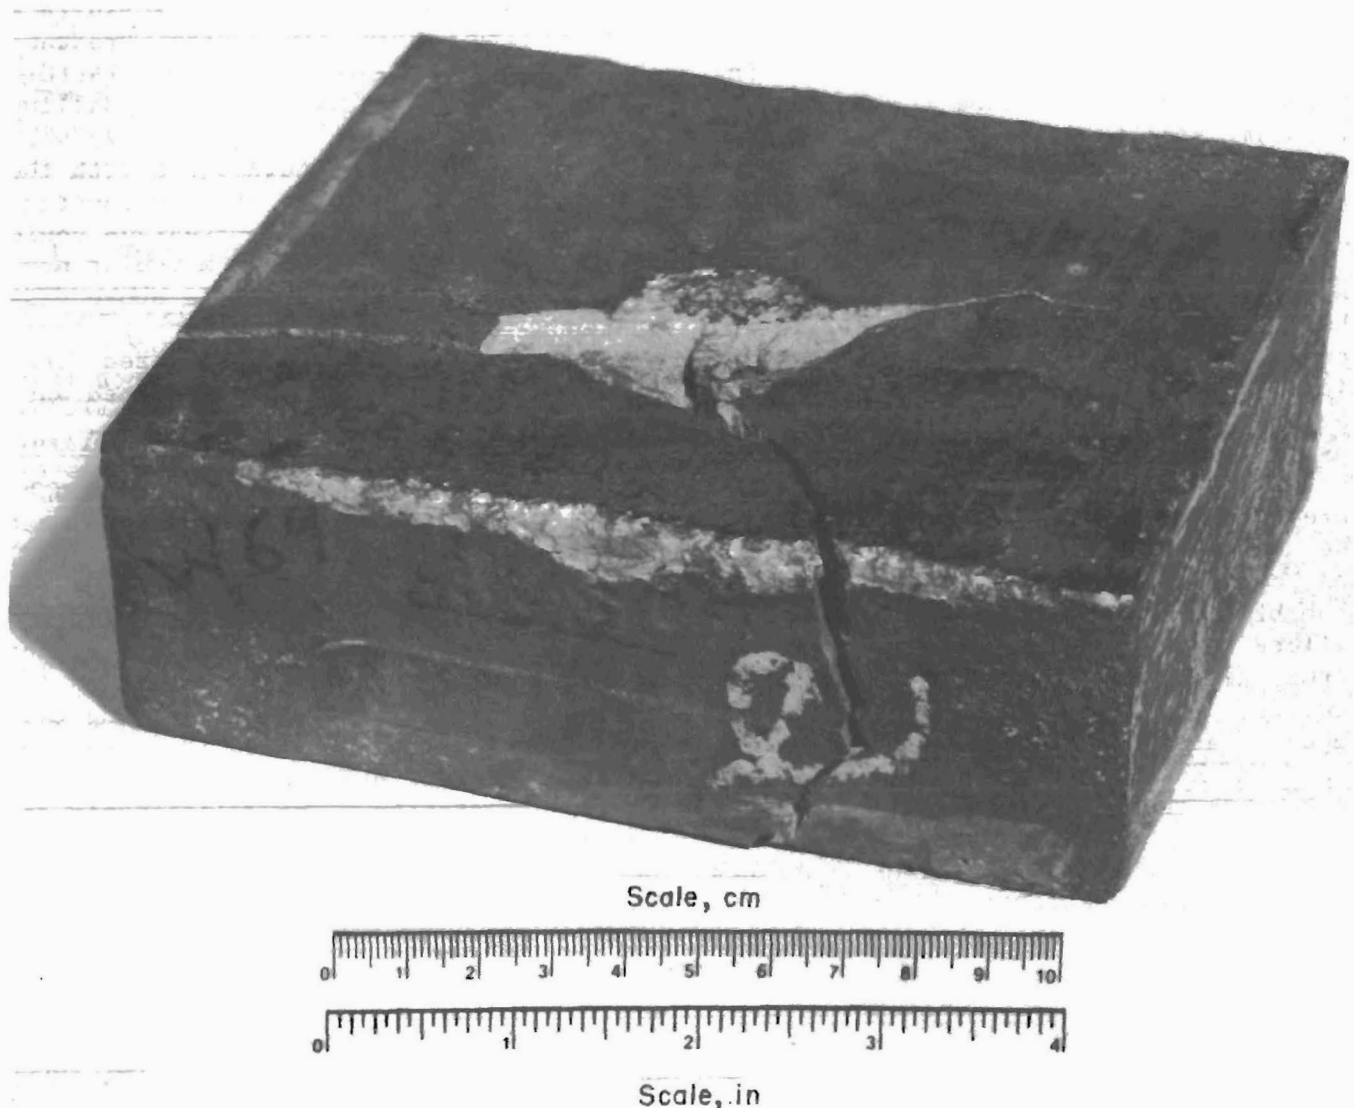
FIGURE 10. - Breakage of a test block. High Cr-Mo white cast iron (block 12c) after 40,300 impacts.

The three high Cr-Mo white iron blocks (12a, 12b, and 12c) developed small spalling craters before they broke. Figure 10 shows block 12c after failure at 40,300 impacts. Part of the spalling crater can be seen in the figure.

However, most of the crater was destroyed by chipping and fracturing that occurred after the block broke but before the ball dropping was stopped, which was typical for most of the blocks that broke. Block 13 almost survived the test but broke at 77,600 impacts.
