Bureau of Mines Report of Investigations/1987

Avoiding Anchorage Problems With Resin-Grouted Roof Bolts

By Howard C. Pettibone

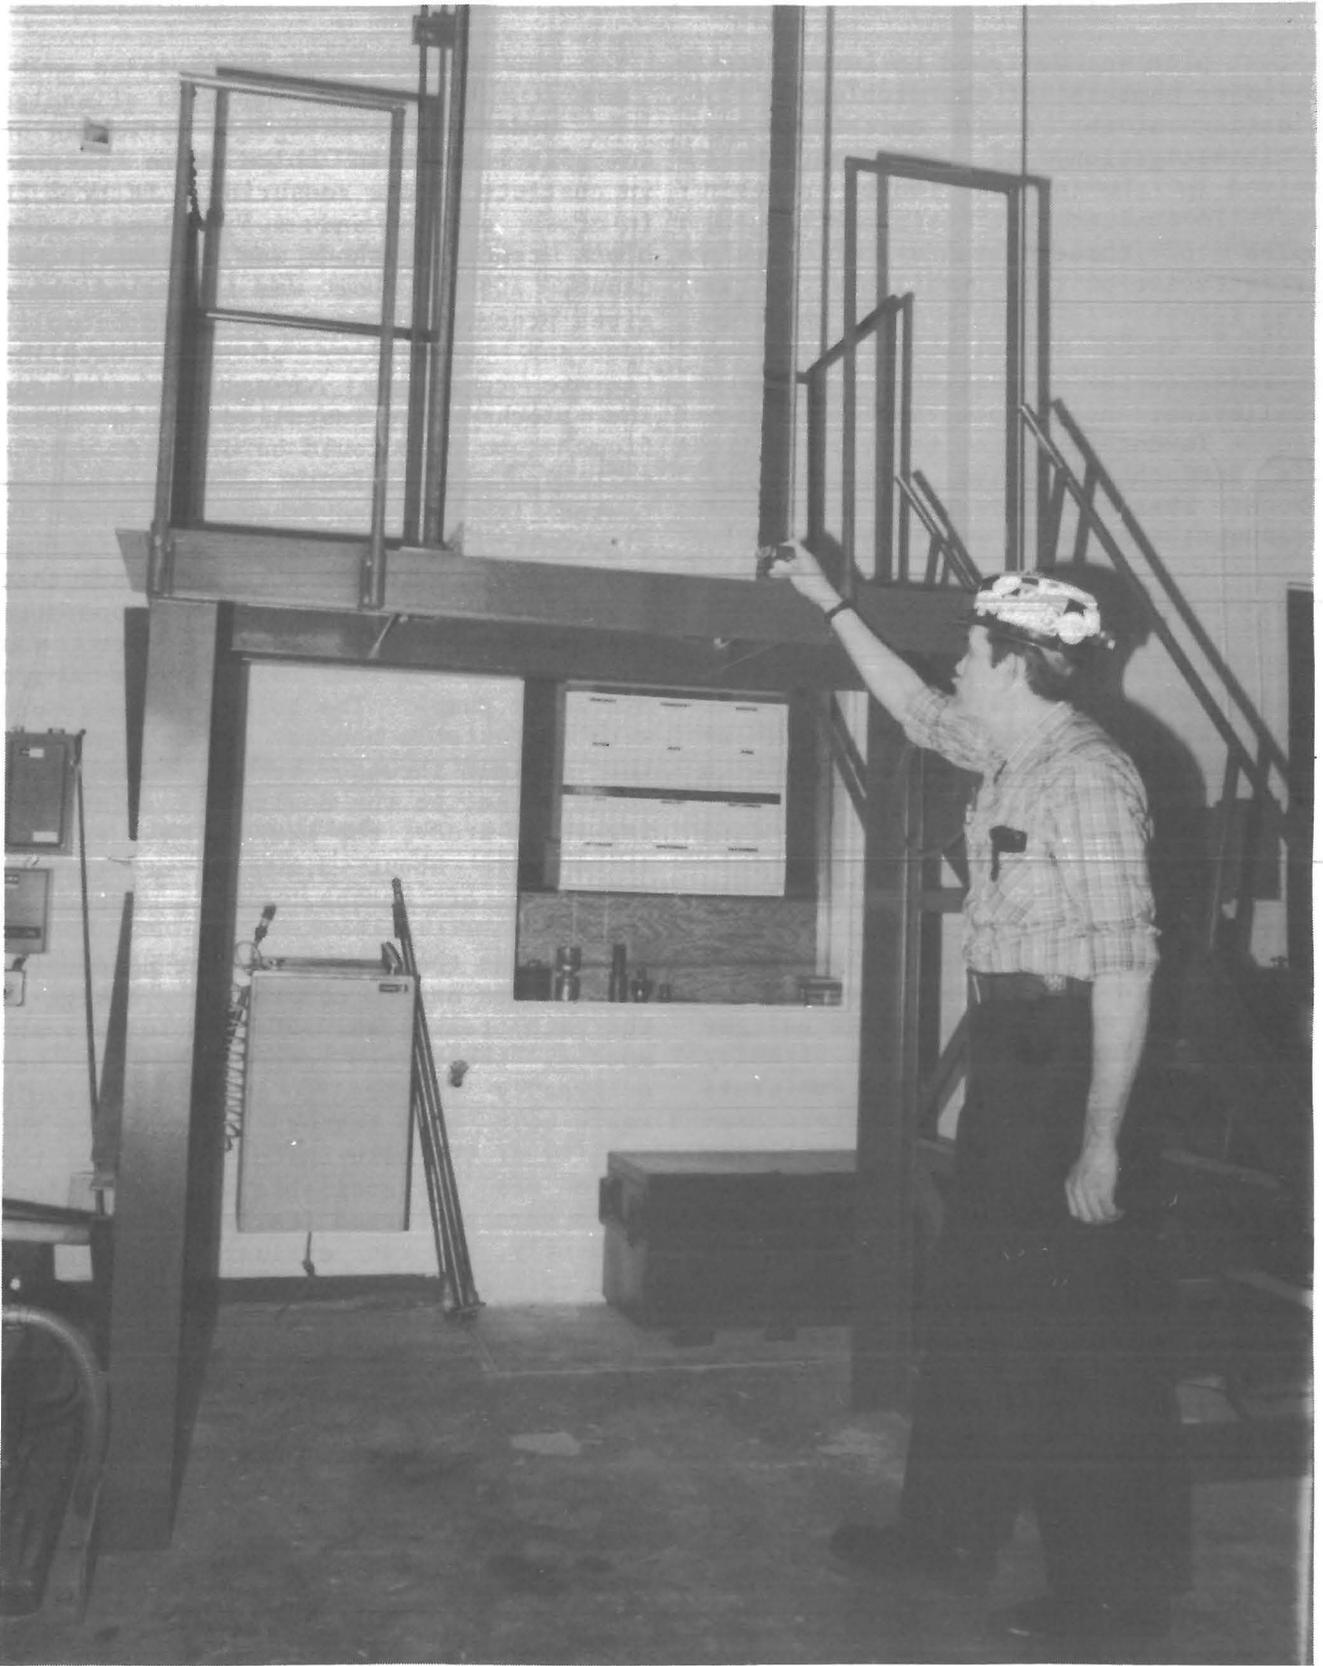
FIGURE 1.—Test frame.

In order to investigate variables of installation, resin bolts were inserted in concrete blocks measuring 2 ft by 2 ft in cross section and 4.5 ft long. The block testing method was selected because, after a bolt was installed by a given procedure, the block could be split open and the quality of the installed fixture could be visually examined. The blocks were installed on a steel frame where they could be drilled with a mast-type roof bolter. The bolts were tested in the same frame, as shown in figure 1. The roof bolter shown in figure 2 was mounted on a small frame that could be moved with a hand-operated hydraulic pallet lifter. Power was supplied to the roof bolter by a 10-gpm hydraulic pump. The bolter was equipped with adjustable needle valves, so that the maximum thrust, torque, and speed could be set to the desired levels. During this study, the maximum values measured were about 3,600 lb of thrust, 900 in-lb of torque, and a speed of 500 rpm.

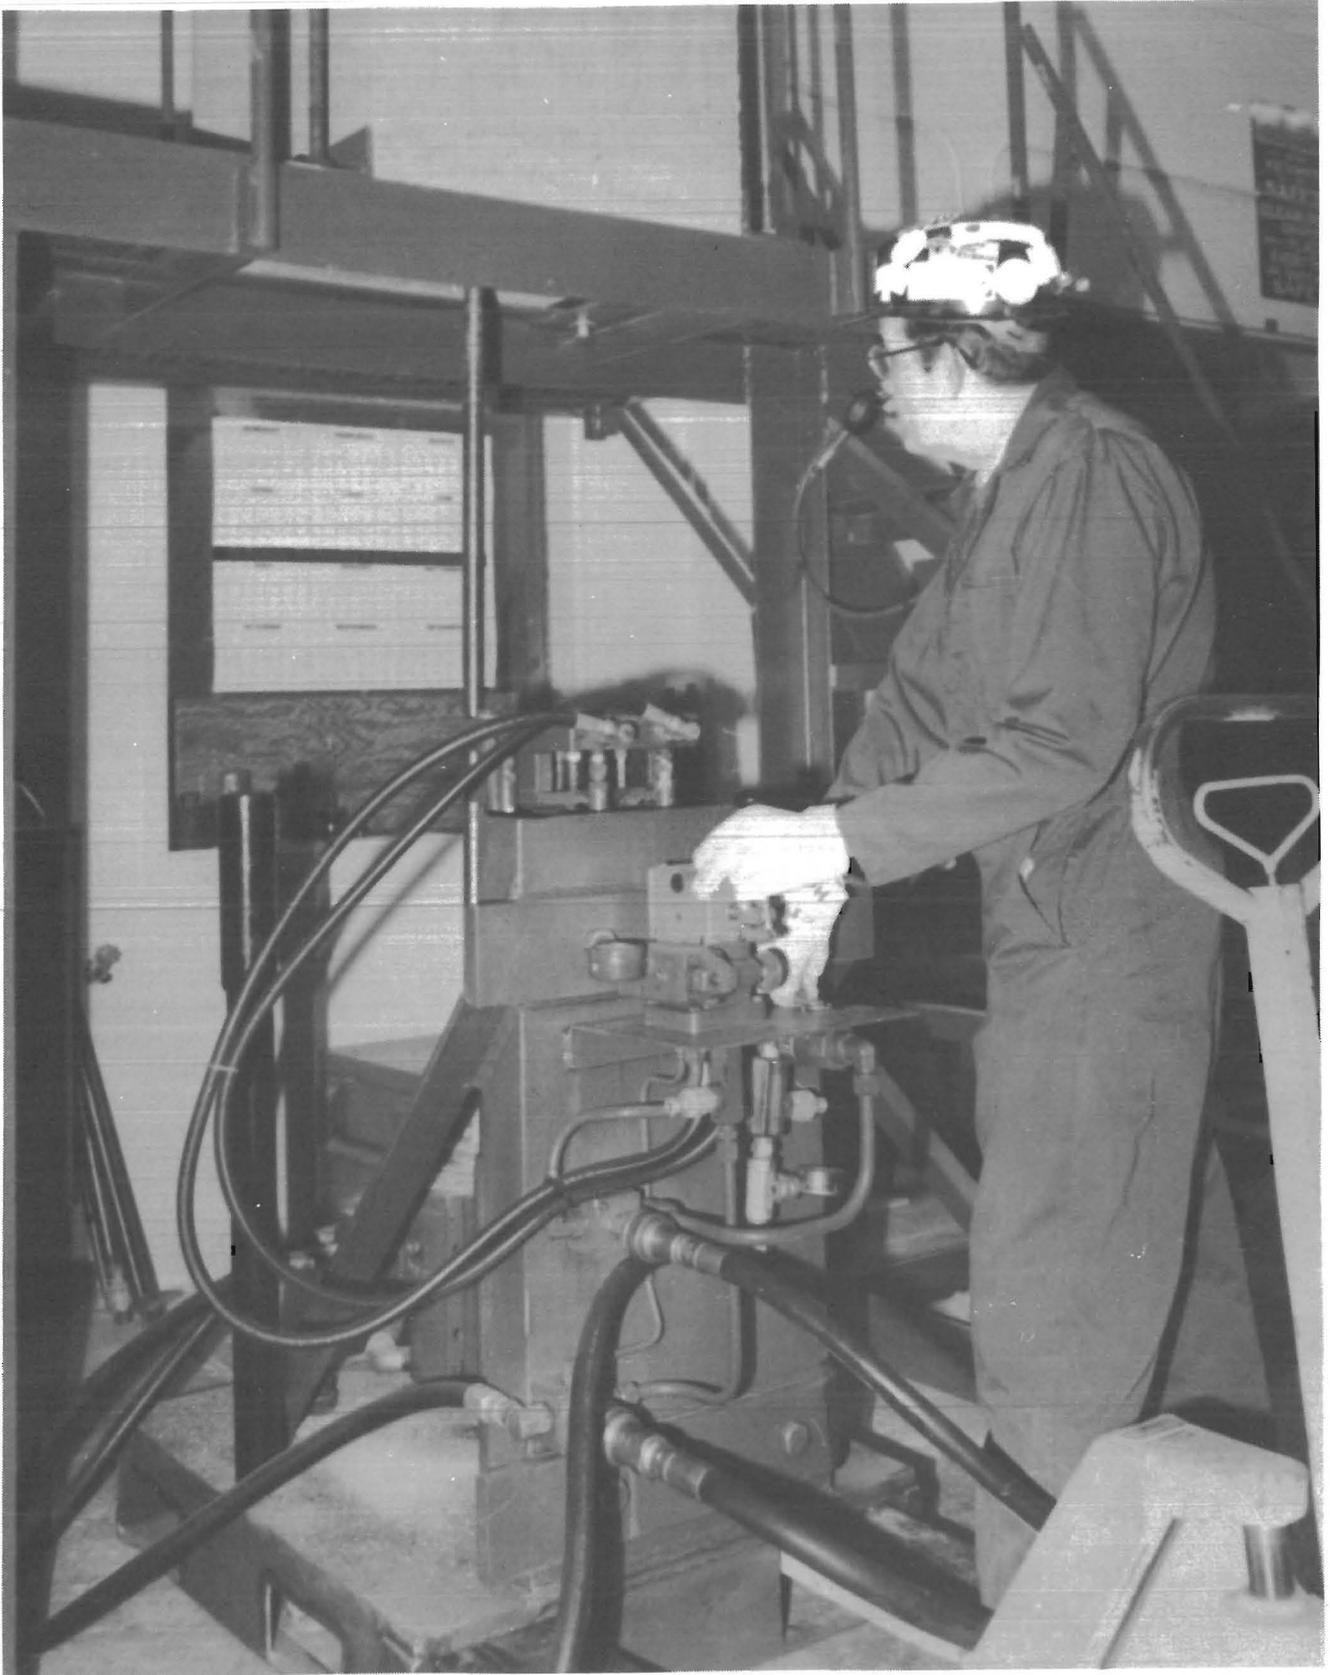
FIGURE 2.—Roof bolter.

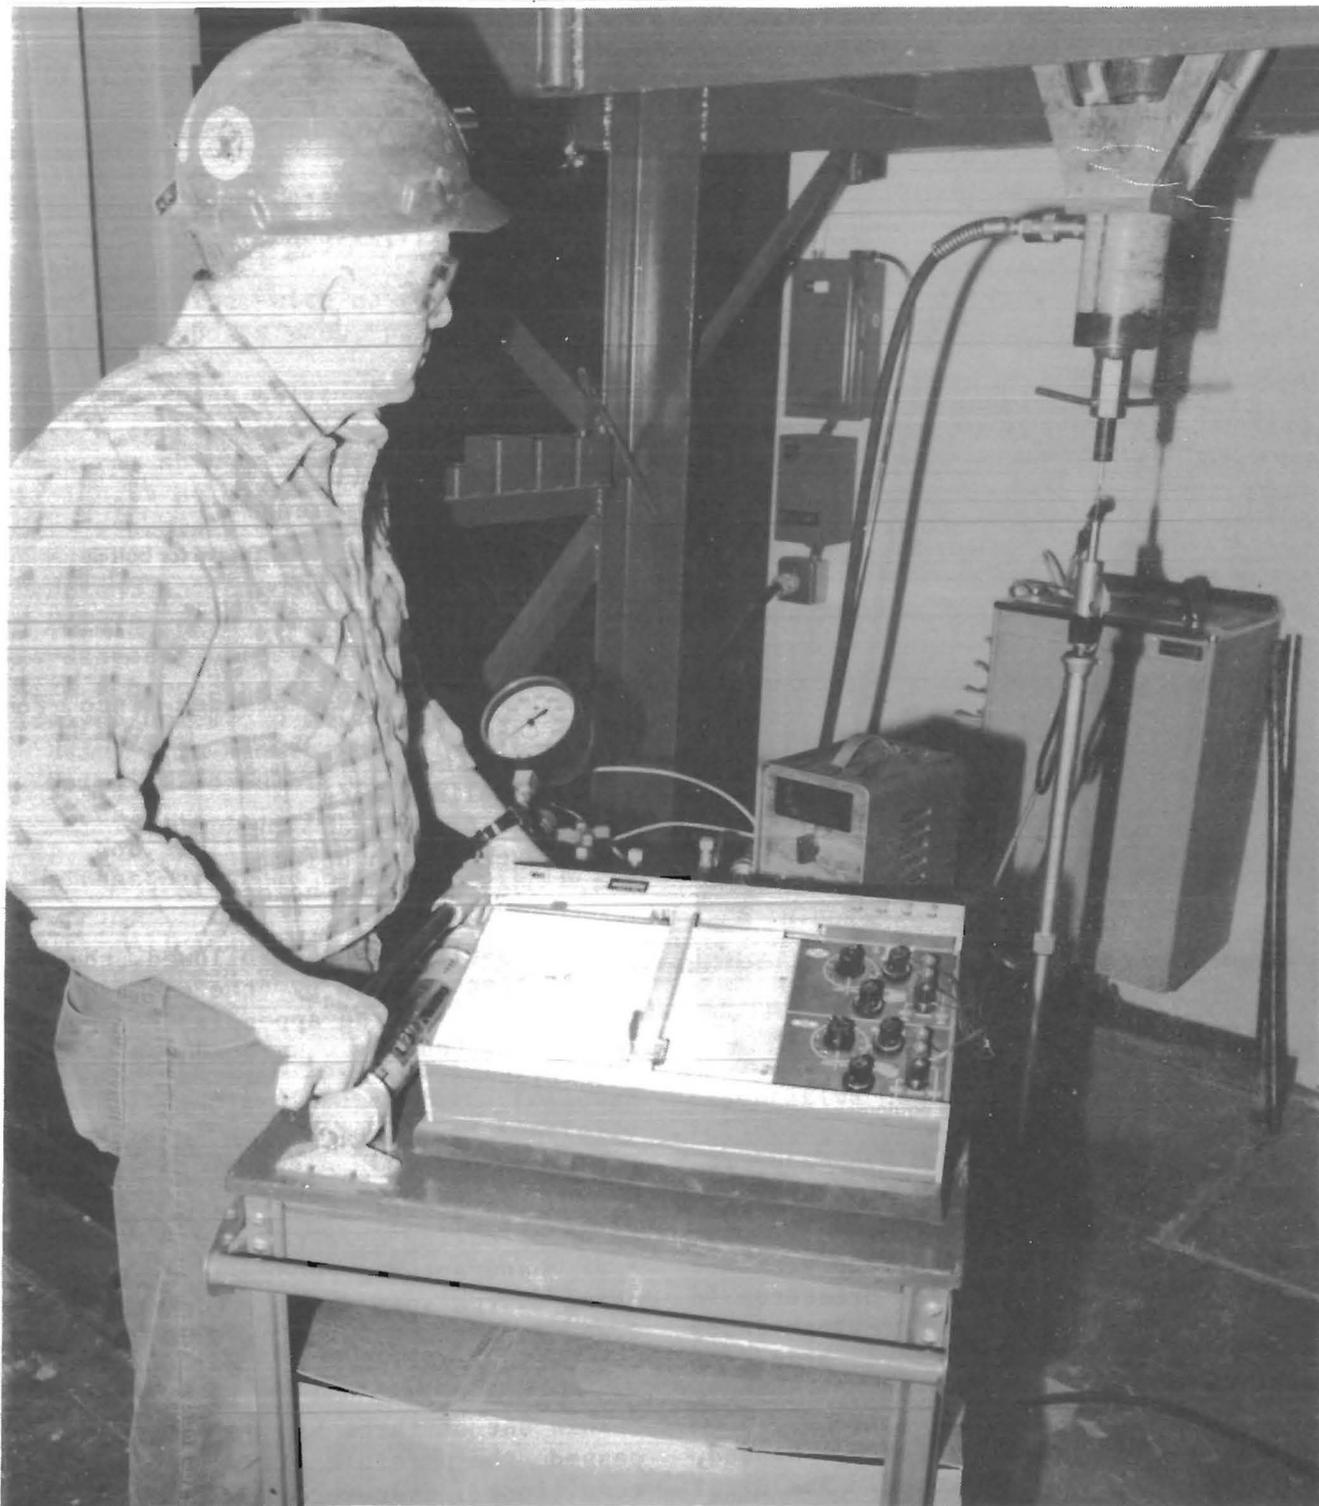
FIGURE 3.—Pull-test equipment.

Pull-tests were performed using the equipment shown in figure 3. The hydraulic center pull jack, pull rod, crows foot, and A-frame shown in figure 4 were installed on the pull collar about 5 min after the bolt had been installed. Each pull-test was begun 10 min after installation unless otherwise noted. Movement of the head of the bolt was measured with a linear-position transducer mounted on an adjustable photographic monopod. The hydraulic pressure was monitored with a pressure transducer. Signals from both transducers were fed to an X-Y plotter (fig. 3), which produced load deflection curves for each bolt tested. A sample curve with calculations of the yield load, P_y , and the stiffness, K , is given in figure 5. First, the pen was adjusted to zero on both axes, then load was applied with the hand pump until failure occurred or until the limit of the equipment was reached.

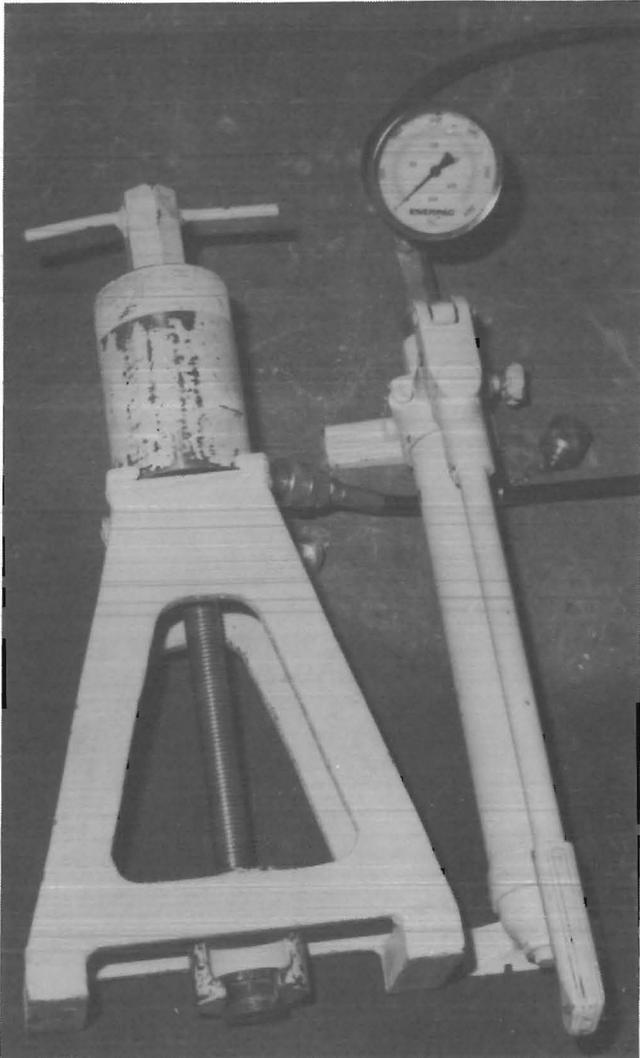
FIGURE 4.—Hydraulic pulling equipment.

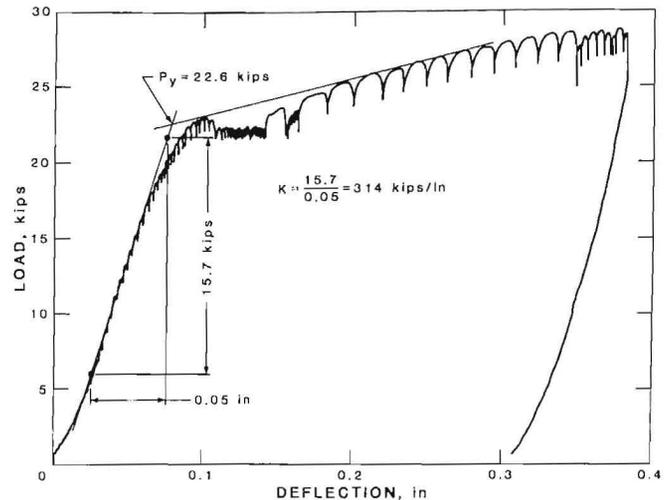
FIGURE 5.—Load-deflection curve for bolt 59.

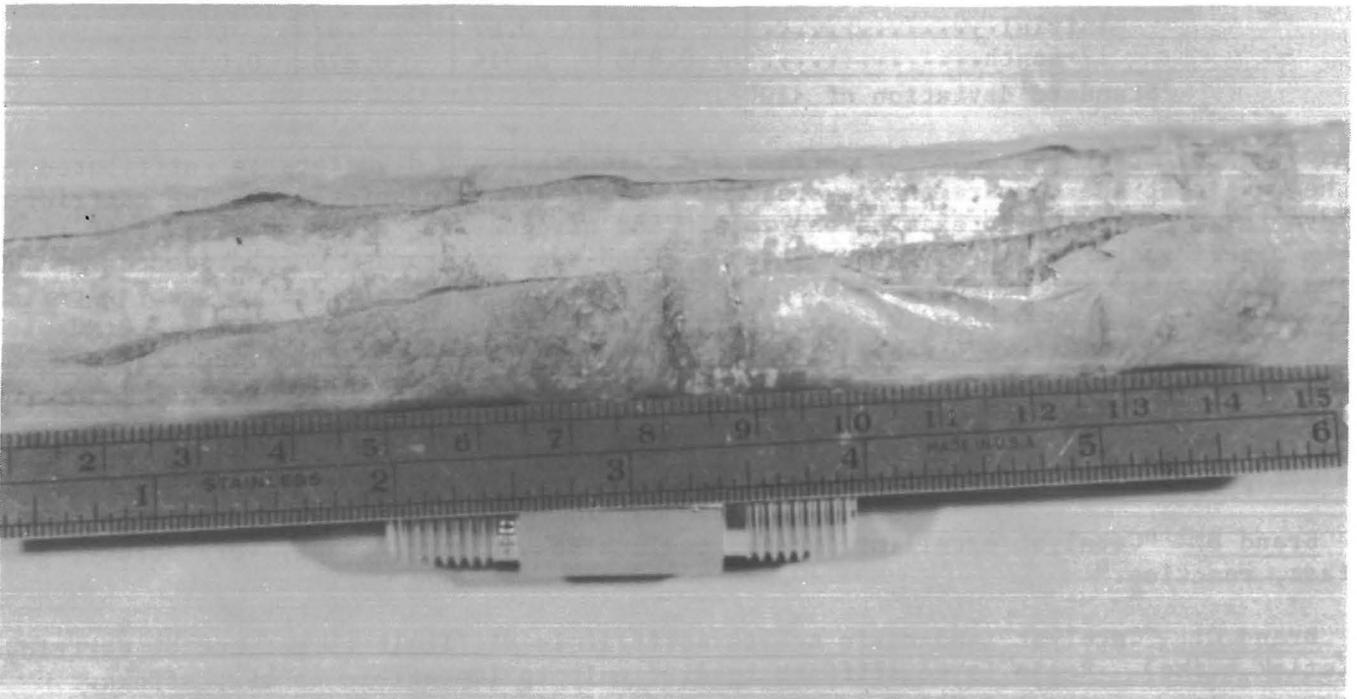
FIGURE 6.—Full glove-fingering on bolt 73.

As stated earlier, glove-fingering means that the plastic wrapper was observed on the outside of the hardened resin when the resin-grouted bolt was removed from the concrete block. As shown in figure 6, the plastic wrapper almost completely encircled the full circumference of the resin-rock interface.

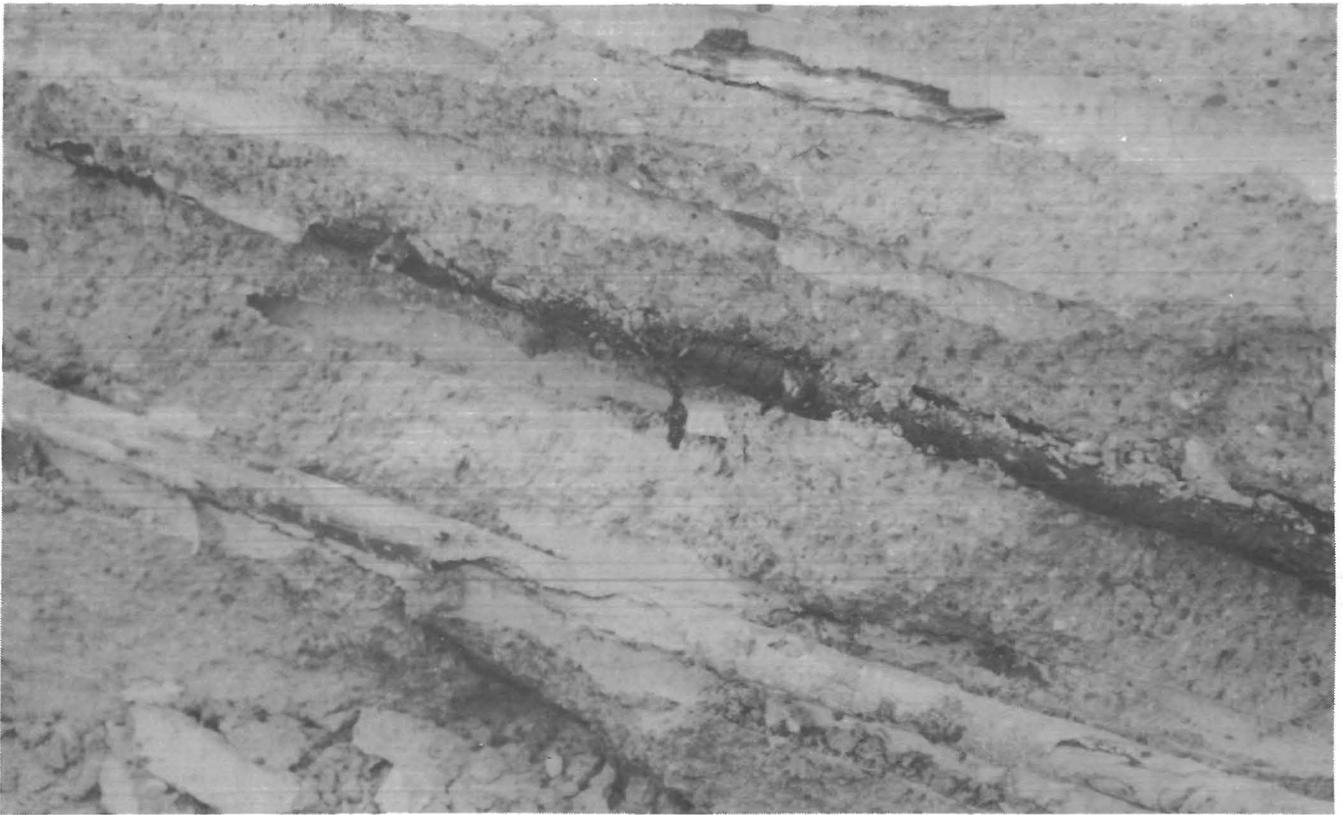
FIGURE 7.—Bolt 1 (top) and bolt 2 (bottom) in split-open block.

The results of the five overspin tests are also given in table 4. Bolt 2 was the first overspin attempted, and the laboratory roof bolter stalled at 20 s. This produced an excellent bolt: The visual inspection showed good, well-cured resin, and the pull-test indicated the same. The length of the bolt was reduced

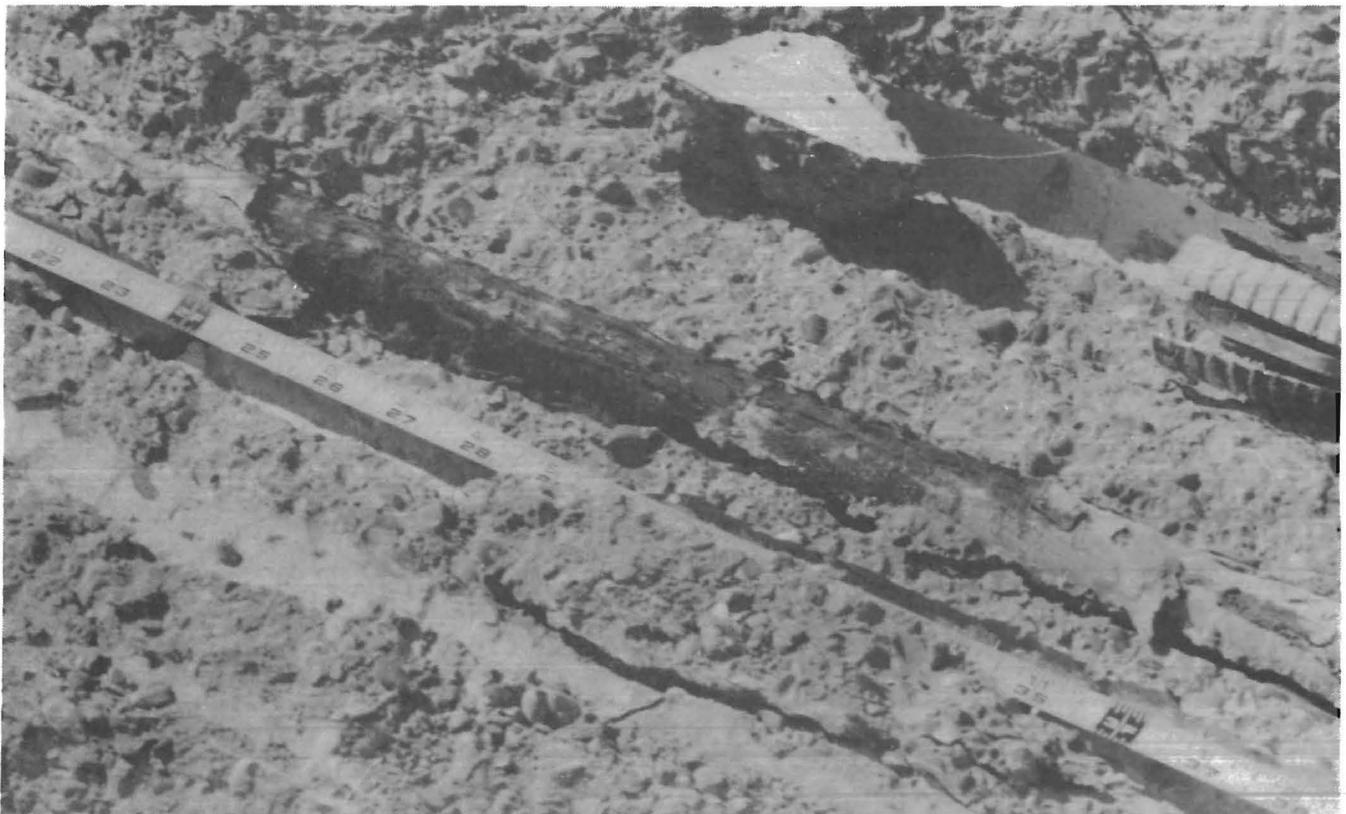
FIGURE 8.—Soft, sticky uncured resin on bolt 5 at 24 to 33 in from top end of bolt.

glove-fingering. The results of the pull load and stiffness tests were in the normal range of a good bolt. This dramatically illustrates the fact that a bolt can be poorly installed, with only the top 20 in out of 47 in having any ability to support load, and yet a pull-test can indicate that it is an excellent bolt. Figure 8 shows an area of bolt 5 (between 24 and 33 in from the top end) where the resin is very soft, sticky, and uncured. Examination of the data on bolt 5 (table 4) also shows that it had poor results in pull load and stiffness tests and that it failed.

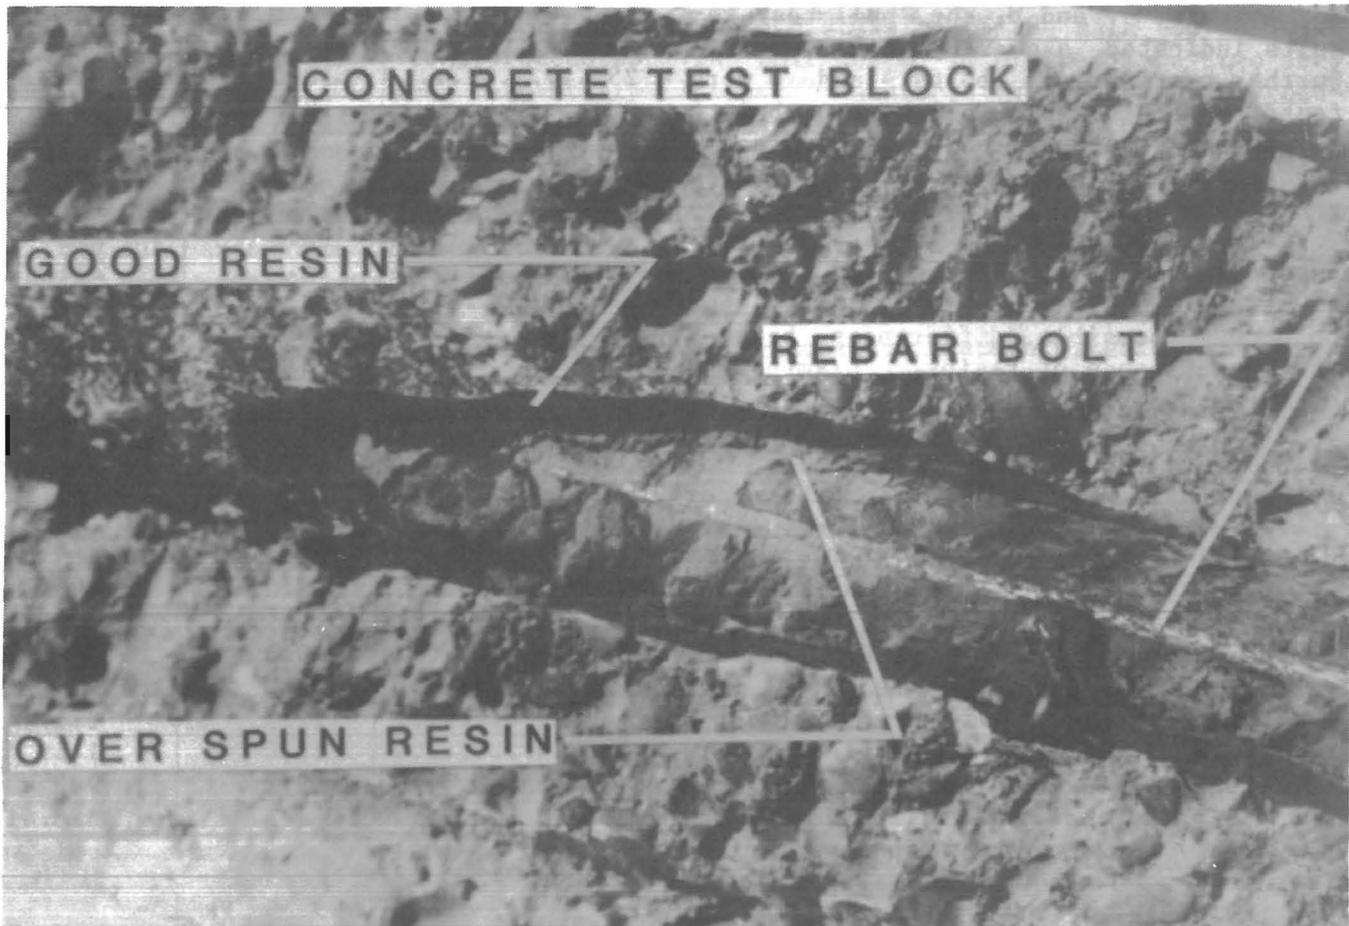
FIGURE 9.—Destroyed resin at bolt resin interface on bolt 3.

to 2 ft for bolt 3, and it was possible to overspin it for a total of 55 s. A light-gray powder thought at first to be concrete, but found later to be granulated resin destroyed by the overspinning, sifted out of the collar of the hole. The load of 4.7 kips and a stiffness of 78 kips/in indicated that the bolt failed. The results of the block split are graphically illustrated in figure 9. Note that the zone of light-gray resin marked on figure 9 is approximately the depth of the deformations on the bar. This zone of resin at the bolt-resin interface was converted to a light-gray powder by excessive spinning, but the surrounding annulus of resin at the concrete-resin interface was a firm, dark gray, excellent quality resin. Bolt 6 was spun a total of 41 s, and both the pull-test and the visual examination indicated that the bolt had failed. This bolt was actually removed from the block

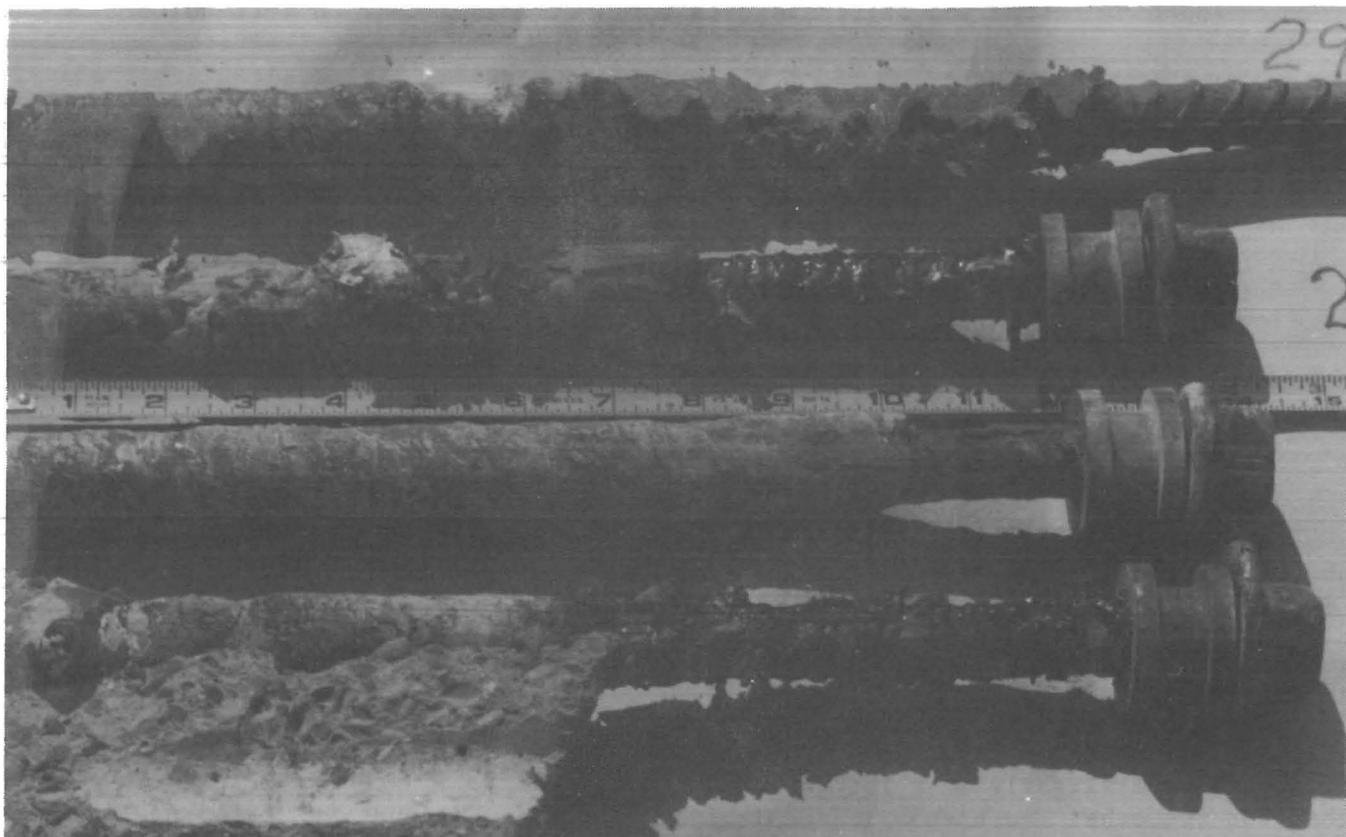
FIGURE 10.—Bolts 26 through 29 after removal from block.

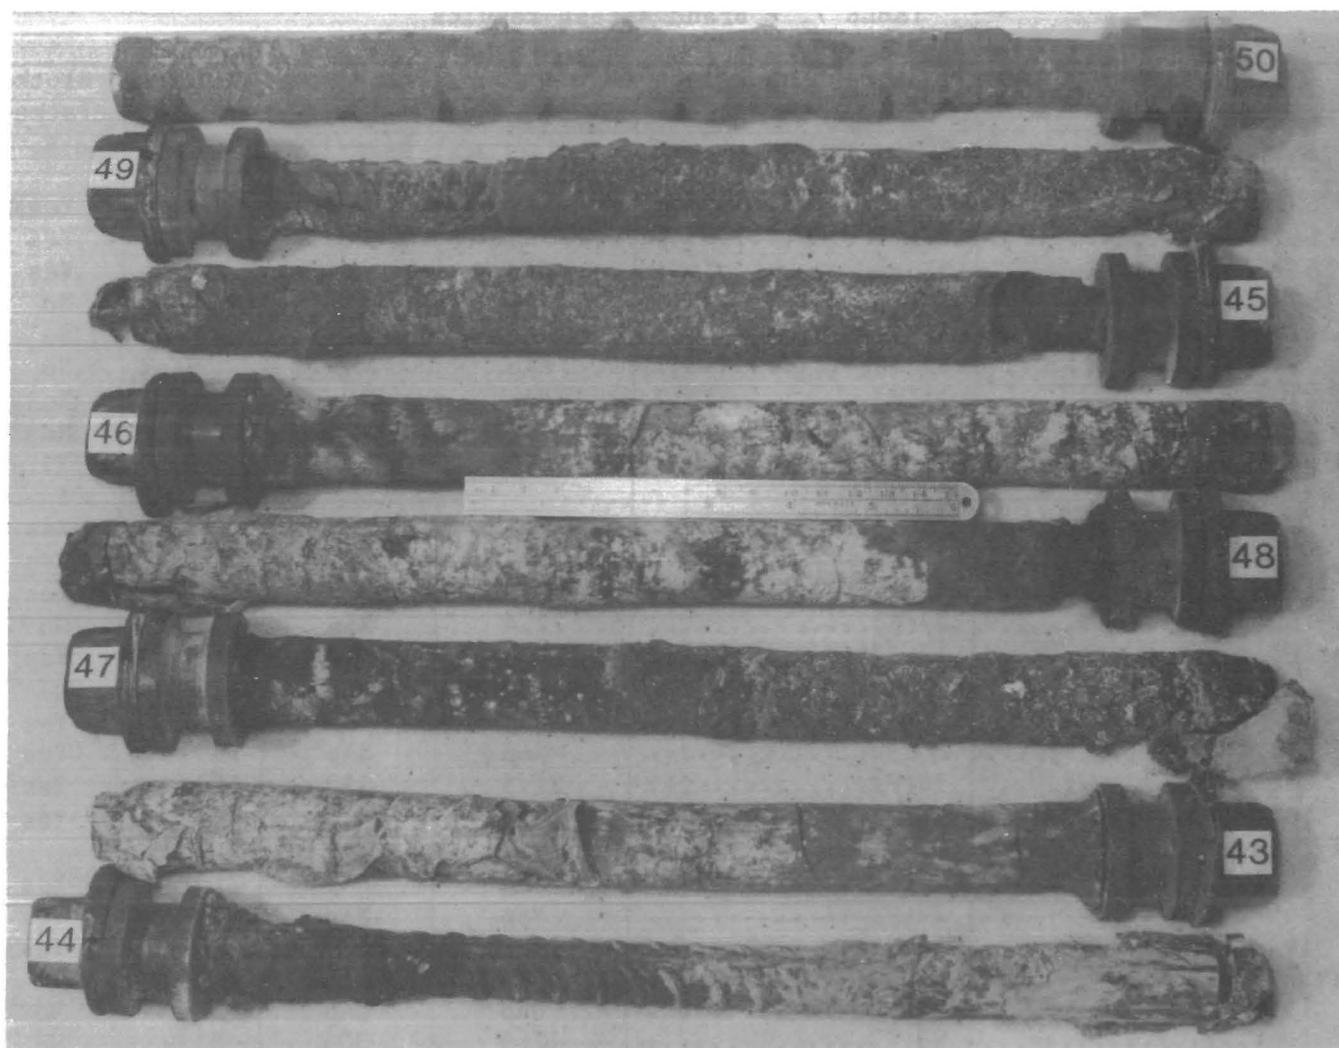
FIGURE 11.—Bolts 43 through 50 after removal from block.
