REPORT OF INVESTIGATIONS/1989

Basic Parameters of Conveyor Belt Cleaning

By C. A. Rhoades, T. L. Hebble, and S. G. Grannes

BUREAU OF MINES

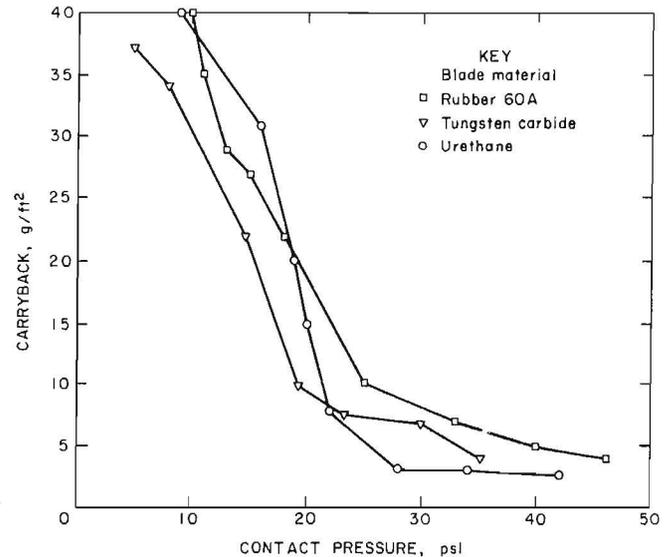
Figure 1.—Carryback material versus blade-to-belt contact pressure curves (Wyle Laboratories contract).

In a series of tests, contact pressure was varied and carryback that passed by the scraper blade was measured. The results indicated a functional relationship between belt carryback material and blade contact pressures. Figure 1 shows that carryback material linearly decreased to a limiting value as contact pressure between the belt and various scraper blades increased. The research identified the phenomenon of a "critical pressure" beyond which cleaning is not improved (2).

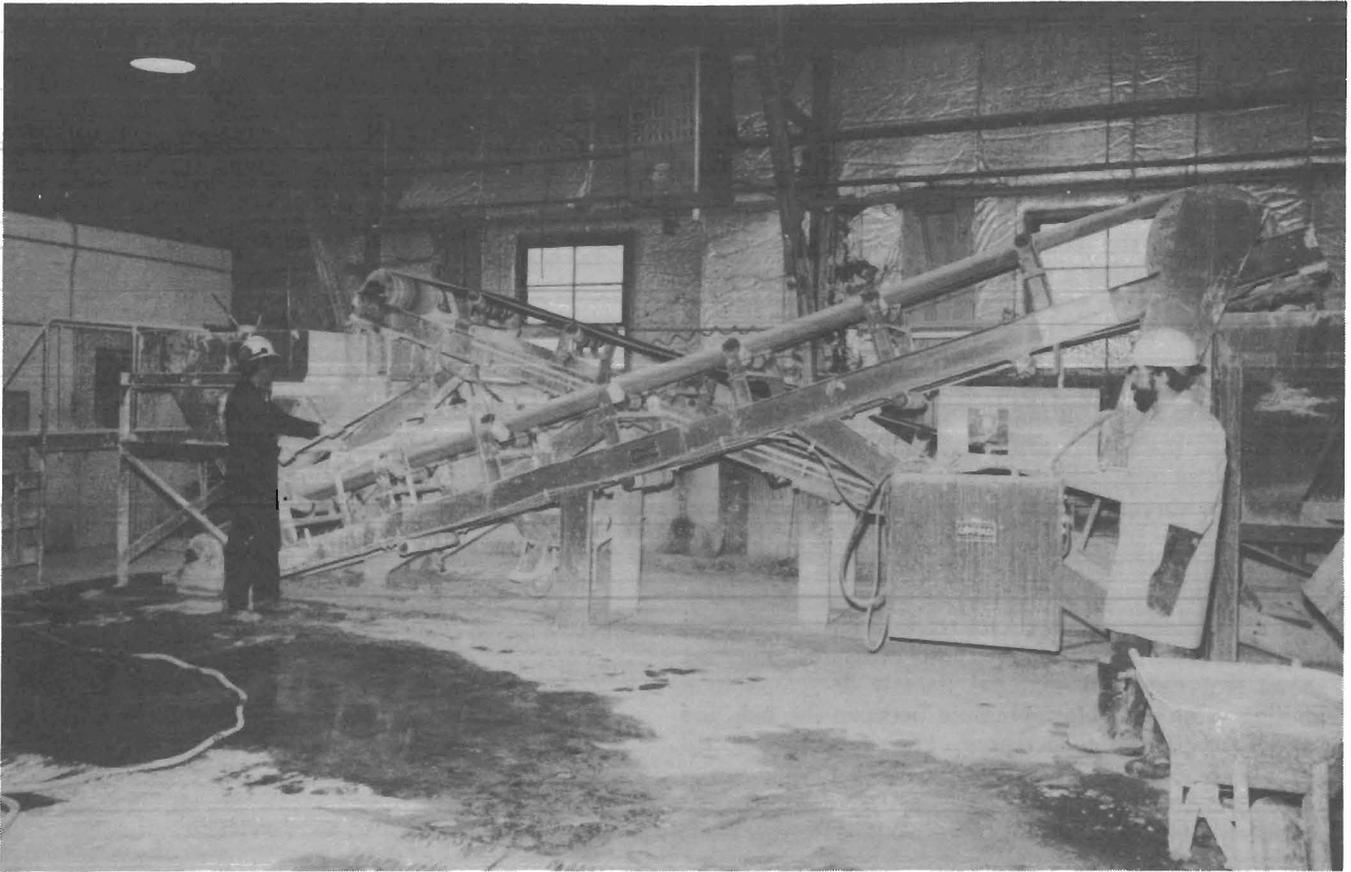
Figure 2.—Bureau test conveyors.

A full-size conveyor test facility was constructed, consisting of two 30-ft-long troughed conveyors with 24-in-wide belts. The two conveyors were mounted side by side and inclined in opposite directions to facilitate the recycling of material (fig. 2). Only one of the two conveyors was used for the belt cleaning research; the other conveyor

was used for recycling material. The discharge end of the test conveyor was fitted with a 24-in-diam pulley to closely represent the size commonly used by industry for large-scale haulage systems. The test conveyor was fitted with a bracket to which the experimental belt cleaning system was attached. The recycling conveyor was fitted with a large storage hopper at its discharge end, to provide constant material flow to the test conveyor.

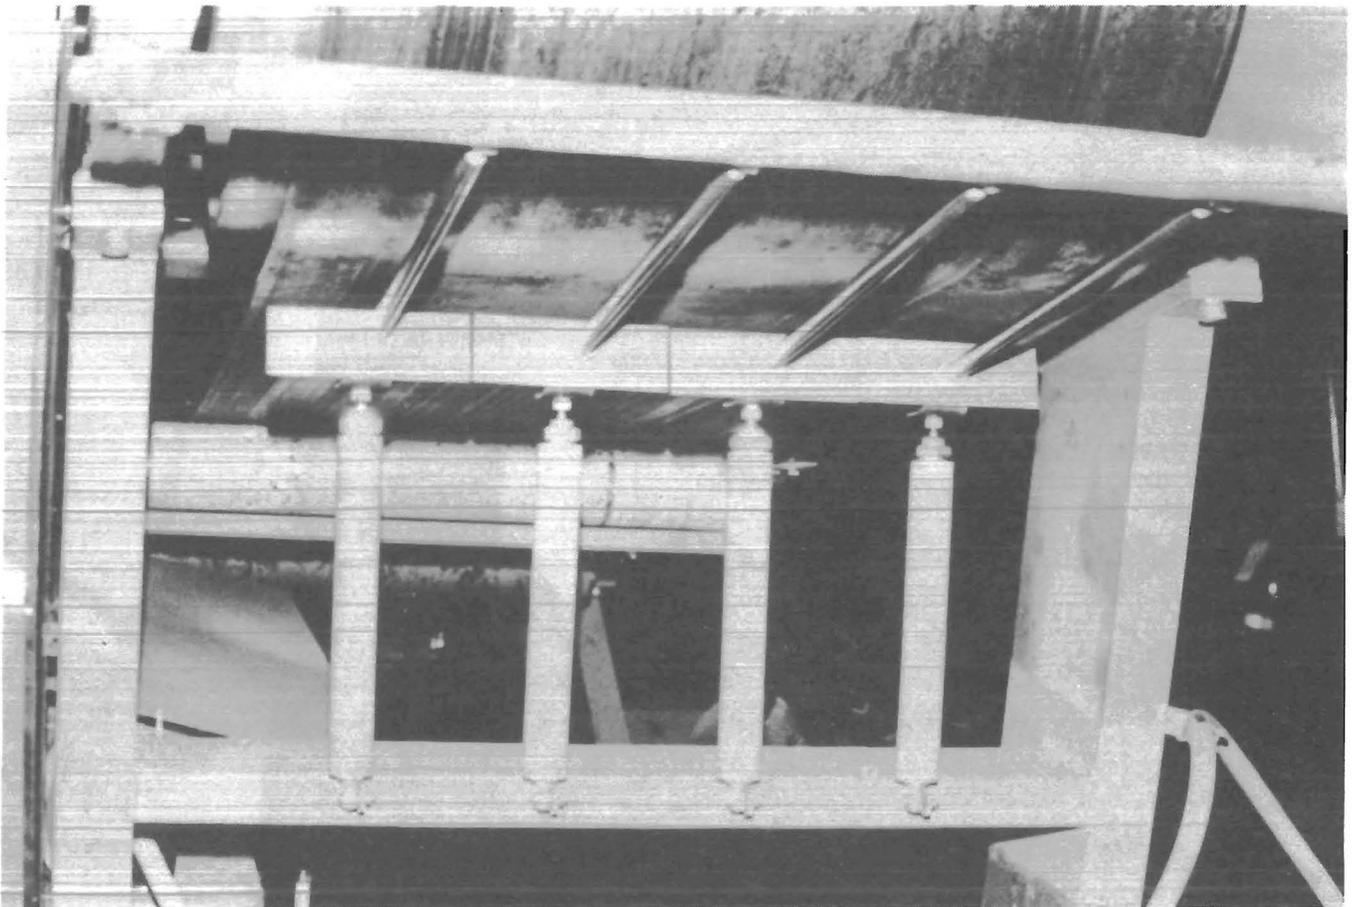
Figure 3.—Test fixture bracket for cleaner blades.

A test fixture bracket was designed to hold four cleaner blades against the conveyor belt. For convenience during data interpretation and reporting, the blades were numbered 1 through 4, from right to left as viewed in figure 3. Each blade was attached to one end of a 1/2-in threaded steel rod. The other end of each rod pivoted about a 1-in rod mounted parallel to the head pulley axis. This arrangement allowed the blades to be swung to and from the surface of the belt in an arc. When they were in contact with the belt surface they formed a 90° angle to the belt. The blades were held against the belt by air cylinders mounted perpendicular to the belt. The force applied to the blades and belt could be controlled by varying the air pressure in the cylinders.

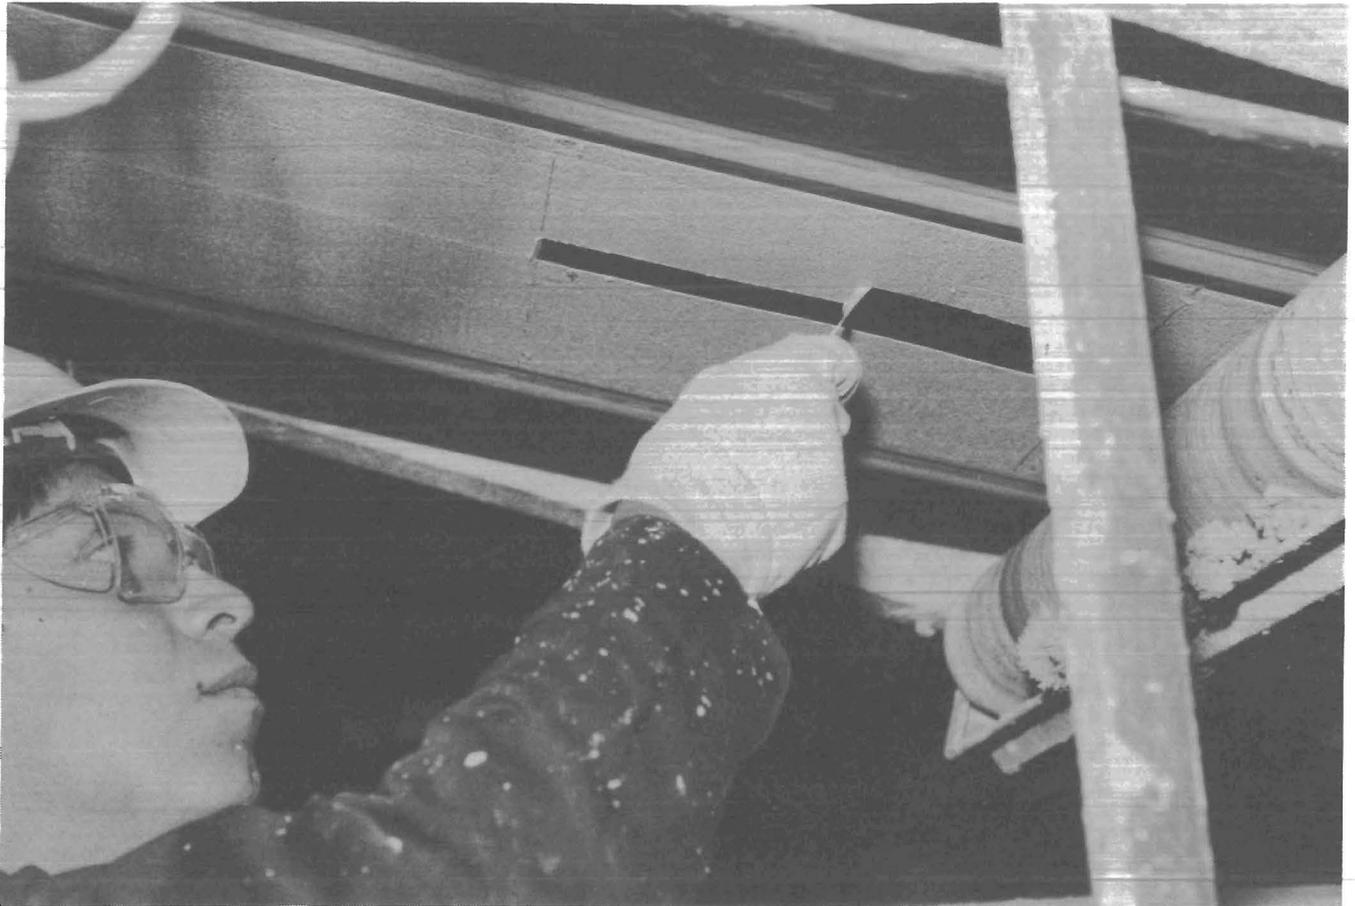
Figure 4.—Sampling carryback material.

To sample the carryback, the test conveyor was shut down and the drive power was locked out. Several 1-ft-long strips of the 6-in-wide area swept by each blade were marked off. The carryback material was then scraped off of the belt (fig. 4). The sample was weighed wet and then dried at 90° C for 24 h and reweighed to determine the dry weight. The data were used to determine the moisture content of the sample.

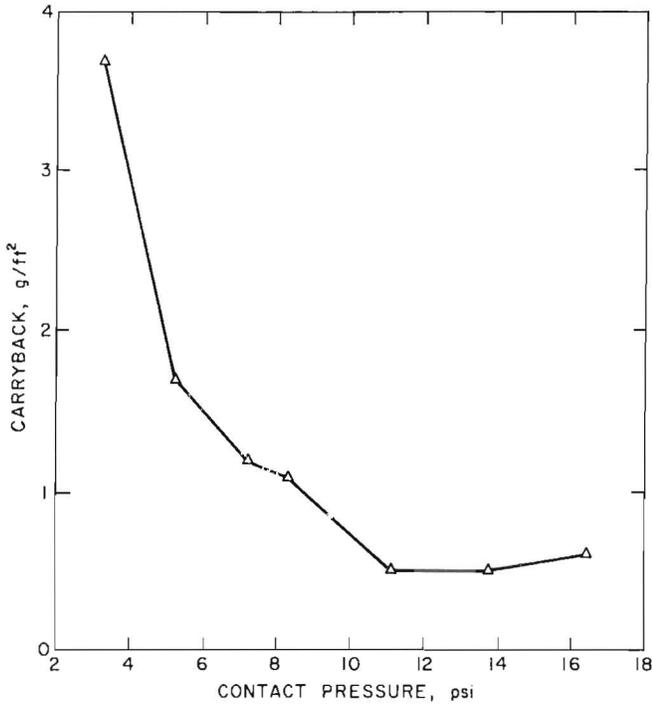
Figure 5.—Carryback material versus increasing contact pressure.

Early trial runs confirmed that conveyor cleaning was directly related to blade pressure. Figure 5 shows the carryback-versus-pressure relationship found during

testing. The carryback-pressure relationship consists of two distinct regions. The first region is characterized by decreasing carryback with increasing pressure to a limiting value or critical pressure. This critical pressure range was found to be 11 to 14 psi. The second region occurs above the critical pressure and is characterized as having a constant amount of carryback with increasing pressure. These two carryback regions are characterized by two general mechanisms: blade-belt separation and particle wedging.

In the first region of the cleaning relationship described by figure 5, material passing under the blade must effectively separate the blade and belt surfaces. This separation is the first general carryback mechanism. The average separation distance is directly related to the carryback amount and is dependent on the pressure exerted by the material between the belt and the blade. This separation pressure is induced by several phenomena, including the momentum change of deflected material, the compression of streamlines because of the curved blade edge, and viscous forces (assuming the test mixture to behave as a viscous fluid). Figure 7 shows a simplified representation of the mechanism by which viscous forces cause material to be carried past the cleaner blade.

The carryback-versus-pressure relationship, as depicted in figure 5, is highly subject to the wear of the cleaner blade edge. It was found in every experimental trial for all blade-to-belt pressures that cleaning effectiveness decreased over time because of uneven blade wear. The unevenness of the wear pattern was found to be the key to understanding cleaner effectiveness. Figure 9 shows the influence of wear time on the carryback-pressure relationship. The cleaner blade were found to effectively wear out and lose cleaning effectiveness after a few hours.

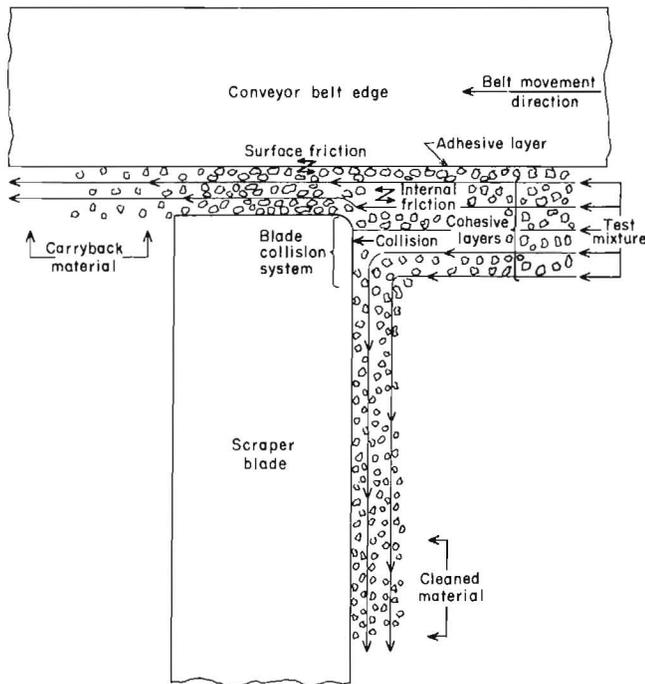
Figure 6.—Interrelationships of forces involved in belt cleaning.

In order to understand the mechanisms of cleaning, it is necessary to examine the forces that cause the carryback material to be carried between the belt and the cleaner blade. The interactive dynamic forces moving the carryback material include friction, adhesion, cohesion, inertia, and collision. The interrelationships among these forces are complex. Figure 6 illustrates these phenomena at the cleaning edge of the blade and belt system. It is at this location that the material will either pass under the blade or be separated from the belt.

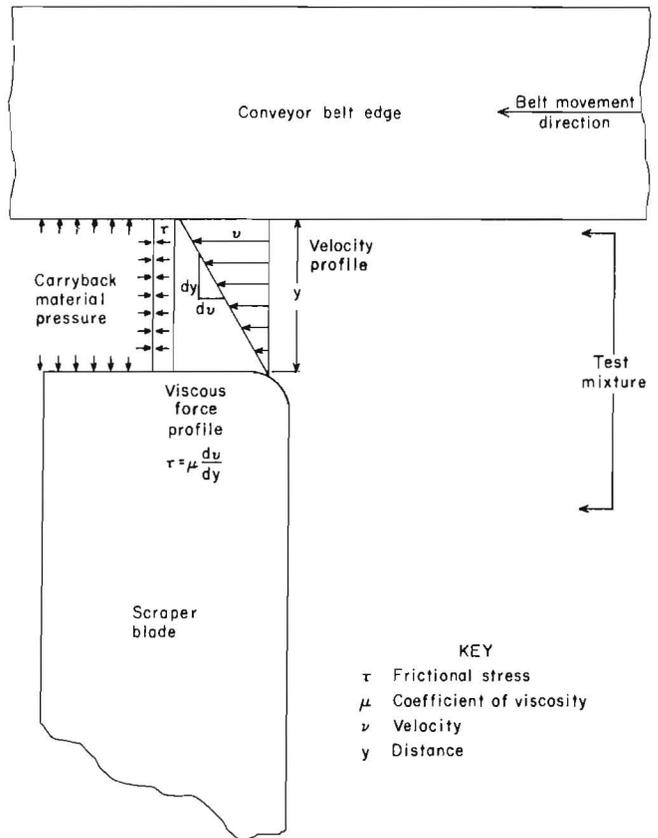
Figure 7.—Forces causing blade and belt separation.

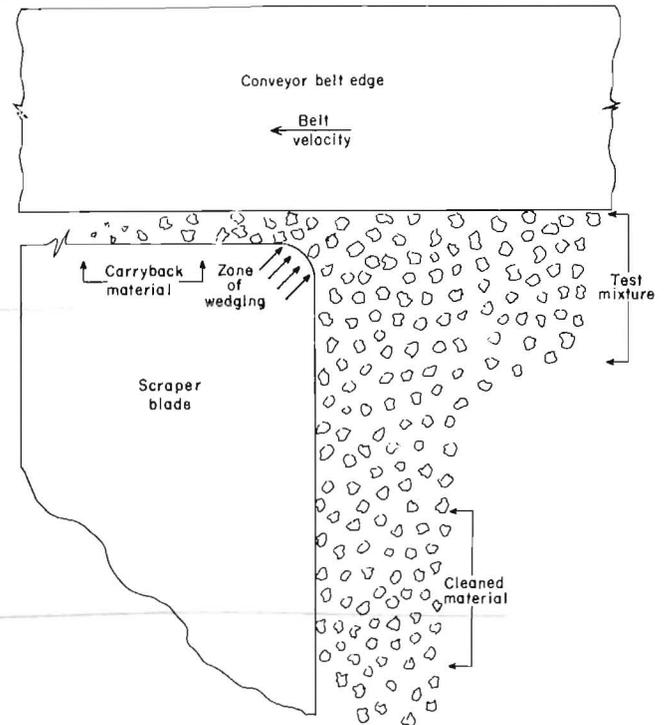
Figure 8.—Wedging mechanism for generating carryback material.

blade and belt. Particles passing between the blade and belt are typically trapped by wedging. This is the second cleaning mechanism and is illustrated in figure 8. Blade pressure is insignificant in this region, and belt smoothness and cleaner blade sharpness are more important for proper cleaning.

A cleaning limit is achieved with this second cleaning mechanism, which is related to the belt roughness, the blade condition, and the blade material (3). This limit is a function of the natural roughness of the blade and belt, which allows material to be trapped or wedged in small pockets in the belt or to pass through microscopic crevices in the blade.

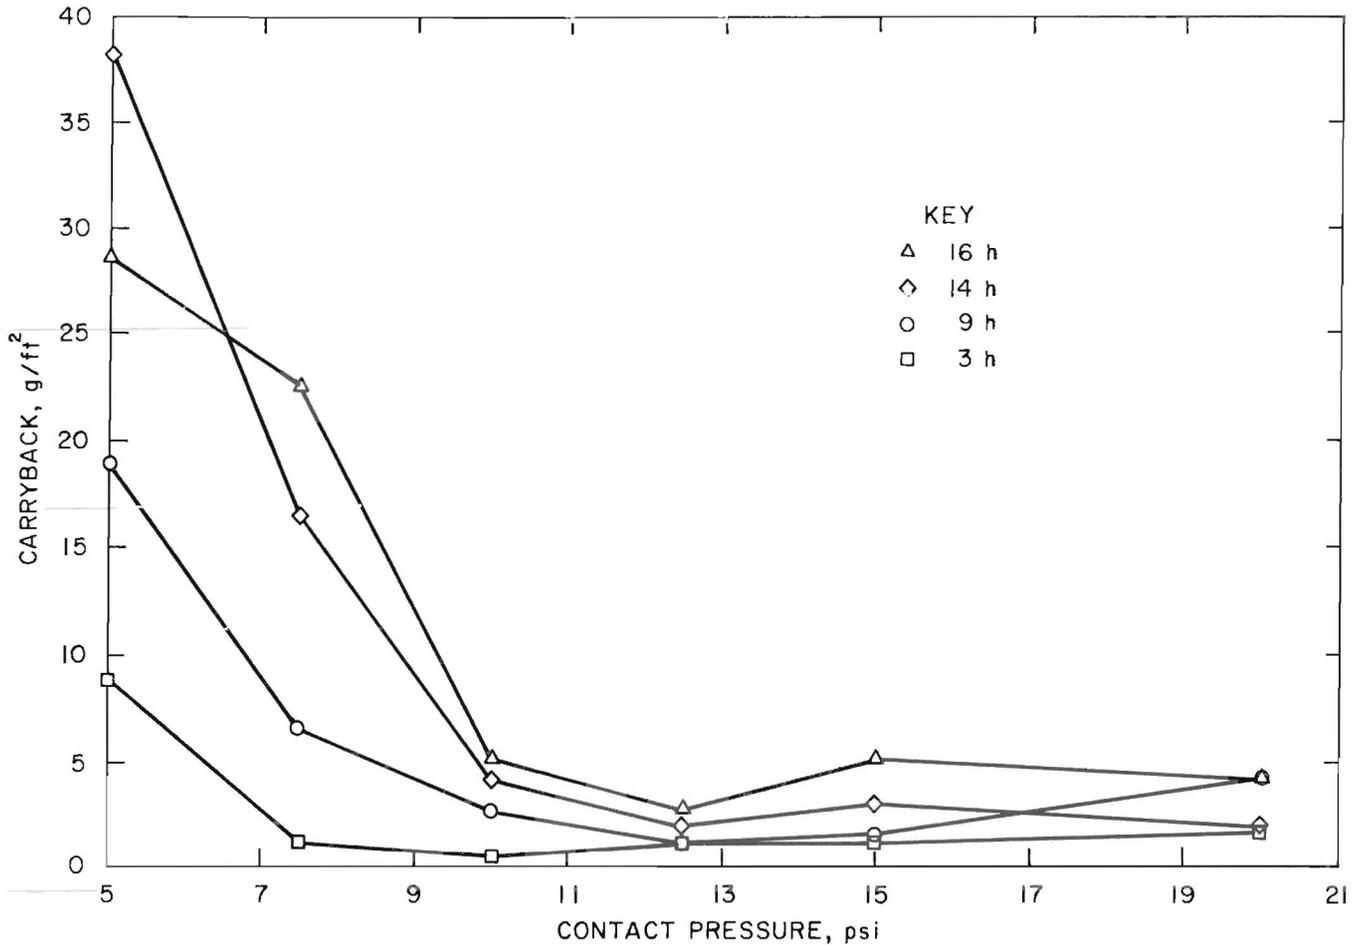
Figure 9.—Influence of wear on relationship of carryback material to contact pressure.

Typical wear consisted of distinct troughs or channels at blade edges and across the blade. (Specifics of blade wear mechanics are discussed in the following section.) These edge and channel wear areas provided local pathways for carryback to pass between the belt and the blade, which compromised cleaning effectiveness because the belt could not conform to the blade in these relatively deep and narrow blade wear troughs. Once the channels formed, no realistic level of blade-to-belt pressure could prevent the blade from wearing out. Material passing through these troughs would form visible stripes on the belt. With consideration given for blade wear, the carryback-pressure relationship was found to be predominantly influenced by the belt conformance to the blade, irrespective of pressure.

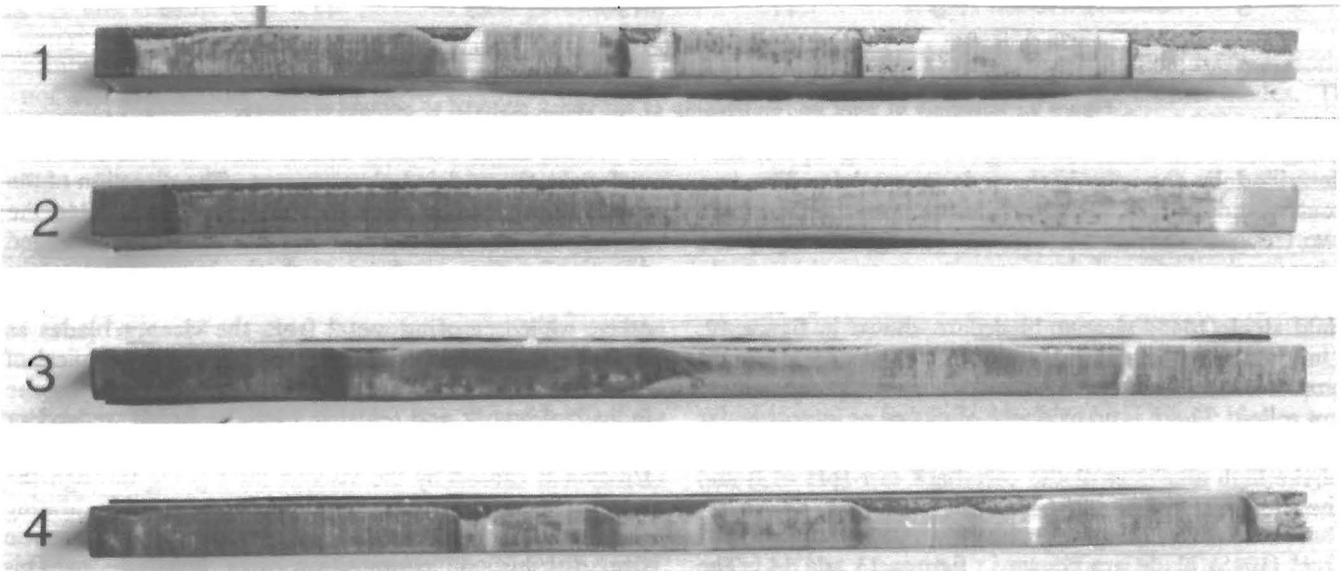
Figure 11.—Worn research conveyor cleaner blades (1045 mild steel) after 18 h. Blades are 6 in long.

described by the carryback wedging model. The two center blades (2 and 3) show edge wear and only one or two troughs. These two blades were used to study the wear mechanisms and cleaning parameters.

Visual examination of mild steel blades 2 and 3 (fig. 11) at 1-h intervals during the 18- to 34-h tests showed that the initial wear occurred at the blades' adjoining edges. In several hours, material would go through the adjacent space between the blades. This space slowly enlarged as the worn edge surface advanced inward. The blade surface was initially flat, but after service the surface was angular from front to back. The leading edge surface was rounded and polished, which allowed the viscous fluid (sand-lime slurry) to collect and erode the surface. Once the erosion lessened blade contact with the belt, slurry particles gouged into the blade's surface and were dragged across the blade-belt interface. After several such actions, small troughs were started. Once a trough started, it widened from the inside out as edge wear worked toward the center by abrasion and erosion. The blade surface topography was measured and compared with that of a standard blade at 2-h intervals. The progression of edge and trough development is shown in figure 15. The area where competing trough and edge wear met accounted for the small sharp ridge.

Visual examination of blades 2 and 3 (fig. 11) indicated that both blades wore by similar forces, but at different rates. Specific areas of the blades wore at different rates, but the same patterns were noted on all blades. This similar pattern allows the use of a general wear rate of mils per year to compare the different metal blades. This unit represents the run time, the density of the various metals, the initial amount of surface area in contact with the conveyor belt, and the blade's weight loss.

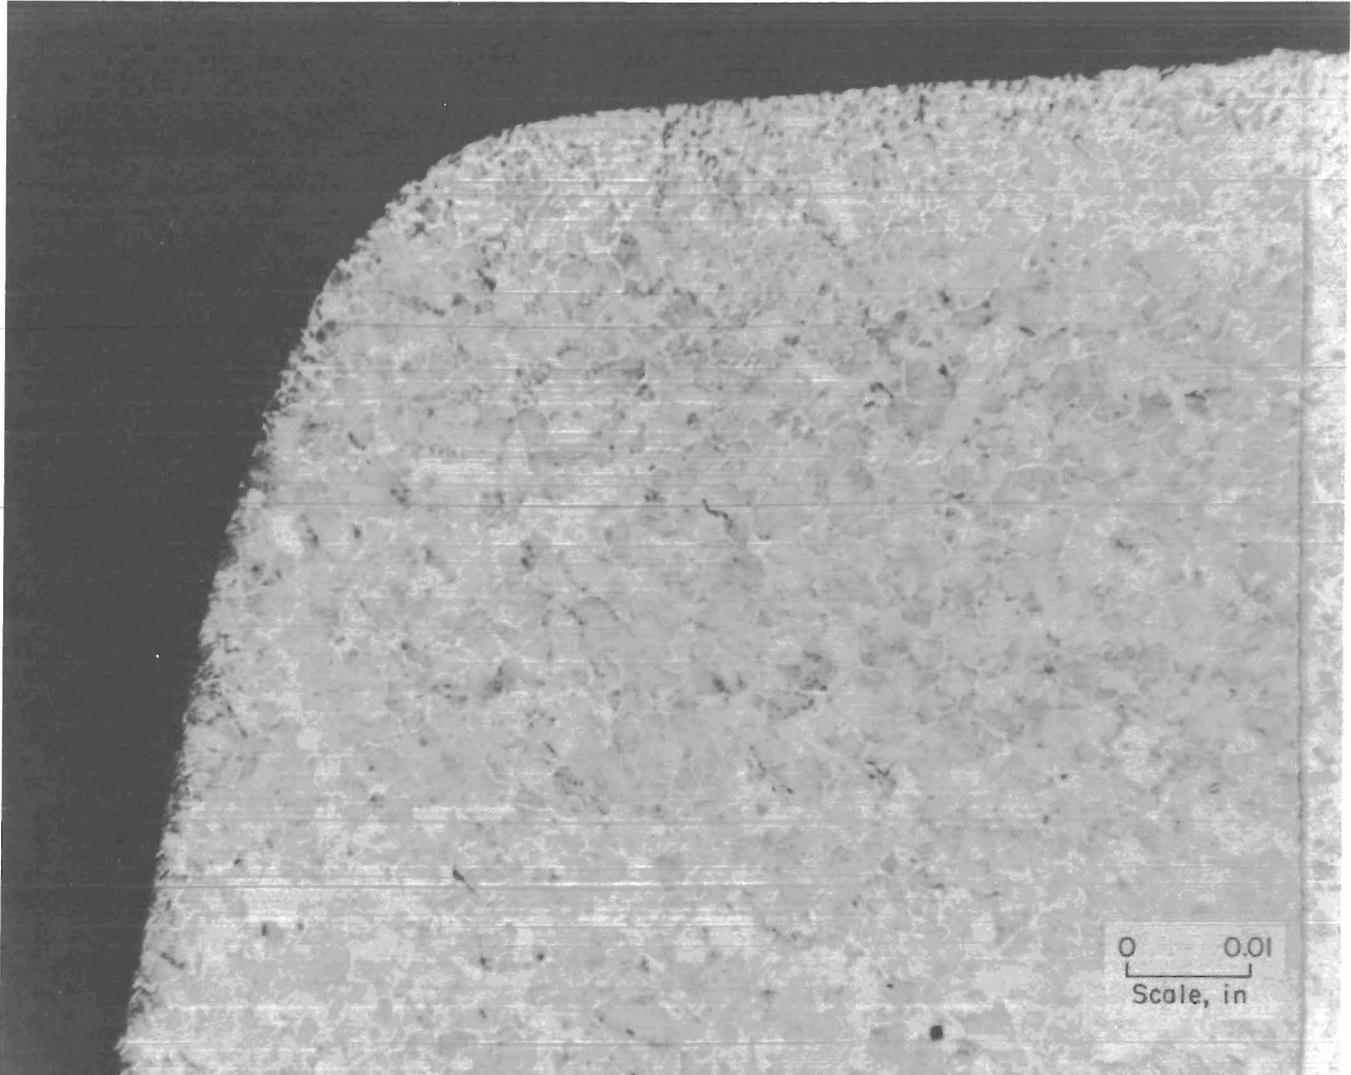
Figure 12.—Mild steel (1045) cleaner blade’s leading edge; photomicrograph.

Longitudinal and cross-sectional photomicrographs of a mild steel (1045) cleaner blade are shown in figure 12. Uniform grain structure is shown in figure 12; the grain size decreases near the surface because the samples were hot rolled. There is no evidence of pitting or intergranular attack. No chemical corrosion would be evident because of the high alkalinity of the carryback mix (pH >12) and the short test period of 34 h (4-5).

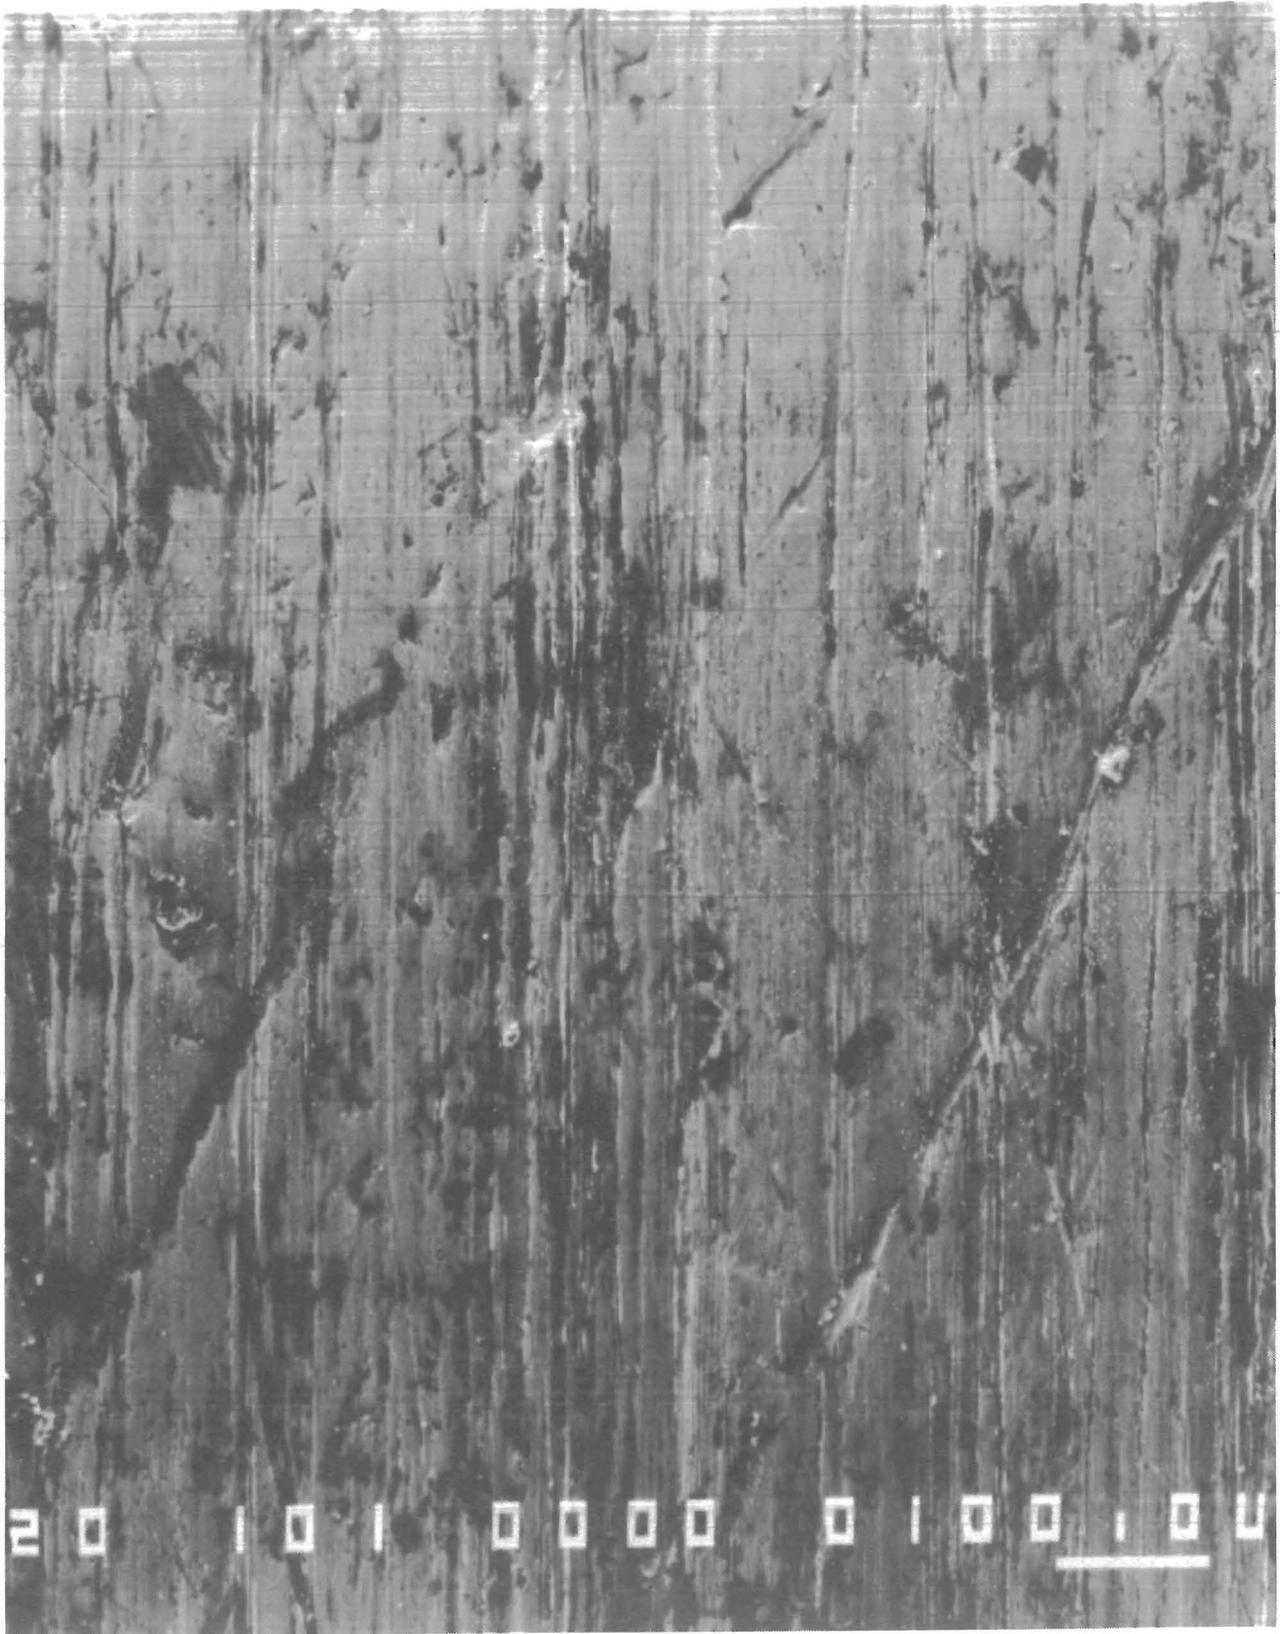
Figure 13.—Mild steel (1045) cleaner blade's wearing surface; photomicrograph.

The details of the gross metal loss or wear from a mild steel (1045) blade are shown in figures 13 and 14. The leading edge after 1 h is shown in figure 14A, while the same material after 8 h is shown in figure 14B. Both figures show deep grooves cut into the cleaner blade's

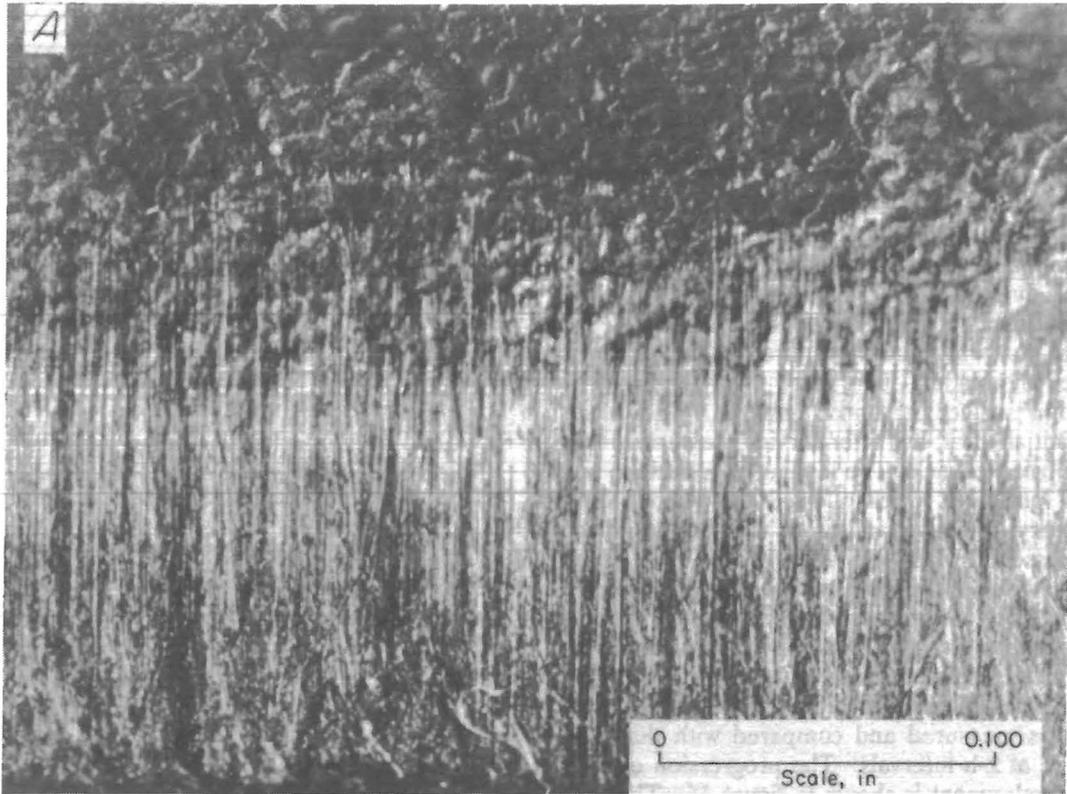
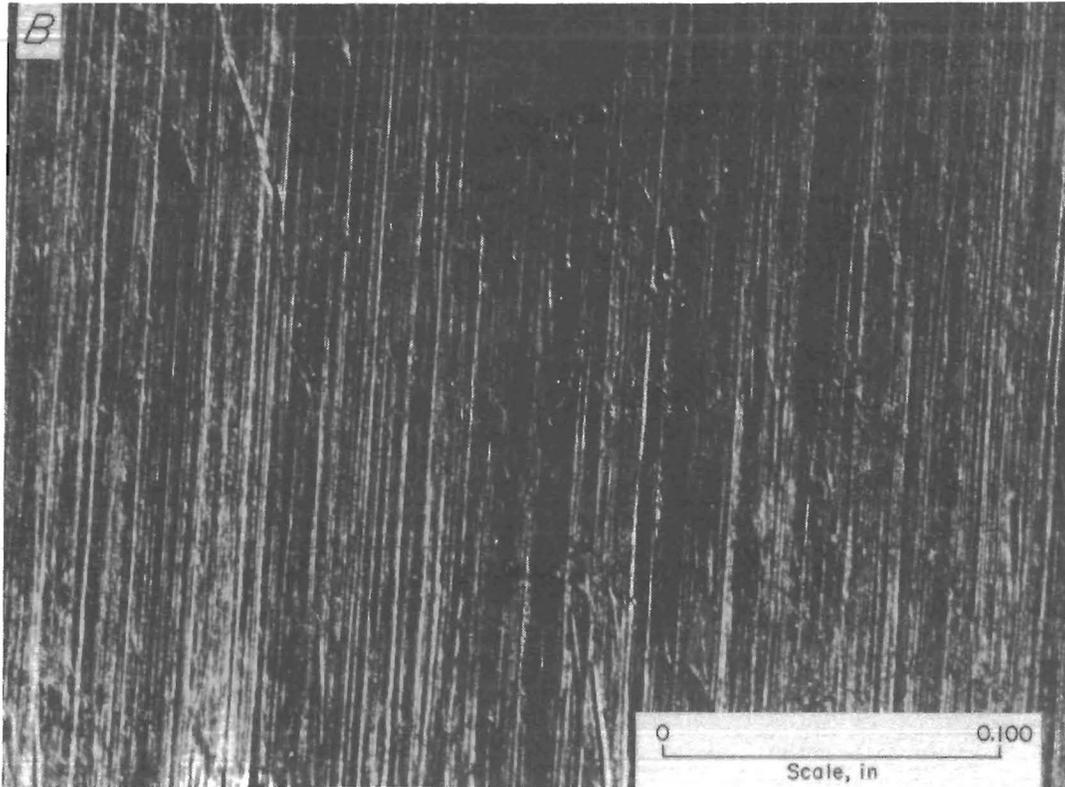
Figure 14.—Mild steel (1045) cleaner blade's surface after 1 h (A) and 8 h (B) exposure to coarse sand-lime slurry.

surface by the wedging phenomenon. The direction of the abrasive particles is shown to be mainly parallel to the conveyor belt's direction, but some particles changed direction. The occurrence of the nonparallel paths indicates that particles rotated or moved relative to each other, while removing metal from the cleaner blades as described by the cleaning mechanisms. This is typical of abrasion and erosion wear. Abrasion is caused by the individual quartz and feldspar particles being wedged or pulled through the blade-belt interface by the belt motion. Erosion is caused by the viscous fluid going through the deep paths cut by the quartz and feldspar particles during abrasion. Tables 2 and 3 list the masonry sand particle size distribution, composition, and hardness. This information shows that coarse quartz and feldspar particles can easily cut the softer mild steel.

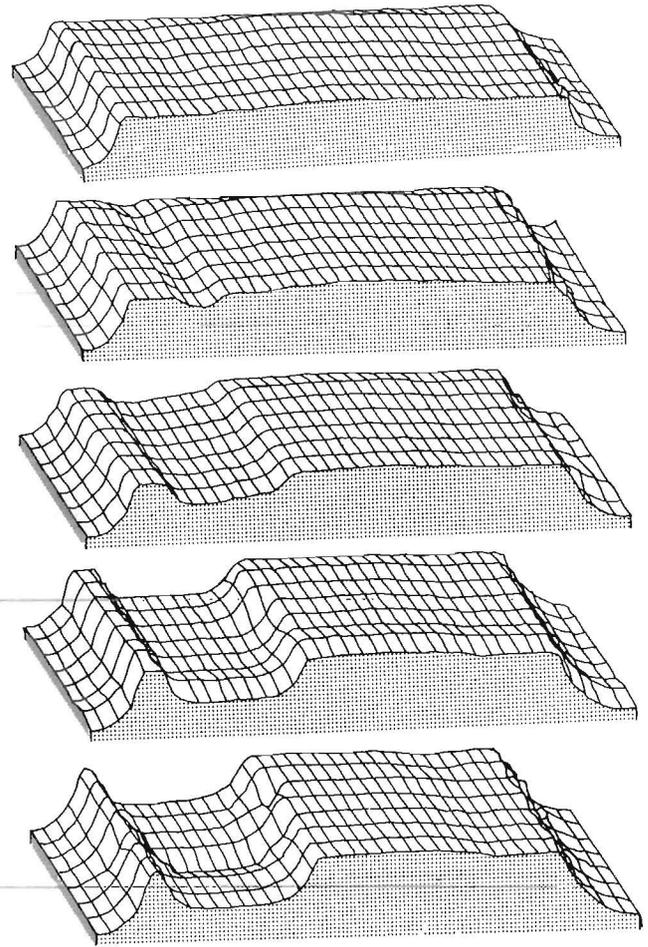
Figure 15.—Graphic progression of edge and trough development cross section at 2-h intervals from bottom to top.

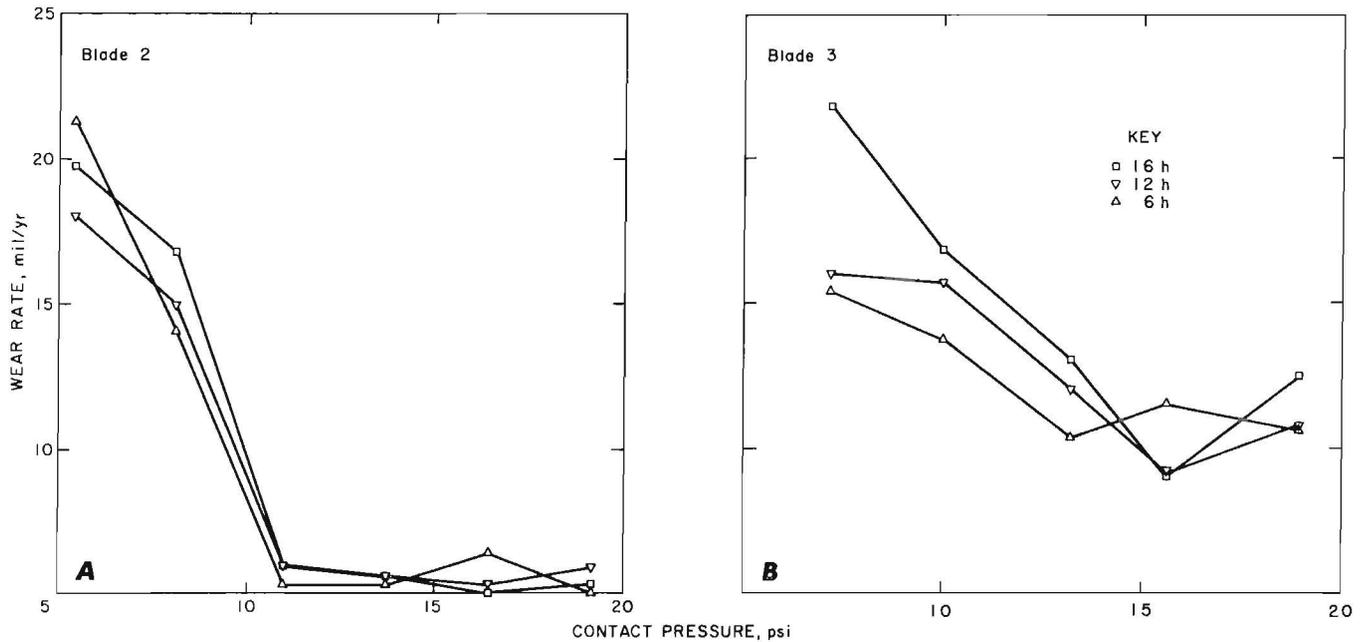
Figure 16.—Effect of applied pressure on wear rates of cleaner blades 2 and 3 (1045 mild steel) at various run times.

Experimental runs showed that blade wear values were directly related to blade-to-belt pressure. Figure 16A shows the wear-versus-pressure relationship found during testing. The amount of wear decreases with increasing pressure to a limiting value, after which the wear rate remains essentially constant. The relationship of wear to blade pressure consists of two distinct regions. The first region is characterized by decreasing wear rates with increasing pressure to a limiting value or critical pressure, which was found to be 11 to 14 psi. The second region occurs above the critical pressure and is characterized as having a constant wear rate with further increases in pressure. The relationships of carryback pressure (fig. 5) and wear rate to pressure (fig. 16A) are identical but

During the same experimental runs, blade 3 was observed to behave in a different manner. Figure 16B, shows both a decreasing and an increasing wear rate as pressure increases. Blade 3 wear rates decreased as the pressure entered the optimum range of 11 to 14 psi, but as the pressure increased the constant wear rate tended to increase. The minimum wear rates of 10 to 12 mil/yr are two times the wear rates of 5 to 6 mil/yr shown for blade 2.

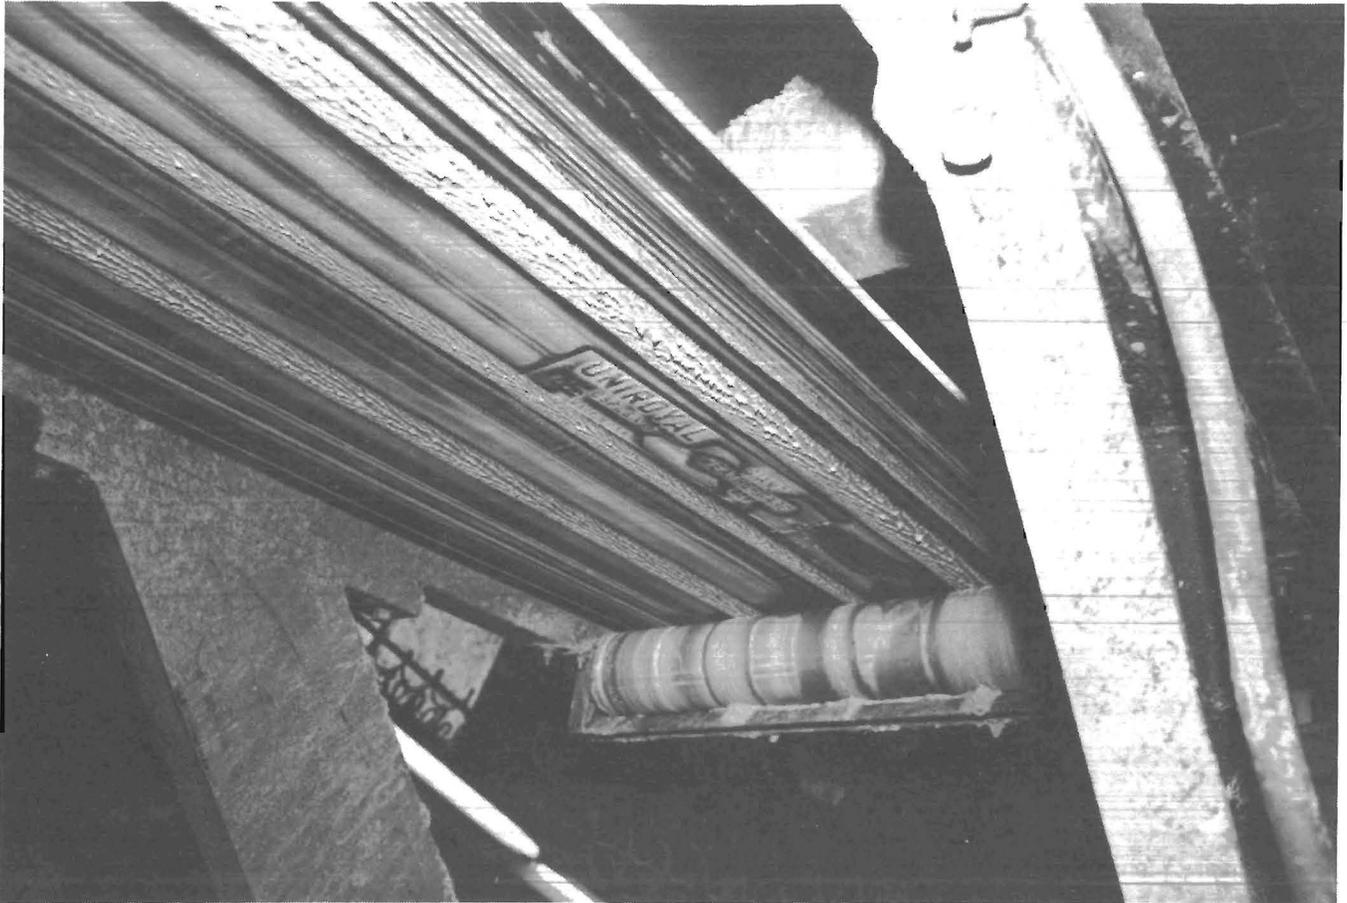
Figure 17.—Manufacturer’s conveyor belt logo filled with carryback material. Logo has just passed cleaner blade fixture and idler.

Company logos or other patterns that are recessed into the belt cover allow material to get between the blade and belt and greatly accelerate uneven blade wear. The

uneven wear pattern of the blade edge will be characteristic of the pattern in the belt and can reduce blade service life by 55 to 60 pct.

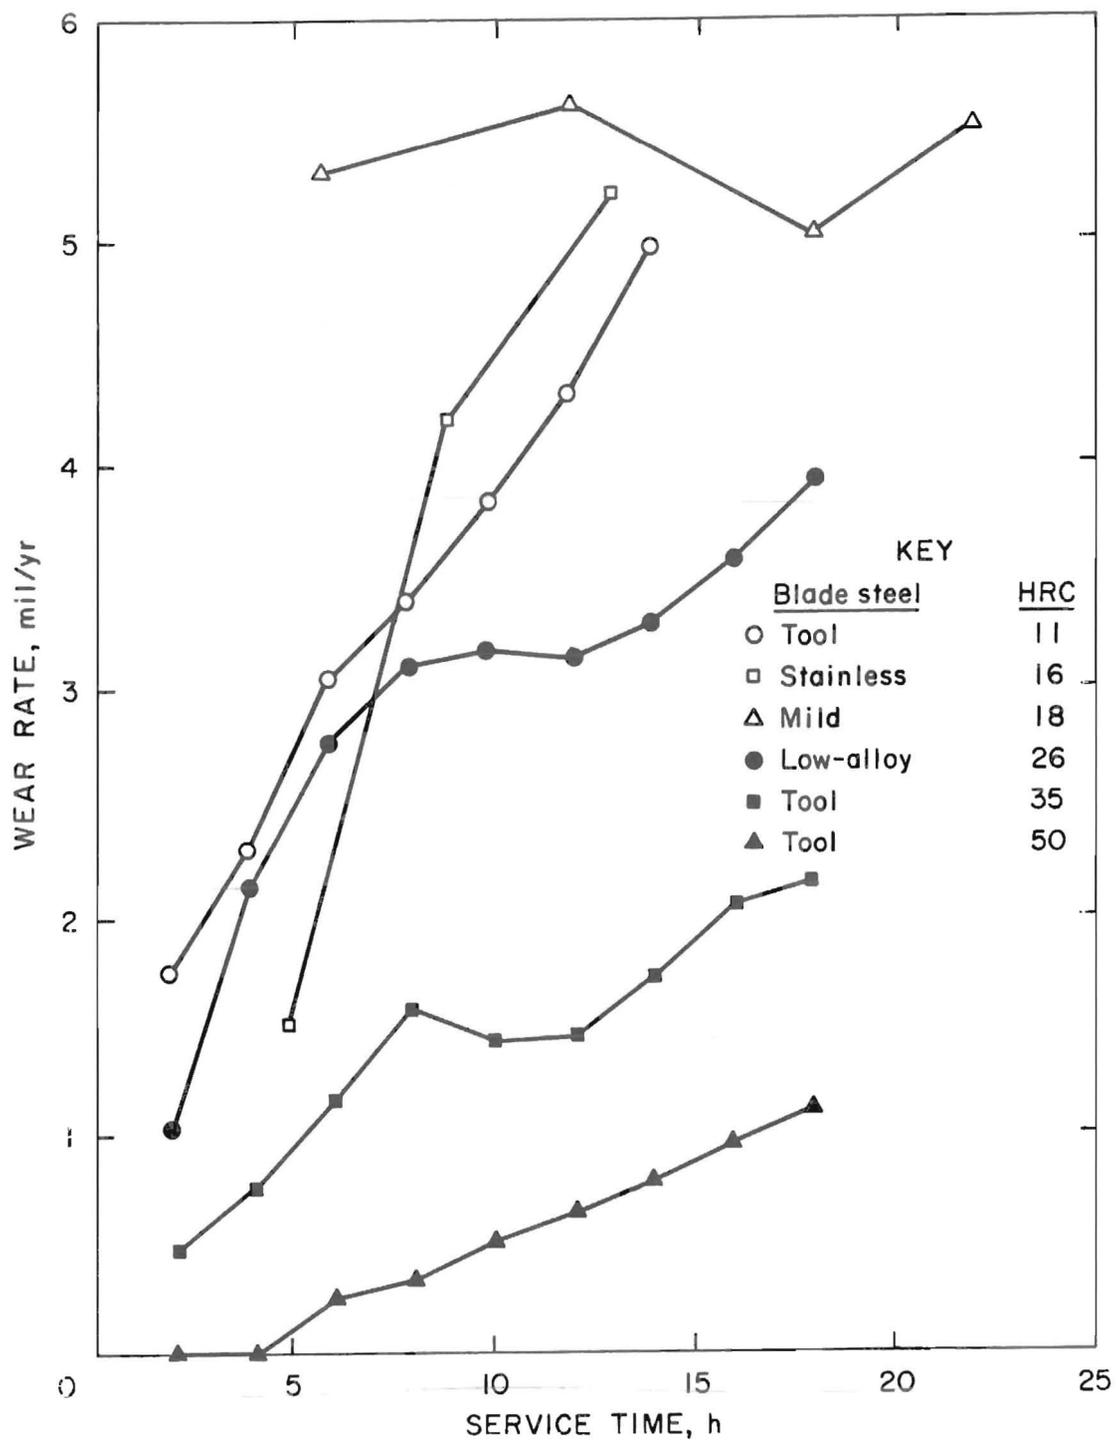
Figure 18.—Effect of service time on cleaner blade (1045 mild steel) wear rates at various steel hardnesses.

The effects of blade composition and metal hardness on wear are shown in figure 18. Samples of 2-in flat stock tool steel (type A-2) and a low-alloy steel (4140) were used. All metal test blades' hardness was measured. Then the test blades were installed in the test fixture to duplicate the mild steel blade runs and blade weights at an applied pressure of 12 psi. Figure 18 shows that increasing metal hardness from HRC 11 to 50 decreased the wear rate from 5 to <2 mil/yr. The metal composition affects the wear rate, but not as significantly as the hardness. This is evident by the high wear rates of steel blades with HRC ≤ 18 . The tool and 4140 steel blades (HRC ≥ 26) show that increasing hardness decreases wear rate. Visual observation of the various blades indicated that the wear mechanism and patterns were identical to those of the previously described mild steel blades, as well as the commercial blades. The increased metal hardness decreased the wear rates and increased the blades' service life, but the viscous and wedging phenomena or abrasion-erosion mechanism still damaged the cleaner blades' surface. Again, no form of corrosion was observed.

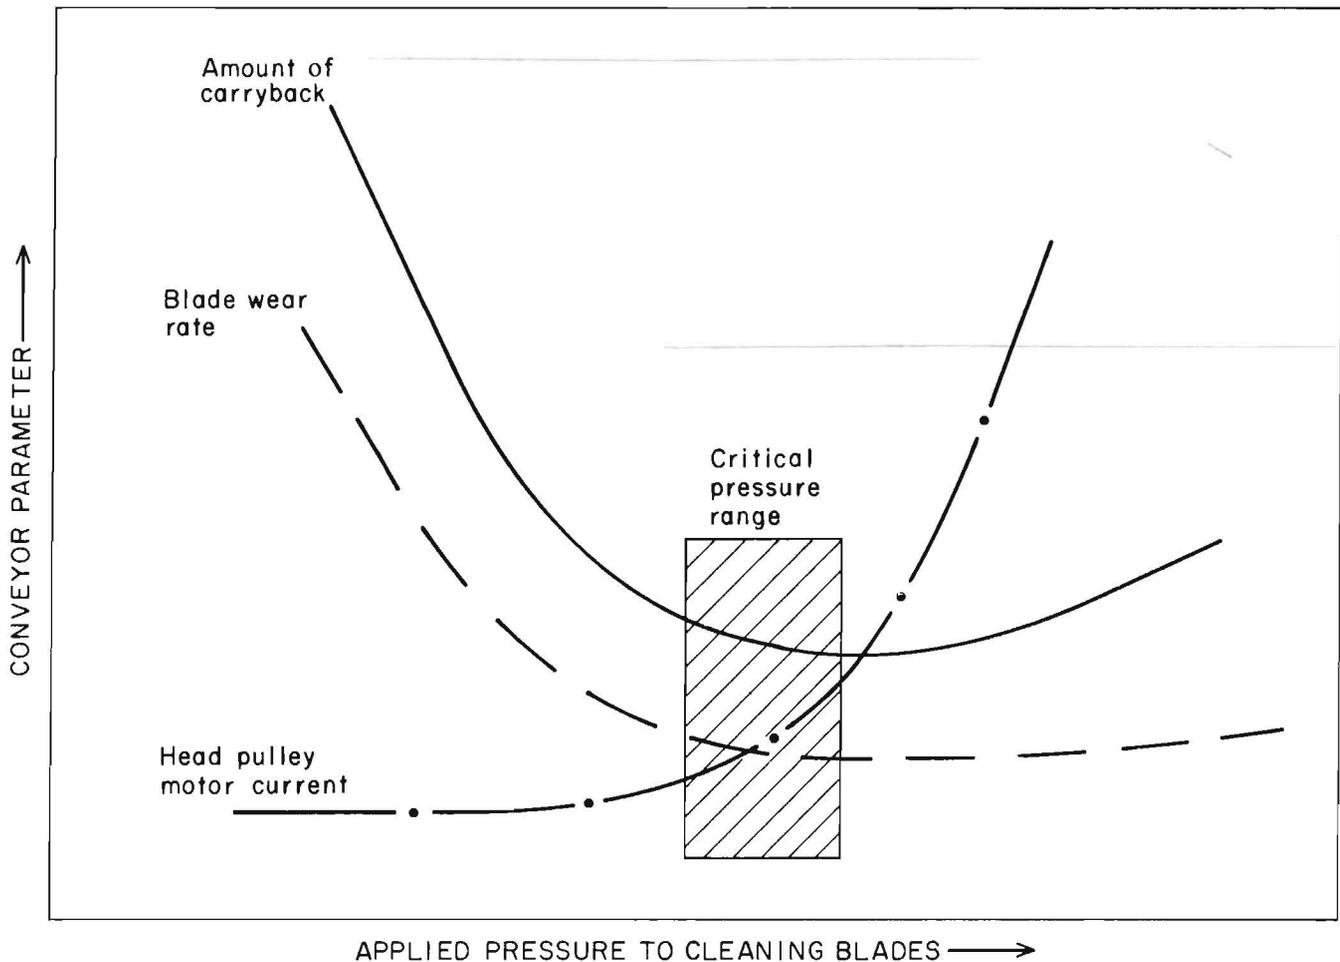
Figure 19.—Pressure dependencies of parameters.

The carryback- and wear-versus-pressure curves indicate the existence of an optimum operating pressure for the type of conveyor belt cleaning system used in this study. Above this optimum pressure, no significant decrease in carryback was observed, but the conveyor belt-blade friction increased. Pressure dependencies of the parameters are shown in figure 19.
