REPORT OF INVESTIGATIONS/1991

Burnout Control at the Albright Coal Waste Bank Fire

By Robert F. Chaiken and Larry G. Bayles

Report of Investigations 9345

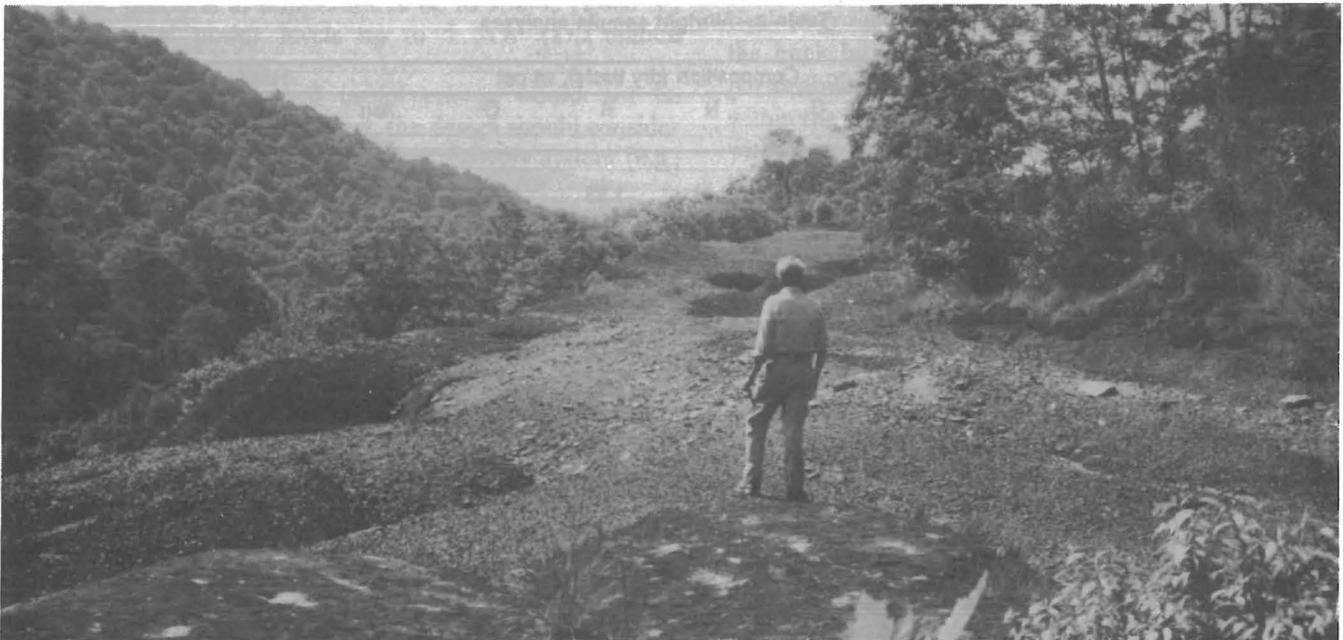
Figure 2.—Top portion of waste bank, looking south.

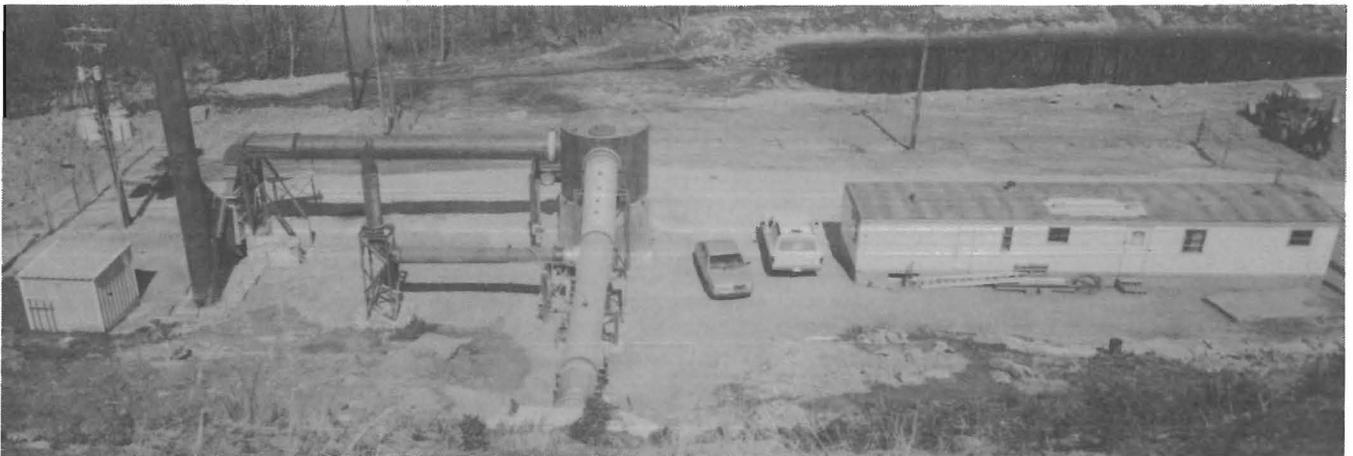
The following is a brief description of the major parts of the Burnout Control ventilation system as initially designed and constructed (see figure 5):

Figure 5.—View of Burnout Control system from top of waste pile (30,000-ft³ sedimentation pond shown in upper right).

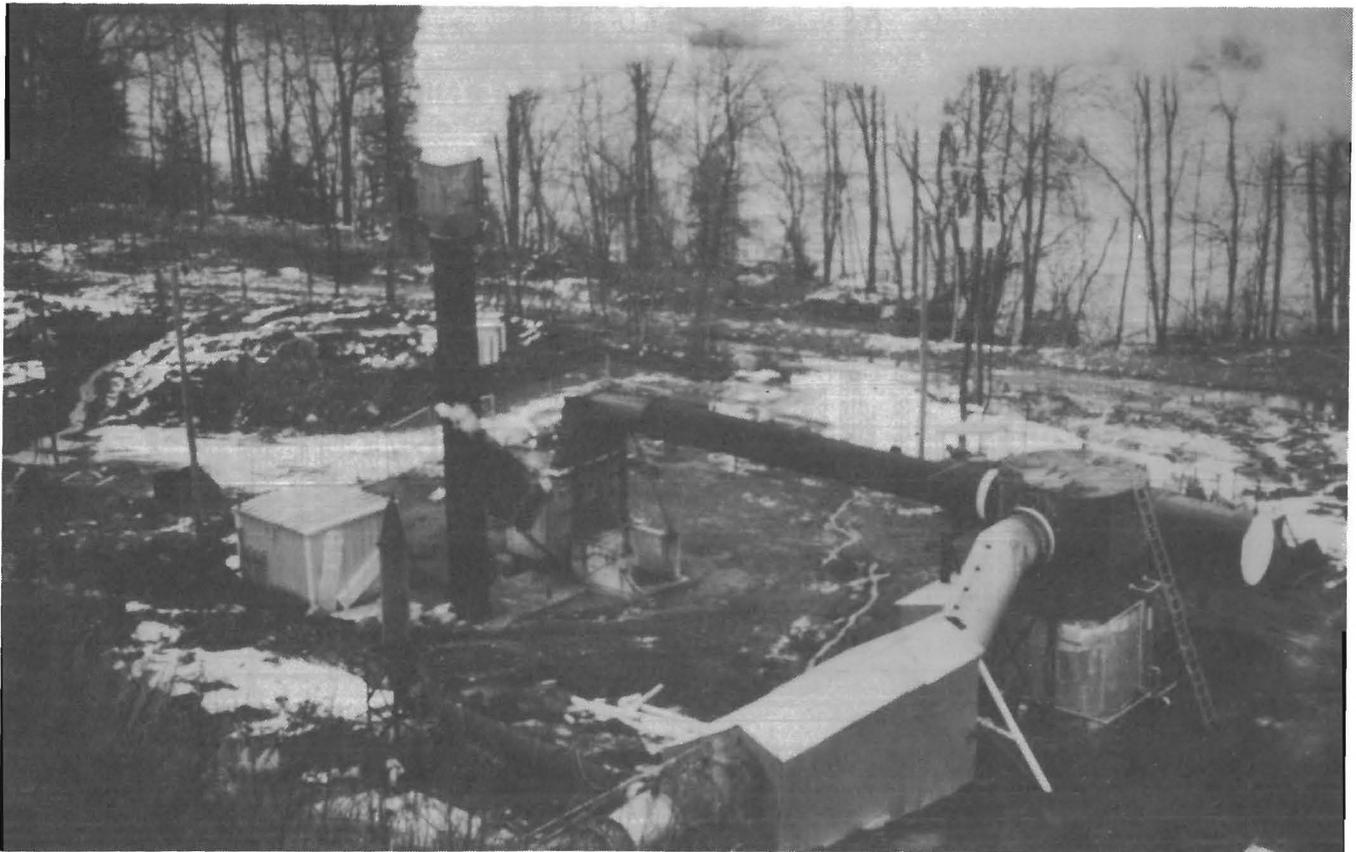
Figure 10.—Burnout Control system after installation of scrubber and stack muffler and after winterizing (metal shed in foreground encloses tube-in-shell heat exchanger).

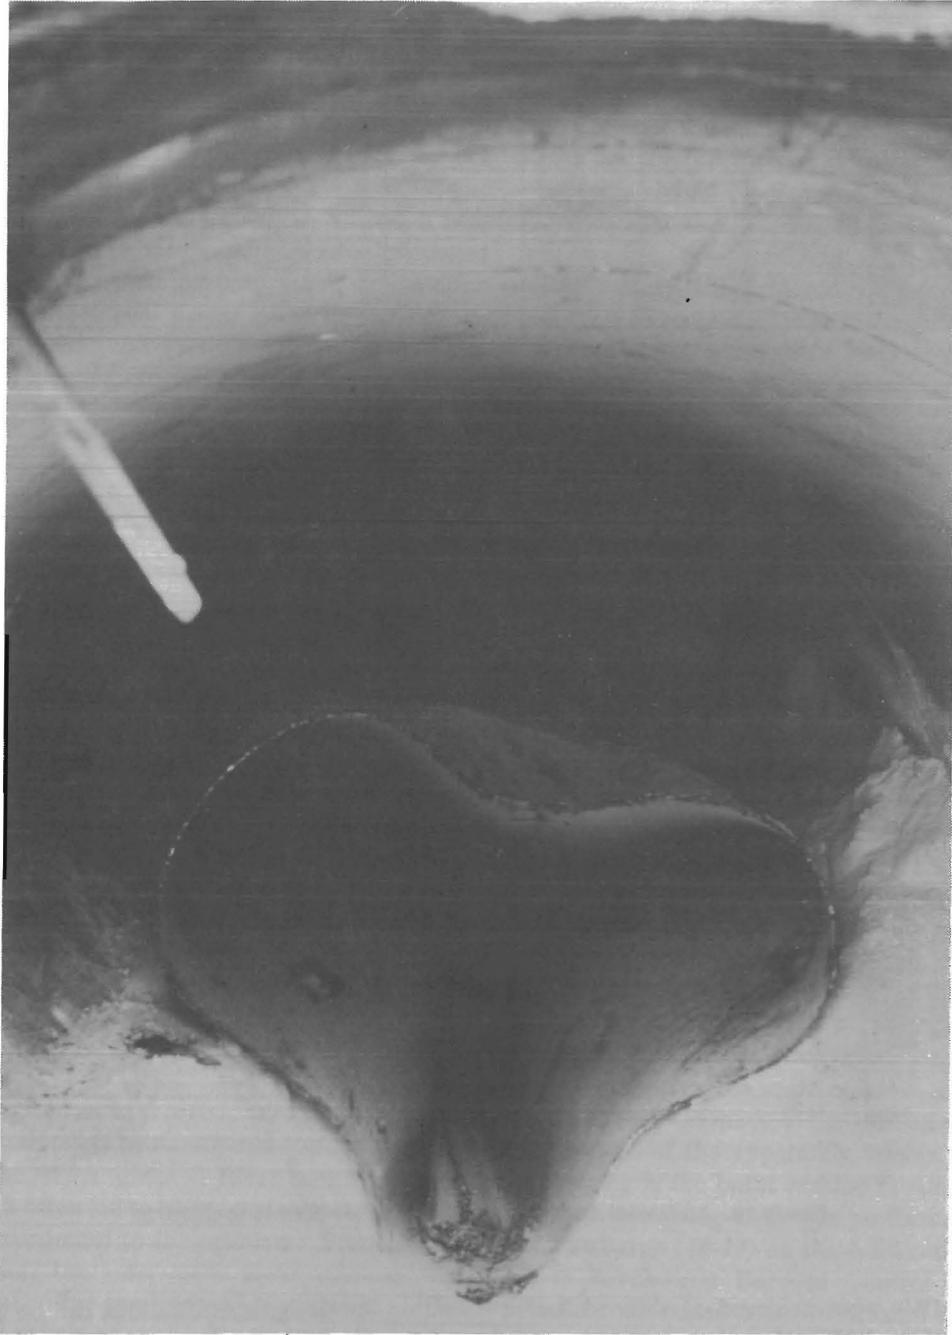
Figure 18.—Manifold cross section at position 15 ft into waste bank (during disassembly of system).

Inasmuch as the pipe was designed to support a 35-psi vertical load at temperatures in the range 1,500° to 1,800° F (800° to 980° C) (7), it must be presumed that the temperature inside the manifold exceeded the temperature measured at station 1. In any event, it was concluded that the field trial should be terminated at this time.
