Bureau of Mines Report of Investigations/1986

Calamity Hollow Mine Fire Project

5. Excavation and Evaluation of the Fire Zone

By K. E. Soroka, R. F. Chaiken, L. E. Dalverny,
and E. F. Divers

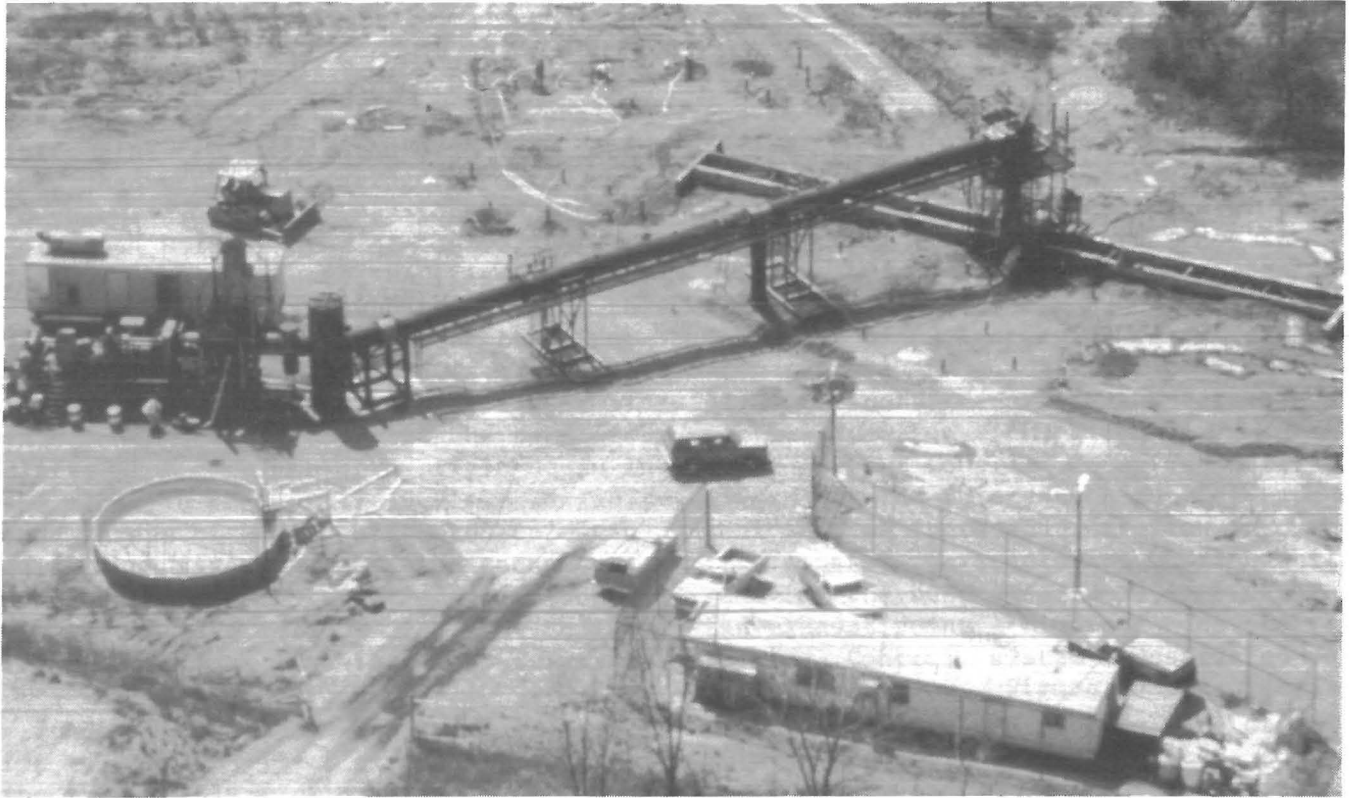
FIGURE 3. - Aerial view of Calamity Hollow site.

The Burnout Control technique utilizes an exhaust fan to create a partial vacuum that induces increased air flow into the fire zone(s) to accelerate burning while removing the heat and fumes at a central fan exhaust point. Figure 2 depicts the Burnout Control system constructed at Calamity Hollow. Figure 3 is an aerial view of the site to provide ease of reference from figure 2 to system components, such as the generator-fan assembly, dropout tank, and exhaust manifold, referred to throughout the excavation description.

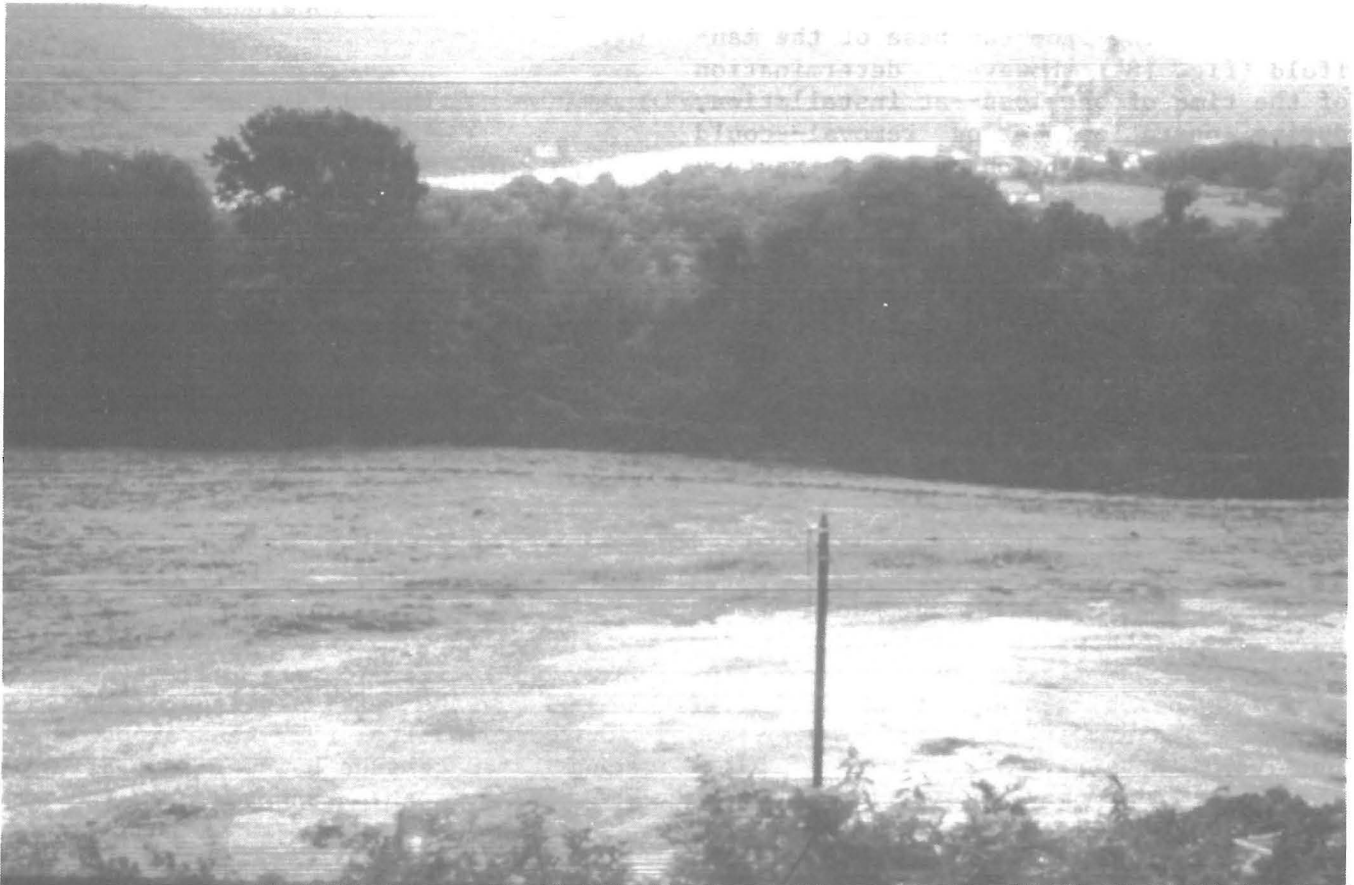
FIGURE 16. - Site several months after termination of project.

and lack of combustion odors indicated that fire had occurred in this area years ago and that enough time had elapsed for the residual heat to have completely dissipated. It was evident that no active fire remained on site. The backfilling was then completed with recontouring and grass seeding. Figure 16 is a view of the site several months after completion of this project.

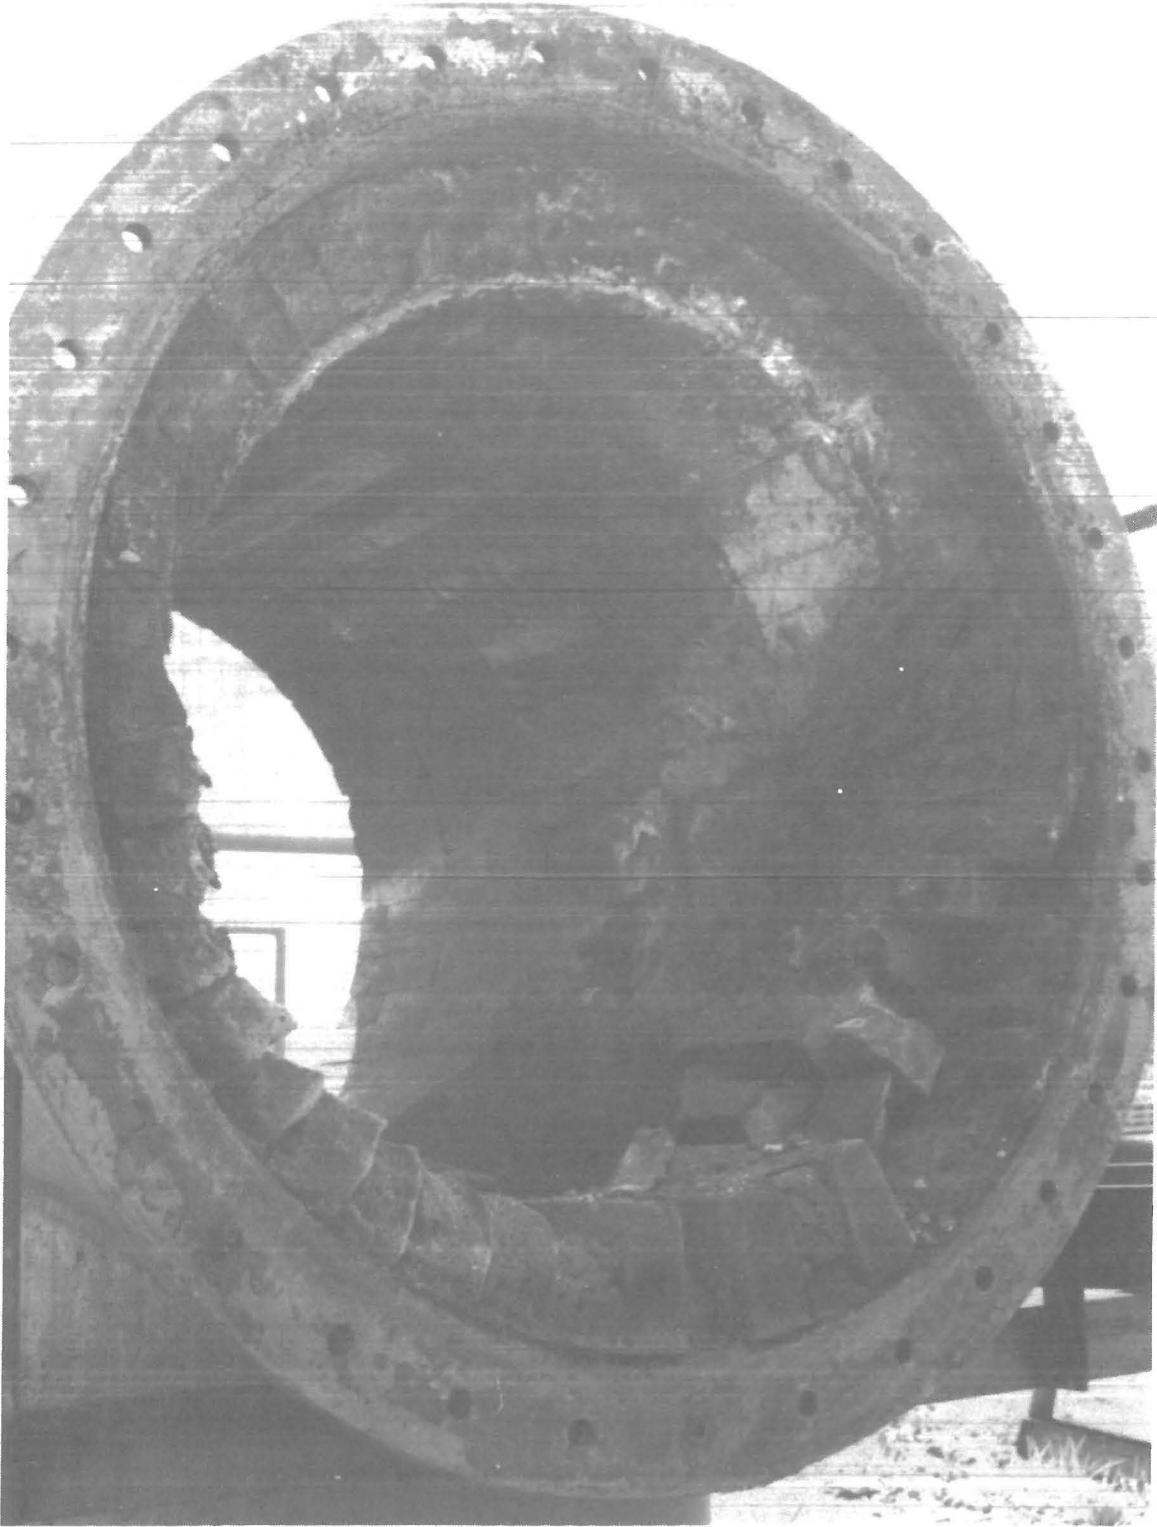
FIGURE 19. - Attrition of refractory lining in T-section of air inlet.

The flanged T-section was most affected by the operation. The combined flow of ambient air, hot moist gas and water spray resulted in attrition of the refractory brick lining of the T-section abutting the unlined duct (fig. 19).

One area of erosion was the air inlet T-section (figs. 17, 19) where attrition was caused by the combined effects of hot gases, cool air, and cold water spray flowing through this section. Redesign of the water spray coolant system could include a fluid-cooled duct with internal horizontal and vertical baffles to provide better mixing of the hot gases and cold air.
