Bureau of Mines Report of Investigations/1983

Corrosion of Selected Metals and a High-Temperature Thermoplastic in Hypersaline Geothermal Brine

Report of Investigations 8792

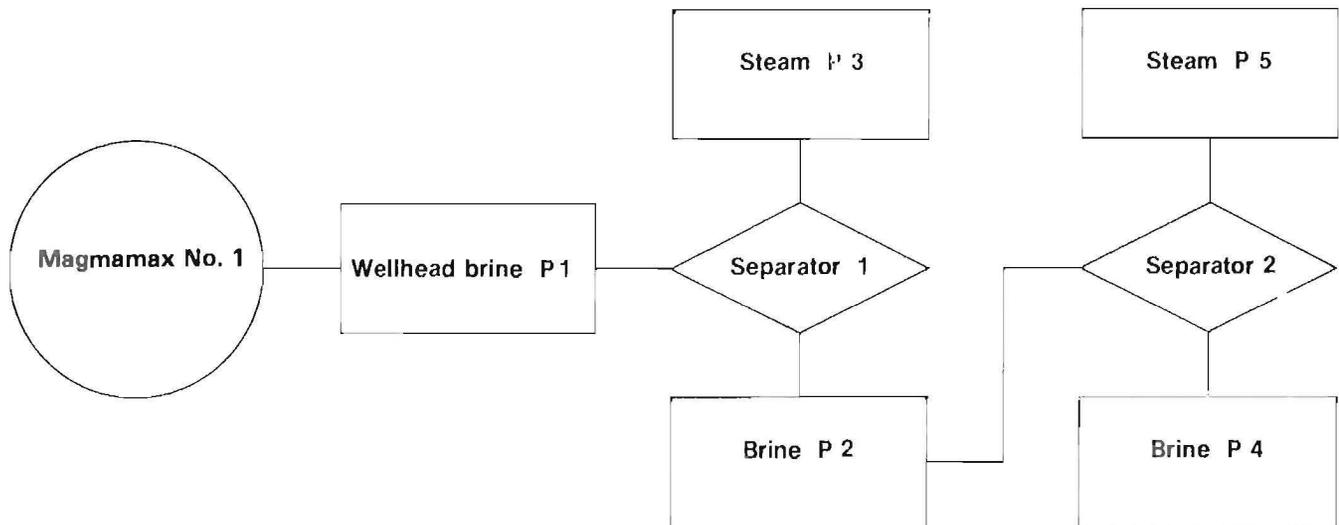
FIGURE 1. - Block diagram of the Bureau of Mines geothermal test facility showing location of corrosion test packages (P1-P5).

Corrosion tests were conducted in brine and steam process streams produced by flash evaporation of wellhead brine from geothermal well Magmamax No. 1 at the Bureau of Mines geothermal test facility on the Salton Sea Known Geothermal Resources Area (KGRA) in the Imperial Valley, Calif. Figure 1 is a block diagram of the facility and shows the relative locations of the test packages for the corrosion measurements. The operation of the facility is described in RI 8350 (5). Weight-loss corrosion measurements and U-bend stress corrosion tests were made in wellhead brine and in the brine and steam process streams from the two steam separators. Electrochemical potentiodynamic and linear polarization measurements were made in wellhead brine only in a separate test package operated in parallel to the weight-loss wellhead brine test package P1.

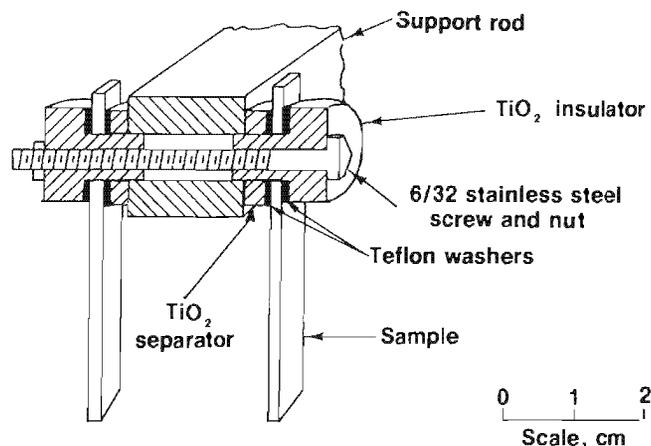
The test samples were mounted, as shown in figure 2, on support rods for exposure to the process environments in the corrosion test packages. Four samples each of the three titanium alloys (only two were cleaned for weight-loss measurements) were mounted on the support rods. The other samples were used for experiments not covered by this report. Single Mo, Nb, Cd, graphite-fiber-reinforced Ryton, and Ryton-coated 316L SS samples were mounted on the support rods on a space-available basis and, hence, only a few tests of each were made in the various

FIGURE 2. - Weight-loss corrosion sample mounting assembly.

Teflon washer and the sample in the mounting assembly (fig. 2). This was observed on Ti50A in wellhead brine and brine and steam from separator 1 (P1, P2, and P3), on Ti6Al4V in wellhead brine and brine from separator 1 (P1 and P2), and on TiCode 12 in the two separated brine environments (P2 and P4).

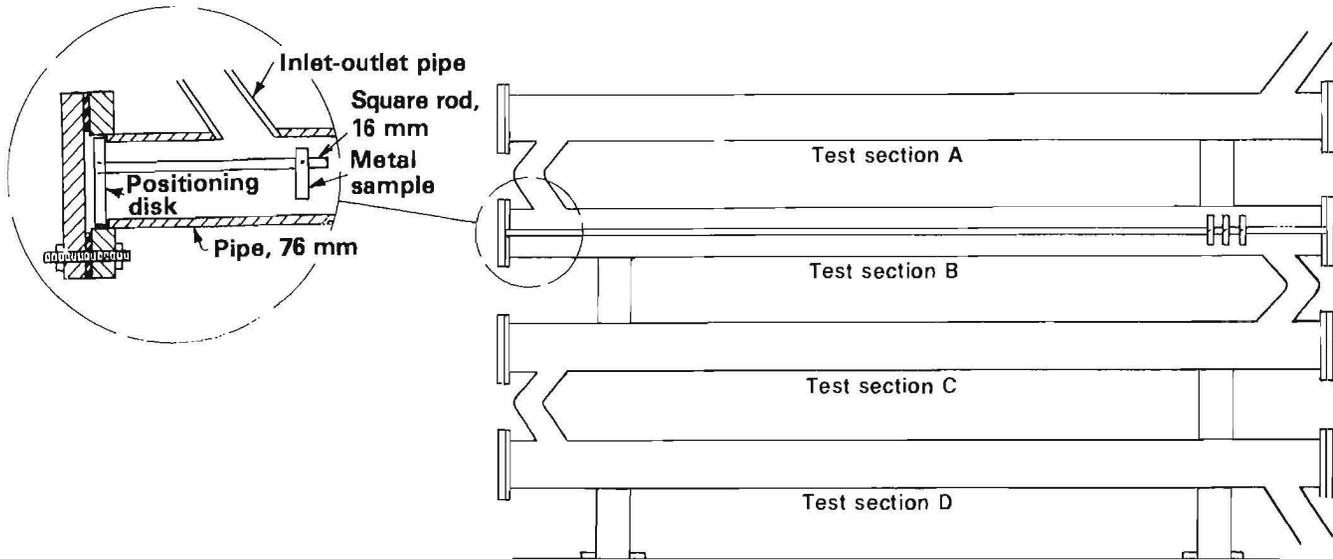
process environments. The 2.4-m-long support rods were axially loaded into one of four sections of the corrosion test package, as shown in figure 3. The details of the sample mounting and corrosion test package loading are given in RI 8350 (5). During the 45-day operation of the test facility, six test packages were exposed, one for 45 days, one for 30 days, and four separate packages for 15 days. All of the Ryton-coated 316L SS samples were exposed for 15 days and graphite-fiber-reinforced Ryton samples were exposed 45 days.

FIGURE 3. - Weight-loss corrosion test package.

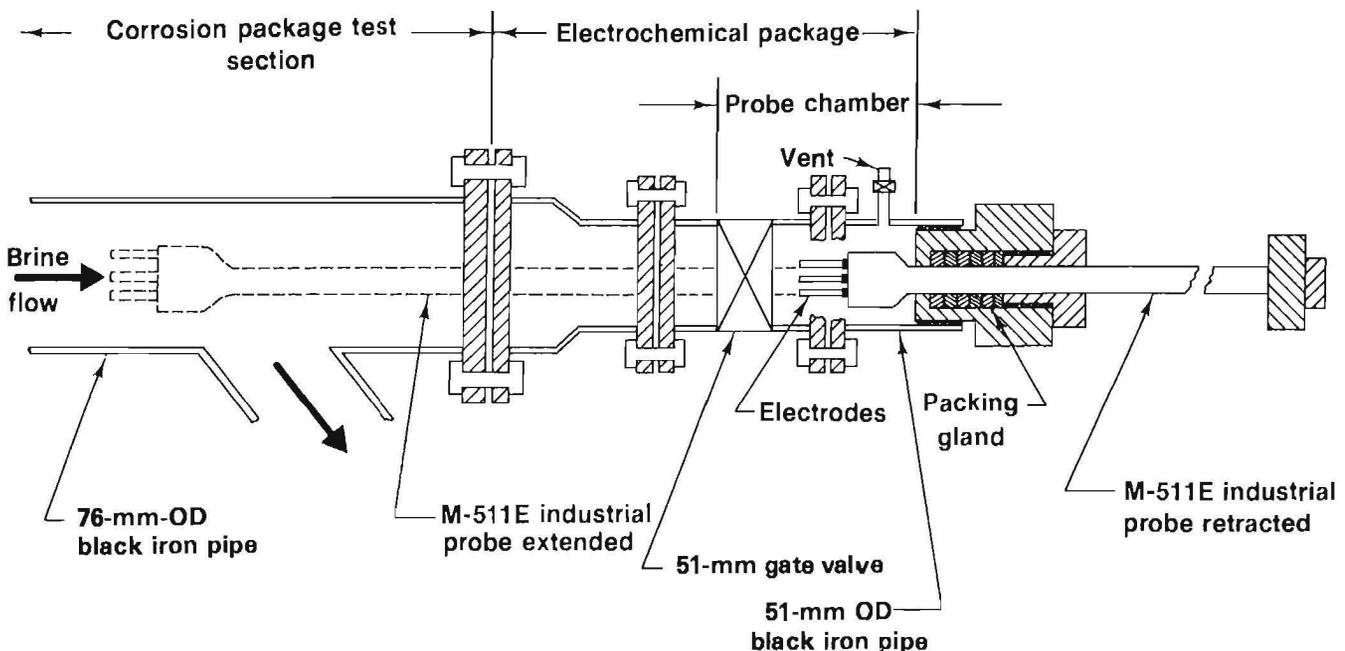
The industrial probe was mounted in the electrochemical package shown in figure 4. At the time of mounting, the probe was in the retracted position, the 0.4-L probe chamber was empty of brine, and the 51-mm gate valve was closed. The corrosion package test section contained hot flowing brine. The probe chamber was filled by first slightly and then fully opening the gate valve while simultaneously venting residual air and then steam

The corrosion test section (used with the electrochemical package) and the electrochemical package were wrapped with an approximately 15.2-cm-thick layer of fiberglass insulation to minimize heat losses and maintain the brine at a constant temperature. Measurements of the brine temperature in the probe chamber, when vented at a rate of 5 to 10 L/h and also after a 20-min period when venting was stopped and the 2-in gate valve was closed, were identical with the wellhead brine temperature, 215° C.

FIGURE 4. - Electrochemical corrosion test package.

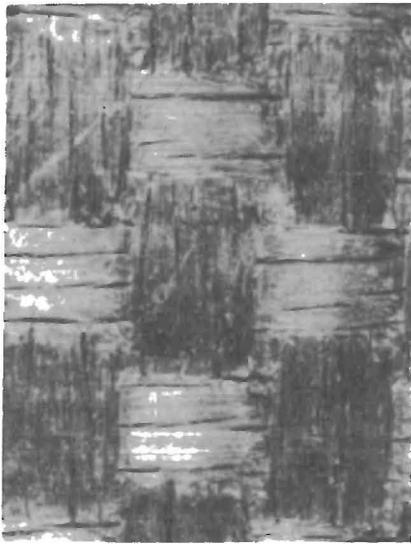
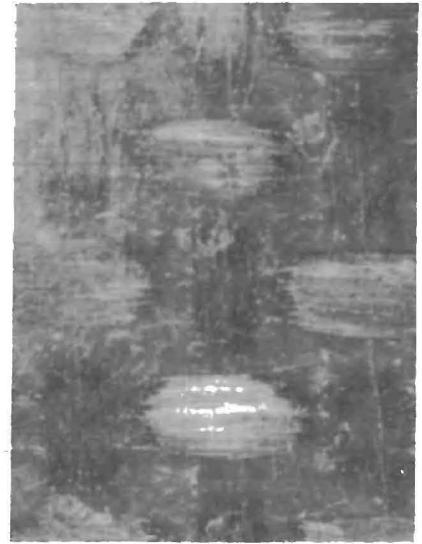
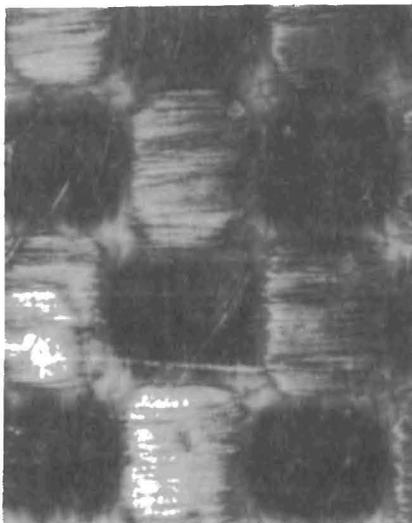
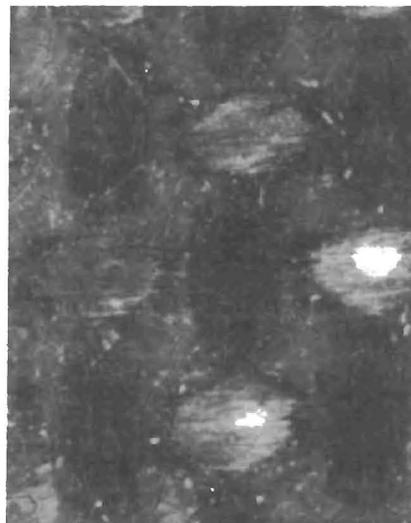
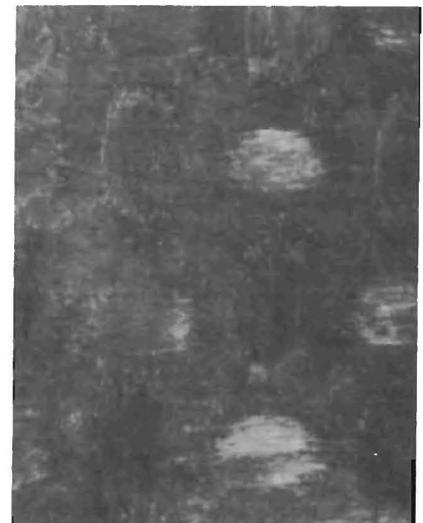
were taken at the same magnification. Samples exposed to wellhead brine (P1) suffered large losses of matrix material (Ryton) everywhere on the surface, exposing the graphite-fiber reinforcement. Cracks formed in the composite parallel to the exposed graphite fibers, and some fibers debonded (separated) from the matrix. Samples exposed to the brine and steam from the first and second separators were damaged substantially less

FIGURE 5. - Graphite-fiber-reinforced Ryton composites exposed 45 days in brine and steam corrosion test packages.

than those exposed to wellhead brine. There was some loss of matrix material from the surface, but cracks in the composite parallel to the fiber reinforcement were the principal form of damage. Cracking and debonding probably resulted from the use of the graphite-fiber-reinforced Ryton composite at temperatures considerably above the maximum recommended temperature, 150° C (1). The loss of matrix material from the sample surface would seem to involve other factors as well, such as erosion.

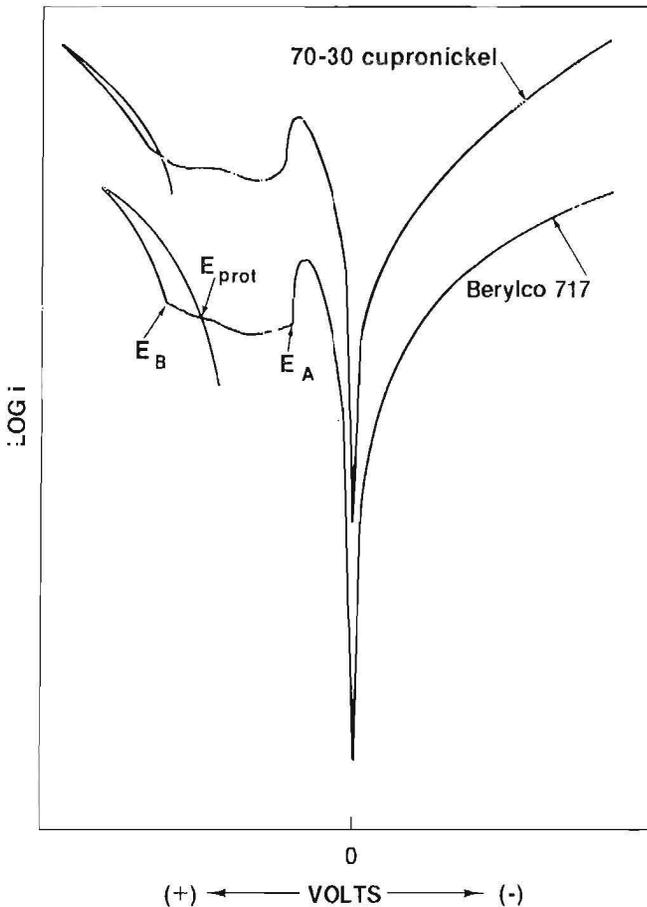
Selected polarization curves, plotted as $\log i$ versus potential (arbitrary units on both axes), are given in figures 6 and 7 to illustrate the performance of the copper and titanium alloys, respectively. Among the features they show are the activation potential, E_A , the least noble potential where passivity is maintained; the breakdown potential,

FIGURE 6. . . Potentiodynamic polarization curves for 70-30 cupronickel and Berylco 717 exposed to wellhead brine at 215° C.

E_B , marking the beginning of the transpassive region and the least noble potential where pitting and/or crevice corrosion will initiate; and the protection potential, E_{prot} , the least noble potential wherein pitting and/or crevice corrosion will propagate. These features have been labeled on the curve for Berylco 717 (fig. 6), but can be found on other curves in figures 6 and 7 as well.

All of the copper and titanium alloys exhibited a region of active corrosion followed by a passive region at more noble potentials. Except for naval brass, the width of the passive region ($E_B - E_A$), for the copper alloys was 200 to 300 mV. Naval brass had a narrow passive region which may be due to its high (35.4 wt pct) zinc content. The width of the passive region for the titanium alloys was 1,100 to 1,400 mV and was characterized by several secondary peaks.

The point where the reverse scan crosses the forward scan is defined as the protection potential, E_{prot} , only when that point is at a potential less noble than the breakdown potential, E_B . Such a case is illustrated in figure 6 for Berylco 717. The attendant hysteresis in the polarization curve is associated with a range of potentials from E_{prot} to E_B where the materials are considered susceptible to localized corrosion through the propagation of pits and crevice corrosion. Berylco 717 was the only copper alloy to exhibit this behavior in wellhead brine. None of the titanium alloys exhibited this behavior. However, Ti6Al4V and Ti50A were shown in the weight-loss measurements to be susceptible to crevice corrosion in wellhead brine, and Ti6Al4V was shown to be susceptible to pitting corrosion in wellhead brine.

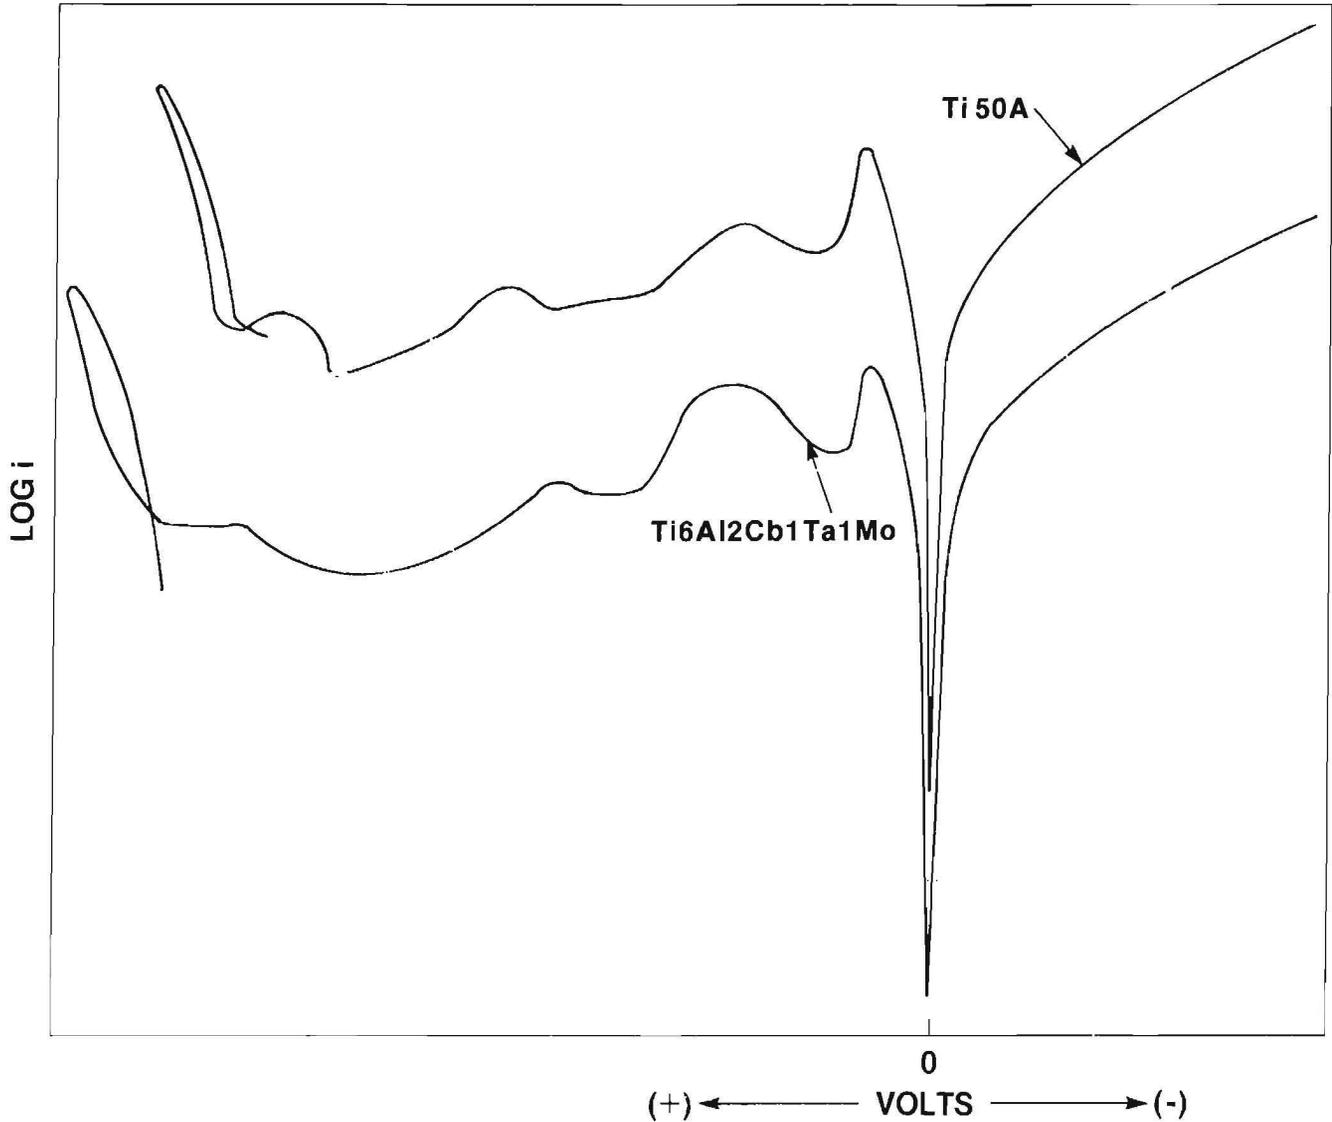
FIGURE 7. - Potentiodynamic polarization curves for Ti50A and Ti6Al2Cb1Ta1Mo exposed to wellhead brine at 215° C.
