Report of Investigations 9044

Evaluation of Bearing Plates Installed on Full-Column Resin-Grouted Bolts

By Stephen C. Tadolini and Bryan F. Ulrich

BUREAU OF MINES

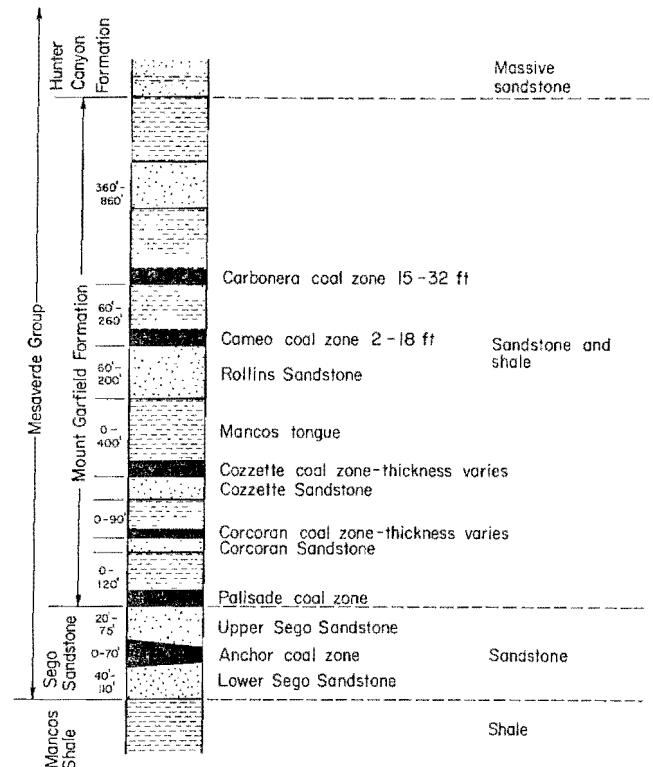
FIGURE 2.—Generalized stratigraphic column of the Roadside Mine.

geology consists of interfingering sandstones and shales of Upper Cretaceous age with several important coal zones. Bedding generally dips about 5° northeast away from the Uncompaghre Uplift toward the southwest rim of the Piceance Creek Basin. A generalized stratigraphic column of the Roadside Mine area is shown in figure 2.

The oldest exposed rock unit in the area is the Mancos Shale, a black to dark-gray soft shale with occasional thin sandstone beds. The Mancos grades upward into the Segoe Sandstone, a fine-grained, buff to light-gray sandstone with some gray shale. The Segoe is divided into an upper and lower member by the Anchor coal zone, a tongue of the Mancos Shale, which has been mined in some parts of the area.

The Mount Garfield Formation consists of buff and gray, medium-fine-grained sandstone interbedded with gray shale. There are five economically important coal zones in the area. The Palisade zone forms the base of the Mount Garfield

Formation. The Corcoran coal zone and the Cozzette coal zone overlie the Corcoran and Cozzette Sandstone Members, respectively. The Cameo coal zone overlies the Rollins Sandstone Member. This zone produces most of the coal from the Book Cliffs Coalfield. The Roadside Mine produces from the Cameo B seam, which is 4.4 to 9.4 ft thick. The uppermost coal zone is the Carbonera.

The uppermost unit in the area is the Hunter Canyon Formation. The Hunter Canyon is a medium-coarse-grained, buff and gray, massive cliff-forming sandstone with small beds of gray to greenish-gray shale. There are no coal deposits in this formation (4-5).

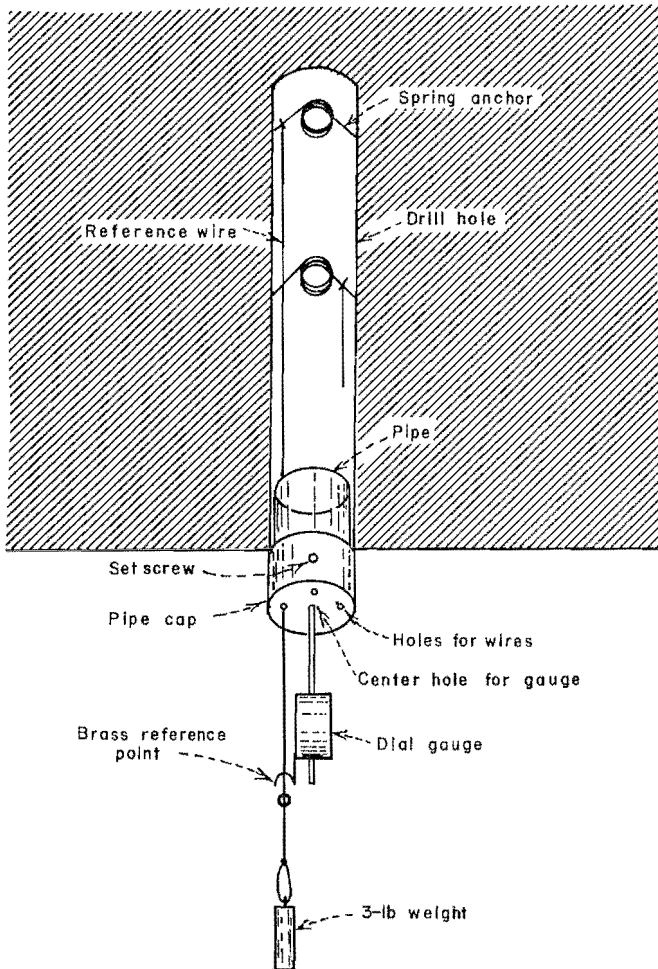
FIGURE 6.—Vertical displacement gauge.

The vertical-displacement gauge (fig. 6) consists of four spring clips used to anchor high-strength, stainless steel prestretched wire at selected depths in a 1-3/8-in-diam hole drilled in the mine roof. The uppermost spring clip is placed in a stable layer to be used as a base reference for measured displacements. For this investigation, a hole depth of 7 ft was used. The remaining three spring clips are placed at 5 ft, 3 ft, and 1 ft away from the bolthead. The wires from the four spring clips run through a 10-in-long tube anchored in the collar of the drill hole. The wires go through numbered holes in the copper cap on the end of the tube and have small brass fittings that are used as reference points. A loop is made at the end of the wires so that a 3-lb weight can be attached to maintain a constant tension on the wire while readings are taken. Readings are made with a dial indicator placed between the cap and the reference point on each wire.

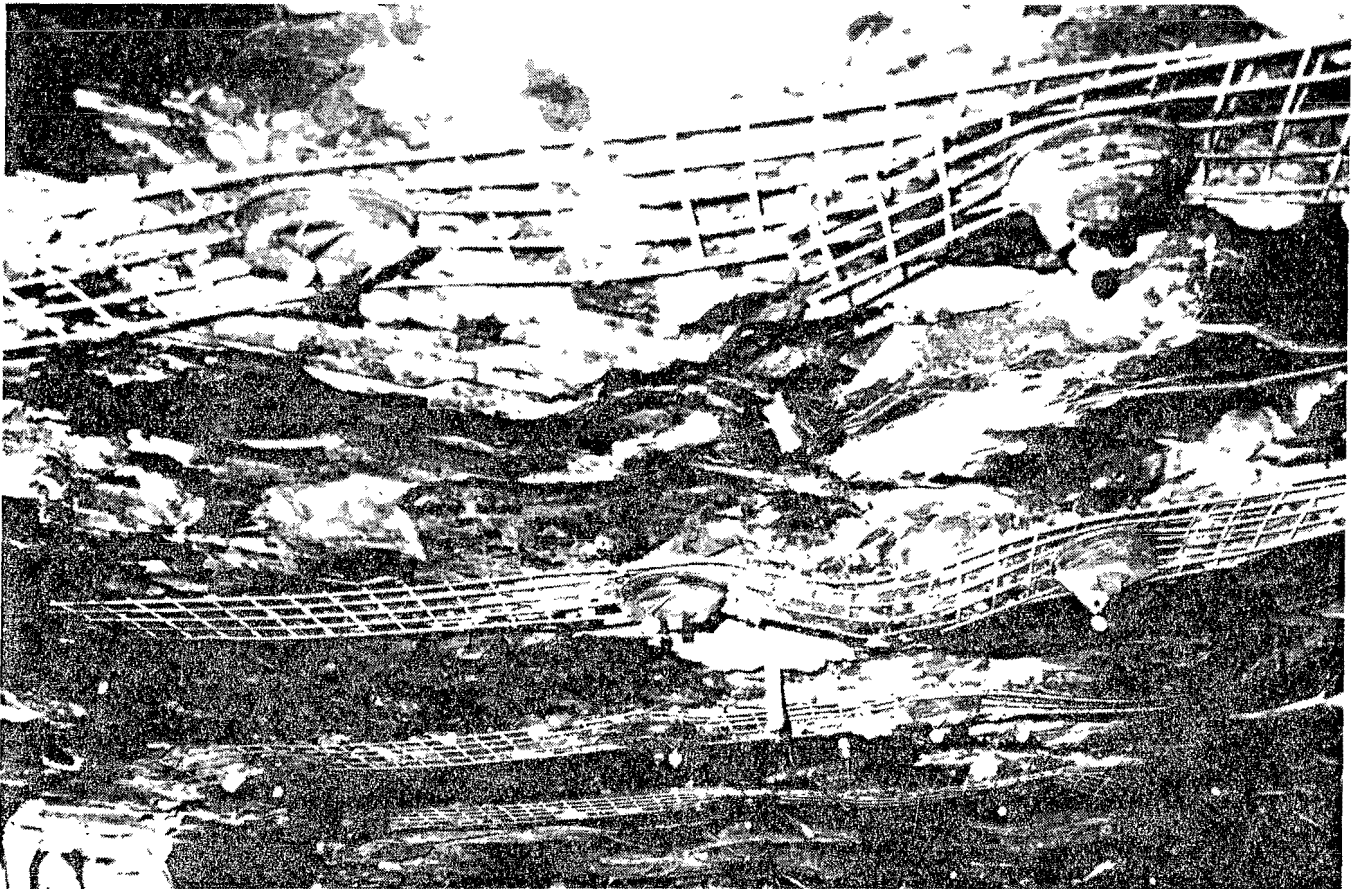
FIGURE 9.--Roof spalling in Roadside Mine test site.

The loading trends observed 72 days after installation were similar to those recorded at 3 days; however, the loads increased by 30% (fig. 9). Loads on the bearing plates ranged from 6,100 lb to

32,000 lb and averaged 18,100 lb. Visual examination of the test area revealed high degrees of roof spalling, as shown in figure 9.
