RI 9474

# Field Evaluation of Cable Bolt Supports, Homestake Mine, Lead, SD

By J. M. Goris, T. M. Brady, and L. A. Martin

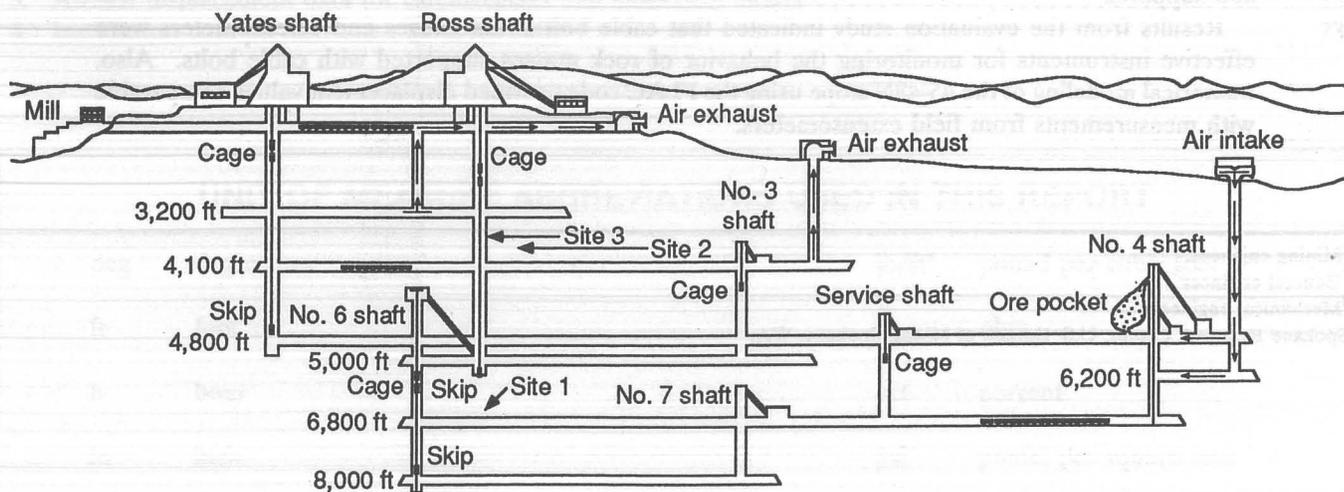
Figure 1.—Generalized cross section of Homestake Mine.

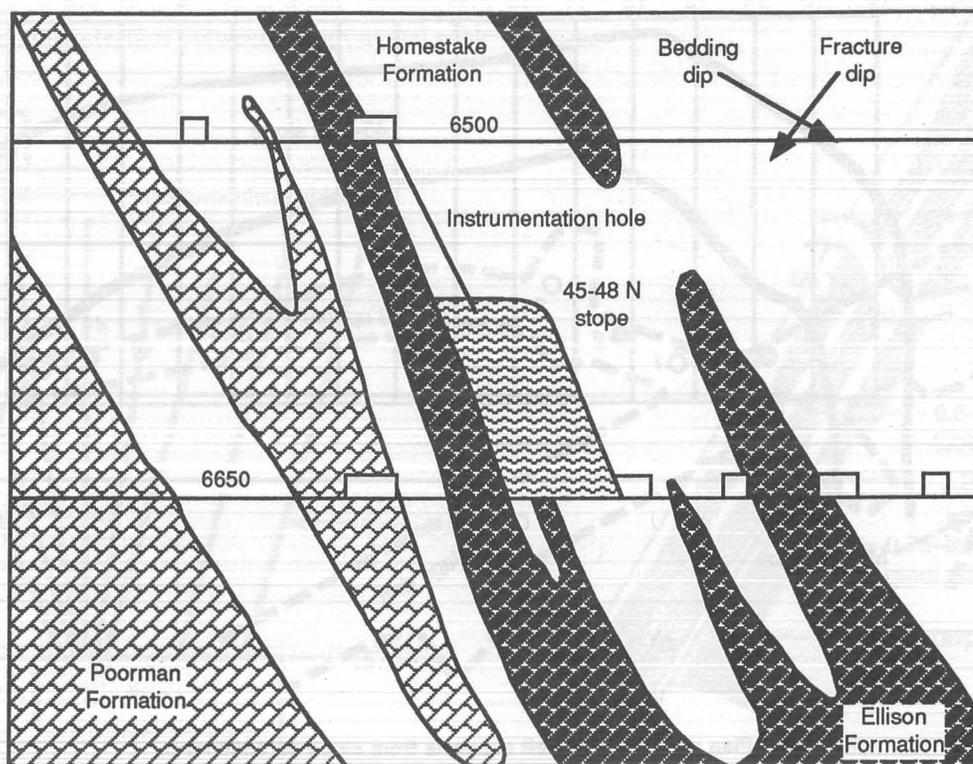
Figure 2.—Cross section of geology surrounding drift on 6500 level and stope on 6580 level.

by 45 ft wide. Between the 6500 and 6650 levels, it dips from 35° to 60° east with a near-vertical plunge to the south. The contact between the Homestake and the overlying Ellison Formation creates planes of weakness along localized graphite layers, and these can cause ground control problems during mining. Figure 2 shows a typical cross section of the 45-48N stope area.

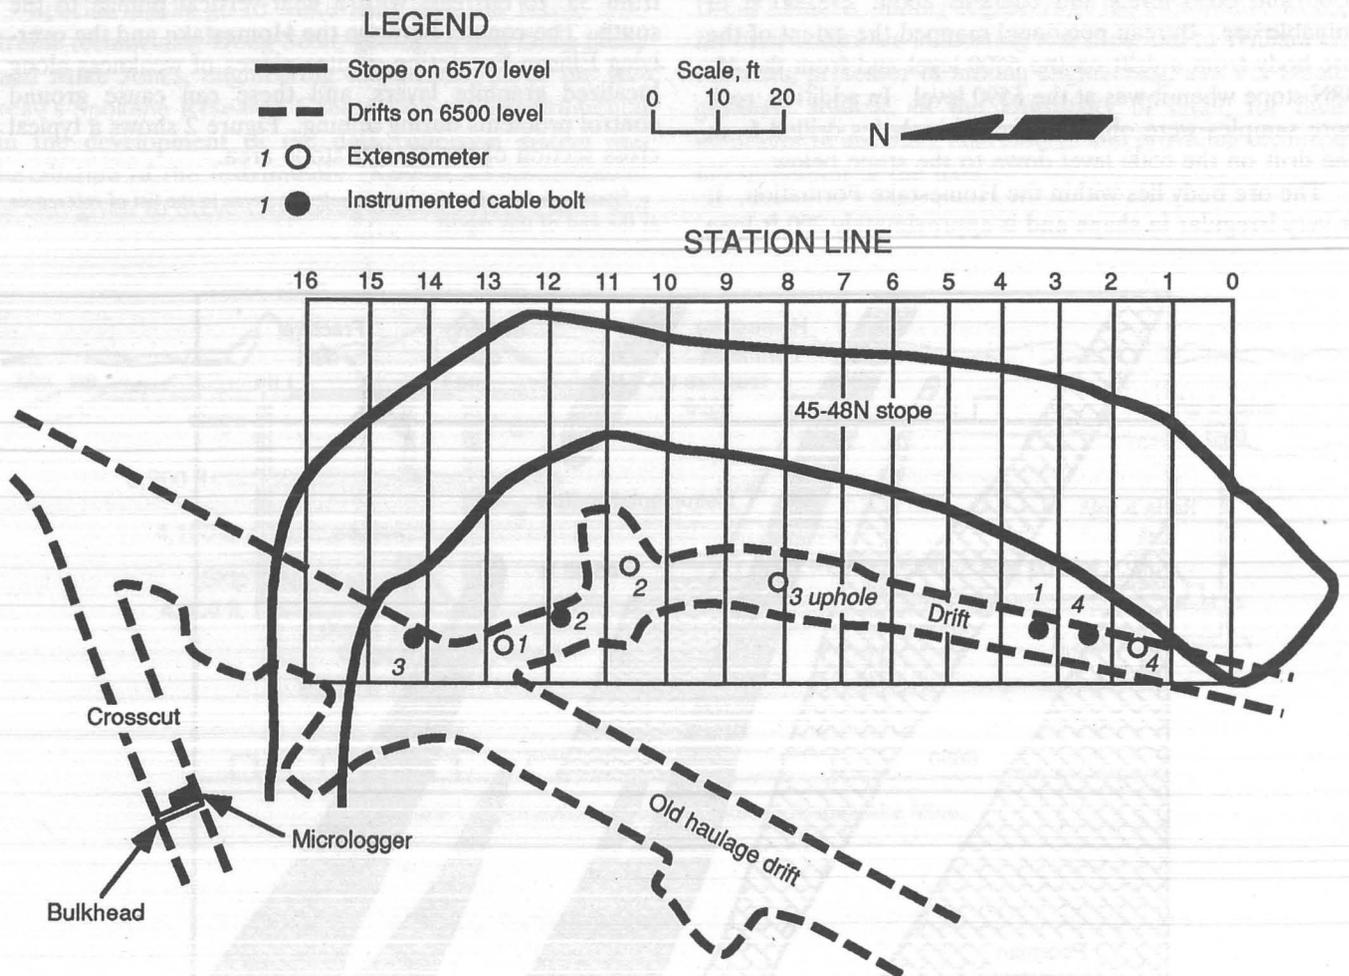
Figure 3.—Plan view of cable bolt supports from stope on 6580 level.

Ground control for this stope consisted of double 60-ft-long conventional and birdcage cable bolt supports as well as 5-ft-long Split Set rock bolts.<sup>5</sup> Stations for the cable support patterns began at the south end of the stope at station 0 and continued north to station 16 (fig. 3).

Conventional cable bolts were installed on 10-ft centers between stations 0 and 8. Birdcage cables were placed on 11-ft centers between stations 9 and 16. A typical cross section of the stope showing the fan-shaped configuration of the cable supports is shown in figure 4.

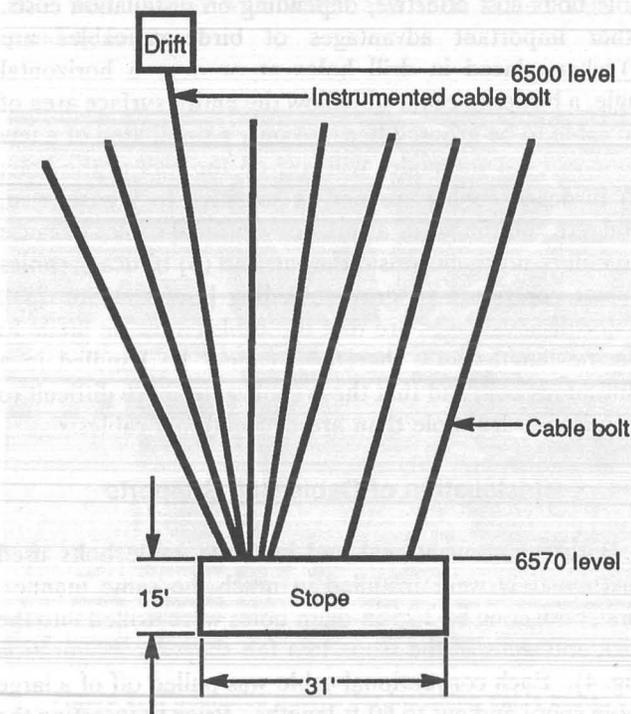
Figure 4.—Cross section of 45-48N stope.

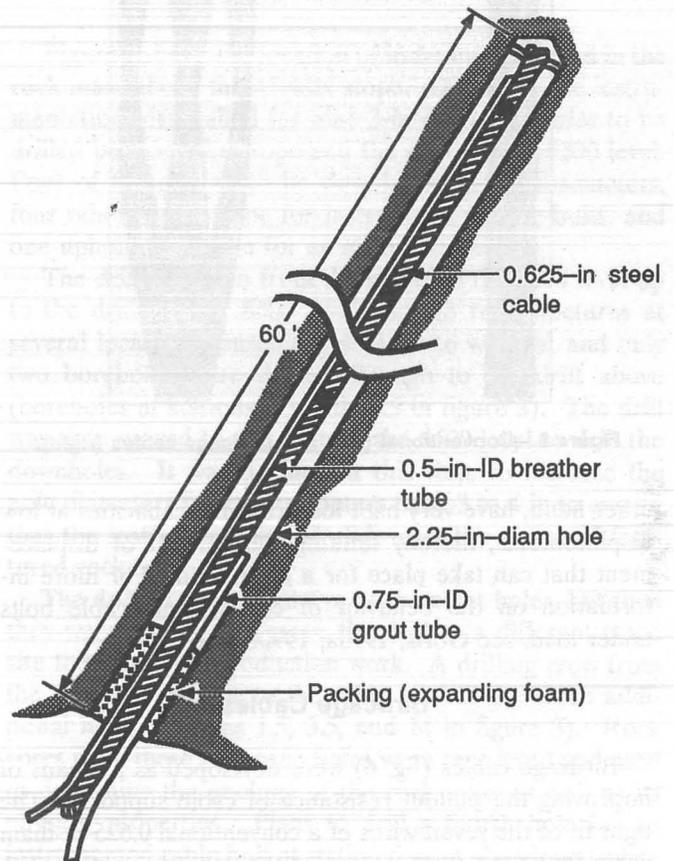
Figure 5.—Cutaway view of typical cable bolt support.

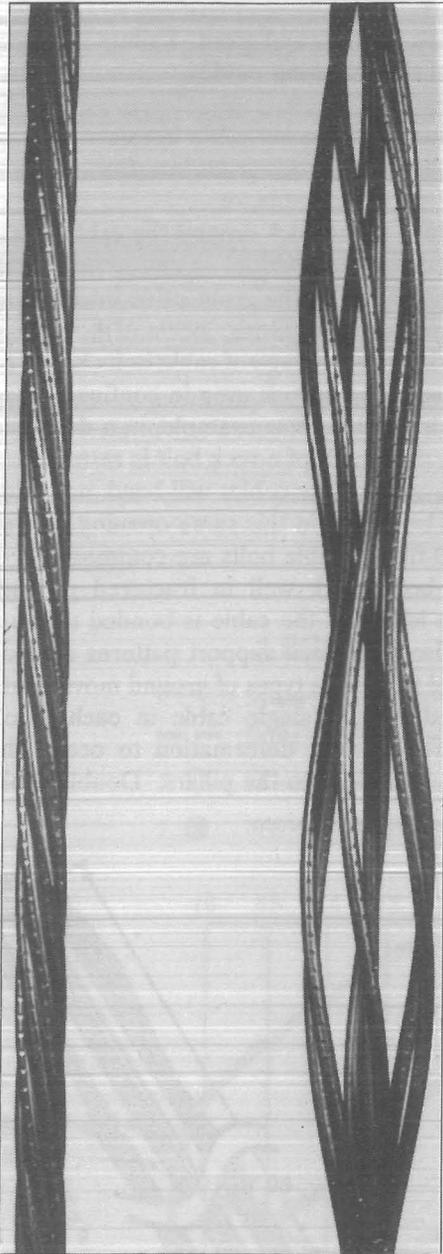
Figure 6.—Conventional (left) and birdcage cables (right).

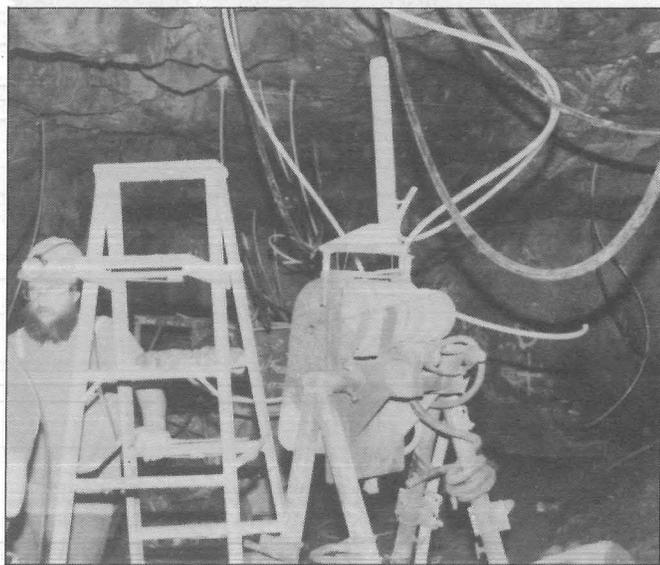
Figure 7.—Pneumatic pusher for installing cable bolts.

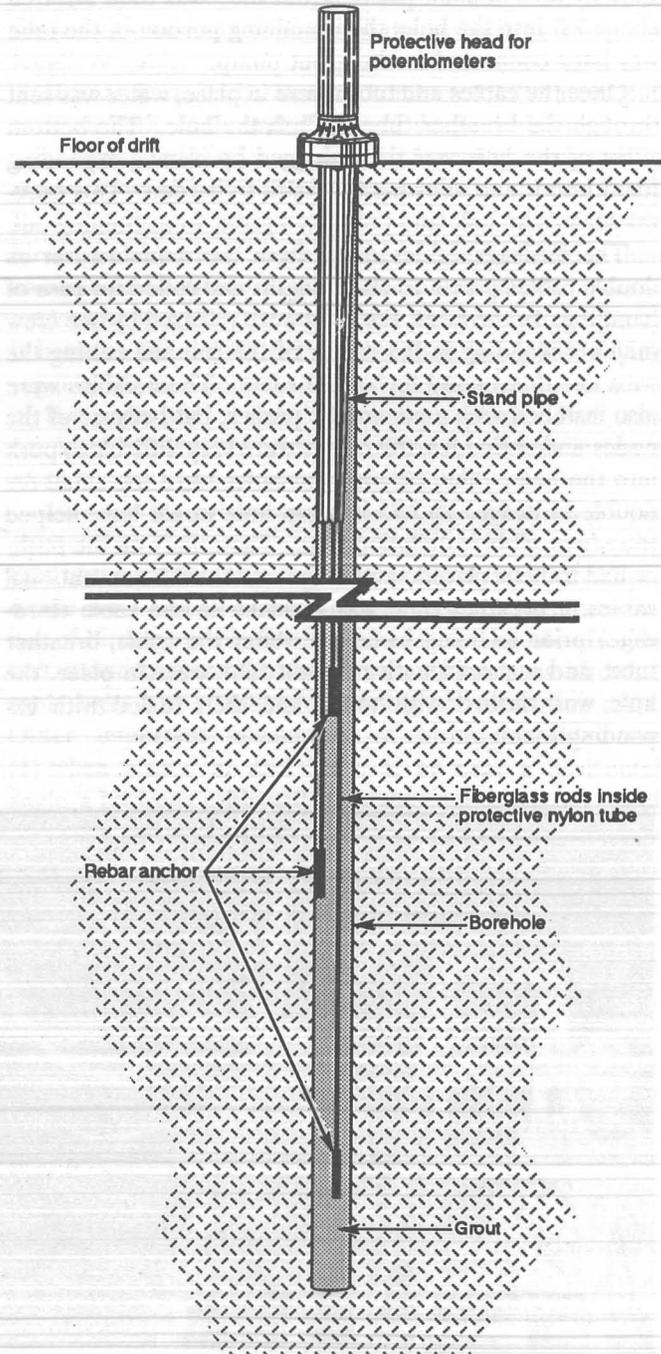
Figure 8.—Profile of extensometer with groutable anchors.

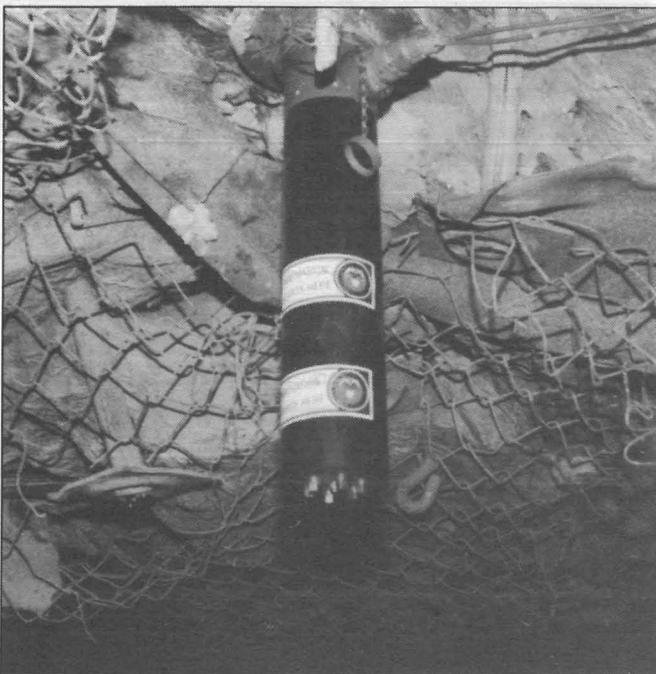
Figure 9.—Head of extensometer at station 8 (uphole).

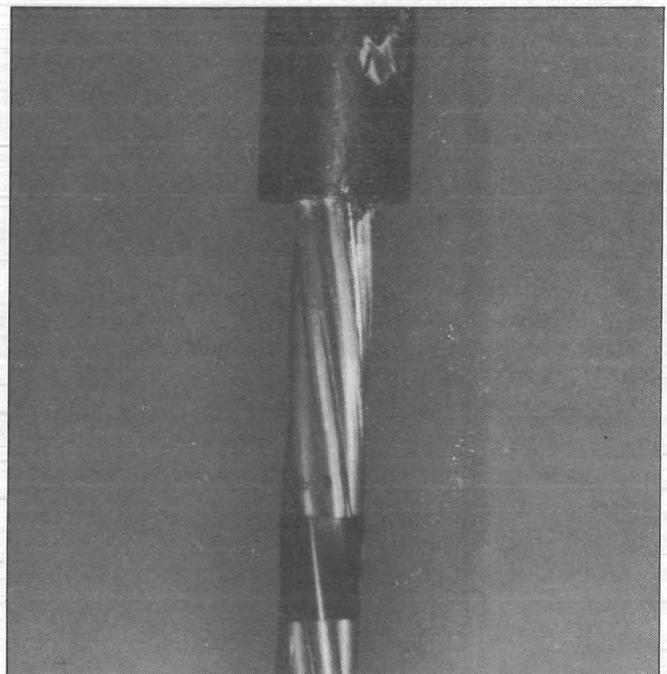
Figure 10.—Closeup of cable bolt strain gauge.

Cable support strain gauges function on the principle that changes in electrical resistance are caused by stretching of electrical wires, and thus by measuring the change in resistance, investigators can determine the amount of load being placed on selected cables.

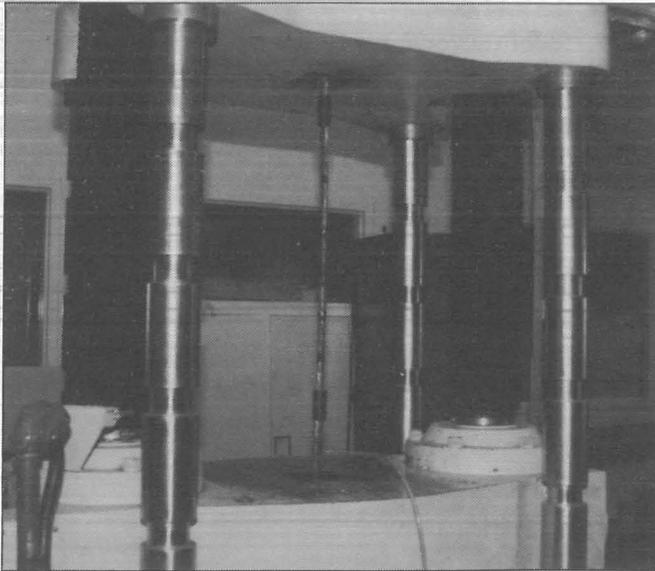
Figure 11.—Cable bolt strain gauge being tested in laboratory.

Although readouts from the gauges can be either in volts or strain, it was decided to generate the measurements in strain. Figure 11 shows a cable bolt strain gauge being tested in a Bureau laboratory. Figure 12 shows the strain versus load behavior of two cable bolt strain gauges. Both gauges were attached to a conventional 0.625-in-diam cable. In the first test, the cable was not embedded in grout. In the second test, both the gauge and the cable were embedded in a cement grout column and allowed to cure for 7 days before testing. The tests were conducted by placing the instrumented cable in a test

machine (fig. 11), securing the ends of the cable with barrel-and-wedge anchors, and then loading the cable. Continuous readings of strain and load were recorded during the test. Both curves in figure 12 are linear, although the gauge embedded in grout showed a little less strain for a given load than the free-standing gauge. A value of  $1.13 \times 10^{-7} \epsilon/\text{lbf}$  was obtained from the gauge embedded in grout, and this value was used as input to the

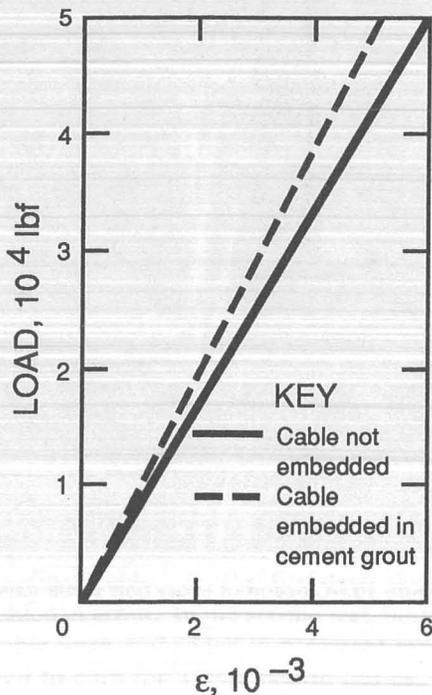
Figure 12.—Load-strain curves for cable bolt strain gauges.

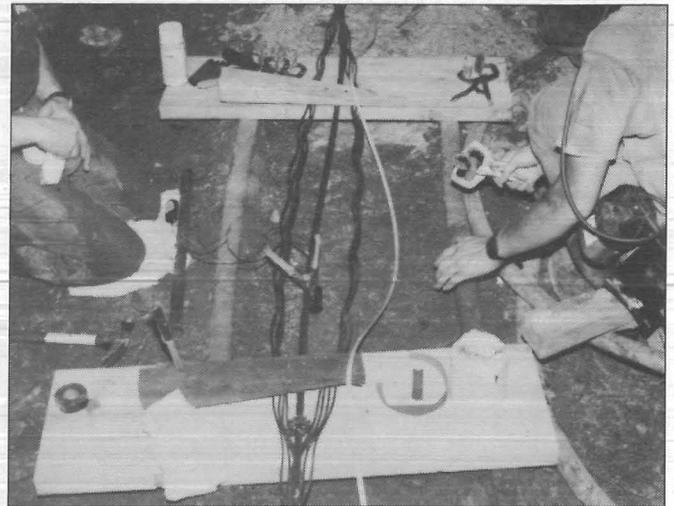
Figure 13.—Strain gauge being placed on combined conventional and birdcage cable.

The strain gauges selected were developed for use on conventional 0.625- or 0.6-in-diam cables and could not be placed on birdcage cables. However, project personnel were successful in combining conventional and birdcage cables into a single tendon so that the strain gauges could be used. Various numbers of outer wires from birdcage cables were placed around a conventional cable, after

which a strain gauge was attached to the conventional cable (fig. 13). A series of these conventional cable-birdcage cable combinations were made and tested to determine how many outer wires of birdcage cable were required to duplicate pull-test results obtained with a double birdcage cable [see Goris, 1990b (8) for details on conducting pull tests]. The combination cables tested included conventional cables with 6, 8, and 10 outer birdcage wires. Load-displacement curves for these tests are shown in figure 14. Each curve represents the average of five pull tests. The figure shows that a conventional cable with eight outer birdcage wires closely approximates the pullout behavior and maximum load-carrying capacity of double birdcage cables. Therefore, two 60-ft-long cables with this configuration were ordered from a supplier in Australia. These cables were then instrumented with five cable bolt strain gauges each and installed in the 45-48N

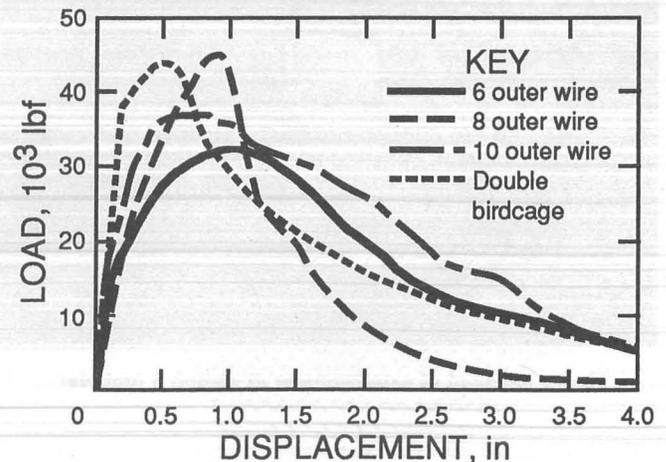
Figure 14.—Load-displacement curves for tests on combined conventional and birdcage cables.

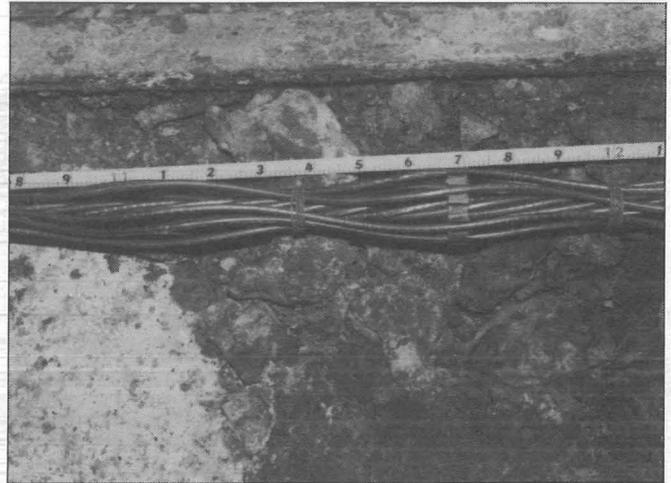
Figure 15.—Combined conventional and birdcage cables.

stope at stations 12 and 14 (fig. 3). Figure 15 shows an instrumented birdcage cable prior to being placed in a hole.

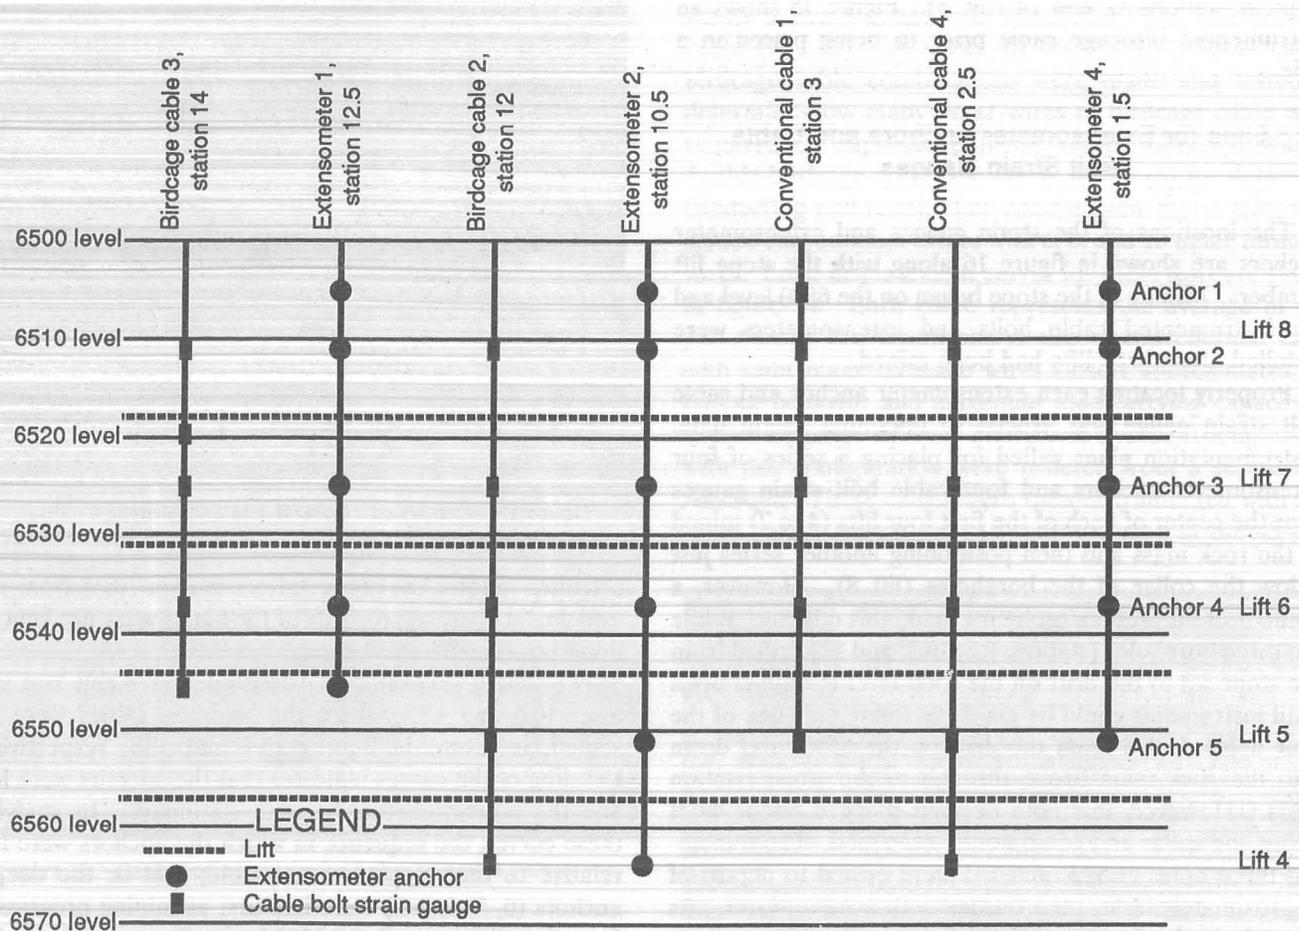
Figure 16.—Locations of extensometer anchors and cable bolt strain gauges.

At station 12.5, there were no extensometer anchors in lift 4 above the 6570 level (fig. 16). Displacements of anchors 1 through 5 for this extensometer during the first 200 days were most likely caused by floor movement in the drift on the 6500 level (fig. 18B).

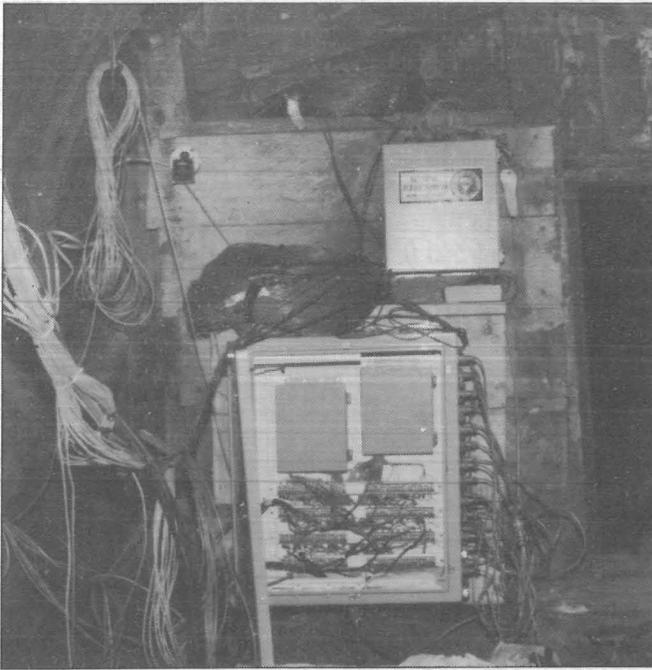
Figure 17.—Micrologger on site at mine.

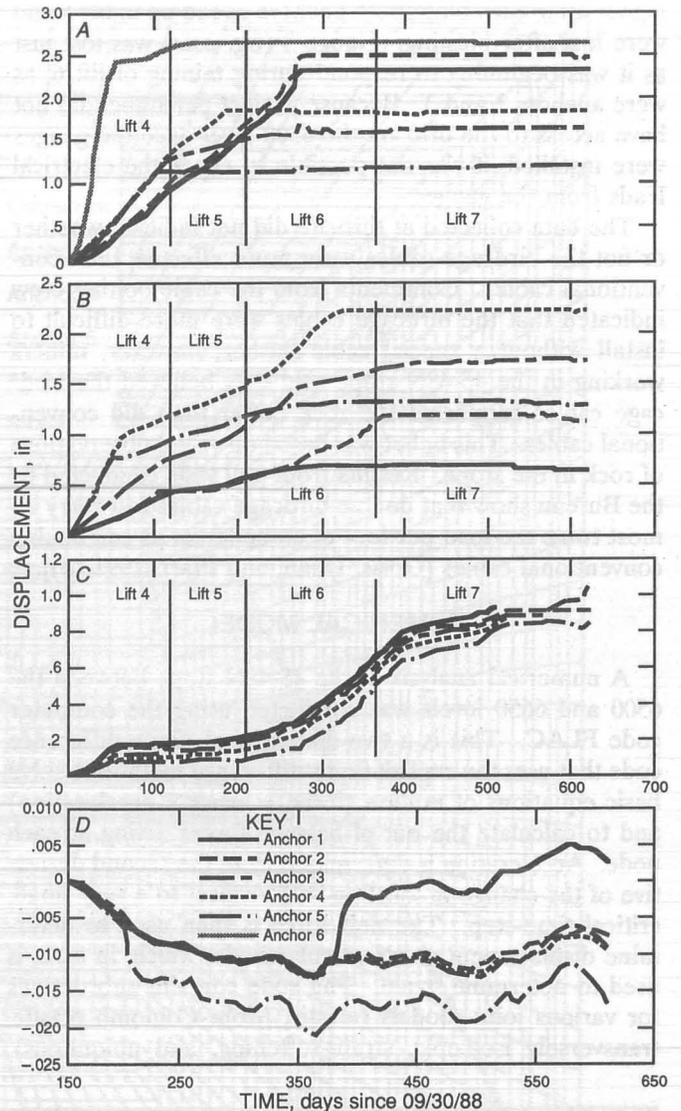
Figure 18.—Time-displacement curves for extensometers. A, Extensometer 2; B, extensometer 1; C, extensometer 3; D, extensometer 4.

Movement recorded by extensometers 2 and 1 at stations 10.5 and 12.5, where the birdcage cables were installed, is shown in figures 18A and 18B, respectively. Leveling of the curves indicates that the anchors were lost and the potentiometers became stationary. In studying these curves, the sequence in which the anchors were lost relative to time appears reasonable; that is, the deeper anchors (6, 5, 4, etc.) were lost first as mining progressed from the 6570 toward the 6500 level. For example, in figure 18A, anchor 6 was located in lift 4, which was approximately 13 ft high, between the 6570 and 6557 level. This anchor was lost after 120 days of mining. Anchor 5 was lost after 250 days, and anchor 4 was lost after 310 days. Anchor 3 continued to be read up to 600 days. Lift 7 had not been mined at the time the data collection system was removed from the mine.

It is important to note that in figure 18A, all of the displacement values are positive, which indicates that the rock at each anchor location was moving down and away from the drift on the 6500 level and toward the stope. There is some question about displacement values for anchors 1 and 2, at least for the first two lifts, lifts 4 and 5. These anchors were only 5.5 and 11 ft below the collar, but the displacement values are approximately the same for both anchors. It appears that the floor in the drift on the 6500 level was heaving as a result of mining in the area around the drift, and this caused the head of the extensometer to move. Photographs of the drift over the period that the instruments were being monitored indicate that a great deal of rock movement was taking place. Figure 19 shows haulage tracks being displaced by floor movement.

placed in an uphole in the back of the stope. Anchors 1 through 5 were placed 5, 10, 20, 35, and 50 ft, respectively, from the collar of the borehole. Displacement readings from all five anchors approximated one another (fig. 18C), indicating that most of the movement was caused by rock movement around the drift. Consequently, when displacement values for any of the anchors were determined, the corresponding displacement value for anchor 1 at that point in time was subtracted to indicate actual movement of the anchor.

Data in figure 18D came from extensometer 4 located at the back of the stope area at station 1.5. This extensometer was installed 150 days after the first three extensometers and after lift 4 had been mined.

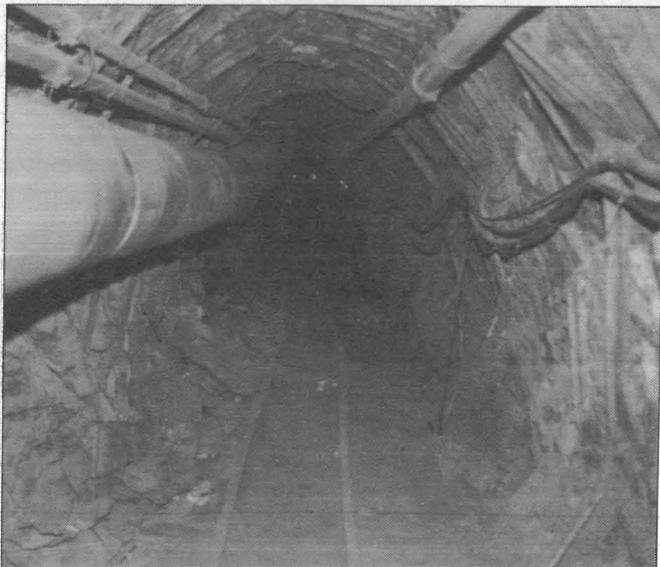
Figure 19.—Drift on 6500 level.

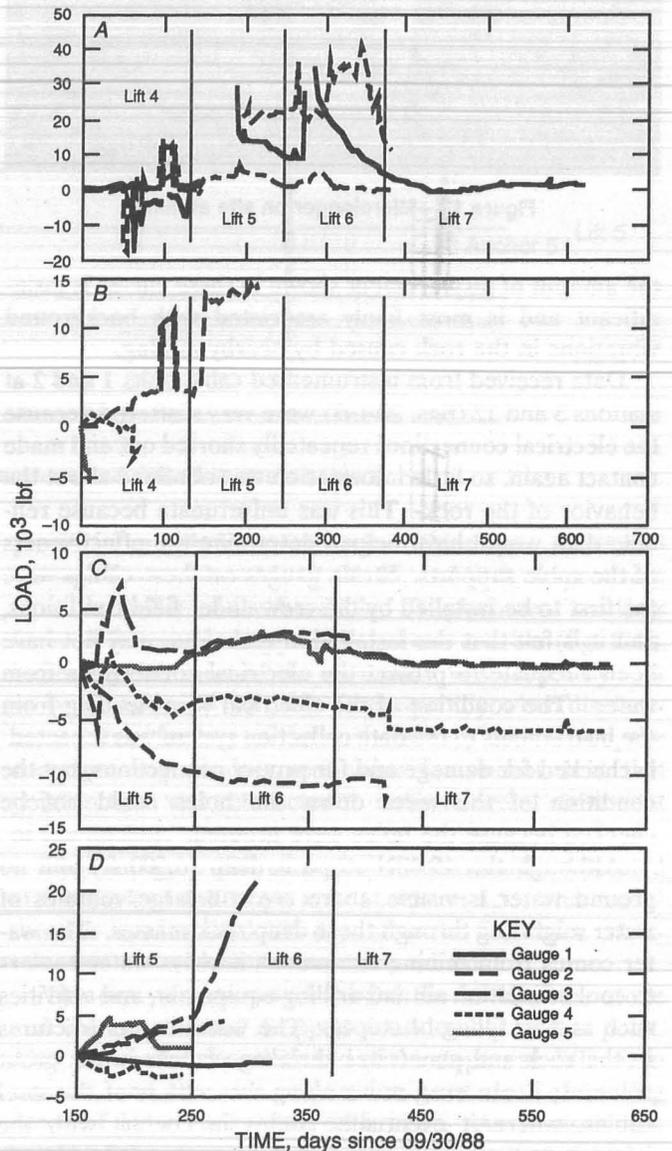
Figure 20.—Time-load curves for instrumented cable bolts. A, Cable bolt 1; B, cable bolt 2; C, cable bolt 3; D, cable bolt 4.

Data received from instrumented cable bolts 1 and 2 at stations 3 and 12 (figs. 20A-B) were very scattered because the electrical connections repeatedly shorted out and made contact again, so little information was obtained about the behavior of the rock. This was unfortunate because reliable data would have helped determine the effectiveness of the cable supports. Strain gauges on these cables were the first to be installed by the crew under field conditions, and it is felt that the installation technique may not have been adequate to protect the electrical connections from water. The condition of the electrical wires leading from the instruments to the data collection system was repeatedly checked for damage and for proper connections, but the condition of the wires down the holes could not be checked because the holes were grouted.

The strain gauges on instrumented cable 3 at station 14 (fig. 20C) responded very well for several months, but then

two of the gauges began to show very low negative load values, indicating that the cables were placed in compression. Part of the negative values were, however, likely the result of creep in the gauges, as discussed earlier. When gauges are installed on cables, they are placed under some strain; therefore, in addition to gauge creep, negative readings may be caused when rock fractures close and cause the cable to compress.

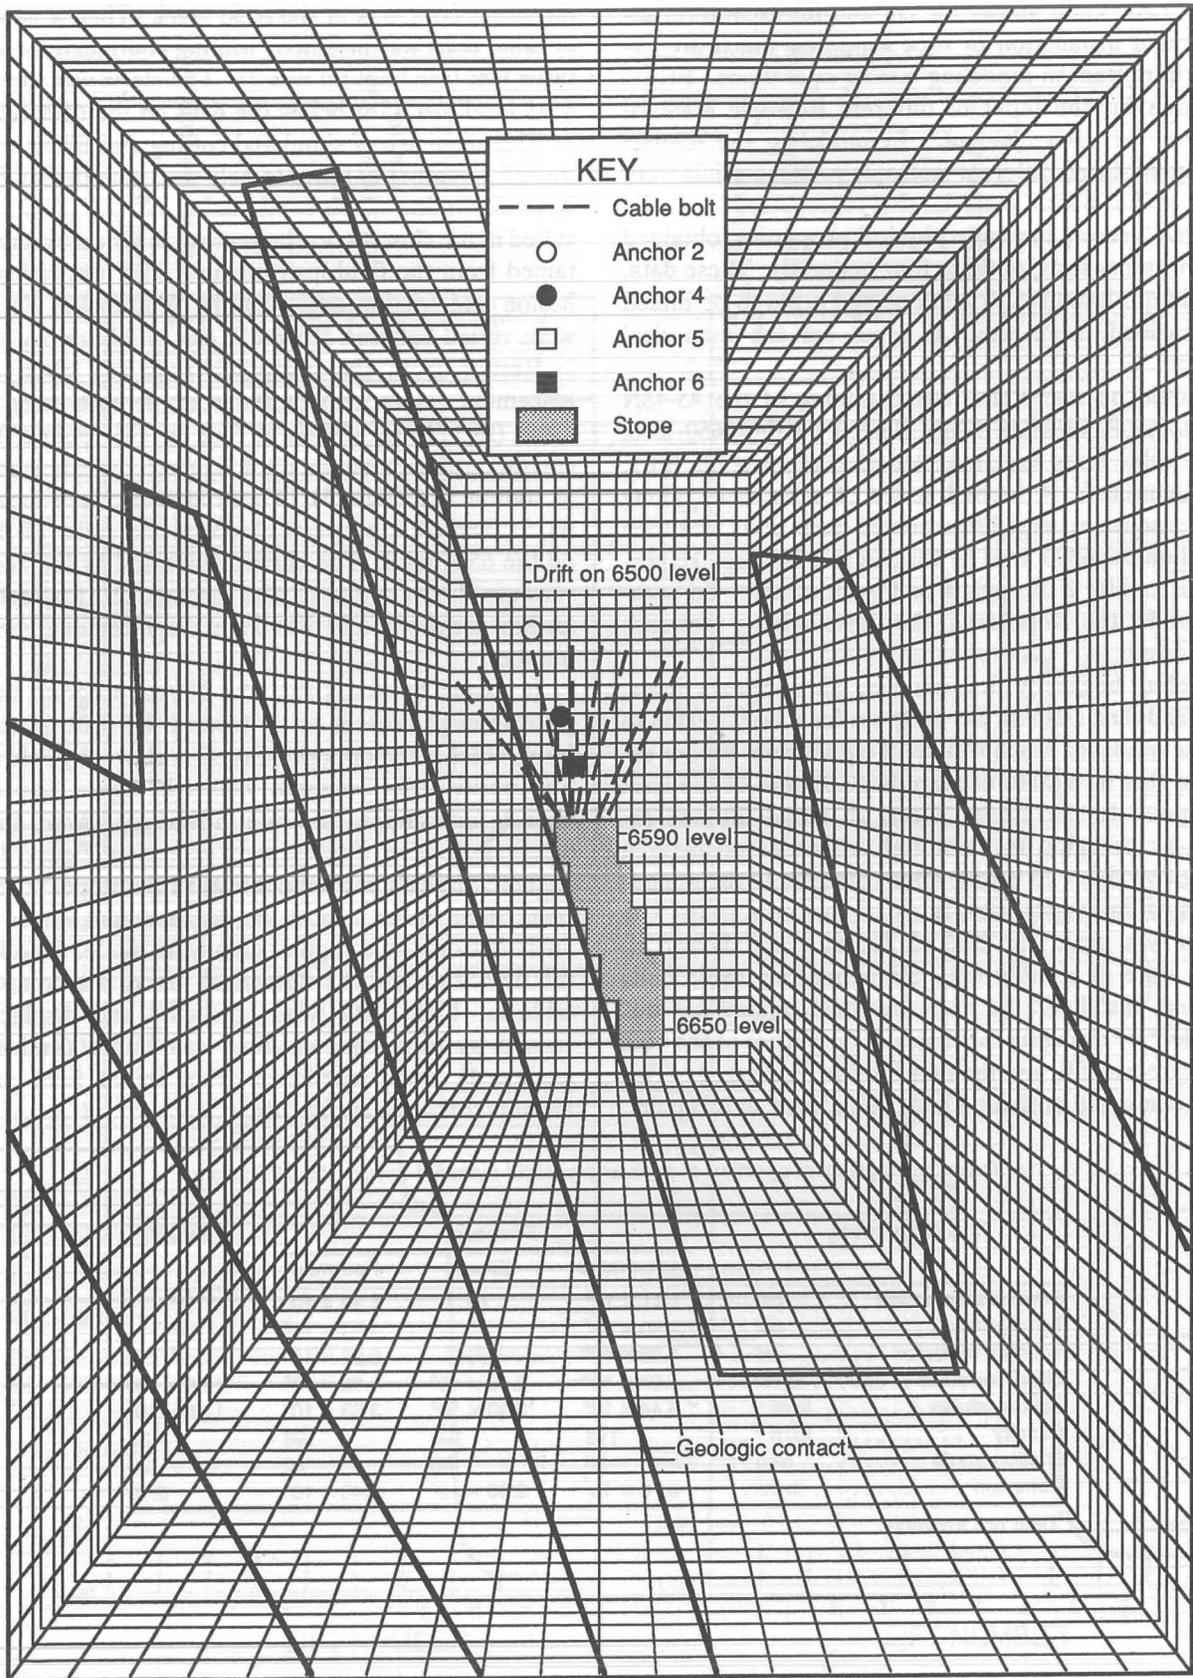
Figure 21.—Computer mesh for numerical analysis of 45-48N stope.

To model the 45-48N stope region, a computer mesh (fig. 21) was developed based on the geology and stope geometry at station 10.5 (fig. 3). This mesh contained 5,600 elements and approximated the profile of the 45-48N stope as seen in figure 2. The mesh represented an area 500 ft wide and 500 ft high around the stope. The inner grid was 20 by 40 ft, with each grid square representing an area 5 by 5 ft. The outer grid was also 20 by 40 ft, but here each grid square varied from 5 to 12.5 ft. The model assumed simple mine geometry and did not include any previously mined stopes or drifts in the vicinity of the 45-48N stope other than those shown in figure 21.

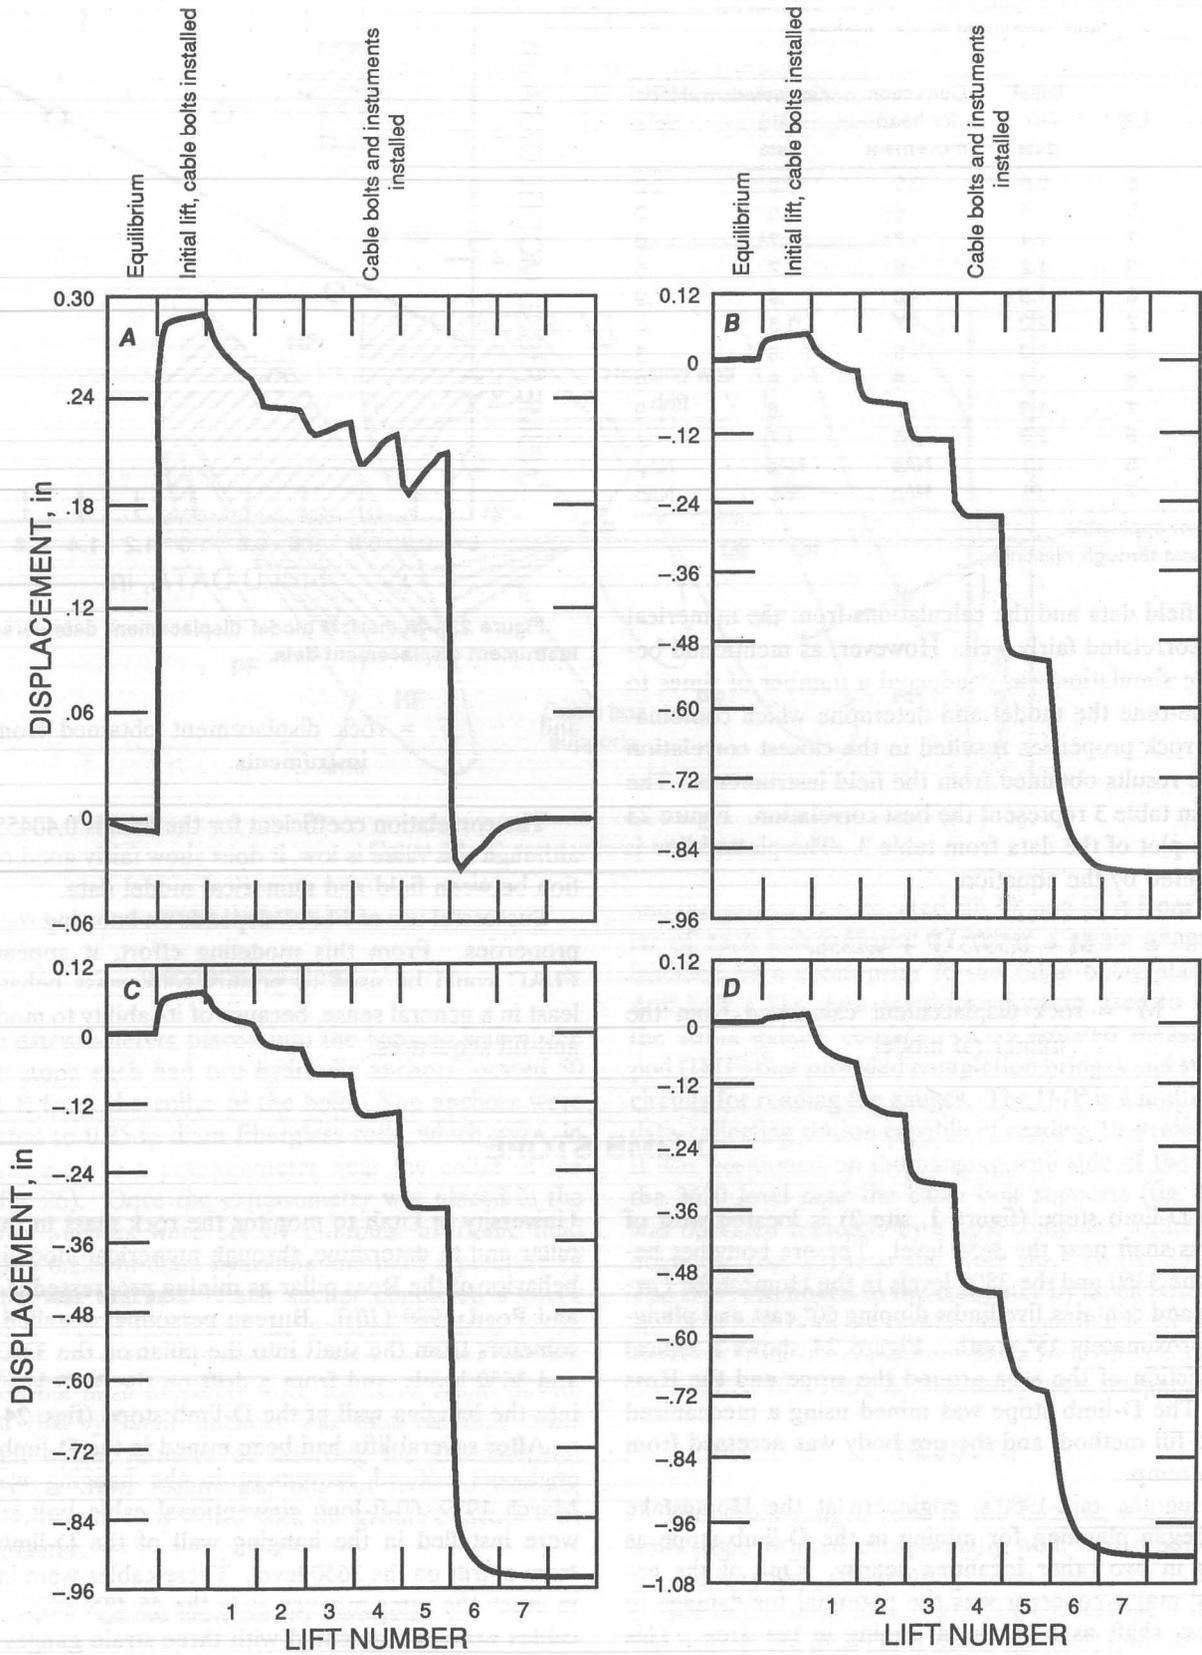
Figure 22.—Displacement curves from numerical analysis of 45-48N stope. A, Anchor 2; B, anchor 4; C, anchor 5; D, anchor 6.

It should be noted that the FLAC program indicates positive displacement as up toward the drift on the 6500 level, which is the opposite direction shown by field results. The positive displacement values in figure 22A for anchor 2, for example, indicate movement toward the drift, whereas positive displacement values in figure 18A for anchor 2 indicate movement toward the stope. Therefore, corrections in the sign of the displacement values for the anchors from the computer data were made. Results from the field data and the numerical model are compared in table 3. Field data were corrected and displacements caused by extensometer head movement (indicated by anchor 1) were subtracted from initial field data for anchors 2 through 6 (fig. 18A).

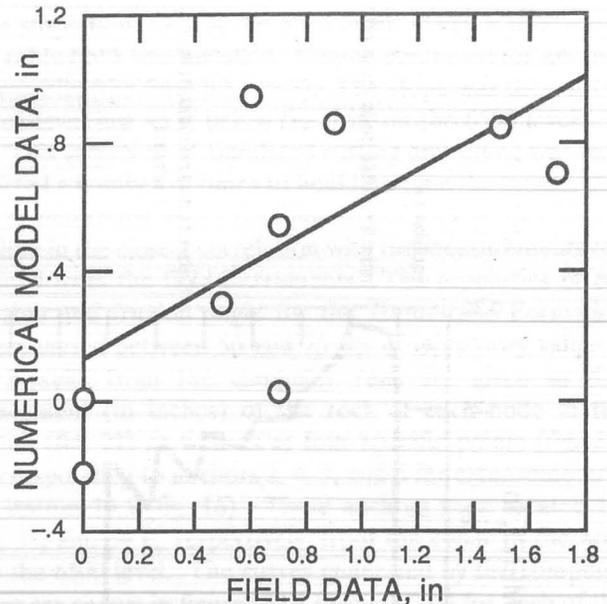
Figure 23.—Numerical model displacement data versus field instrument displacement data.

$$M = 0.5073 \cdot F + 0.1358,$$

where  $M$  = rock displacement calculated from the numerical model

and  $F$  = rock displacement obtained from field instruments.

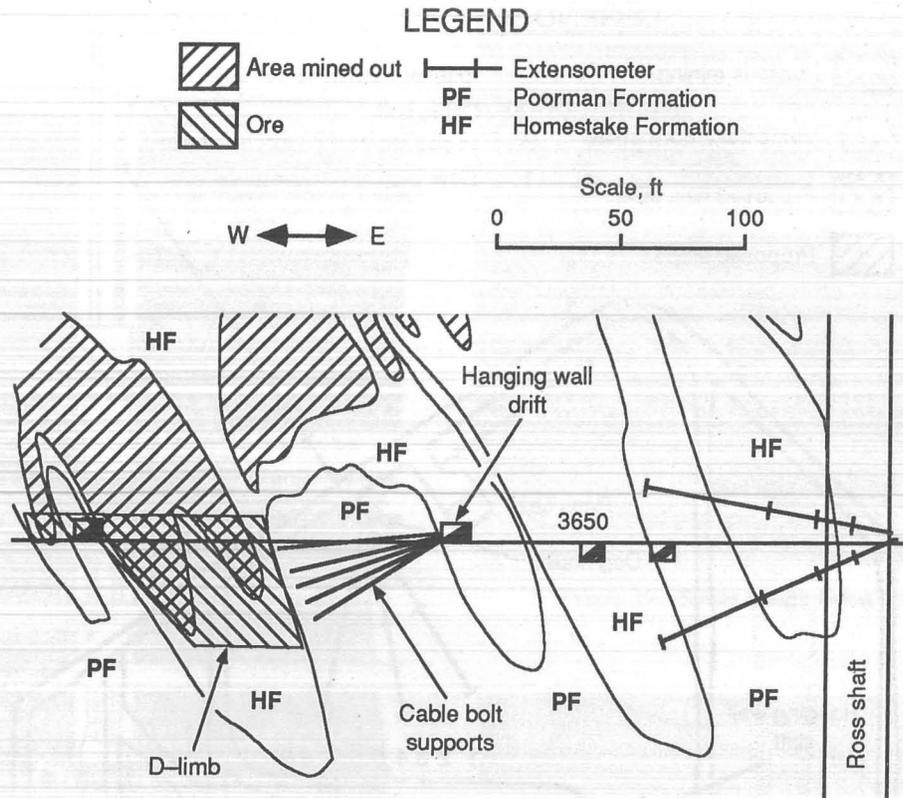
Figure 24.—Cross section of D-limb stope area.

University of Utah to monitor the rock mass in the Ross pillar and to determine, through numerical modeling, the behavior of the Ross pillar as mining progressed [Johnson and Poad, 1989 (10)]. Bureau personnel installed extensometers from the shaft into the pillar on the 3350, 3500, and 3650 levels, and from a drift on the 3650 level down into the hanging wall of the D-limb stope (figs. 24-25).

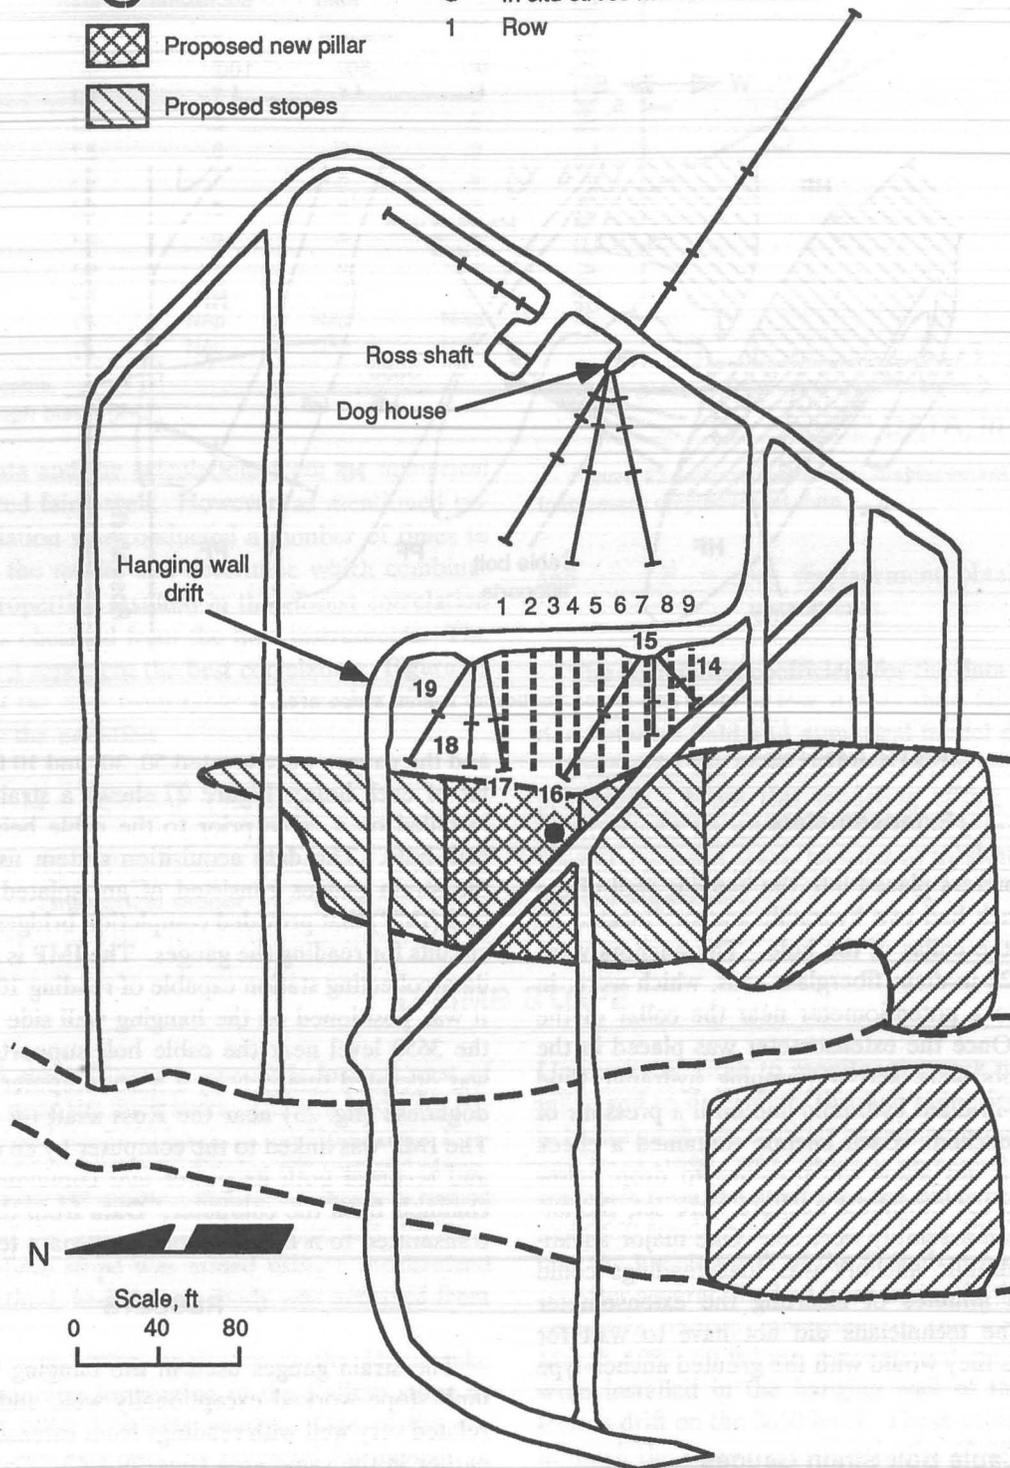
Figure 25.—Plan view of 3560 level near Ross shaft.

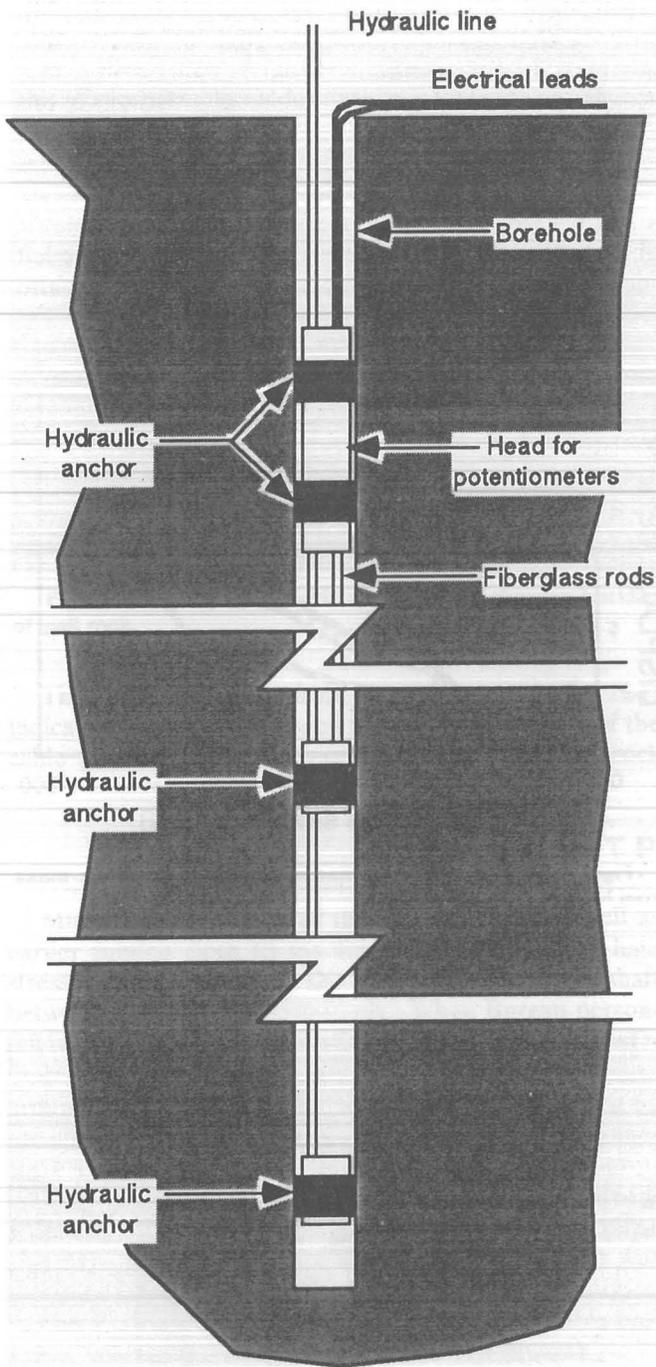
Figure 26.—Profile of extensometer with hydraulic anchors.

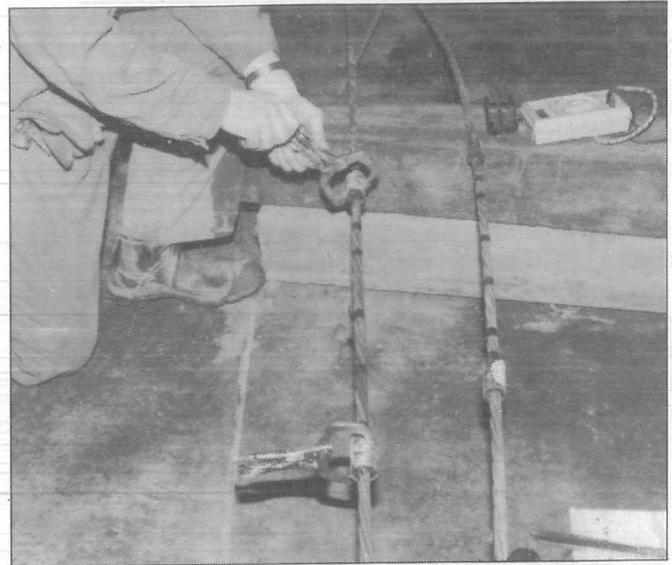
Figure 27.—Strain gauge being installed on cable.
