RI 9474

# Field Evaluation of Cable Bolt Supports, Homestake Mine, Lead, SD

By J. M. Goris, T. M. Brady, and L. A. Martin

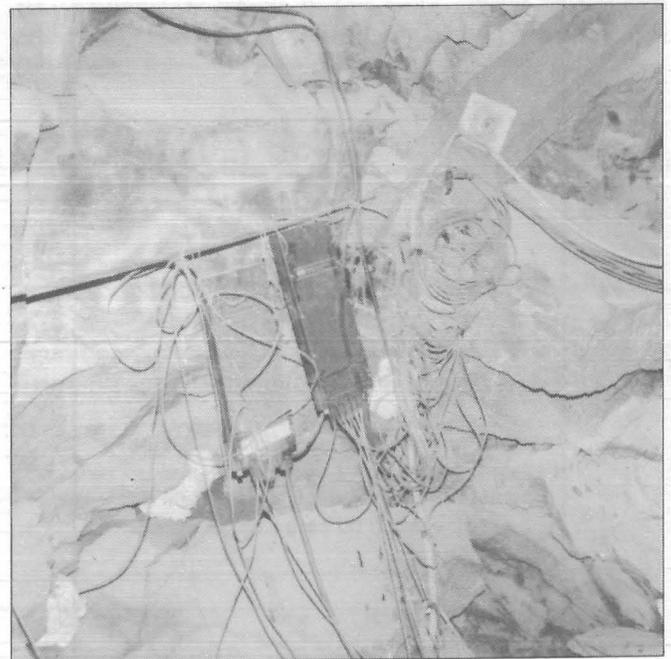
Figure 28.—Isolated measurement pod unit on wall of hanging wall drift.

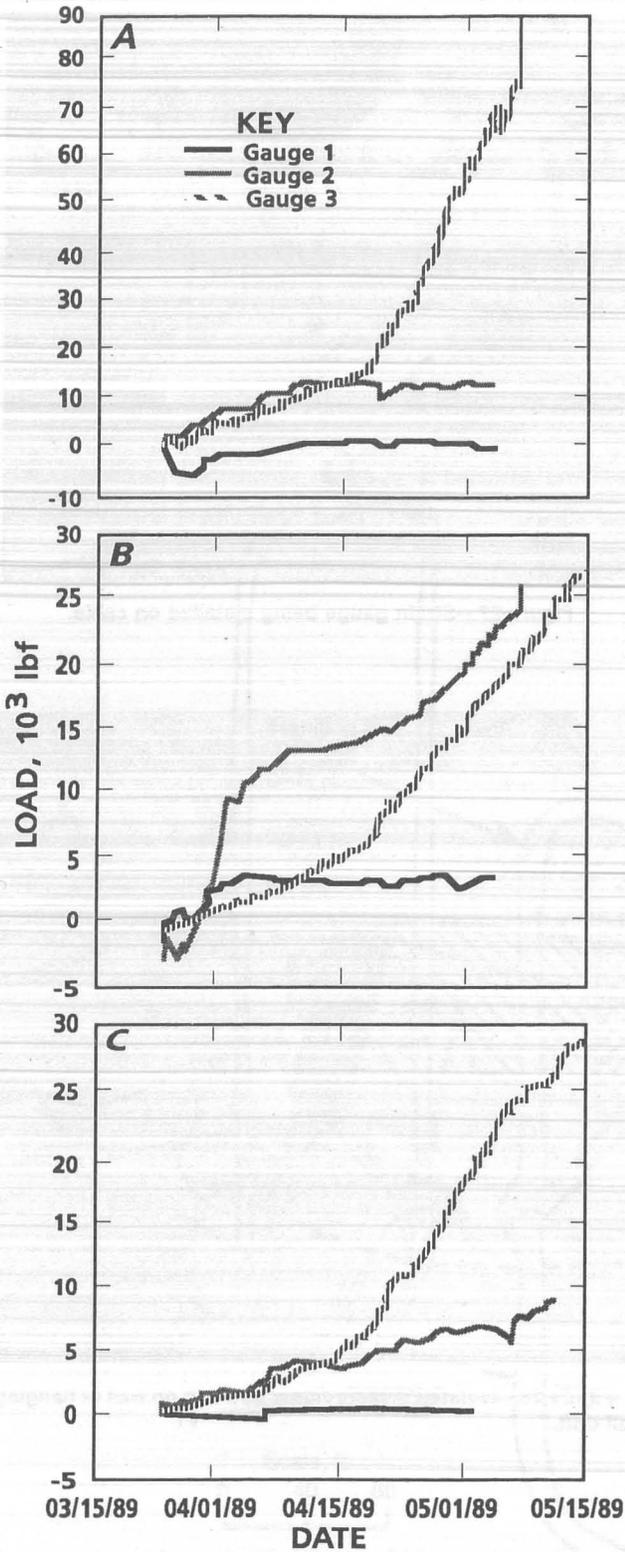
Figure 29.—Time-load curves for instrumented cable bolts. A, Row 1; B, row 3; C, row 6. Gauge 1 located 50 ft down hole; gauge 2 located 30 ft down hole; gauge 3 located 10 ft down hole.

The last few readings from gauge 3 in row 1 (fig. 29A) indicated that loads exceeded the ultimate strength of the cable (58,000 lbf). This was most likely caused by rock

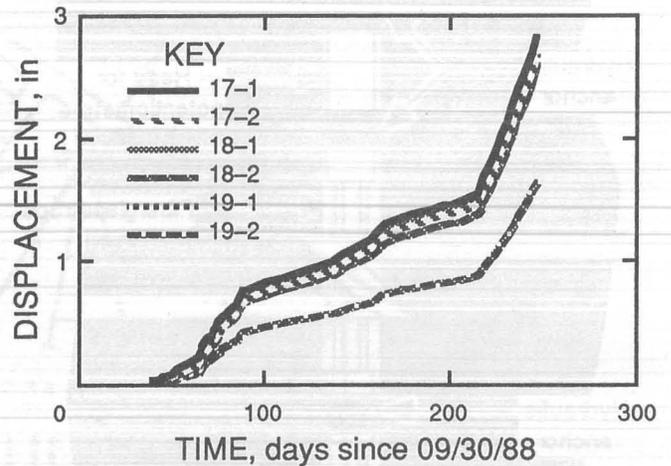
Figure 30.—Data from extensometers placed in rock mass from hanging wall drift.

displacements for anchors in the same holes (fig. 30). Anchors 17-1, 17-2, 18-1, and 18-2 (fig. 30) were used to determine movement of the hanging wall because they were close to the instrumented cable bolts. Results of this rock movement are seen in figure 31 in which an old air door frame in the hanging drift on the 3650 level has buckled. The collars of the holes for the cable bolts are on the left side of the photograph and have white plastic tubes protruding out from the rock. The rock on the left side of the drift where the cable bolts were placed is also buckling (fig. 32).

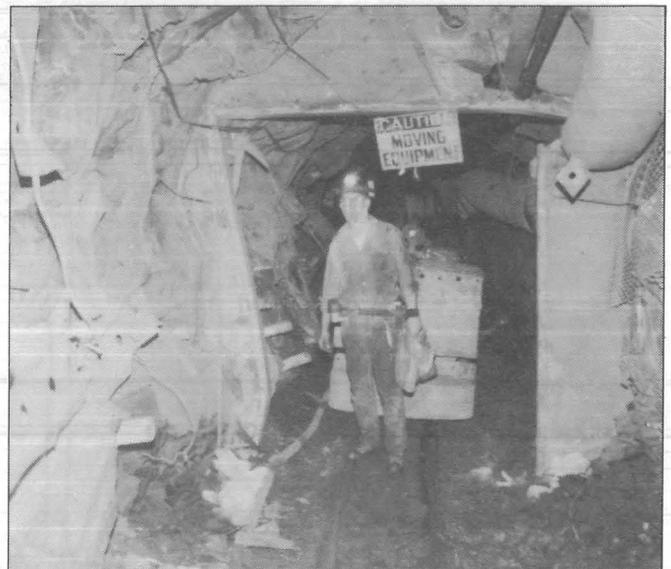
Figure 31.—Hanging wall drift on 3650 level showing buckling of old air door frame.

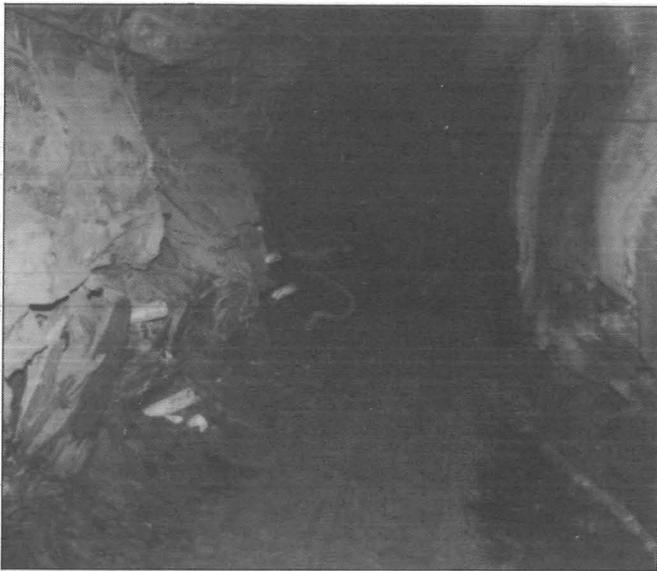
Figure 32.—Hanging wall drift on 3650 level showing buckling of wall rock.

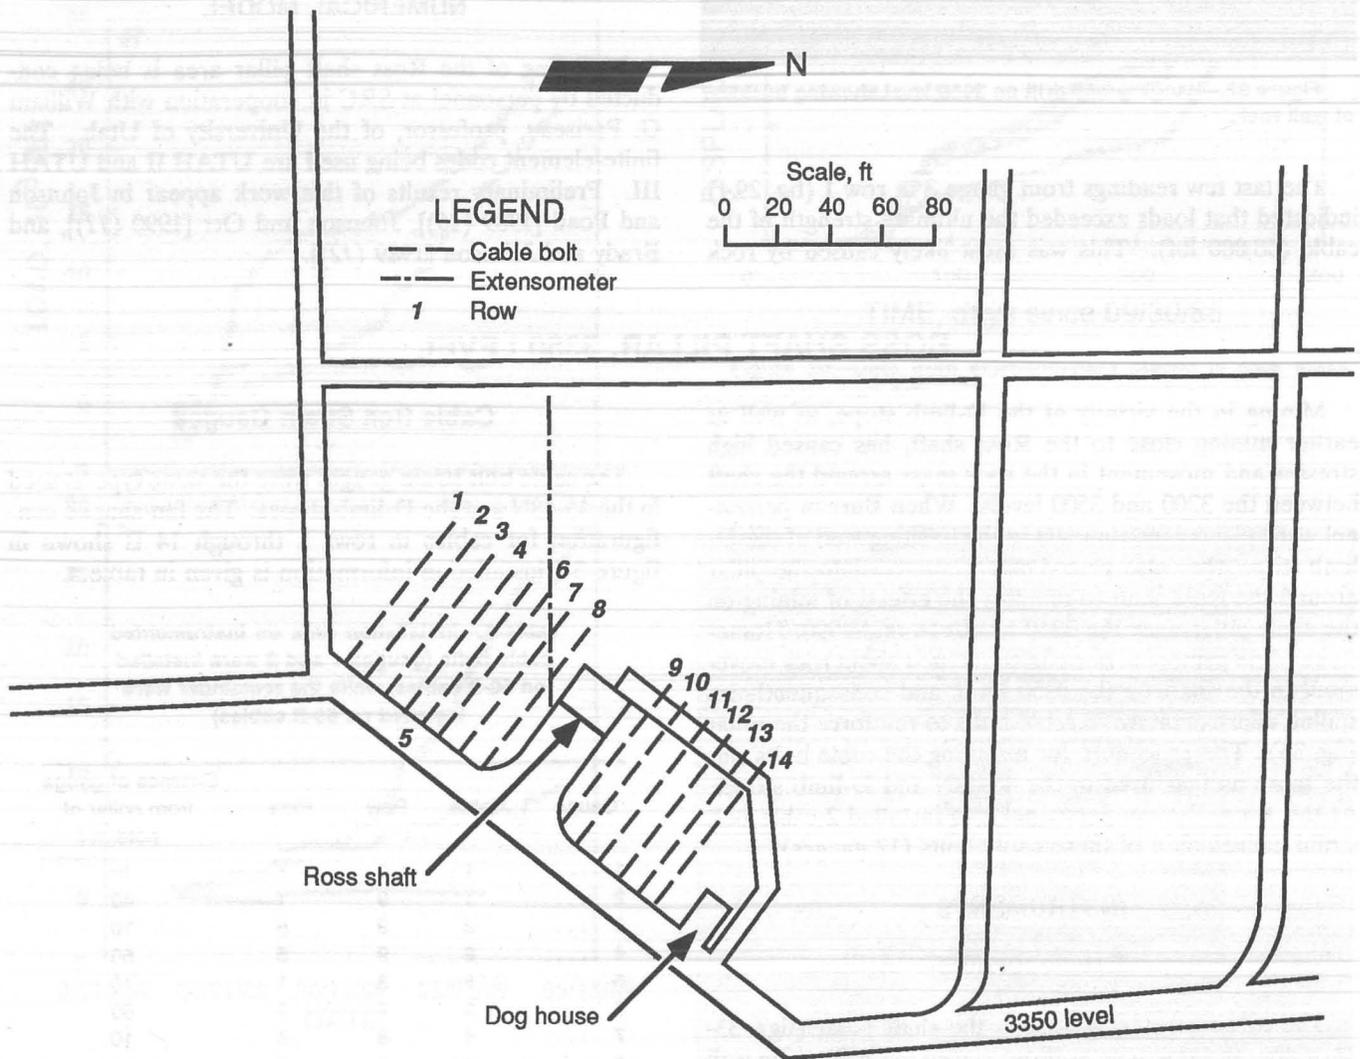
Figure 33.—Plan view of 3350 level showing location of cable bolts installed in shaft pillar.

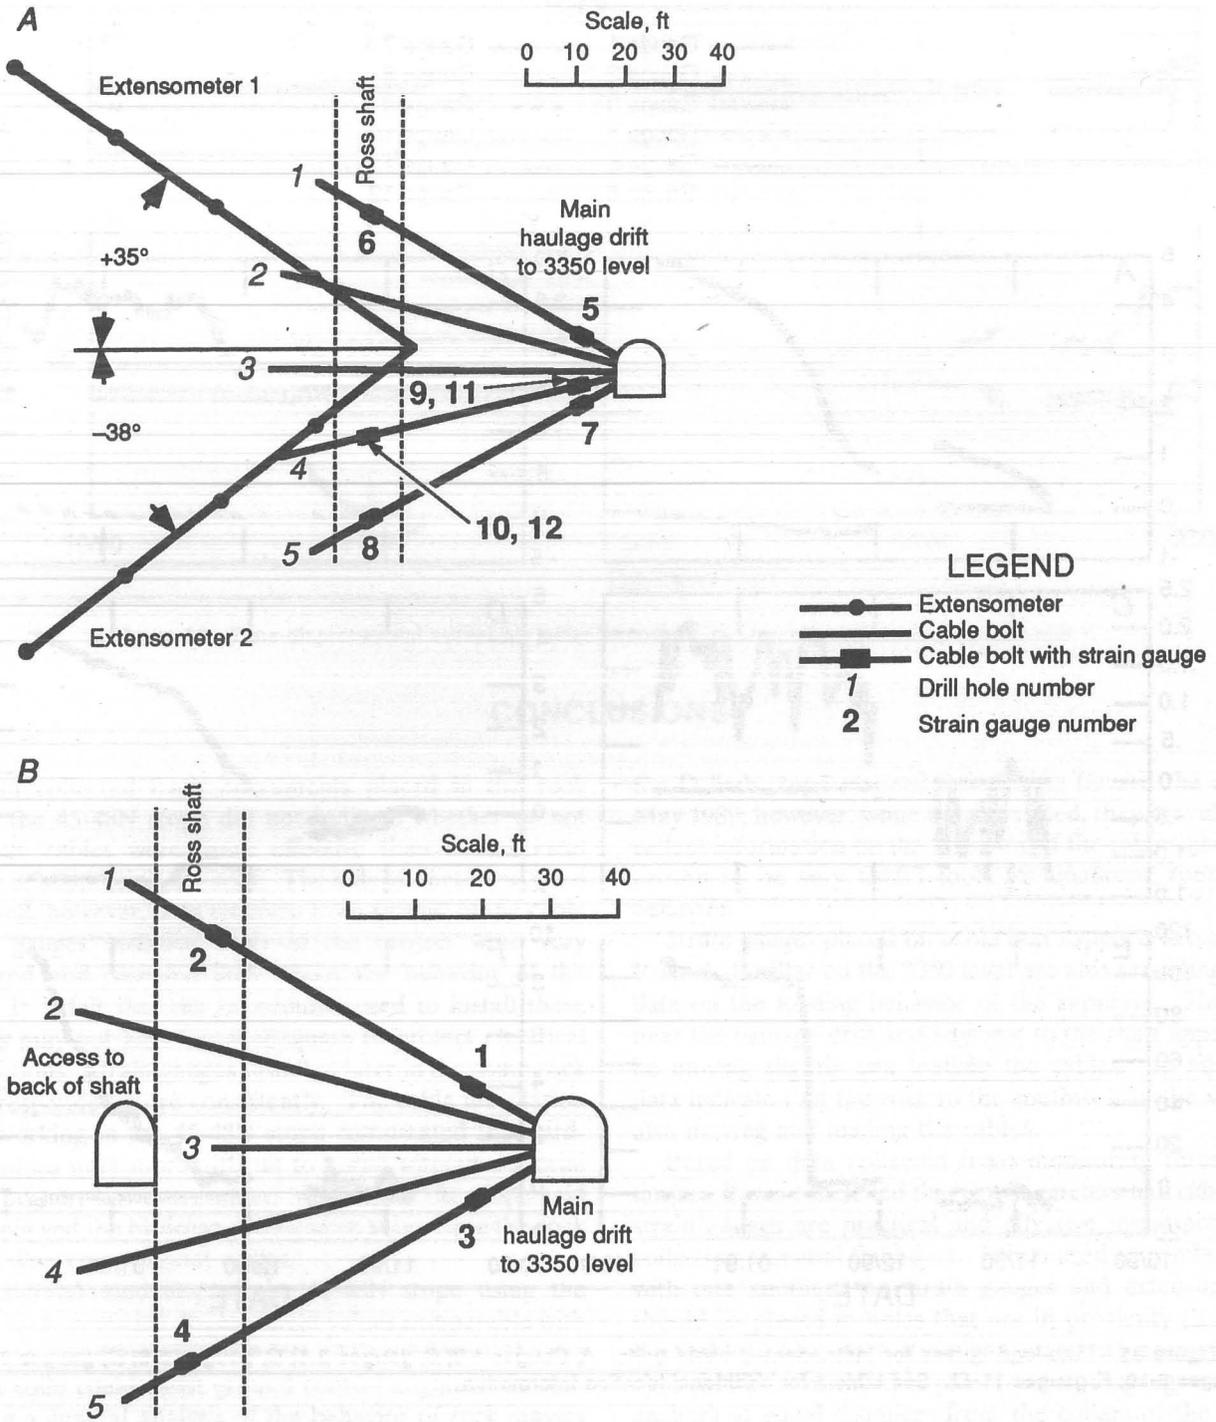
Figure 34.—Cross section of 3350 level showing typical fan-shaped configuration of cable bolts. A, Rows 1-8; B, rows 9-14.

These data indicated that the rock near the haulage drift and adjacent to the shaft was moving slightly and loading the cables (fig. 34B). In addition, data from gauge 12 indicated that the rock to the southwest of the shaft was also moving and loading the cables (fig. 35F). The two extensometers in this region have not indicated any rock movement (fig. 36); curves are more or less level and consistent.

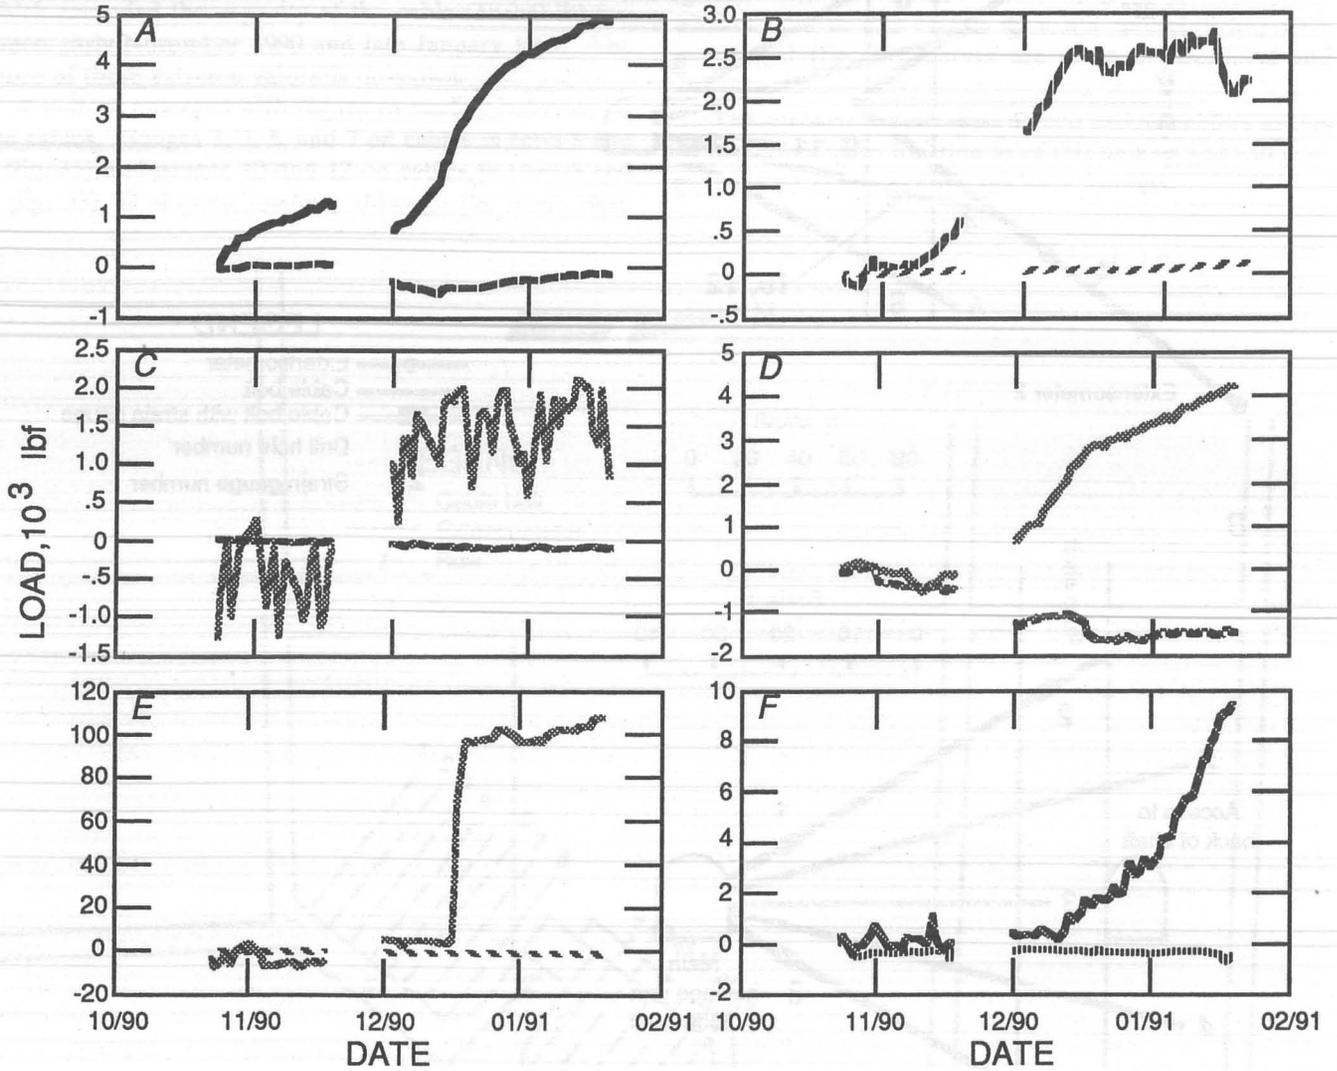
Figure 35.—Time-load curves for instrumented cable bolts. A, Gauges 1-2; B, gauges 3-4; C, gauges 5-6; D, gauges 7-8; E, gauges 9-10; F, gauges 11-12. See table 5 for additional location information.

The loading history for instrumented cable bolts 1 through 6 is shown in figure 35 as collected between October 1990 and early January 1991. A malfunction of the data collection system caused a gap in the data between November 18 and December 2. Most of the gauges appeared to be functioning well except gauge 10 (fig. 35E), which exceeded the capacity of the cable (58,000 lb) between early November 1990 and late January 1991. The cause of these extreme values is unknown.

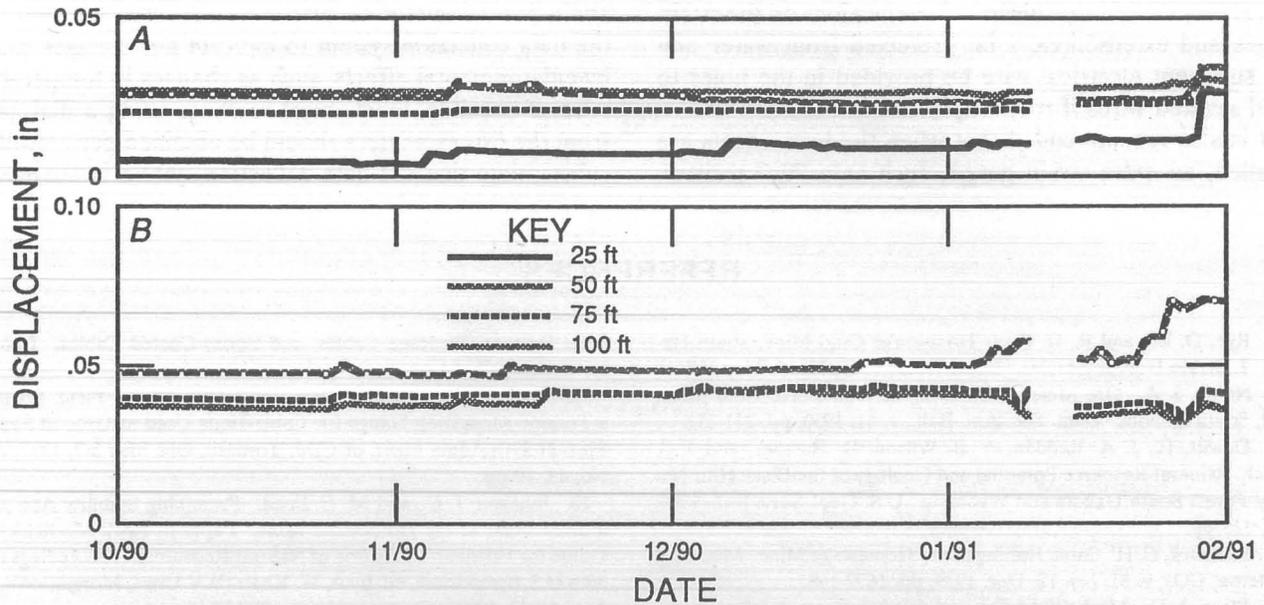
Figure 36.—Time-displacement curves for extensometers. A, Extensometer 1; B, extensometer 2.
