RI 9207

REPORT OF INVESTIGATIONS/1988

Fire Endurance of Mine Stoppings

By D. Ng, C. P. Lazzara, K. E. Mura, and C. Luster

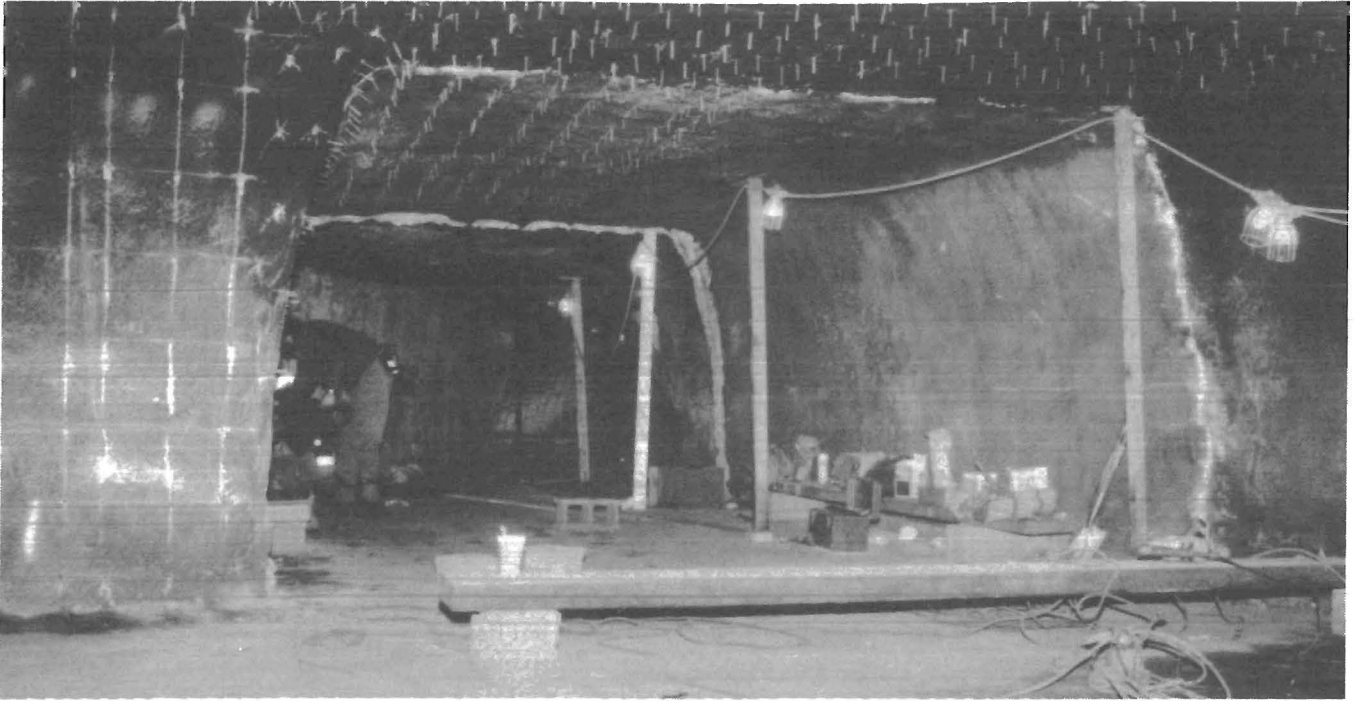
Figure 3.—Installation of fireproof material at test site.

and roof immediately in front of and behind the test stopping and in the crosscut were therefore protected with fireproof ceramic fiber blankets. The ceramic blankets were installed by impaling them on stainless steel studs that were cemented in holes drilled into the roof and ribs of the test area at spacings varying from 1.2 to 1.5 ft (fig. 3). Additionally, a layer of sand, about 2 in thick, was used to protect the concrete floor in front of the stopping from potential spalling because of the extreme heat.

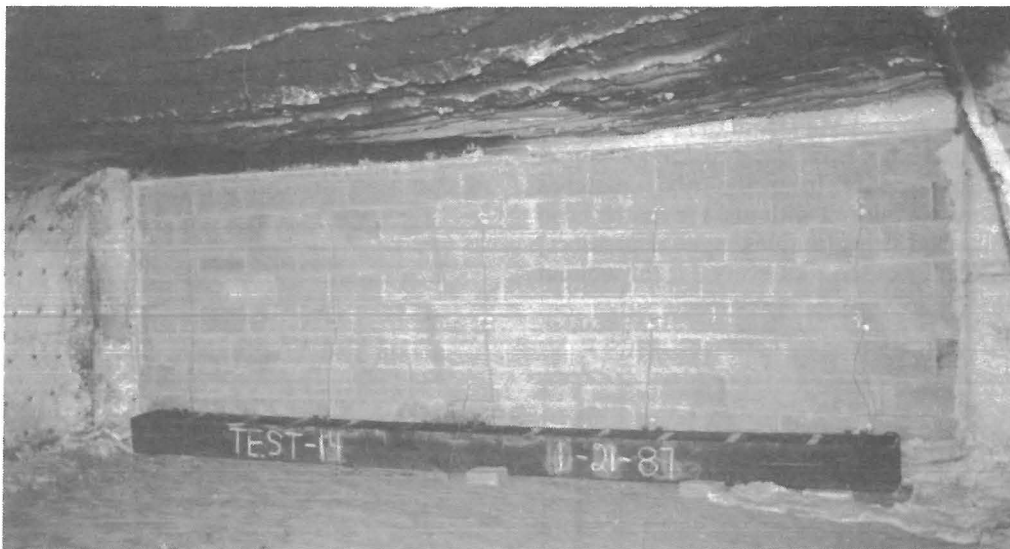
Figure 5.—Concrete (top) and metal (bottom) stoppings used in test.

Concrete or metal stoppings, 6 ft high by 18 ft wide were constructed in the test frame. The concrete stoppings were built using 8-in-thick, hollow, two-cell concrete blocks laid with wet mortar joints. The commercial metal stopping was erected from 1-ft-wide 18-gauge telescopic galvanized steel panels. It was installed with assistance from the manufacturer, adhering to recommended procedures (8). The small gaps that existed between adjacent panels and at the perimeter of the stopping were sealed using a water-glass-based paste to make the stopping airtight. Figure 5 shows the completed stoppings.

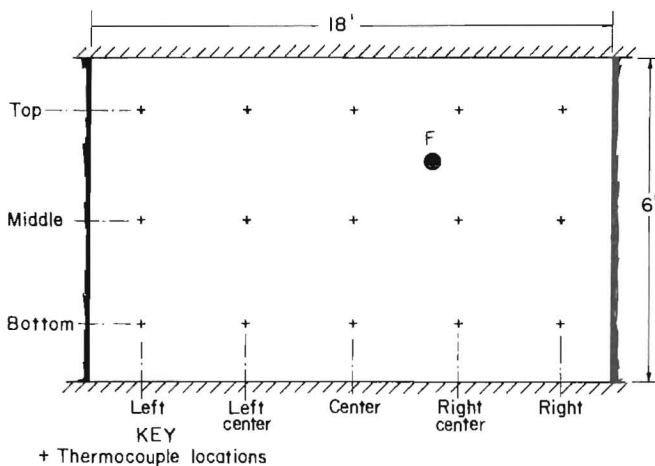
Figure 6.—Location of thermocouples and flux gauge (F) on stopping (viewed from the fire side). An identical set of thermocouples is located on back of the stopping and are identified in the same manner.

In all the stopping tests, 15 type K thermocouples, in a 3 by 5 array (fig. 6), were installed on the exposed and unexposed sides of the stopping to measure the surface temperatures. The bare thermocouple beads were in contact with the stopping surface. The type K thermocouples were constructed from ceramic insulated, Inconel braid shielded 20-gauge wires. The location of the water-cooled total heat flux gauge (F) is also shown in figure 6. The output of all these sensors were recorded by the data acquisition system.

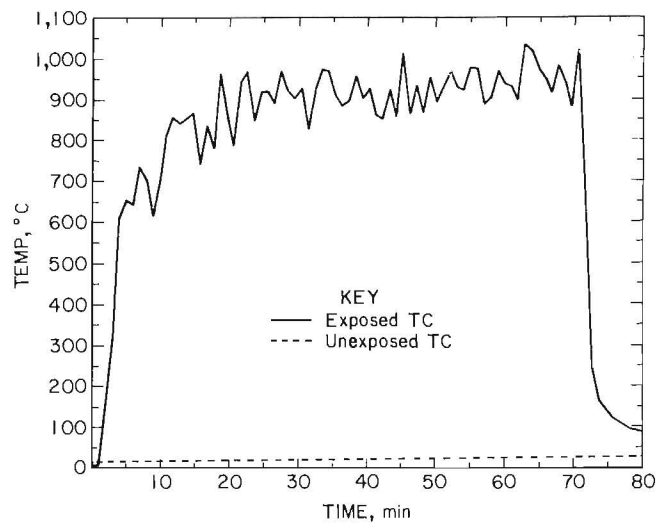
Figure 9.—Temperatures of thermocouples (TC's) located on top (exposed) and under (unexposed) ceramic insulation blanket above tray fire.

Figure 8 shows the average temperature of five thermocouples located near the roof above the tray. It indicates that the fire intensity attained a steady level within 10 min after ignition of the tray fire. Temperatures near the roof in the region where the flames were most intense reached $1,000^{\circ}\text{C}$; however, the mine roof protected by the ceramic blanket insulation experienced a temperature rise of only

about 10°C (fig. 9). In both figures 8 and 9 one can see the sharp drop in temperatures that occurred with the termination of fuel into the tray.

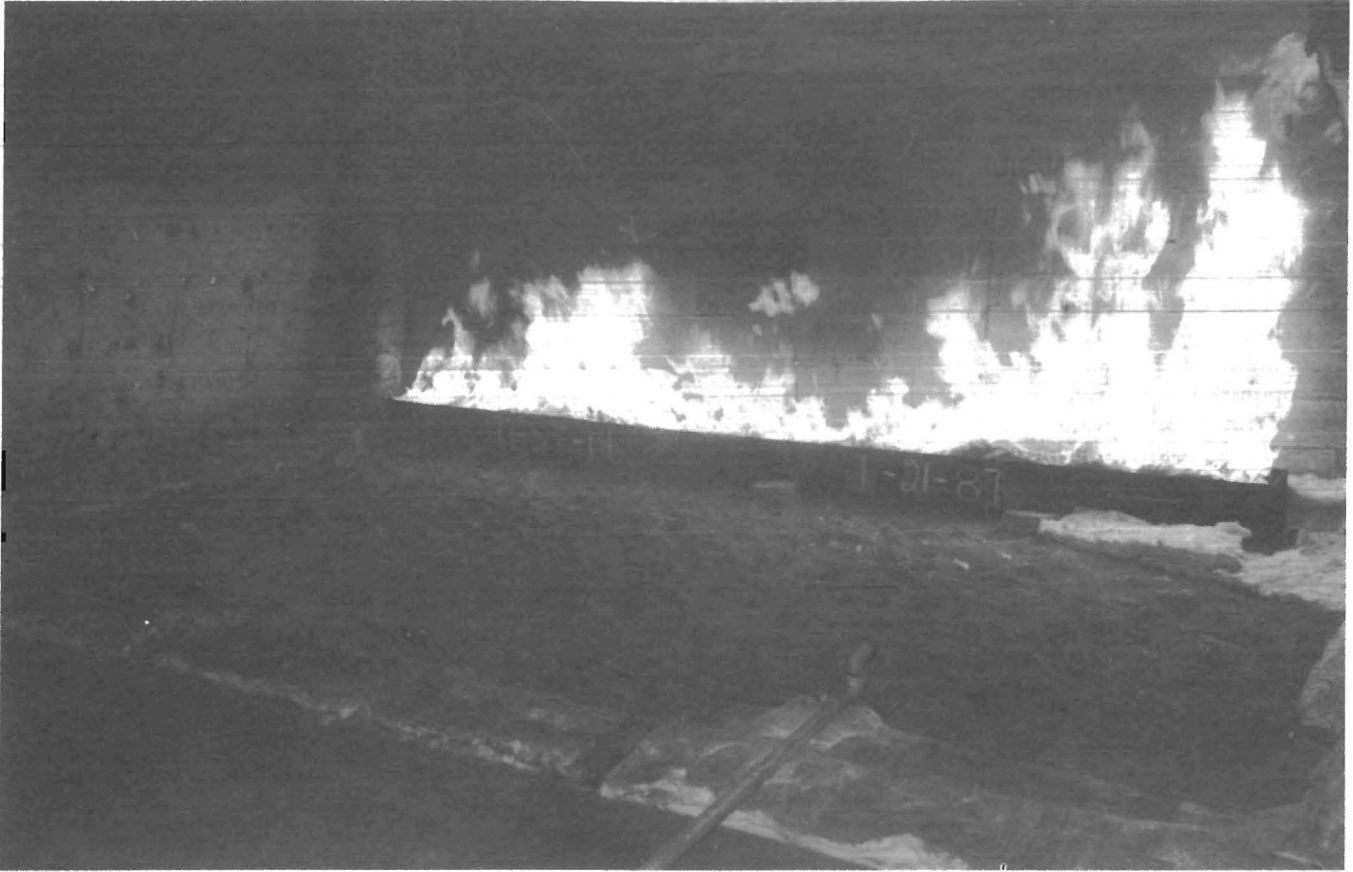
Figure 10—Tray fire.

A fuel delivery rate of 0.7 gal/min was found to produce the desired fire characteristics—a fire over the entire tray without excessive smoke (fig. 10). The heat output of the fire was about 75,000 Btu/min. It took about 10 min for the flames to spread over the surface of the tray and the fire to "burn in." A tray fire with these characteristics and a 70-min duration was selected as the standard fire for the stopping tests.

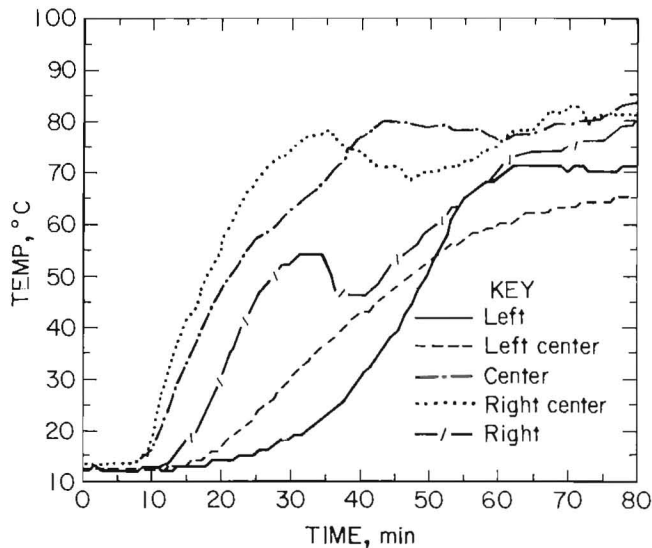
Figure 14.—Temperatures of top row of thermocouples on back surface of concrete block stopping.

All 15 thermocouples positioned on the back surface of the stopping recorded temperature rises above ambient. However, none of the temperatures were higher than about 80° C. The temperature-time histories of the top row of these thermocouples are shown in figure 14. The left-right designations correspond to those of the front surface of the stopping.

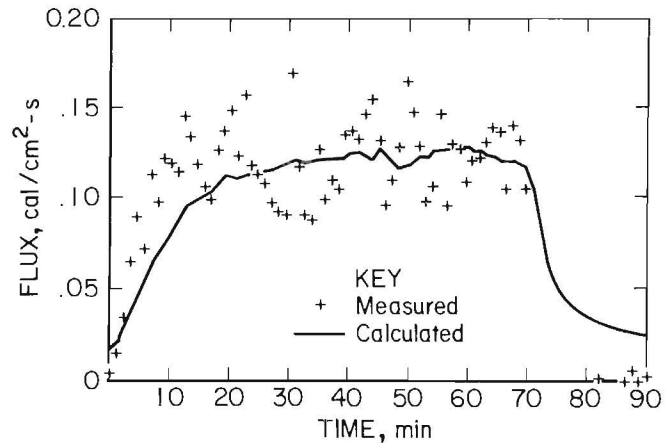
Figure 22.—Calculated and measured heat flux at flux gauge located 2 ft from back surface of metal stopping.

The calculation is for the flux detected by a flux gauge directed at the stopping. The x,y coordinates in the formula in the appendix are taken along the horizontal and vertical direction of the stopping, the z direction is the direction perpendicular to this surface. In this case, the calculated and the measured values are shown in figure 22. In this calculation, the only adjustable parameter is the emissivity, which is taken to be 0.21. The agreement is quite good indicating that heat transfer to points remote from the unexposed surface of the metal stopping is predominately by radiation.

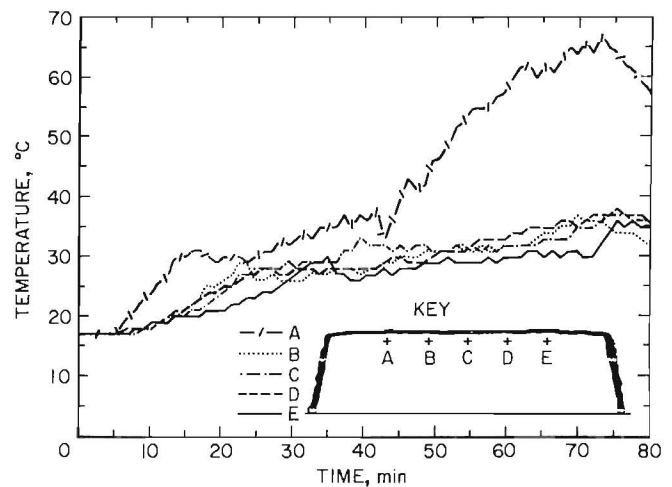
Figure 25.—Temperatures of air thermocouples 1 ft from back surface of plaster-coated metal stopping.
