Bureau of Mines Report of Investigations/1986

Geotechnology in Slate Quarry Operations

By Noel N. Moebis, Gary P. Sames, and Thomas E. Marshall

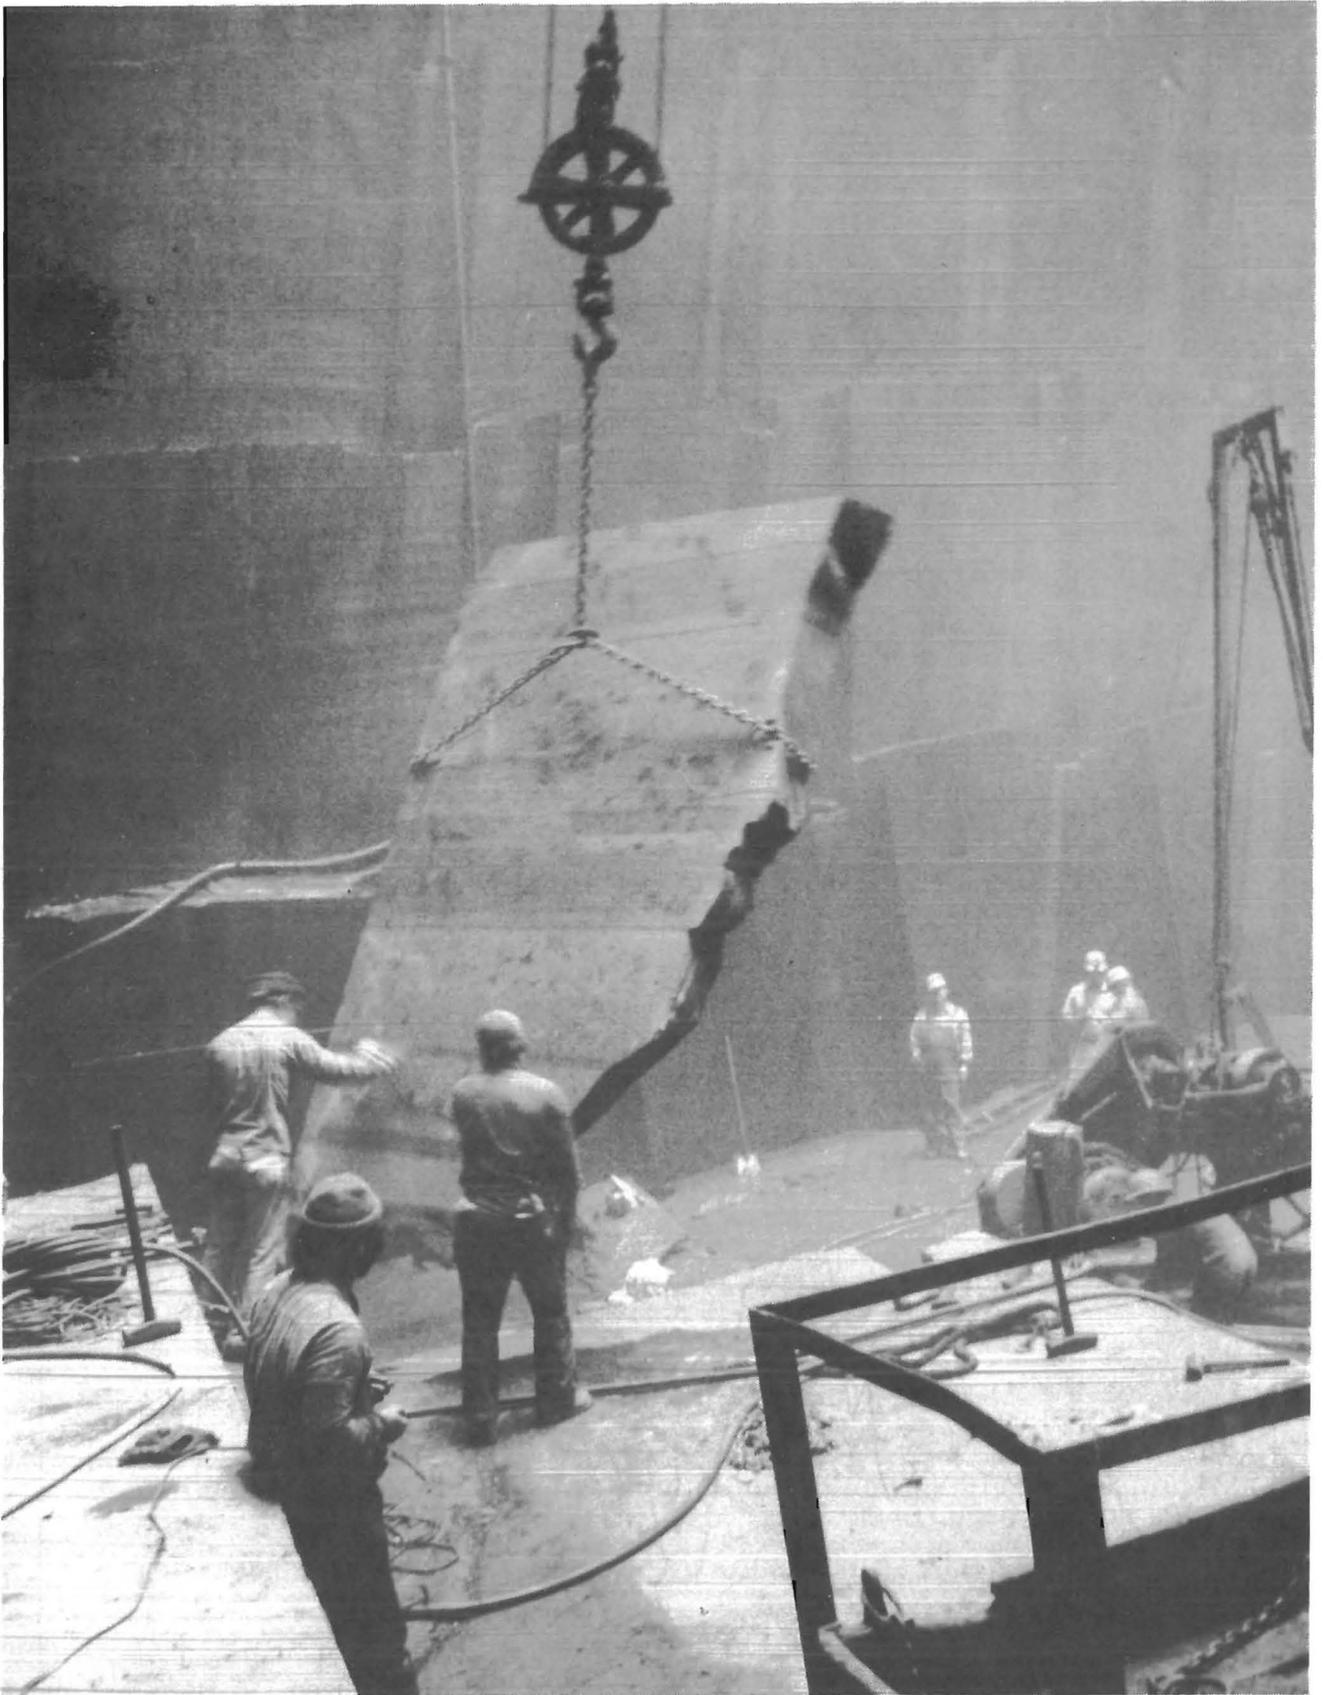
FIGURE 3. - Method of hoisting slate slabs to surface.

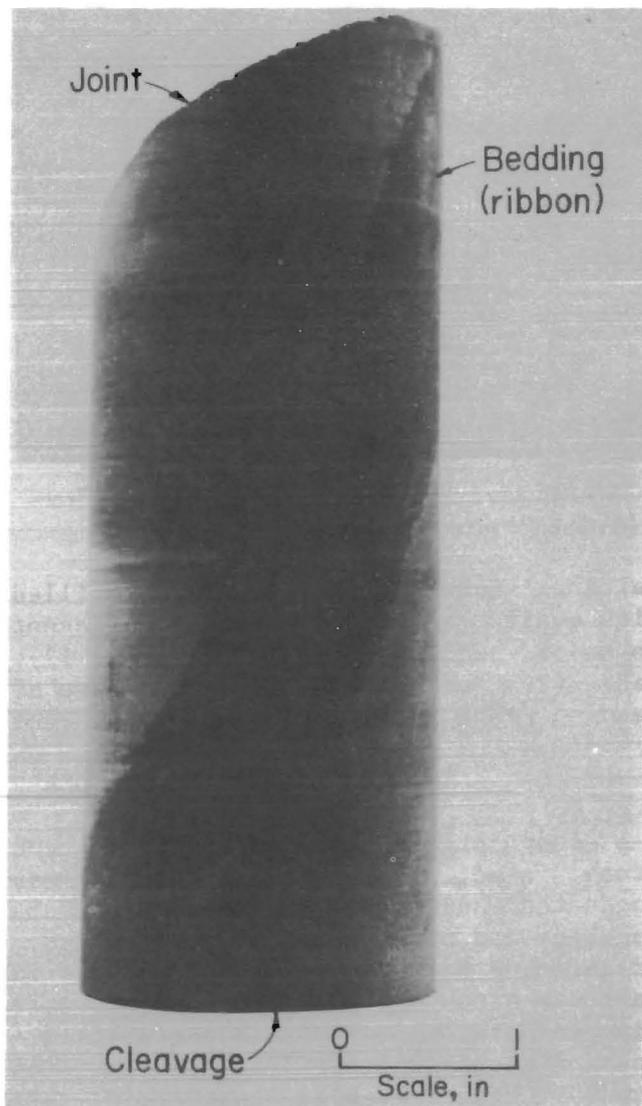
FIGURE 10. - Section of drill core showing bedding, cleavage, and joint.

A nearly perfect cleavage unrelated to bedding (fig. 10) was formed in the slate belt as a result of the deformation. Faulting also occurred in many directions but is principally parallel to bedding where exposed by quarry openings. These bedding slip faults sometimes are weathered and clayfilled at shallow depths (fig. 11) and are then designated as "rotten ribbons" by quarriers. Many faults are filled with vein quartz and

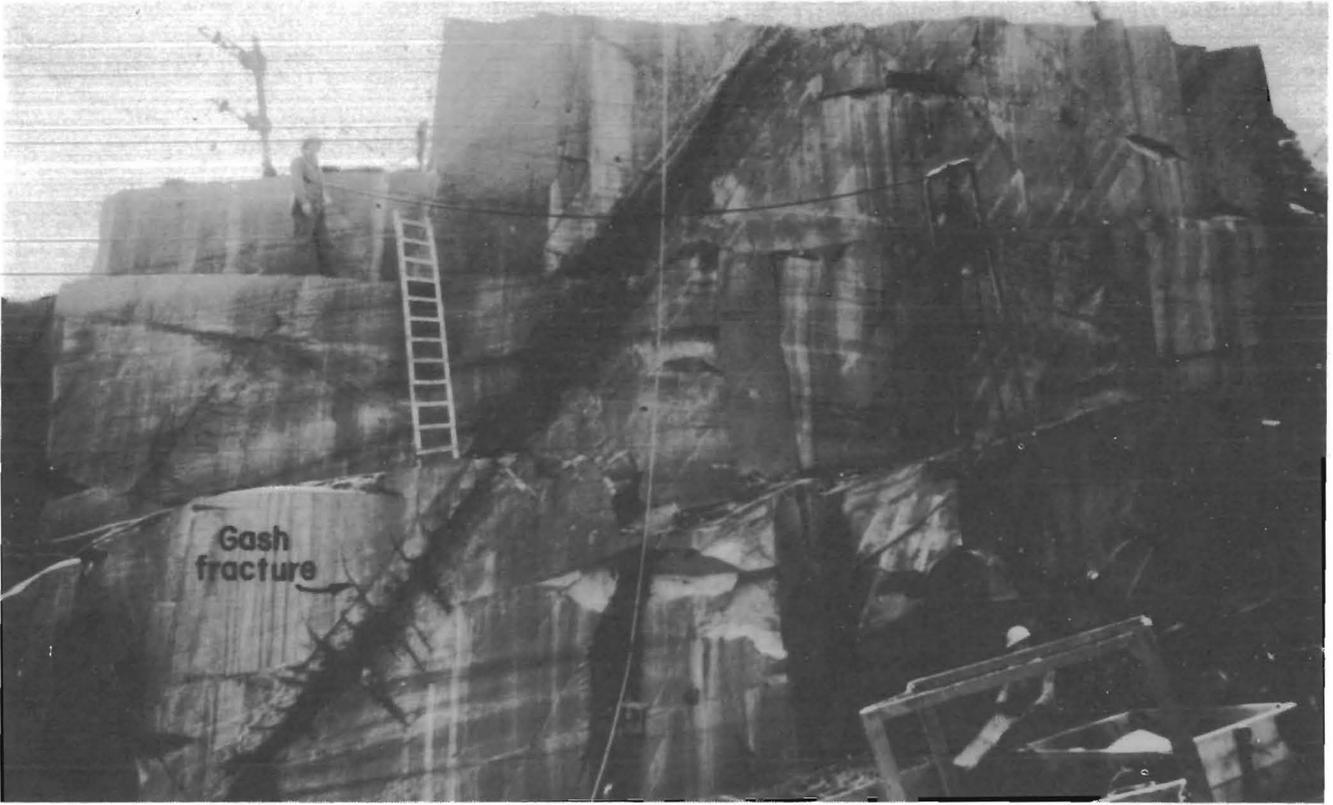
FIGURE 12. - Gash fractures in lower portion of bedding plane fault.

calcite. Subsidiary gash veins filled with quartz and calcite occur adjacent to major bedding slip faults (fig. 12). Behre (29) described a special case of bedding plane faults in which the thrust

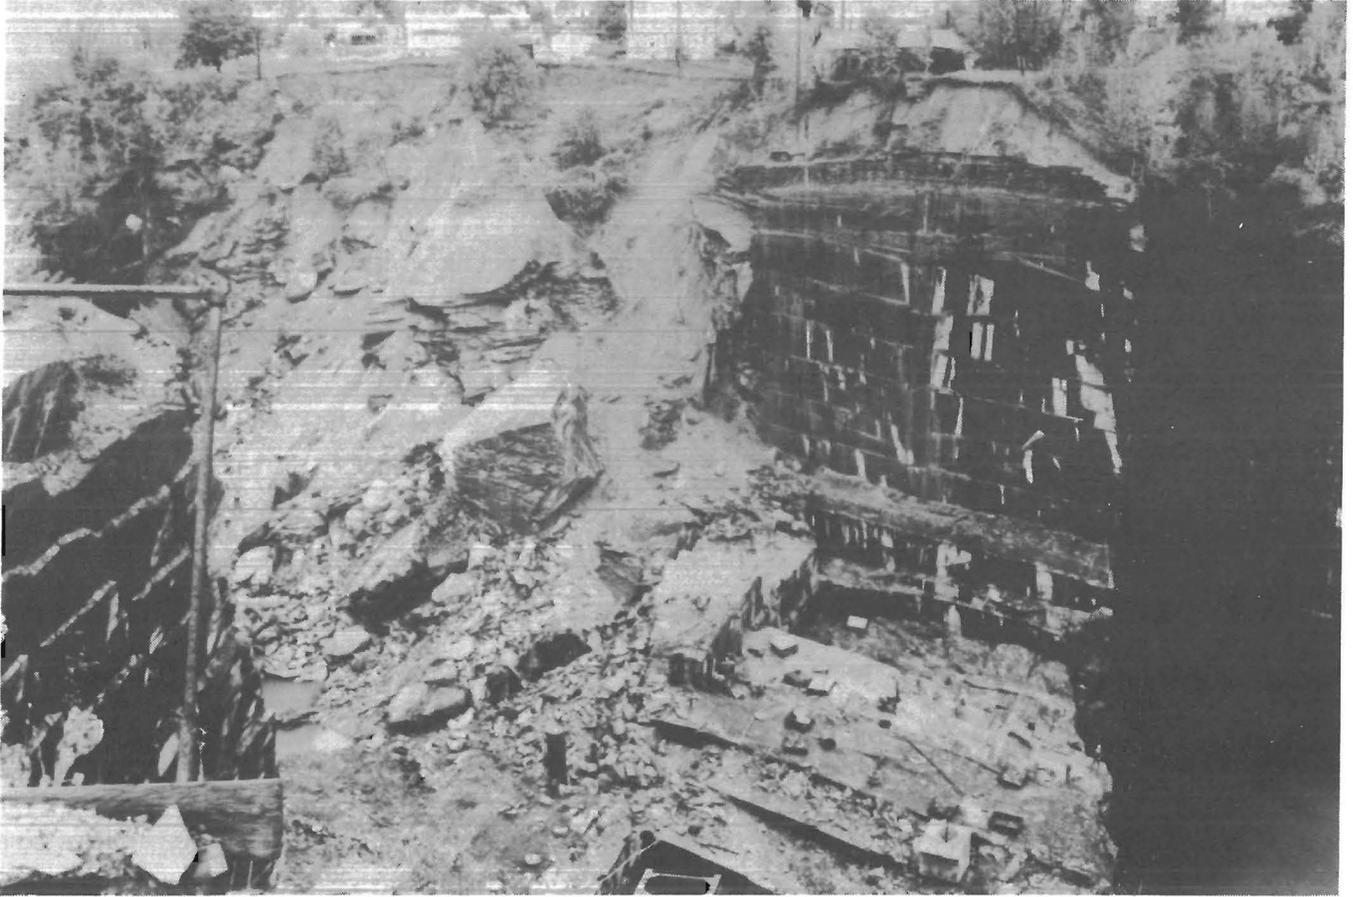
FIGURE 15. - Collapse of quarry highwall adjacent to operating section.
