Bureau of Mines Report of Investigations/1984

# Properties of Filter Cloths for Seepage Control in Coal Mine Waste Embankments

**Report of Investigations 8871**

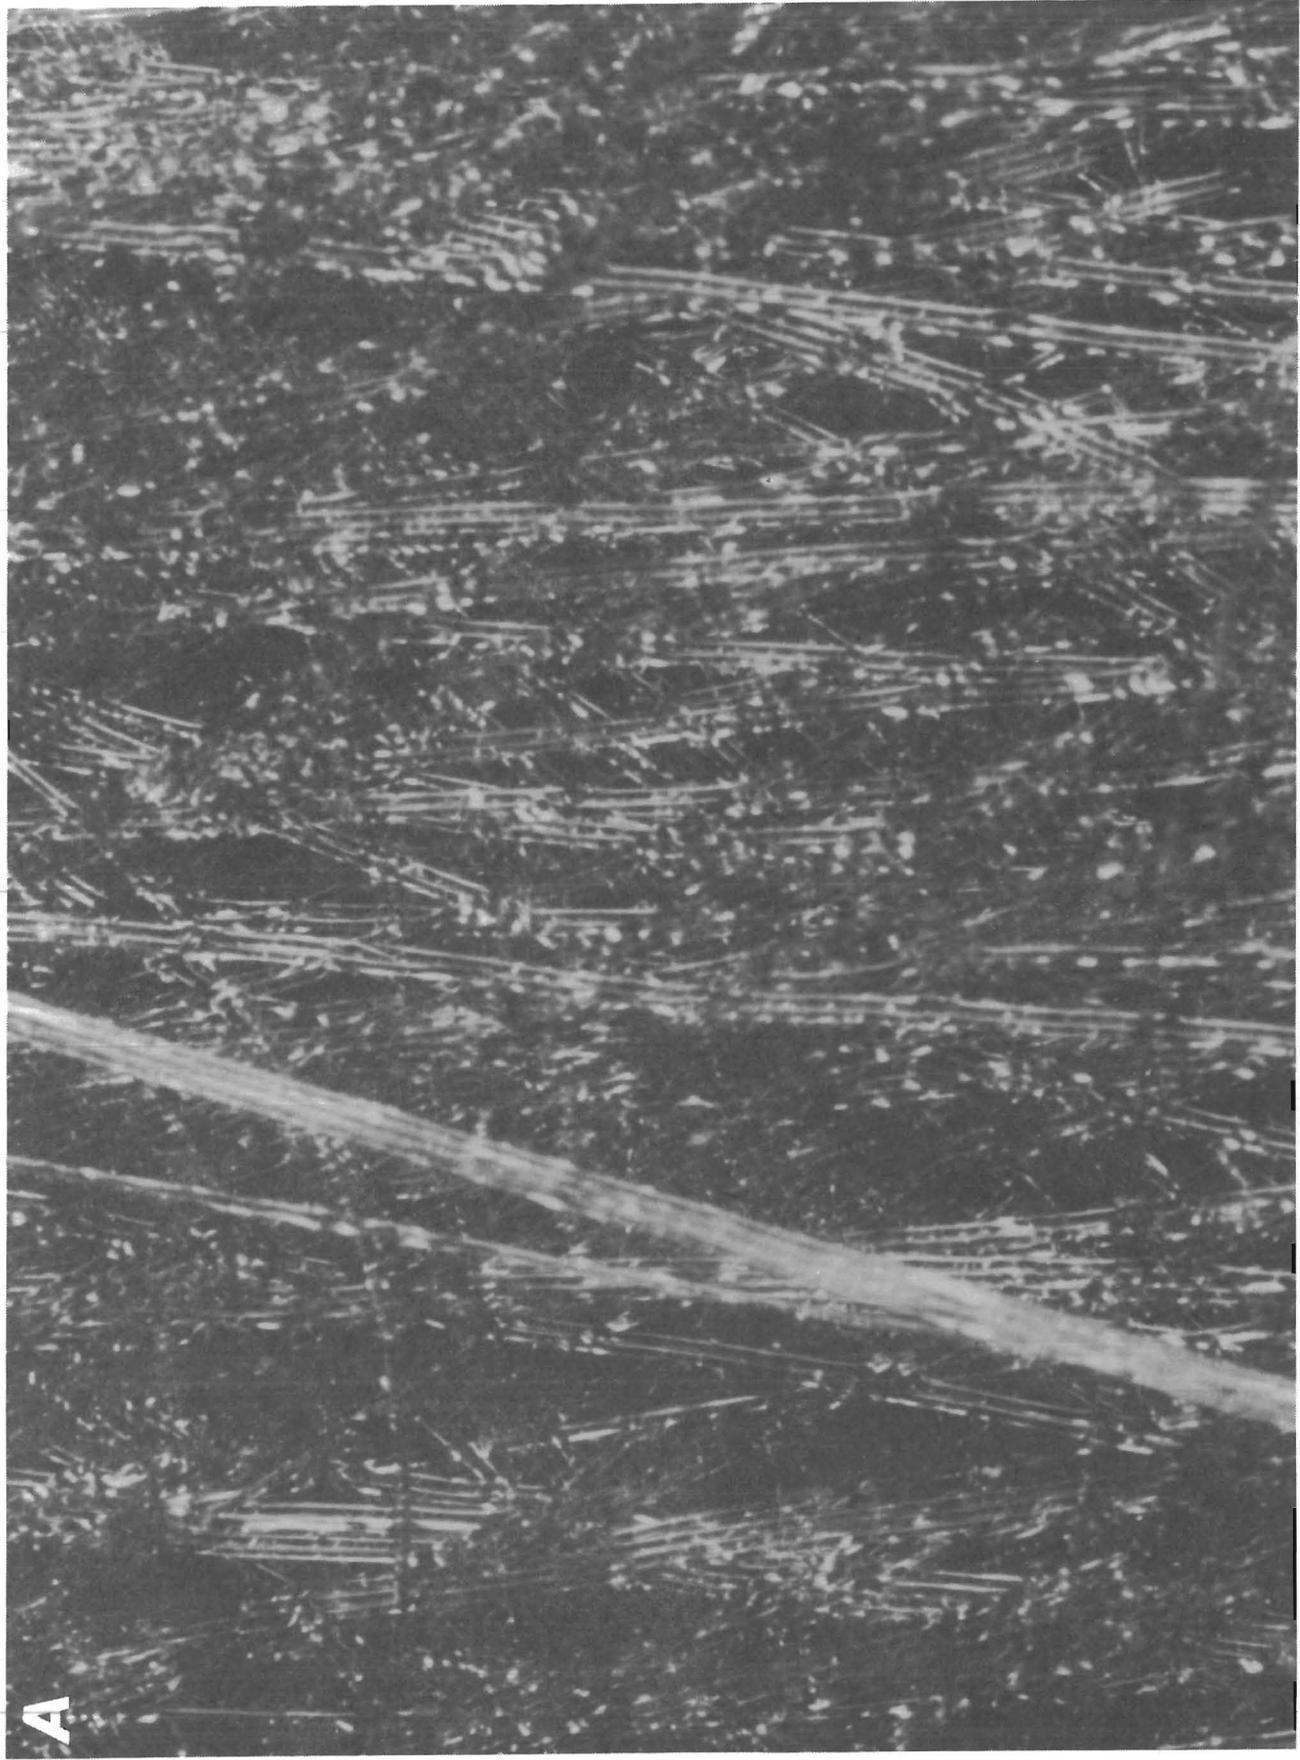
FIGURE 4. - Unused and used Typar 3401 cloth samples (magnified). A, New cloth.

FIGURE 4. - Unused and used Typar 3401 cloth samples (magnified)—Continued. *B*, Cloth partially clogged with coal wastes.

FIGURE 4. - Unused and used Typar 3401 cloth samples (magnified)—Continued. C, Cloth completely clogged with precipitated material.

All Typar 3401 samples (used with Island Creek waste) showed some degree of clogging by coal waste both on the surface and in the cloth. In addition, all the Typar samples were clogged with a precipitated yellowish-red material identified by energy-dispersive X-ray techniques as being composed mainly of iron and silicon. The amount of this precipitated material appeared to vary with both pond water pH and time of exposure.

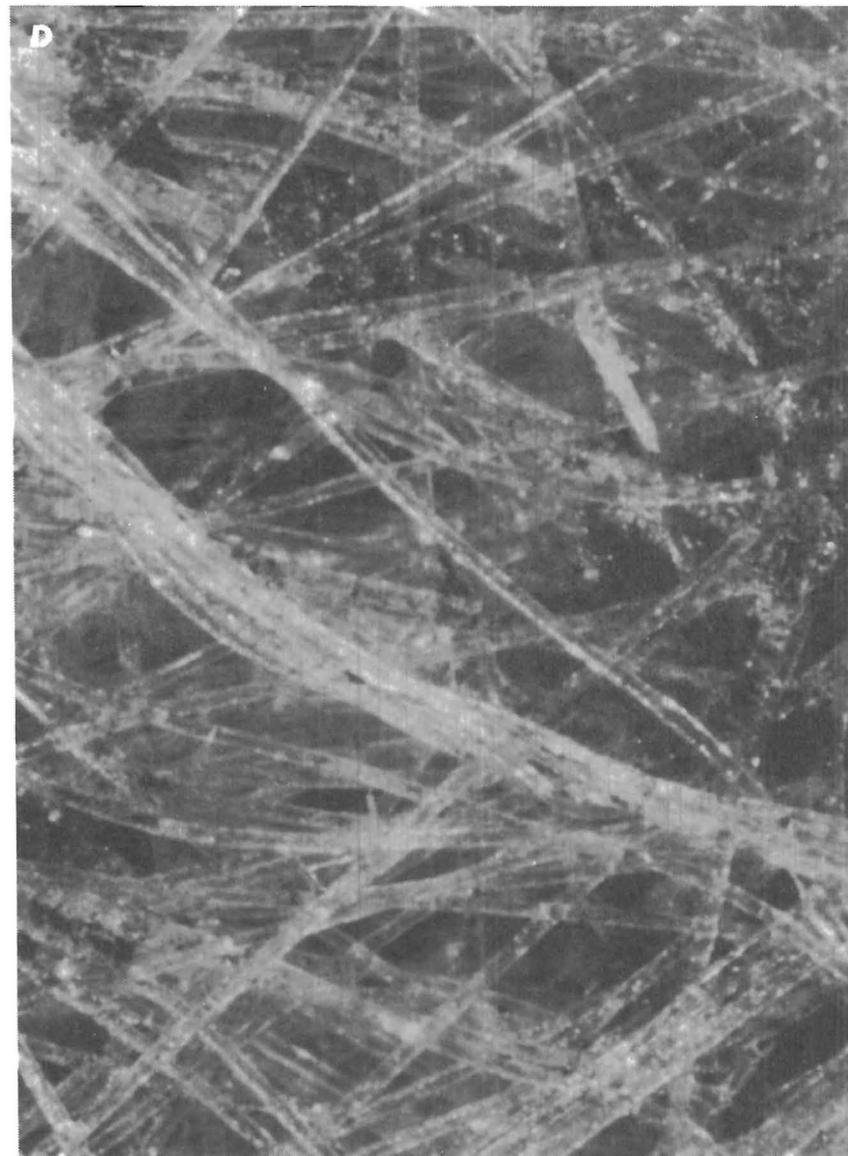
FIGURE 5. - Unused and used Mirafi 140S cloth samples (magnified). *A*, New cloth; *B*, unclogged area.

FIGURE 5. - Unused and used Mirafi 140S cloth samples (magnified)—Continued. *C*, Clogged area; *D*, waste trapped within fabric.

All the Mirafi 140S samples (from the Schumate waste setups) had large areas of clear, unclogged cloth. Figure 5 shows a new piece of cloth and portions of a used cloth with clear, unclogged areas; clogged areas; and waste trapped within the thickness of the fabric. The clogging generally caused only a slight drop in flow rate (table 4), with most values within the spread of the normal range. The cloth sample that yielded the lowest flow rate--one of the two 6-month samples--had a filter cake but appeared to be no more clogged than the other samples when it was washed and examined before the flow rate was measured. The 8-month sample, which also had a filter cake, had a flow rate in the normal range (but near the lower limit of the normal range). The 12-month sample had a flow rate below the normal range. No precipitated material similar to that from the Island Creek waste was found with the Schumate waste on any filter cloth examined.

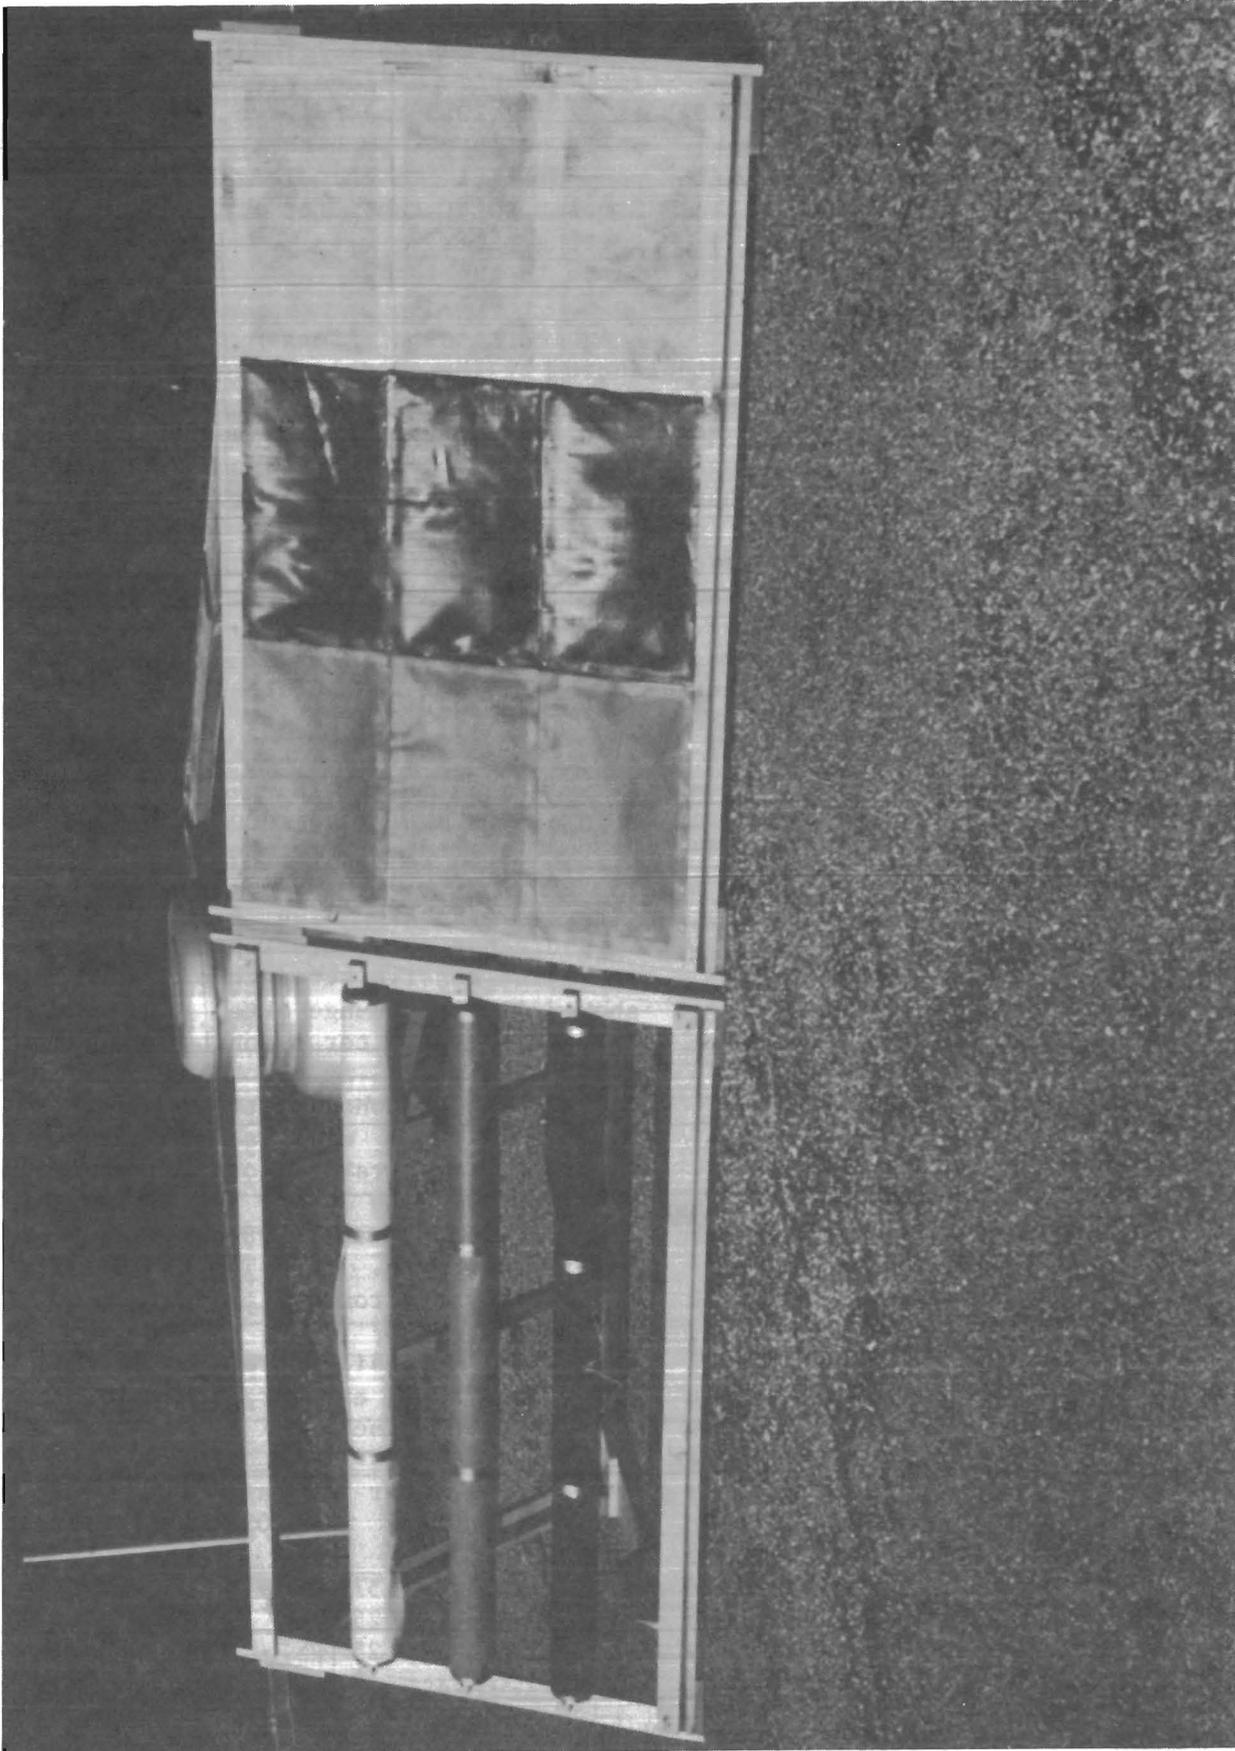
FIGURE 7. - Rack used for sunlight exposure tests.

Cloth samples were prepared for sunlight exposure tests using the test rack shown in figure 7. Half the rack held nine flat panels (three for each cloth) to test the effect of complete exposure to sunlight. The other half held samples in rolls eight layers deep to test the effect of sunlight on rolls of filter cloth used to simulate rolls left exposed in the field. (During visits to waste disposal sites, cloth rolls left exposed to sunlight were frequently observed.) Each flat sample (12 by 22 in, or 30.5 by 55.9 cm) was oriented so that the short dimension was in the direction of the length of the roll. All roll samples
