Bureau of Mines Report of Investigations/1983

Surface Evaluation of the 4M Miniminer System

By August J. Kwitowski

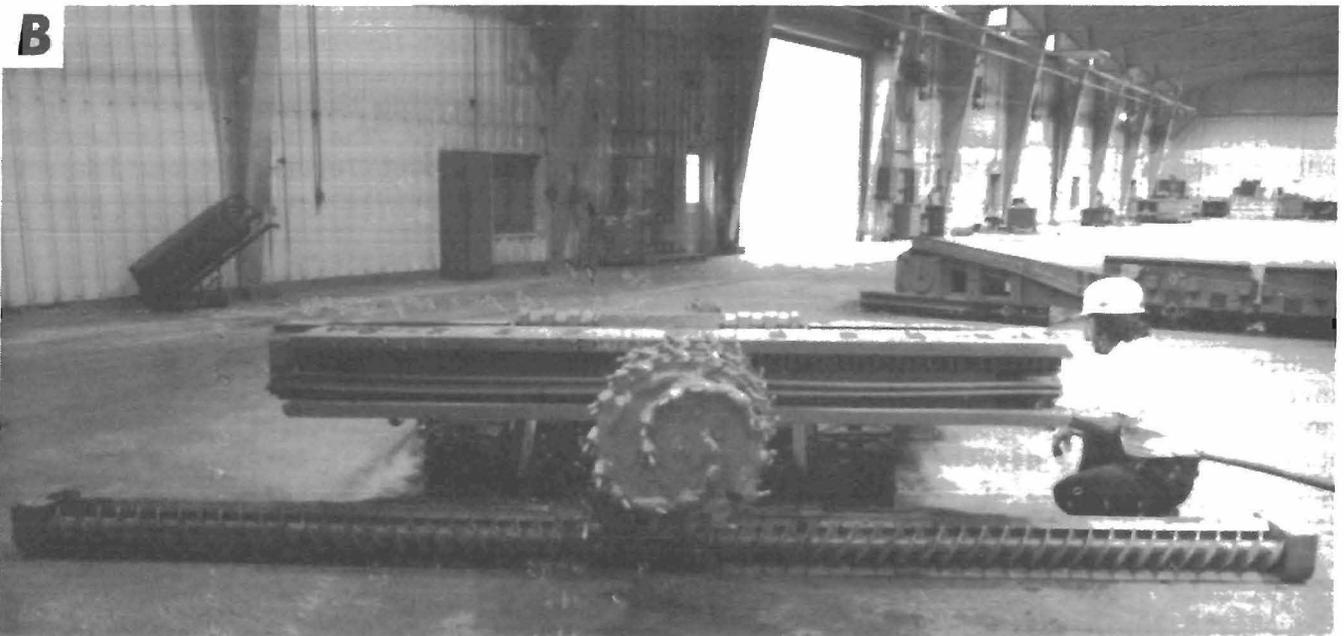
FIGURE 2. - Miniminer with gathering augers folded (A) and extended (B).

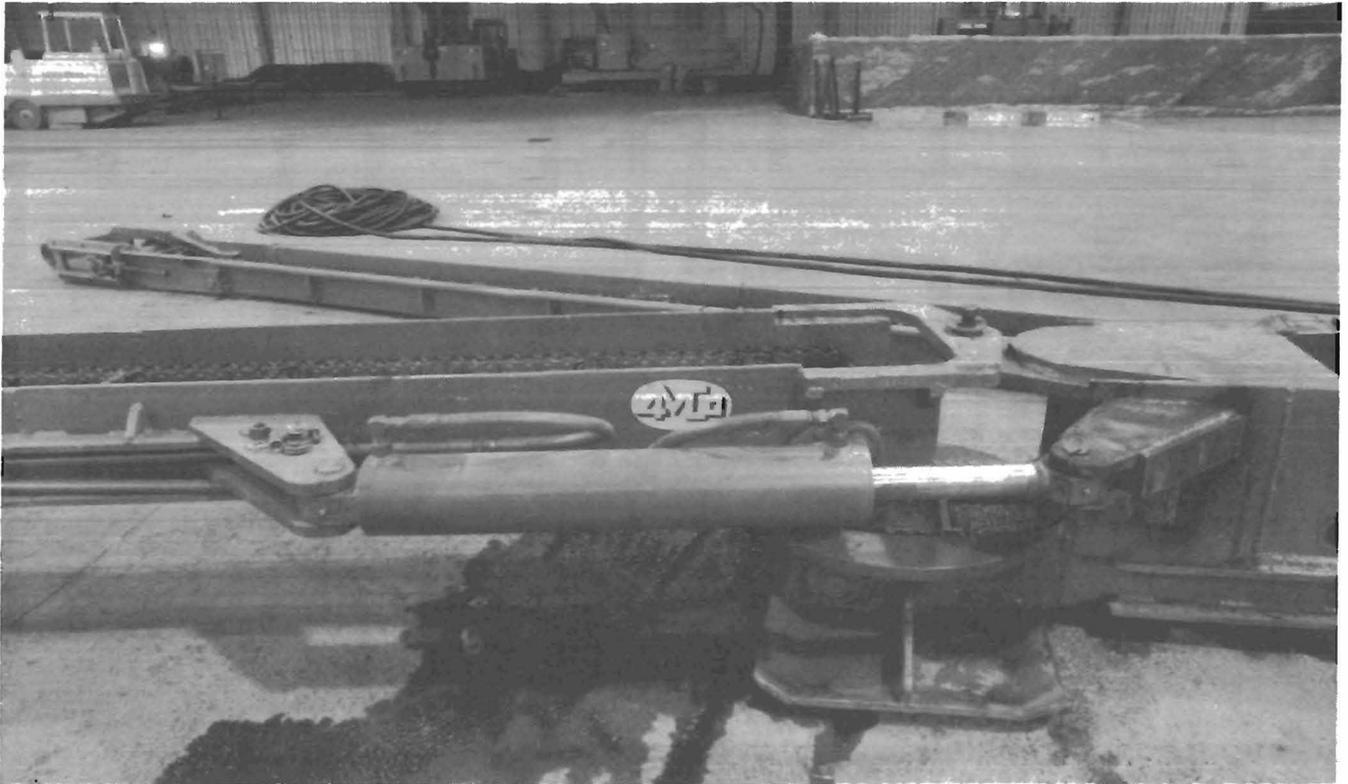
FIGURE 18. - View of powered articulation point.

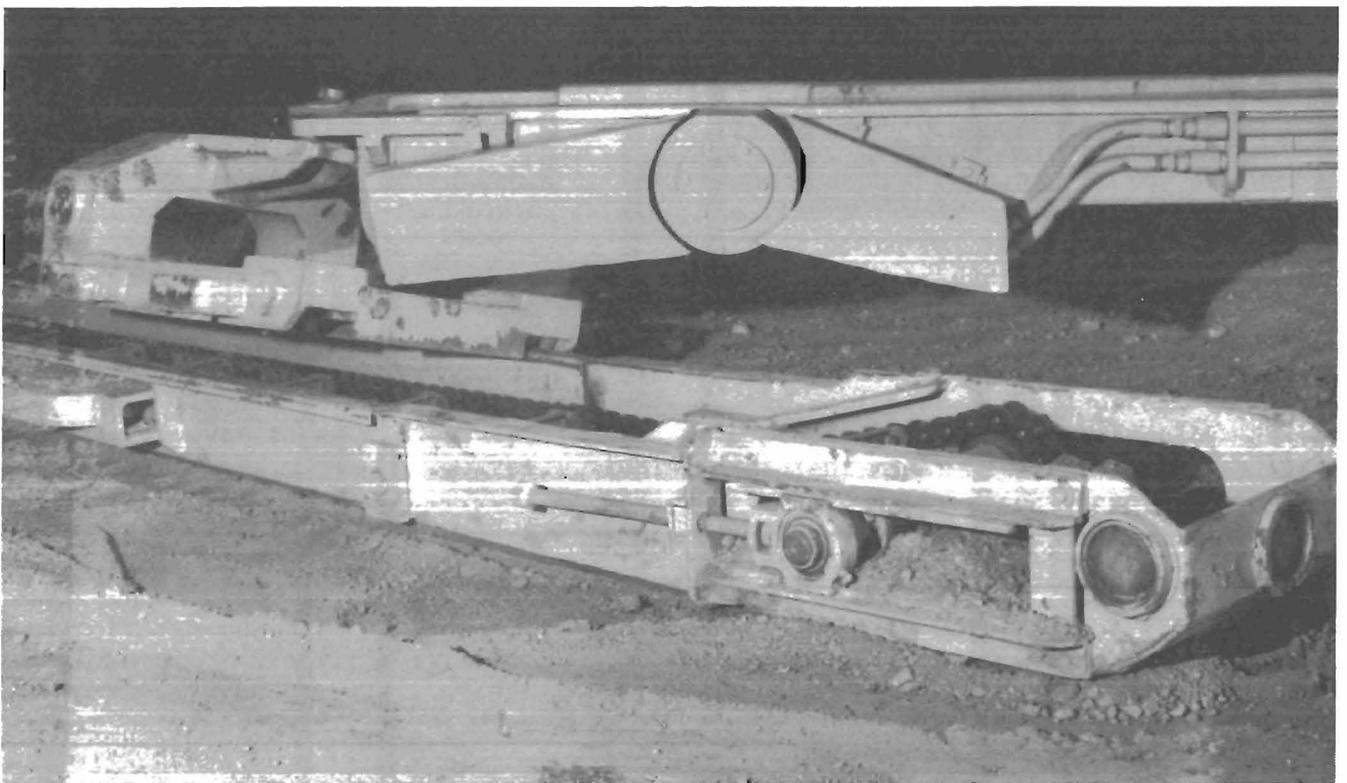
FIGURE 19. - View of panline dolly.

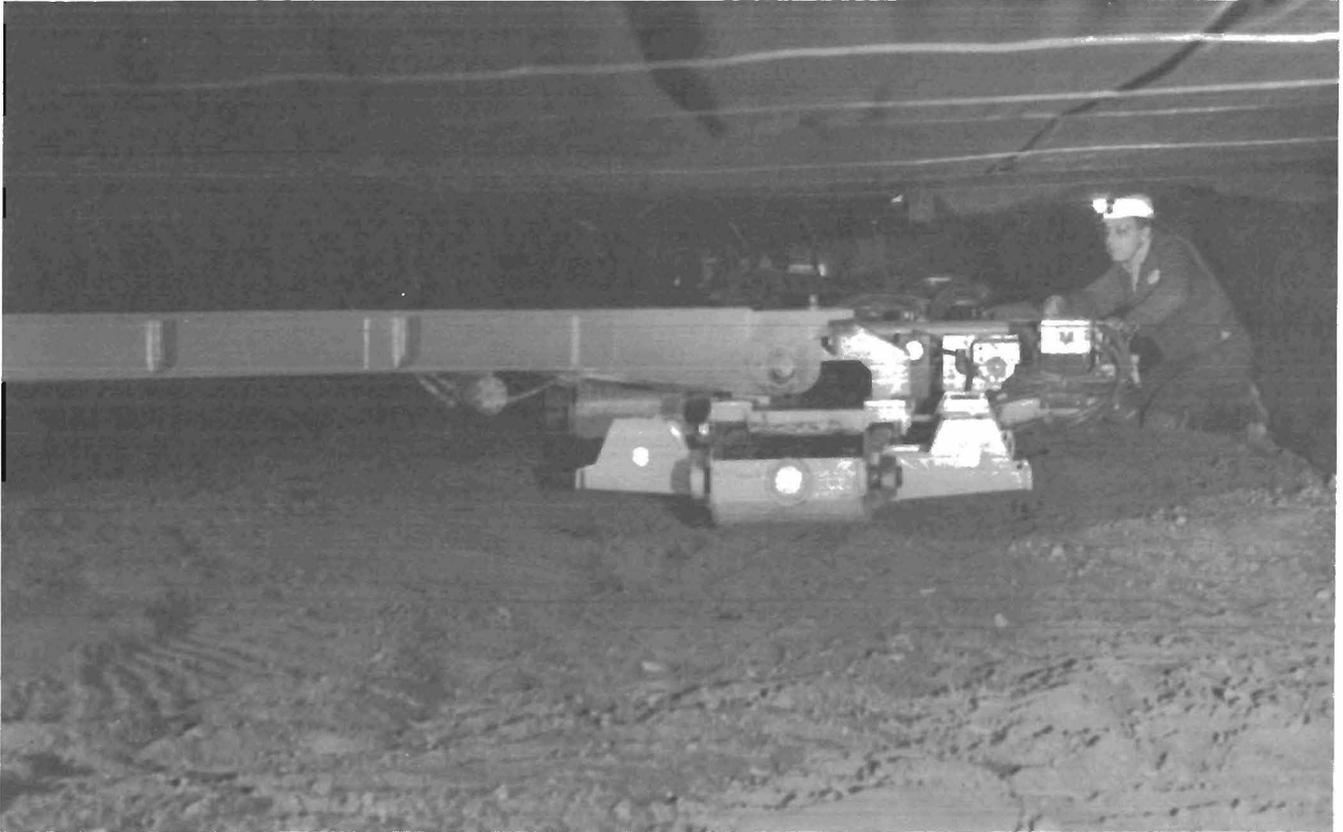
FIGURE 27. - Position of the mobile bridge carrier operator during execution of a right-hand turn.

The primary potential safety hazard identified involves the bridge carrier operator. Also, it appeared too much was expected of this operator because he or she must watch for safety hazards while crawling beside the machine when tramping. The major concern is that when the mining system is turning right (in the convention of the time trials, going from the retreated position of entry 2 to the face area of entry 3), the operator is forced next to a rib of the entry from which the turn is being executed. This situation is shown in figure 27. Here the operator is exposed to a potential crushing hazard that could be caused by a rib roll or inadvertent activation of the

The recommended solution to the above problems is for the bridge carrier to be operated remotely, from controls placed on an umbilical cord, in the same manner as was done with the miner's controls. Additional positive reasons for doing this follow.

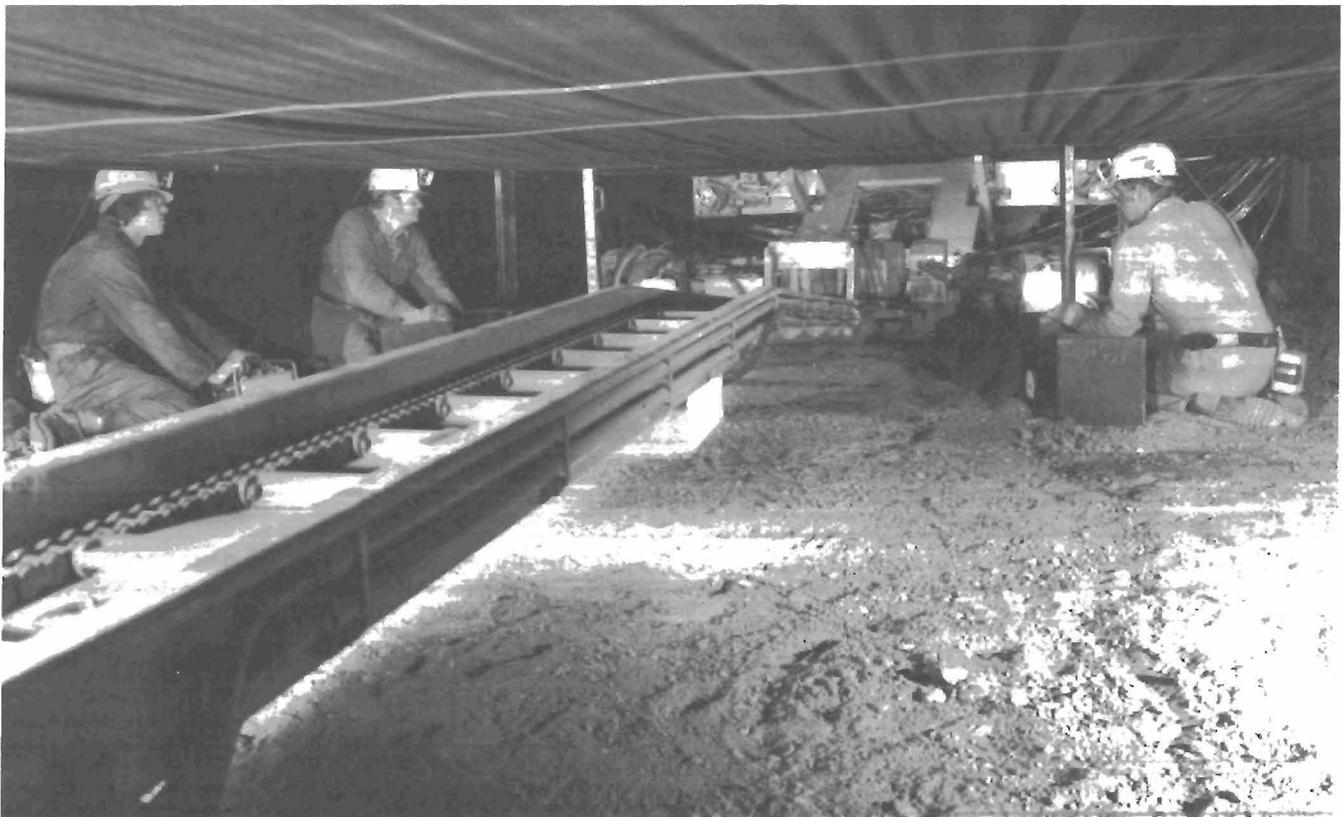
FIGURE 28. - View of open areas behind miniminer allowing for roof bolting.

A quick search of available bolting equipment produced a small, manually propelled, hydraulically powered, roof drill-bolter, manufactured in Great Britain, that would easily fit in the open areas between the miner, the ribs, and the bridge carrier. This roof drill-bolter could provide the miniminer system with the present-day capability of truly continuous mining. Figure 28 is a staged photograph showing the open areas both to the sides and behind the miner. Here, roof bolting personnel and the miniminer operator are shown, along with some temporary supports and "mockup fabrications" of the British roof drill-bolter and the bolters control modules.

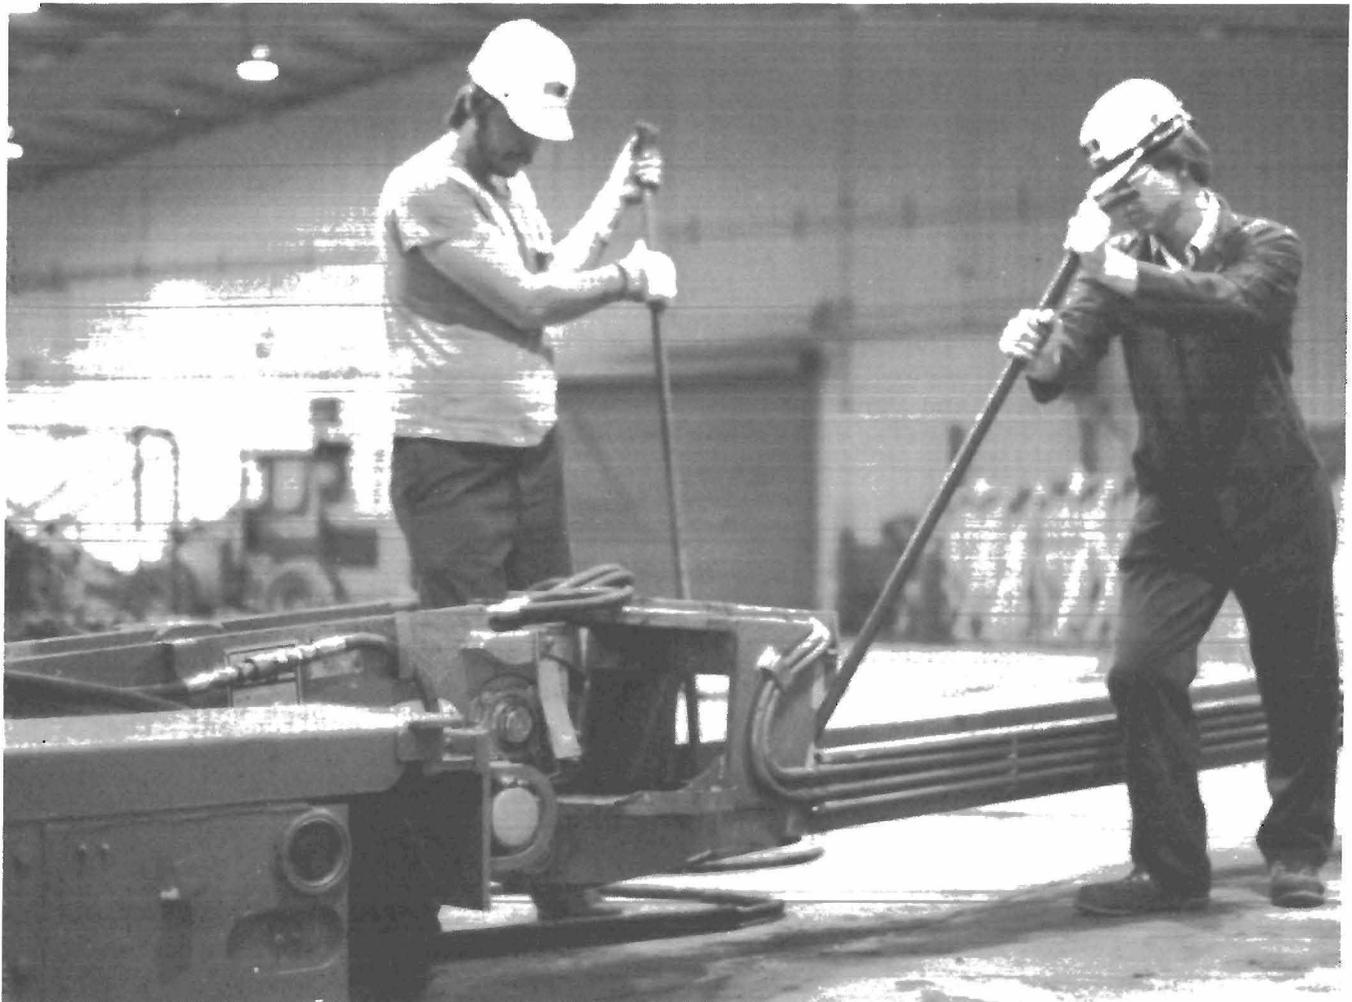
FIGURE 32. - Jammed conveyor being freed.

A problem that would re-surface during the formal cutting tests was discovered during the preliminary cutting trials. The miner conveyor and the bridge conveyor jammed approximately eight times during the cutting of the four lifts. In trying to determine the cause(s) of the jamming, several small pieces of cast metal were discovered in the coal that had been conveyed. The metal pieces apparently came from the artificial coal block and were blamed for the jamming. During later testing, it became apparent that the jamming of conveyors was caused by the physical properties of the artificial coal material and not by metal pieces. The root of the problem was apparently the fly ash component of the mixture, as it did not grind down as readily as genuine coal and caused increased friction.

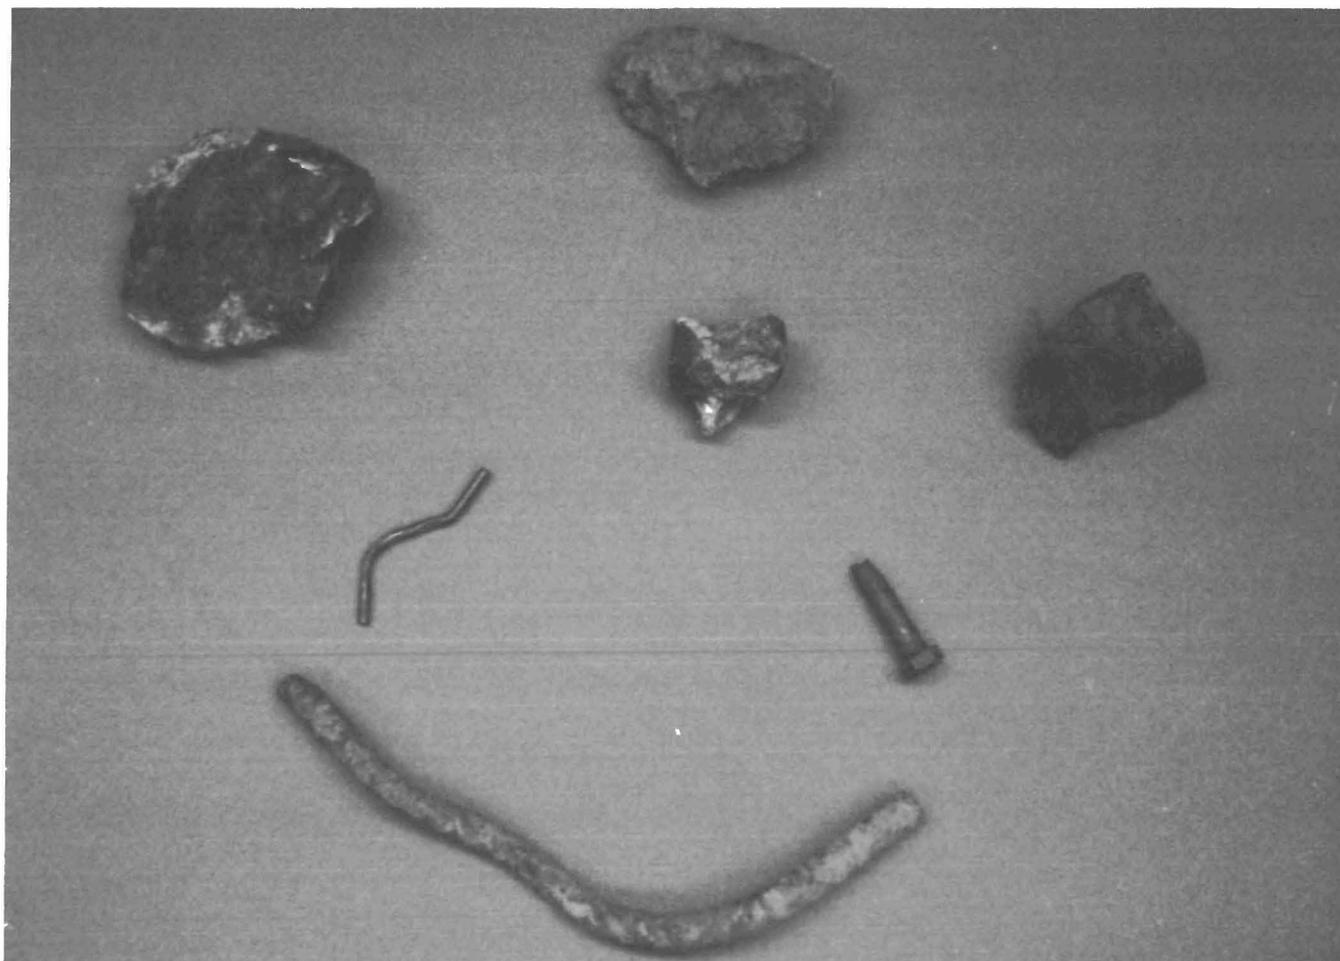
FIGURE 56. - Objects that jammed gathering augers. The bolt is of 3/8-in in nominal diameter.

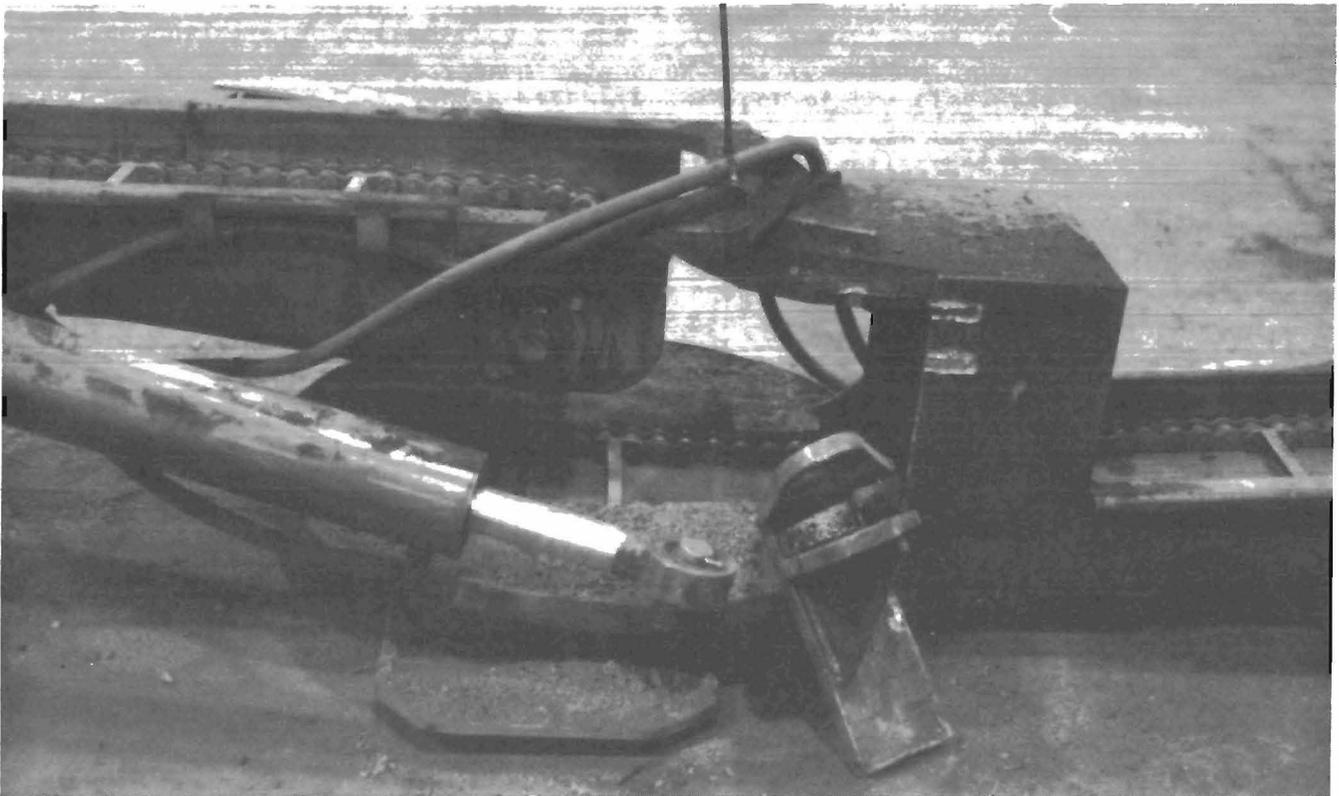
FIGURE 57. - Failed mount for articulation cylinder.
