MODIFICATION AND APPROVAL
OF
MINE RESCUE SUPPORT MACHINE

FINAL REPORT

Contract Number 200-2017-94151

ROHMAC INC

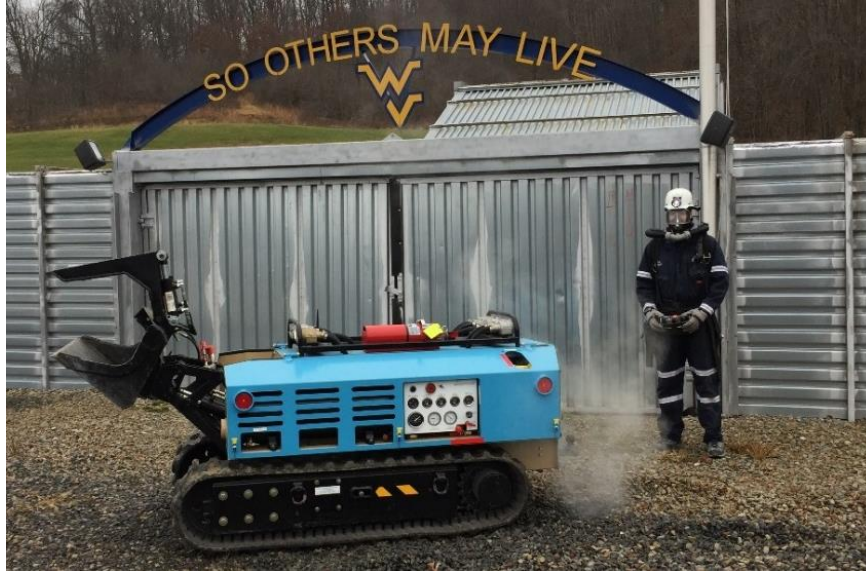
Figure 1 - MICROTRAXX™ Mine Rescue Support Machine Prototype

Under previous research efforts, a prototype mine rescue machine was designed and built for the purpose of assisting mine rescue personnel in mine rescue and recovery efforts. Comments offered by the mine rescue community were an instrumental part of the prototype design and development process. The machine prototype was well received by mine rescue personnel, who expressed a cautious optimism that it would benefit mine rescue and recovery work by not only improving the rate at which laborious tasks could be accomplished, but also by reducing exposure of personnel to potential hazards, thus improving safety. Successful demonstrations of the prototype machine indicated that it could be developed into a valuable tool for mine rescue work. In order for the machine to be useful to the mine rescue community in its designed purpose, it was decided that the machine needed to meet the requirements of permissible equipment as established by MSHA. Continued development and testing of the prototype was also necessary to improve machine performance. Figure 1 shows a picture of the prototype mine rescue machine, and an operator wearing mine rescue apparatus, at a demonstration conducted by CDC NIOSH at the Doll's Run Mine Training Facility of West Virginia University.

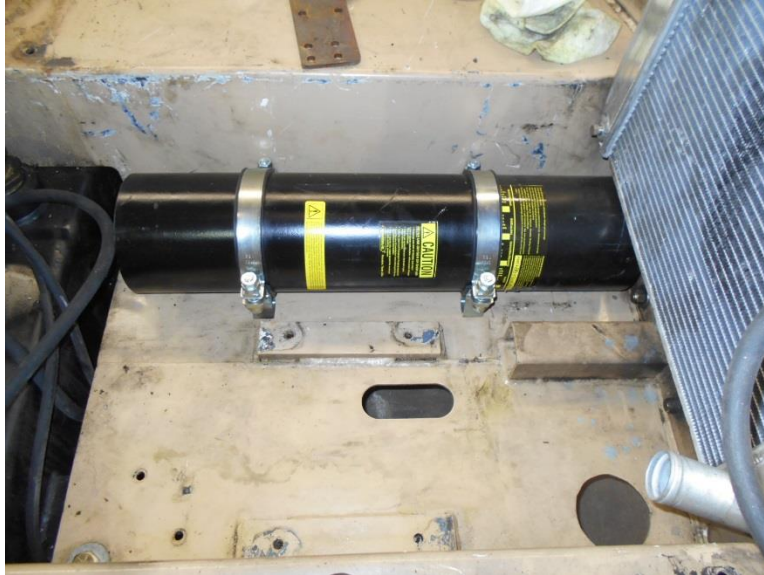
Figure 2 - Accumulator Installation

Several changes were necessary in order to change the pneumatic start and control system to a hydraulic control system. The air tank was removed from the machine and replaced by a 2.5-gallon hydraulic piston accumulator. The size of the accumulator was recommended by the hydraulic starter manufacturer. The accumulator is recharged by the hydraulic pump after startup, also, an on-board hand pump can be used to charge the accumulator when the engine is not operational. A ball valve is used to close the accumulator to keep pressure from leaking off when the machine is parked for extended periods. The accumulator was located under the exhaust system beside the engine, Figure 2 shows the installation. The hand pump installed on the front corner of the machine is shown in Figure 3.

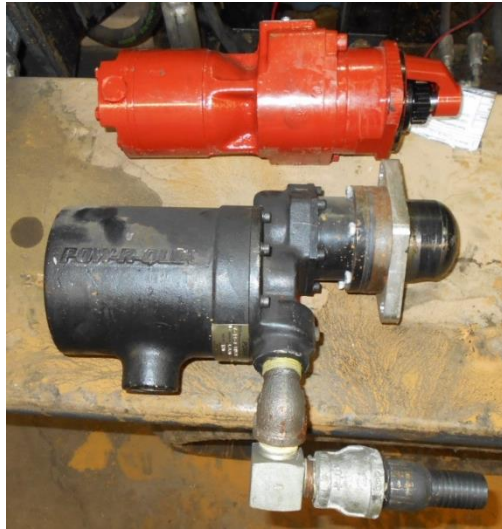
Figure 4 - Hydraulic and Pneumatic Starter Comparison

The pneumatic starter was replaced with a hydraulic motor starter. A data sheet on the hydraulic starter is shown in Figure 5. The starter requires approximately 10 gpm fluid flow to operate. The accumulator charge of 3000 psi provides up to 10 seconds of cranking effort. The hydraulic starter is more compact than the pneumatic starter, a

comparison photograph of each component is shown in Figure 4, with the hydraulic starter on the top and pneumatic on the bottom.

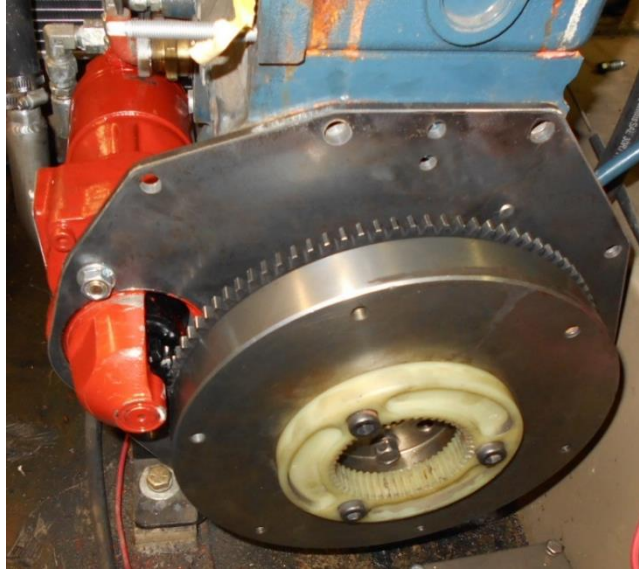
Figure 6 - Starter Mount Plate Design Comparison

The pinion and pilot on the hydraulic starter were different than the engine manufacturer's design, therefore, a new mounting plate was fabricated to mesh the starter to the flywheel. The pilot for the hydraulic starter was larger and the center moved away from the flywheel center approximately 5mm radially and 20 mm horizontally, while lowering approximately 40 mm vertically, as compared to the original position. Prior to fabrication, a three-dimensional model of the starter was evaluated with the model of the engine. Figure 6 shows a drawing comparison of the original and new starter mounting plates. Figure 7 shows a picture of the starter mounted on the engine with the new mount plate. A small modification was also performed to the pump mount bellhousing in order to match the new mount plate.

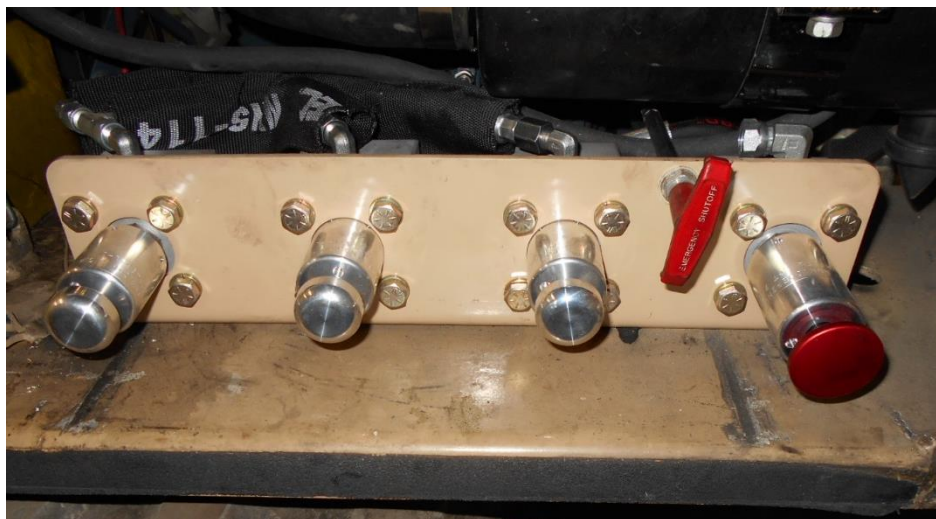
Figure 11 – Manual Control Valves

Figure 11 shows the installation of the manual control valves used to start and stop the machine. On the left side was an enable valve, which pressurized the downstream control valves for the engine start, and then override, shown respectively left to right. At the far right was a stop valve, and the emergency intake shutoff pull handle was also mounted as shown.

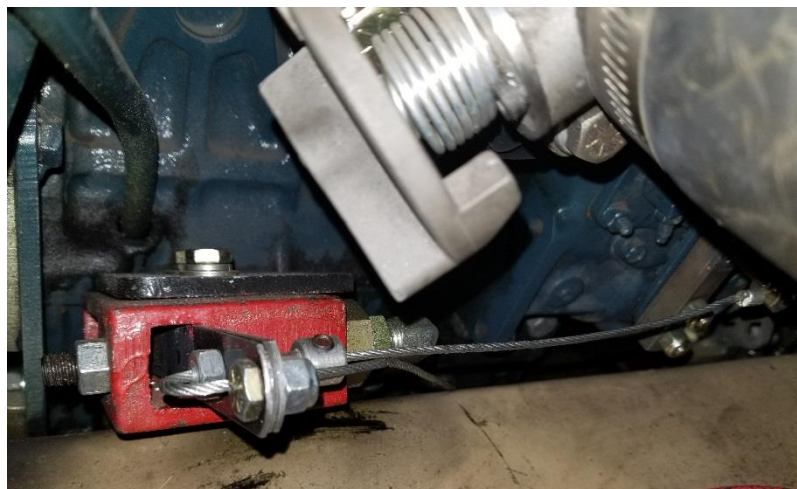
Figure 13 - Hydraulic Throttle Controller

Throttle was controlled by a hydraulically operated spring return throttle valve, that actuated when the hydraulic pump pressure increased from standby. This provided the automatic, on-demand throttle response that was requested by mine rescuers. A flow control valve with a free flow in the opposite direction was installed to allow the pressure to throttle up the machine quickly, and slow the return to idle to even out engine operation. A picture of the throttle device mounted on the machine is shown in Figure 13.

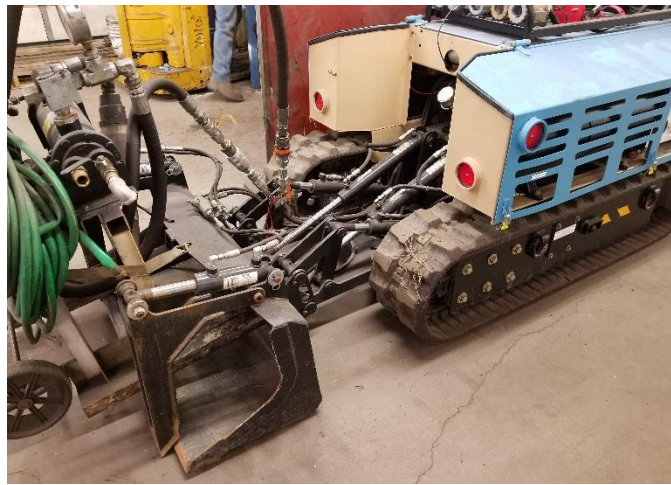
Figure 16 - Load Test Device Attached to Machine

Figure 16 shows the load test device connected to the mine rescue machine prototype. The device was on a cart in the bucket of the machine, the control valve and oil cooler are visible on the left-hand side of the picture. To test the machine, the control was placed in manual mode, PTO was engaged, throttle was opened to maximum, and the pressure on the circuit was raised to the maximum attainable point before the engine became overloaded and began to stall. The engine was held at 2900 rpm, and the hydraulic circuit measured 19 gpm at 1100 psi.

To induce a load on the engine, a hydraulic loading device was attached to the PTO circuit on the prototype mine rescue machine. The device adjusted the pressure to load the hydraulic circuit and had a water-cooled heat exchanger to remove heat from the fluid. A dial pressure gage was used to measure system pressure, and an inline flowmeter indicated the flow rate.

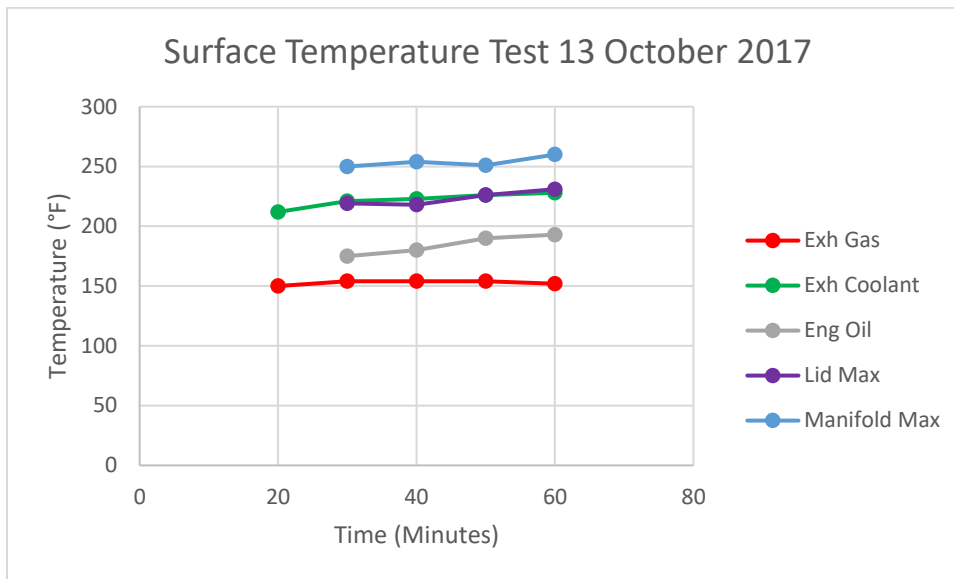
Figure 17 - 13 October 2017 Test Data

The data shows that Exhaust Gas Temperature stabilized around 155 °F, while Exhaust Coolant Temperature rose to nearly 230 °F. It was later learned that the maximum coolant temperature allowed by MSHA anywhere on the power package was 212 °F. The maximum temperatures observed on the DPM Filter Lid and Engine Exhaust Manifold area were 230 °F and 260 °F respectively. Engine Oil temperature was also recorded, and it rose to approximately 195 °F during the test. None of the temperature sensitive paint applied to the engine and exhaust components was observed to melt during the test. The backpressure recorded during the test was high, nearly 50” H₂O. The contractor determined that this was an indicator of a clogged DPM filter. It

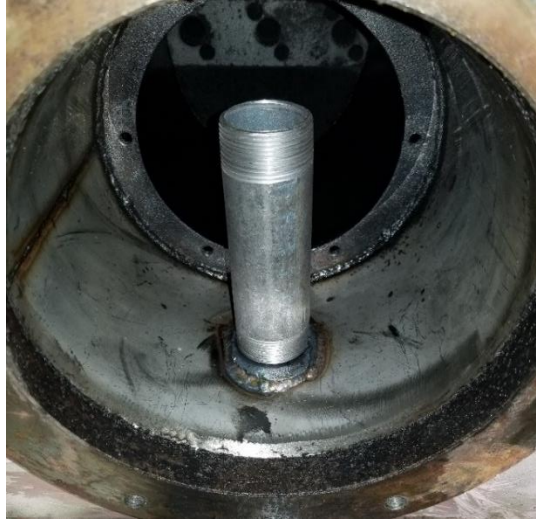
Figure 20 - Exhaust Box Riser Pipe Modification

approximately three more gallons of water than originally designed. Additional water could not be added as exhaust gas pressure pushed it out of the exhaust tailpipe.

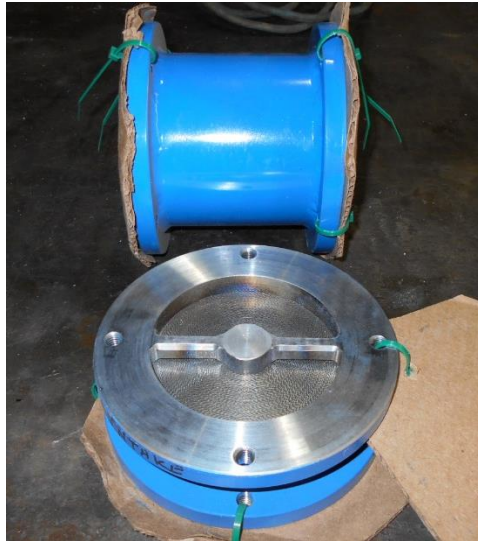
Figure 30 - Intake and Exhaust Flame Arrestors

style flame arrestor was added to the exhaust exit. The flame arrestors for the exhaust and intake were sourced from the same manufacturer, and are shown in Figure 30.

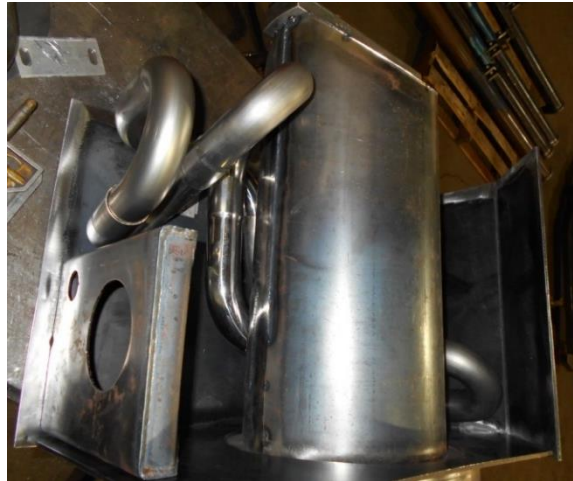
Figure 32 - Exhaust Piping Fabrication

Figure 32 shows exhaust piping during fabrication. This piping is surrounded by coolant when in operation. In this design, the exhaust exited the filter chamber through two separate 1.75-inch pipes, one of which is visible in the photograph. The pipes recombined into a single 2-inch pipe and then transferred to the exhaust expansion chamber, shown in the lower left of the figure. A flange ring was welded to the expansion chamber and the flame arrestor bolted to this flange. The lower port in the expansion chamber was for the exhaust gas temperature shutdown control. The reservoir side plate also welded to the exit flange, and the lower port fitting, to form a coolant jacket around the expansion chamber.

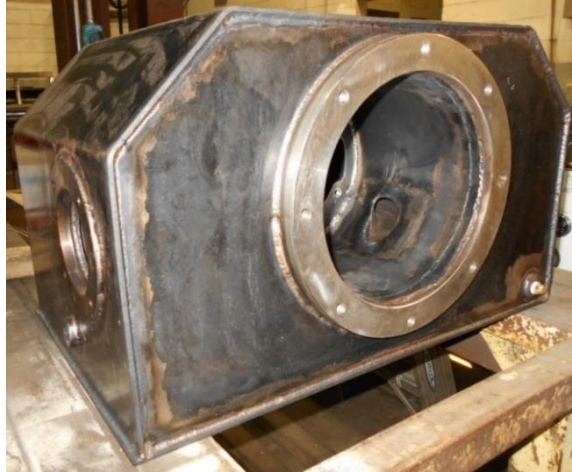
Figure 33 - Dry Exhaust System Weldment

passed a low air pressure leak test, after this test, the housing was filled with a water antifreeze mixture, and was monitored for any leak or loss of coolant level.

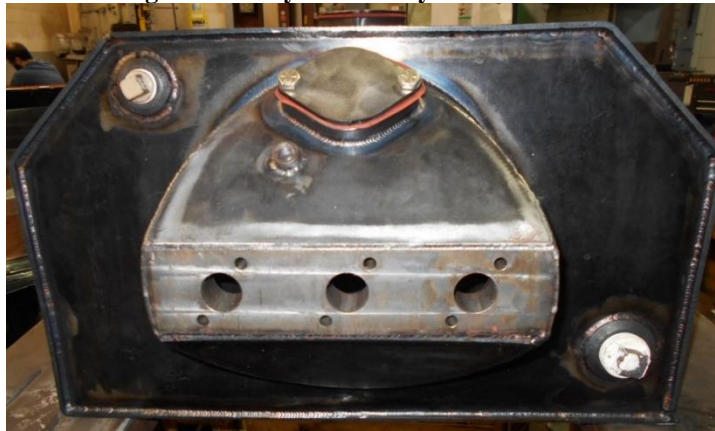
Figure 34 - Exhaust System Manifold Side

Figure 34 shows the engine side of the exhaust system. The exhaust manifold ports and engine bolt pattern are shown in the center. Above the manifold plate is the raw exhaust gas / backpressure sample port, and the water inlet port, which was covered for leak testing. After testing, the cover plate was replaced with a bolt on water neck fitting. The port on the lower right was connected to the engine water pump inlet, the port on the upper left was for a temperature sensor. On the top of the assembly was the

fill port; the test cover shown was replaced with a bolt on coolant filler neck with a pressure cap.

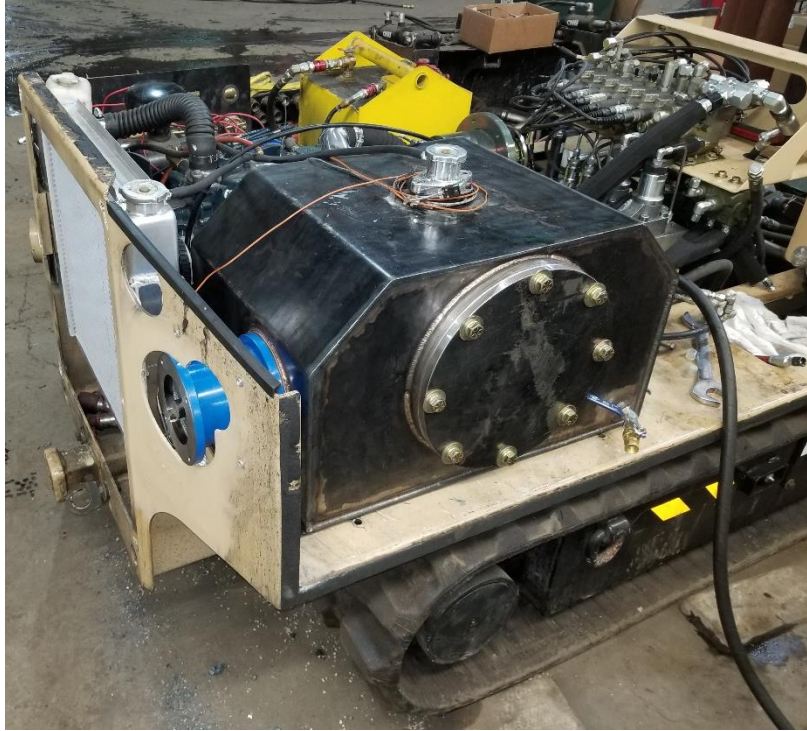
Figure 36 – Exhaust System on Machine for Initial Start Test

Figure 36 shows the exhaust system installed on the machine for an initial start test. The cooling system, with the exhaust system installed, held approximately sixteen gallons of coolant. Visible in the figure are the two pressure caps, one on the radiator and one on the exhaust system, that allowed the machine to be filled from either location and prevented air bubbles from being trapped. The vents were teed to a common overflow reservoir, visible in the upper left part of the figure next to the radiator. In the lower left, the exhaust flame arrestor can be viewed. Figure 37 shows a picture of the exhaust exit pipe installed on the flame arrestor. The exit pipe housed the exhaust gas temperature shutdown sensor, and directed the exhaust toward the radiator to be diluted by airflow from the cooling fan.

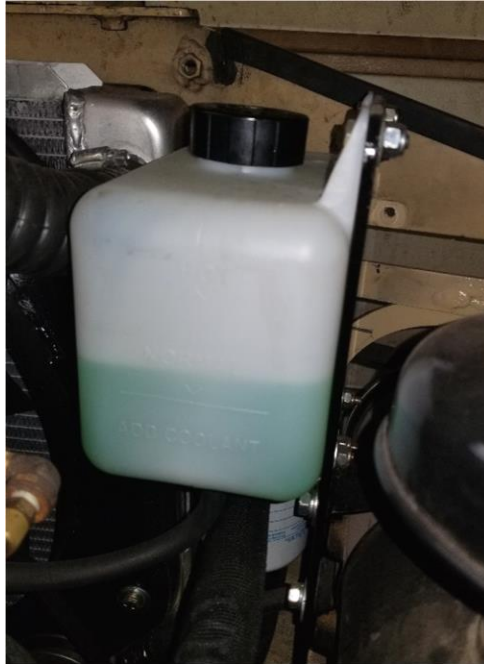
Figure 38 – Coolant Expansion Bottle

During initial testing, it was determined that the coolant system required a larger coolant expansion bottle than had been installed, as the existing bottle overflowed when the engine was at temperature, and was empty after the system cooled back down. Figure 38 shows the installation of a larger expansion bottle.

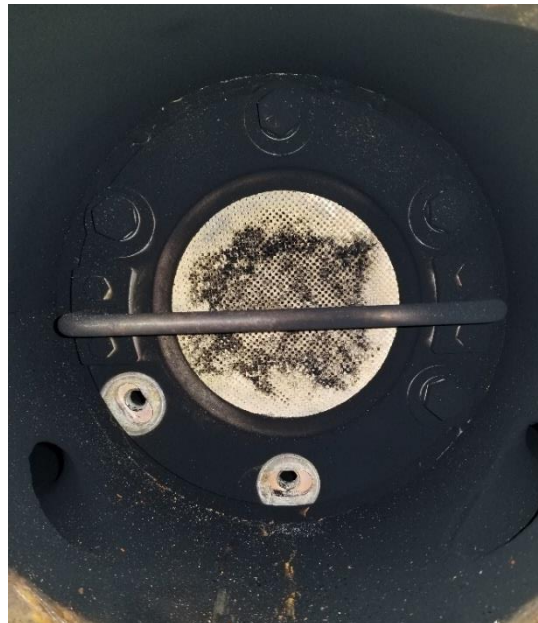
Figure 40 – DPM Filter post-test 11 March 2019

ring and other surfaces in the picture, also evidenced by the “clean” areas where two bolts were removed near the six and eight o’clock positions. The filter was removed from the assembly, and, after discussions with the filter manufacturer, sent out for evaluation. As the filter and catalyst assembly were fabricated in a single housing arrangement, removing the filter involved cutting the filter housing away from the mount ring and the oxidation catalyst housing. The oxidation catalyst was later re-welded to the mounting ring so that it could be re-installed for testing the system with catalytic converter only.

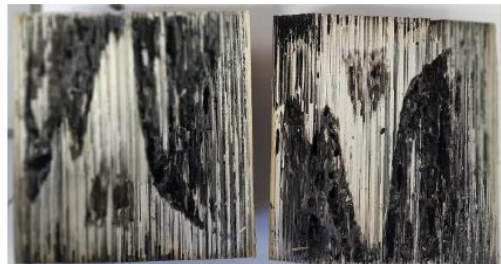
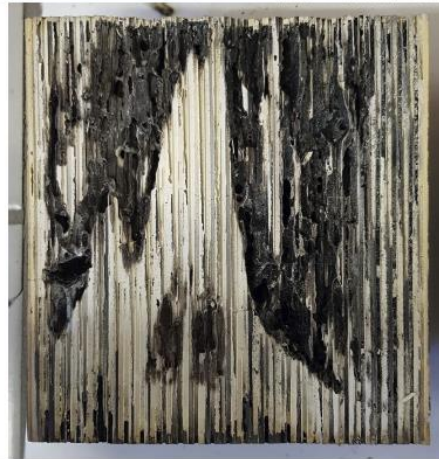
Figure 43 - Filter Failure Report page 3

The DPF showed no external sign of damage at the inlet and the outlet surface. However there are numerous indications of soot breakthrough on the outlet surface. Our borescope analysis showed extensive cell wall collapse in several locations of the DPF. In addition, there were several areas with vertical cracks in the cell walls. These are all signs of high temperature failure inside the filter, which lead to a decrease in DPF integrity and melting of the brick. The DPF was cut open to further investigate the extent of the failure.

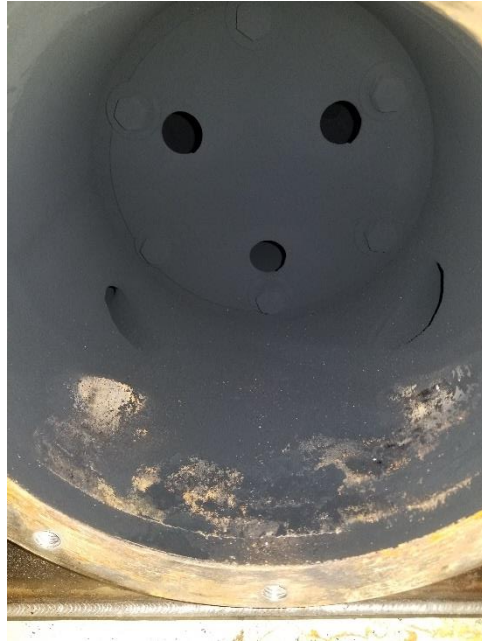
Figure 48 - Exhaust Baffle Plate Post-Test

condition is visible. It was believed that the heavy soot coating in the exhaust system was affecting some level of heat transfer.

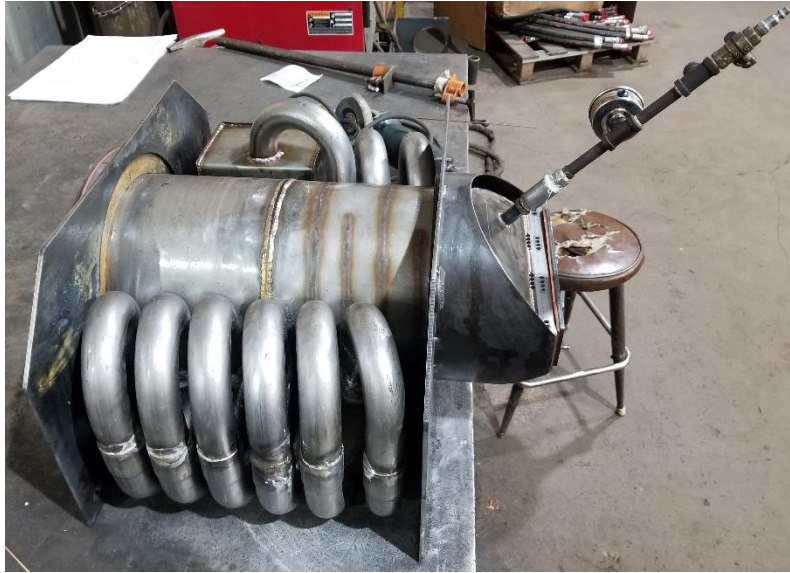
Figure 63 - Exhaust Cooler Fabrication

Figure 63 shows the exhaust cooler fabrication during a leak test. The filter chamber is visible in the center of the figure and the cooler tubing is shown on each side of the chamber. Also visible is the tubing connection at the top of the exhaust exit chamber.

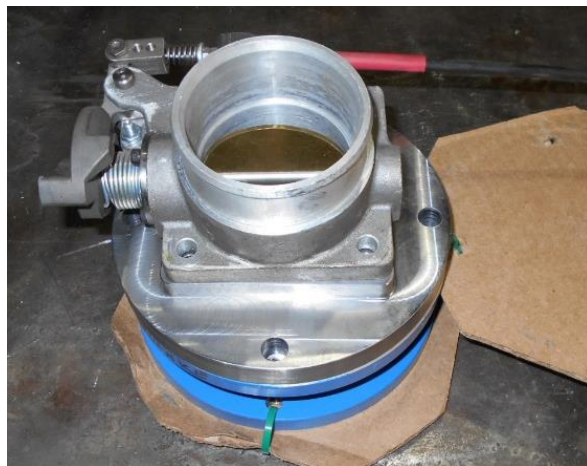
Figure 68 - Intake Shutdown Device

Figure 68 shows the intake shutdown device and adapter plate on the intake flame arrestor. Initially, copper gaskets were used to seal the bolt flanges of the flame arrestors. Bolting the shutdown device directly to the adapter plate reduced the shutdown device to about half the original size by eliminating the outlet tubing adapter. Along with these changes, the air filter was also relocated. A 90-degree tube connected the air filter housing to the intake shutdown inlet. Access to the air filter was moved to the rear of the machine, instead of the front. To accommodate this change, the fuel tank was moved forward, and the engine control and gage panel was redesigned.

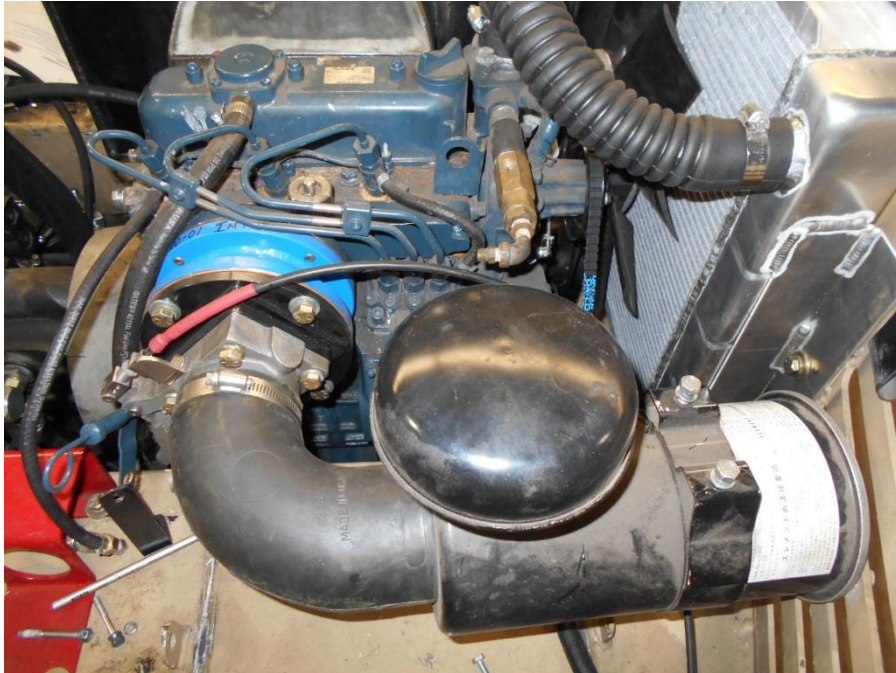
Figure 69 - Intake Manifold Installed on Engine

Figure 69 shows the intake as installed on the engine. The flame arrestor was visible with the intake shutoff valve mounted to the flame arrestor via an adapter plate. Figure 70 shows the reconfigured air filter location and service point on the back of the machine, also visible to the right of the filter was an updated fuel filter / water separator.

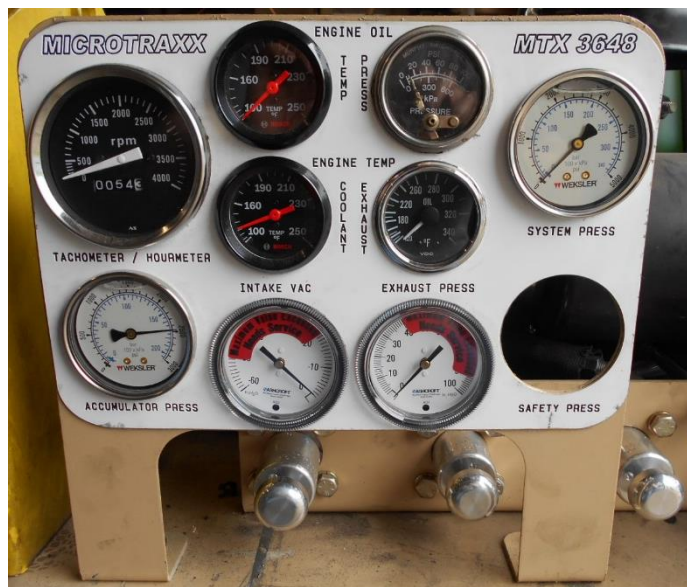
Figure 71 – Gauge Panel

Figure 71 shows the redesigned gauge panel installation, which was near the manual start and override valve actuators. Engine monitoring gauges include the tachometer / hourmeter, engine oil pressure and temperature, engine coolant and exhaust gas temperatures, and intake restriction and exhaust backpressure. Hydraulic pressure gauges were included for the accumulator, safety shutdown system, and pump system pressures. The yellow fuel tank was visible to the left of the panel.

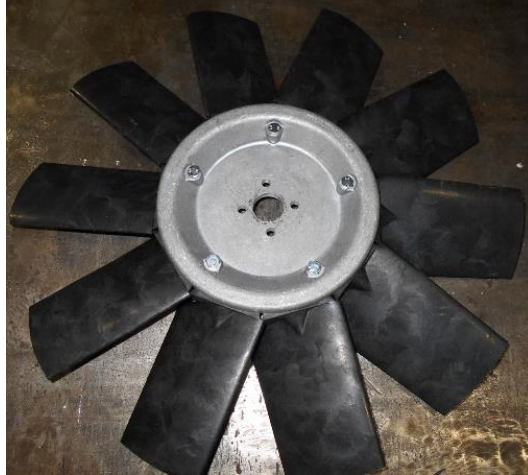
Figure 72 - Cooling Fan

In order to meet MSHA requirements, the OEM engine cooling fan had to be replaced with an anti-static fan. The radiator, and mounting location and size of the fan were also modified to improve the cooling efficiency of the system. Figure 72 shows a picture of the new cooling fan, and additional fan details are shown in Appendix B.

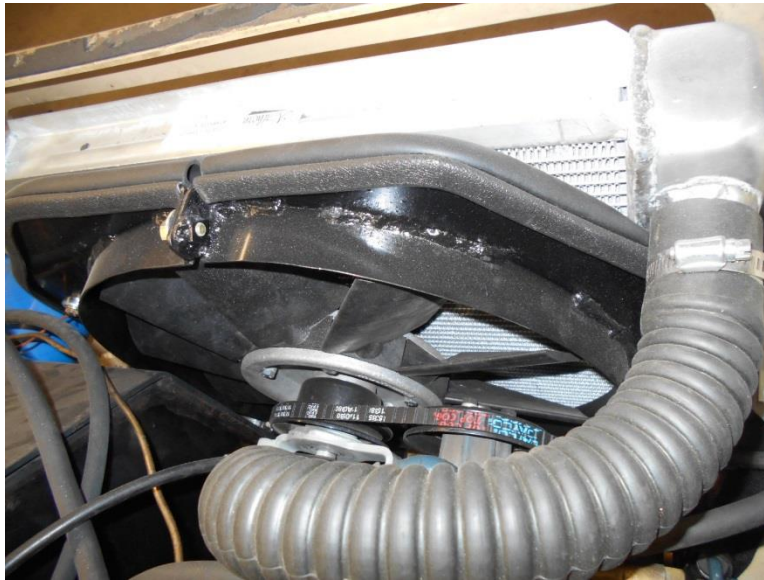
Figure 73 – Cooling Fan Shroud

Figure 73 shows the updated cooling fan mounting. The fan shroud was designed as a bolt together unit that could be removed without disconnecting the radiator or removing other components of the assembly. A fan lowering kit bracket manufactured by the engine OEM was modified to create the new fan mount. To align the fan belt drive, the water pump pulley was modified by cutting the belt sheave away, shortening the backspacing bell material and rewelding the sheave on. The radiator was replaced to

alter the inlet and outlet port locations such that hosing to the engine and new exhaust system were simplified.

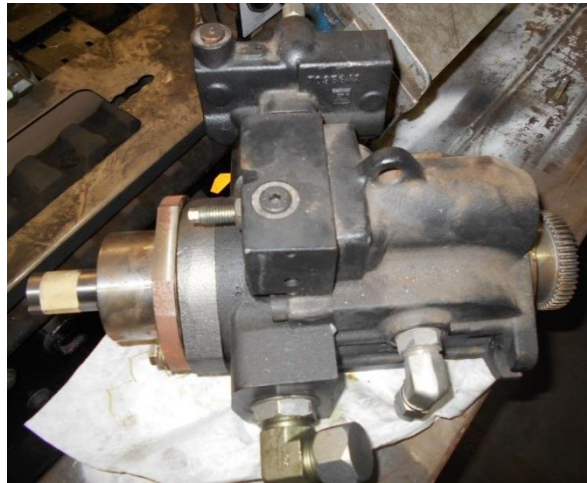
Figure 74 - Hydraulic Pump with Auxiliary Drive

As mentioned, the size of the MSHA approved alternator required some consideration and design to locate it on the machine. To drive the alternator, a through shaft drive with an auxiliary PTO shaft on an overhung load adapter was used. Figure 74 shows the hydraulic pump with the devices installed.

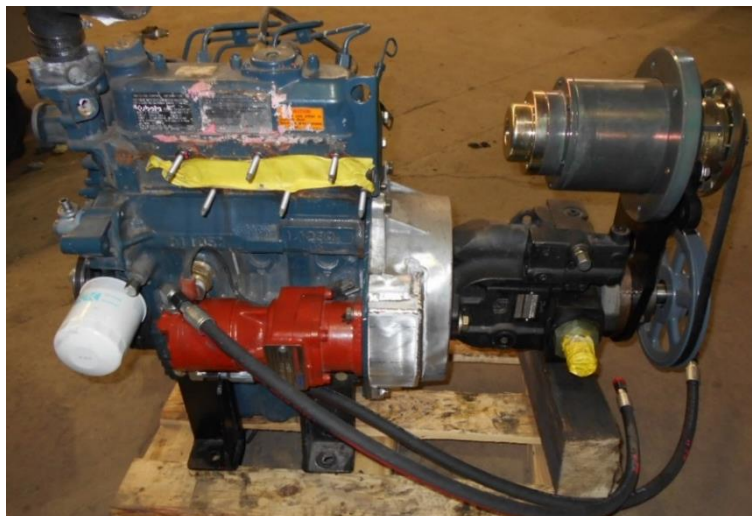
Figure 75 - Engine Assembly

Figure 75 shows the belt driven alternator and mounting bracket connected to the hydraulic pump, attached to the engine. Also visible was the oil filter; the original

prototype used a remote filter mount primarily because of the size of the pneumatic starter. As the hydraulic starter was smaller, the oil filter was returned to the original location on the side of the engine. The modification to the bellhousing pump mount adapter mentioned earlier in the report was also visible in the picture. Figure 76 shows a guard for the alternator belt drive that was designed and installed.

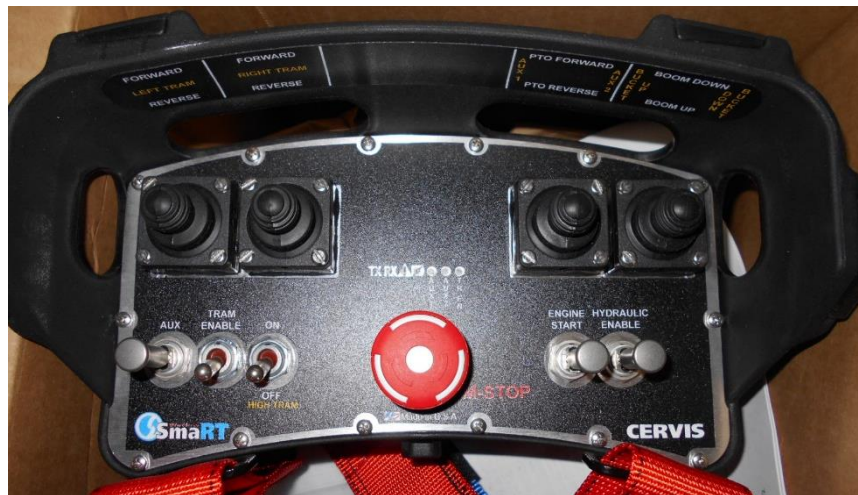
Figure 80 - Permissible Radio Transmitter

Figure 80 shows the permissible radio control transmitter, and Figure 81 shows the MSHA approval tag on the transmitter. This radio transmitter used a shoulder harness that was anticipated to be more user friendly than the belt harness used on the original prototype version. The shoulder harness also had a break away design that added to safety, whereby if the transmitter were caught and pulled, the harness would break away from the operator, to prevent possible injury. The transmitter was powered by two C-Cell batteries, which provided up to 100 hours of operation.

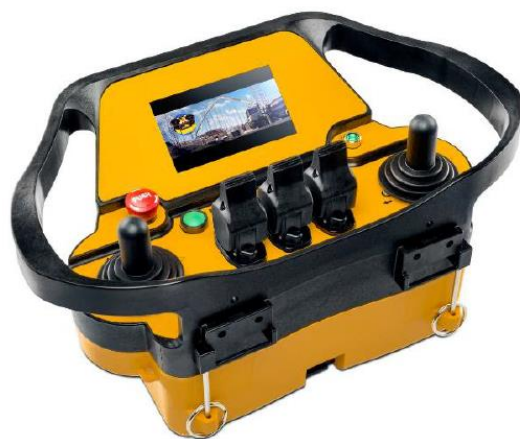
Figure 82 - Stock Photo of Radio Transmitter

Another radio manufacturer was later discovered, that offered a radio remote control system with an integrated video component. Upon discussion with the manufacturer, they indicated that they were pursuing MSHA approval for some of this equipment. A meeting was scheduled with this manufacturer on 5 February 2020 to discuss their system and see if it could integrate into the prototype machine, and the possibility of providing an improved system that enhanced one of the original project objectives. During the meeting, it was learned that the system was capable of operating up to 4 cameras and viewing the camera feed on a 4-inch screen on the transmitter. This system had been extensively used in fire-fighting robot applications, and the manufacturer had developed several systems for hazardous areas that require ATEX approval. It was also discussed that these representatives had met with MSHA A&CC representatives on 4 February 2020 to discuss the needs and procedures to develop and approve their system. It was further discussed about the integration of this system with the mine rescue support machine and the desired operating frequency range. Comments were generally positive and the radio manufacturer representatives indicated that they

believed that MSHA approval of their equipment was possible and that it would be a good fit for this machine. A follow up phone call from the radio manufacturer was received on 19 February 2020, during this phone call it was indicated that the radio manufacturer was moving forward with pursuit of MSHA approval for their equipment. At the time, a no-cost time extension was requested to allow additional time to evaluate this new radio system, as well as allow time for this system to move closer to MSHA approval. Figure 82 shows a sample picture of the radio transmitter with a camera monitor screen. During a later meeting with representatives of this same manufacturer on 10 June 2022, a new prototype system was displayed with features that operators had requested, for instance, offering joystick control with a tablet interface. The representative also indicated that the manufacturer was still interested in pursuing MSHA approval, but that some other approval work for their systems was taking precedent. As of the date of this report, there has been no indication that the system has been approved for use by MSHA, but at such time that it may be approved in the future, it would merit consideration for use on the mine rescue machine, as it appears to offer several of the features that were requested by the mine rescue community.

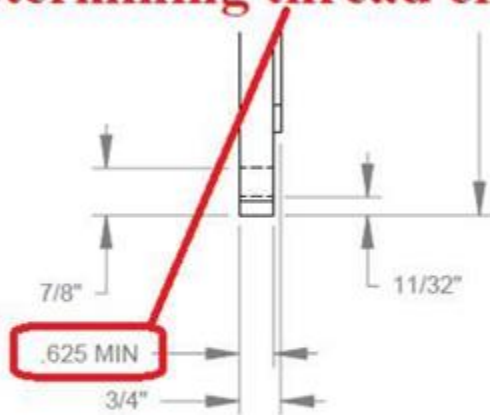
Figure 91 – Drawing Excerpt showing XP Enclosure Cover with Tolerance Comments

- Lock washer thickness needs tolerance added or general tolerance will be used.
- Using a 1-1/8" long fasteners. You do not meet the minimum 1/2" required thread engagement. You will use Max LW Thickness, Max Flat Washer Thickness and Max Cover Thickness to determine minimum thread engagement.
- Cover Thickness

This thickness is critical in determining thread engagement.

It must be listed as a min/max or a nominal with +/- Tolerances

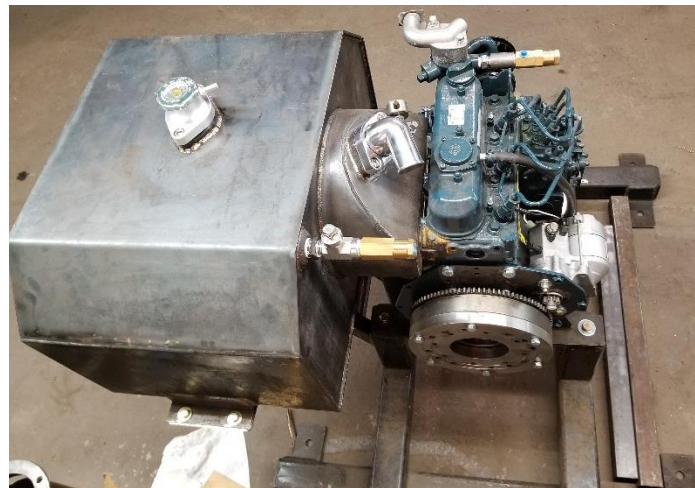
Figure 120 – Test Engine Unit

In preparation for submitting the diesel power package approval application, a test engine assembly was fabricated for the necessary MSHA approval testing. Once the test unit was completed, preliminary testing and break-in of the engine were performed before the apparatus was taken to MSHA A&CC. Figure 120 shows the test unit, which consisted of the diesel engine with cooling, intake, and exhaust systems, mounted on a skid that adapted to a dynamometer test bed.

In order to install the exhaust system, the electrical starter had to be relocated to the other side of the engine, which required modification of the starter mounting plate. The test unit was permitted to use the OEM electric starter to simplify the laboratory testing process. Also visible in the picture was the flywheel adapter plate that was built

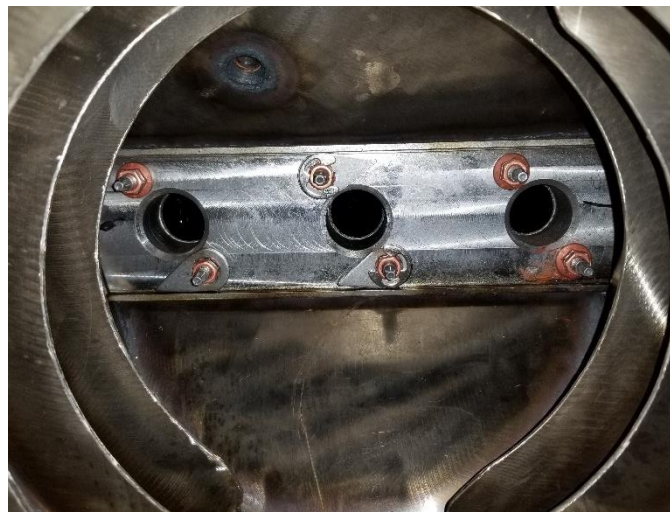
Figure 121 - Exhaust Manifold Locking Nuts

to attach the engine flywheel to the dynamometer driveshaft. Figure 121 shows the exhaust manifold during installation. The fasteners and locking devices mentioned previously in this report are shown in the picture. The 7 mm nuts used on this engine were specialty copper fasteners, that had to be sourced by the lock manufacturer. Teardrop profile tabs, having a multipoint pattern that engages the hex nut, were placed over the manifold nuts after they were properly torqued, and they prevented the nut from turning by contacting the machined ledge on the manifold plate. Retainer clips were installed in a groove on the nuts, and held the locking tabs in place. Figure 122 shows the finished installation of the exhaust manifold. Also visible in the pictures were the exhaust sample port in the upper left, and the baffle plates against the wall of the chamber, note that the baffle openings alternated top and bottom as the baffles move close to the viewer.

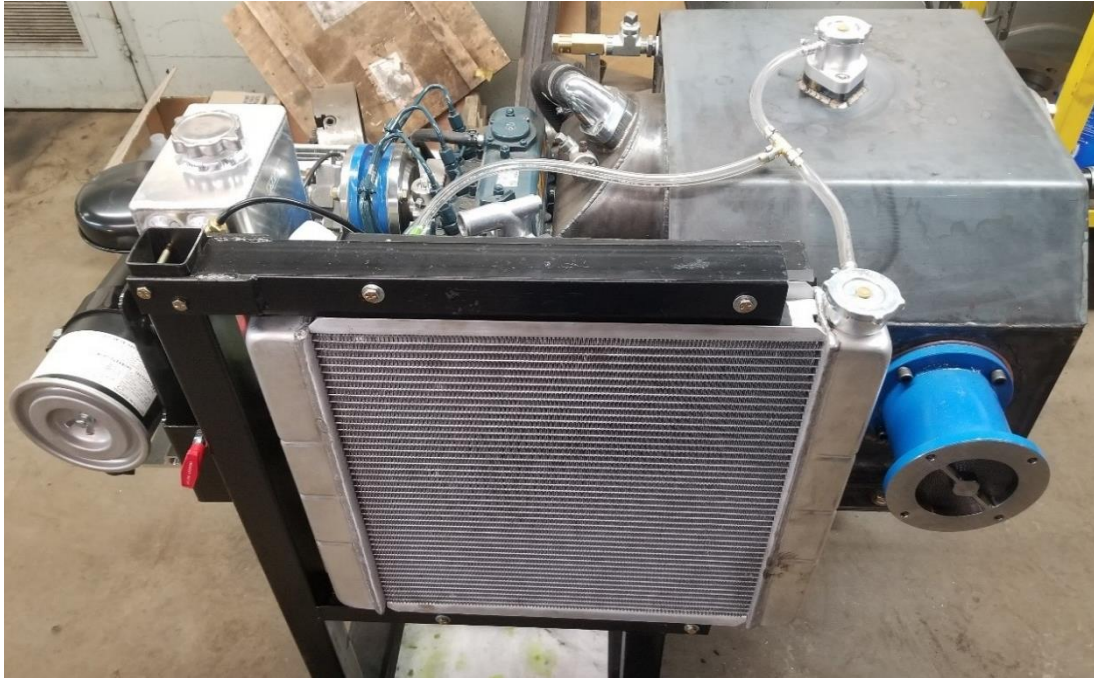
Figure 123 – Complete Test Engine Assembly Front View

Figure 123 shows the test unit stand from the exhaust exit side, the exhaust flame arrestor was visible in the lower right of the figure. The radiator was located in the middle of the picture, and the air intake filter, shutdown actuator, and coolant expansion tank were visible on the left side. The radiator cap was slightly lower than the pressure cap on the exhaust system, and the lines from these points to the expansion tank were connected together. Figure 124 shows a view of the test unit from the air intake side. The temperature sensor for the exhaust tank was visible in the upper left, and the coolant line from the radiator to the exhaust system was clamped to a bracket to secure it from movement. The intake flame arrestor and intake manifold were shown near the center, the intake shutdown device was attached to the flame arrestor, and a 90-degree reducer elbow connected the device to the air filter housing.

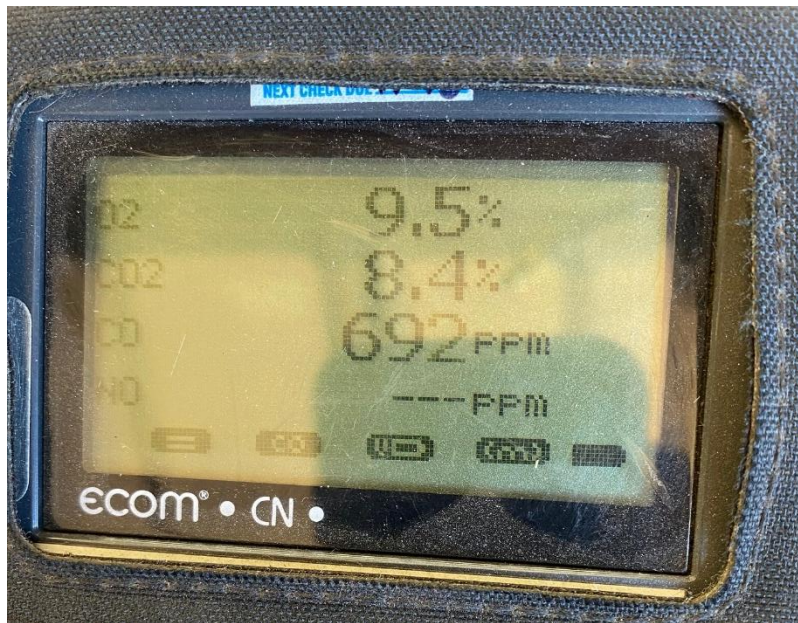
Figure 125 - Raw Exhaust Gas Reading

coupler, such that repairs to return to service were not reasonable. At the time of the failure, the engine was operating near full load. Figure 125 shows a reading from the ECOM exhaust gas analyzer measuring the raw exhaust during this test. The Oxygen level is shown at 9.5% and the Carbon Monoxide reading is 692 ppm. This analyzer displayed a calculated Carbon Dioxide value of 8.4%. Figure 126 shows a reading from the Omega temperature instrument during this test. The instrument was displaying measurements from two J-type thermocouples. T2 was located in the raw exhaust stream and was nearly 930 °F, T1 was the cooled exhaust gas and was nearly 150 °F.

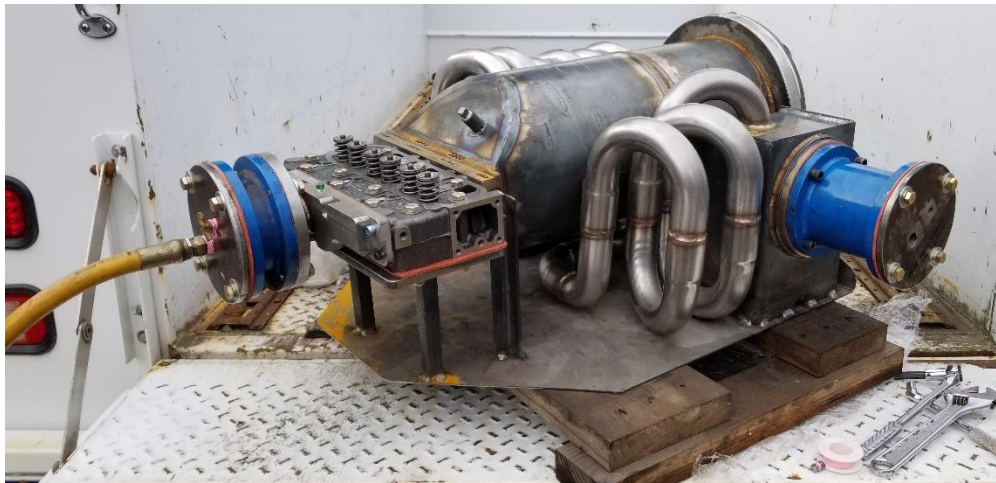
Figure 127 - Hydrostatic Test Unit Intake Side Test

On 12 November 2020, the hydrostatic test unit, as well as the diesel power package test unit, were taken to MSHA A&CC to perform preliminary testing and review of the devices. A hydrostatic test of the intake and exhaust systems was performed to verify the strength of the components used in the design. The test apparatus filled the system with water to eliminate air, and pressurized the water to 150 psi for 10 seconds. Flame paths were measured with feelers gages before and after the pressure tests, to ensure there was no deformation that could open a flame path. Figure 127 shows a picture of the water line hooked to the intake side of the test unit during the test. Figure 128 shows the test apparatus during the test, the hydrostatic pump used to pressurize the system was visible near the center of the picture

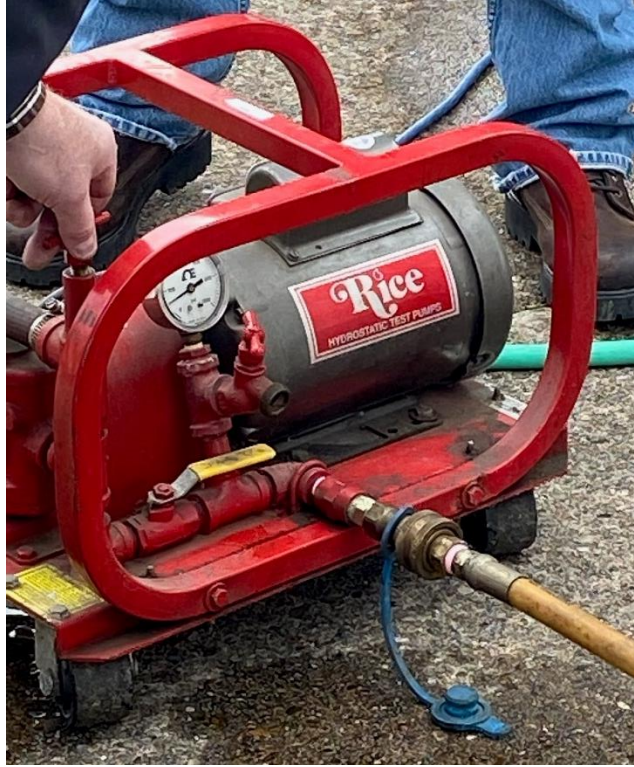
Figure 129 - Hydrostatic Test Pump

Figure 129 shows the hydrostatic test pump during a test. The picture displayed the adjustment of system pressure by turning a bypass valve closed, and a pressure on the gage of approximately 150 psi. Figure 130 shows the test apparatus installed on the exhaust side of the test unit.

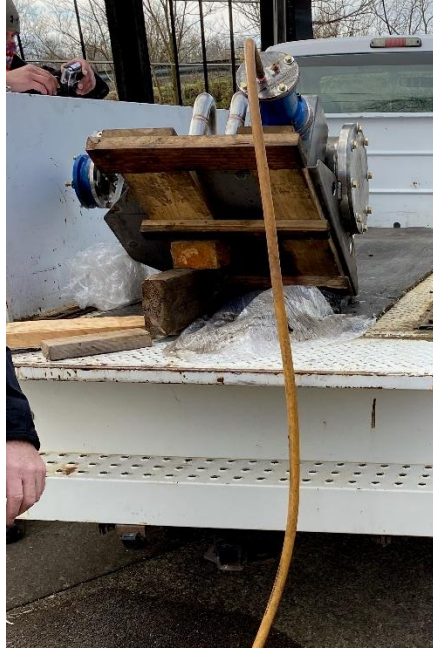
Figure 131 - Exhaust Side Hydrostatic Test

Figure 131 shows the test unit during the hydrostatic test. Note that the test unit was placed on an incline to elevate the exhaust exit, which ensured that air was completely evacuated from the system. It was necessary to remove all air prior to pressurizing the water, as compressed gas inside of the system could have created a safety hazard. The picture also shows the use of a video camera that was used to record the tests. The test results indicated that the system fasteners were sufficient to meet the necessary performance criteria. After the tests were performed, there was a general discussion and review of the design, and the diesel power package. It was indicated that the test unit appeared ready and complete for performing the necessary tests, and it was therefore decided to leave the diesel engine test unit at the laboratory.

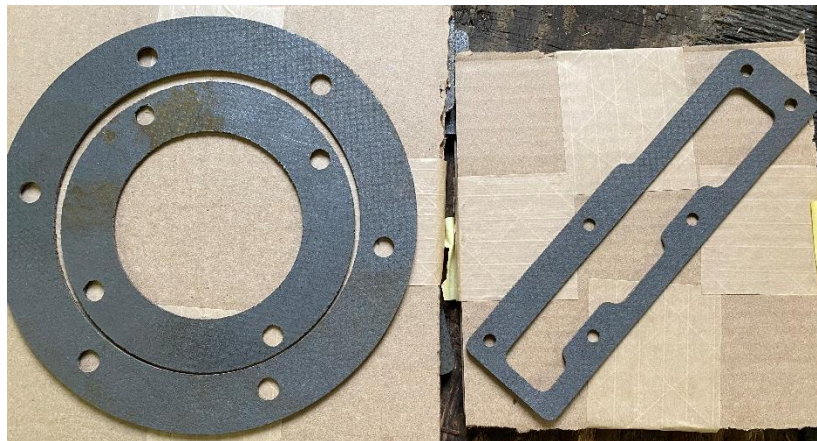
Figure 132-Exhaust and Intake Gaskets

Research was conducted, and another gasket material was found for the intake manifold, and exhaust filter and bonnet gaskets. Initially the gaskets were a 0.040” thick copper, they were changed to a 0.078” thick CS-830 graphite / fiber material with metal tang. Figure 133 shows a specification sheet for the updated gasket material. This material was rated for 1400 °F, and was less fragile than the graphite gaskets that were previously discussed and tested on the exhaust filter. After review and consideration of this material, it was decided to replace the other system gaskets for commonality. Figure 132 shows a picture of the updated exhaust filter, flame arrestor, and intake gaskets.

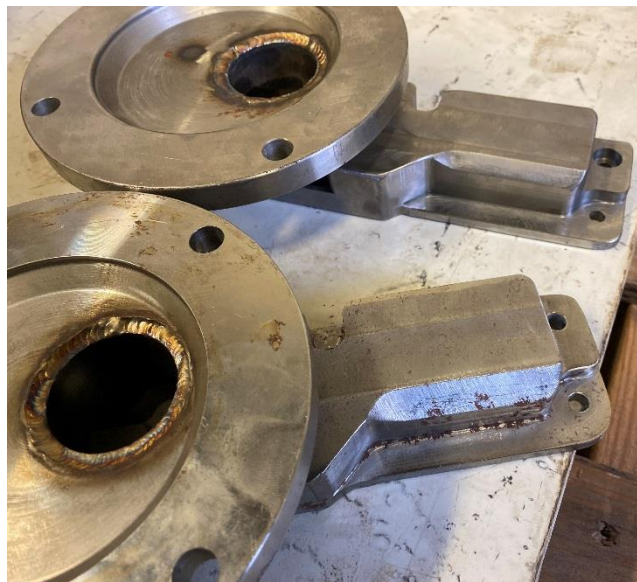
Figure 135 - Intake Manifolds

On 17 March 2021, the contractor travelled to MSHA A&CC test lab to install the updated intake manifold on the test engine, and assist in placing the engine on the small engine dynamometer. Figure 135 shows a picture of the original (bottom) and replacement (top) intake manifolds. The recessed bolt hole is visible on the top right corner of the new intake manifold. The new intake manifold gasket was also installed.

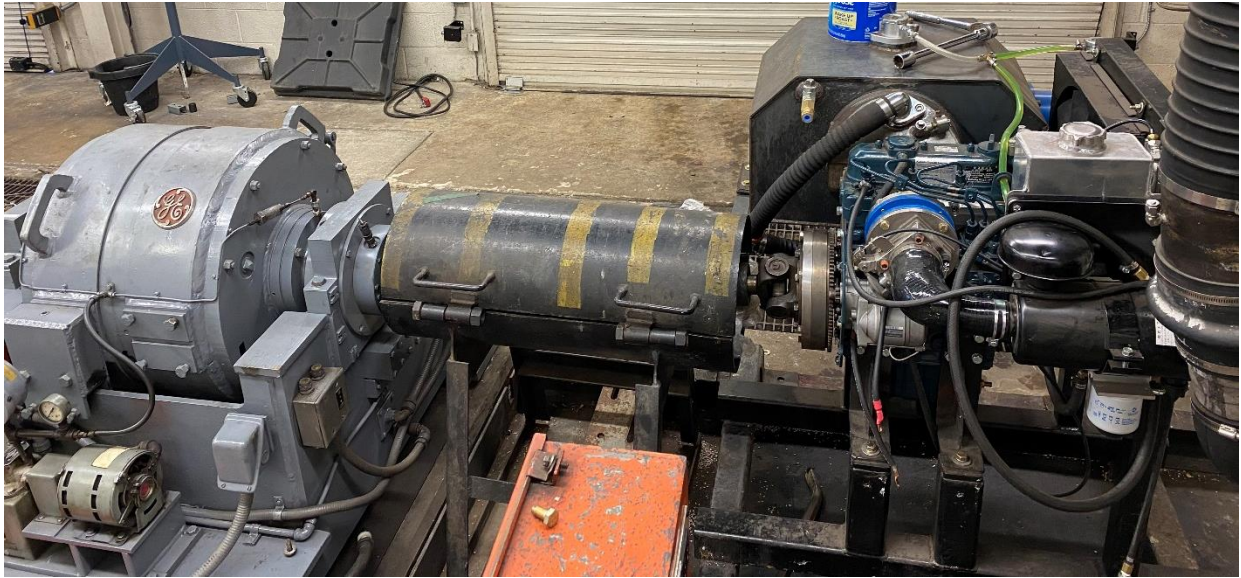
Figure 138 - Test Engine Dynamometer Installation

Figure 138 shows the test unit installed on the dynamometer stand.

During the intake manifold replacement work, MSHA representatives prepared the small engine dynamometer to install the test engine. Once this work was complete, the power package test unit was placed onto the dynamometer test bed, and connections needed to operate the engine were made. It was also decided to remove the catalytic converter / dpm filter assembly and install the catalytic converter only device, to prevent damage to the dpm filter during initial tests. An initial startup was performed to check
