MODIFICATION AND APPROVAL
OF
MINE RESCUE SUPPORT MACHINE

FINAL REPORT

Contract Number 200-2017-94151

ROHMAC INC

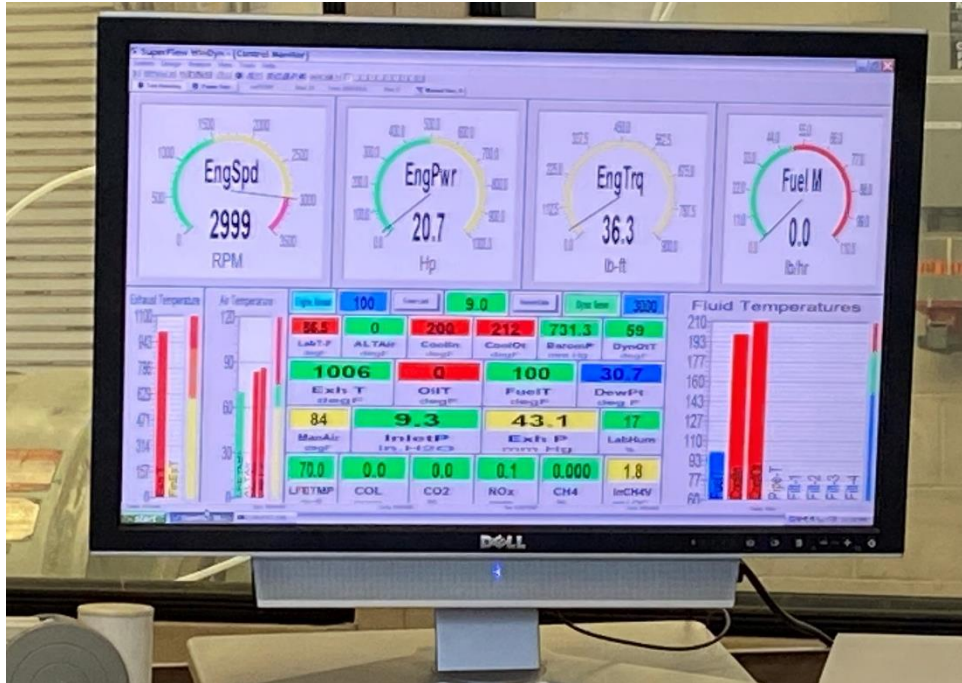
Figure 146 – Control Room Data Monitor

Figure 146 shows the control room monitor readout of data during the test. In the top of photo, the engine speed was 2999 rpm and it was producing 36.3 ft-lb of torque, resulting in 20.7 hp. The torque and horsepower were corrected for dynamometer loss, which was stated to be 17 hp. The raw exhaust temperature was 1006 °F, which was shown both on a bar graph in the lower left corner, and a digital readout near the center of the screen. The cooled exhaust gas was approximately 250 °F, as shown on the bar graph. The engine coolant exit temperature and inlet temperature were approximately 212 °F and 200 °F respectively, as displayed on the bar chart in the lower right of the photograph, and digital readouts near the center. It was noted that the cooling efficiency of the radiator and the system made reaching the 212 °F coolant temperature a challenge, and that in fact the radiator cooling area had to be partially blocked from airflow for the test to reach the required temperature. Figure 147 shows the power package on the

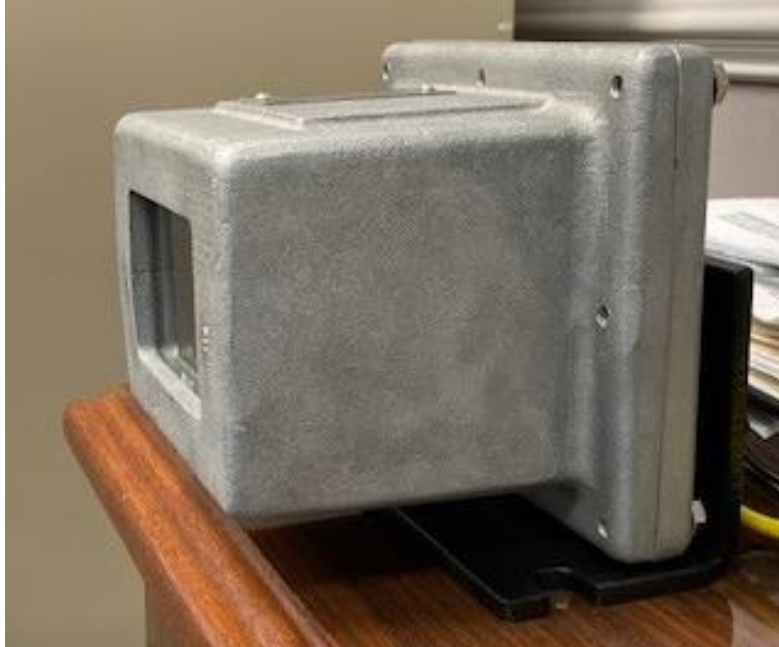
Figure 187 - Prototype Camera Enclosure

While working to gather additional information on the camera and emitter devices, it was learned that they were no longer available, thus designers began looking for suitable alternative devices. Reputable manufacturers with approved camera systems were contacted to gather information on available technology for use on this machine. It was also discovered that there were thermal imaging cameras approved for mining outside of the USA, however, in discussions with MSHA, it was learned that these cameras used a germanium lens, which was brittle and could not withstand impact testing, and therefore no thermal imaging camera had been approved by MSHA. During January 2022, a camera vendor responded with a proposal for a new camera system. This camera was very similar to the original camera used on the prototype machine, with some added features. It could operate in color or black and white, and was not a thermal imaging camera, so an IR emitter would be used to improve visibility in low light, much like the original prototype setup. This camera did not, however, fit inside of the dual headlight enclosure previously used, and the vendor offered a slightly larger enclosure to house the camera. The IR emitter would need to be located in a separate enclosure, and the vendor was planning to do some testing of the setup to determine its low light capability. Figure 187 shows a picture of the proposed camera housing on a desk. The

housing was approximately 6 inches tall and 7 inches wide, which was much taller than the original dual headlight housing. This size increase made the system somewhat undesirable.

As the cameras used in the initial prototype were no longer available, and an approved replacement system required more space and was also prohibitively expensive, it was recommended that the on-board camera system be tabled until a later time. It was believed that a simplified machine electrical system would give the best chance of producing a functional, approved machine design. Removing the video component also reduced power consumption, and could be added as an option later after the basic machine approval was done.

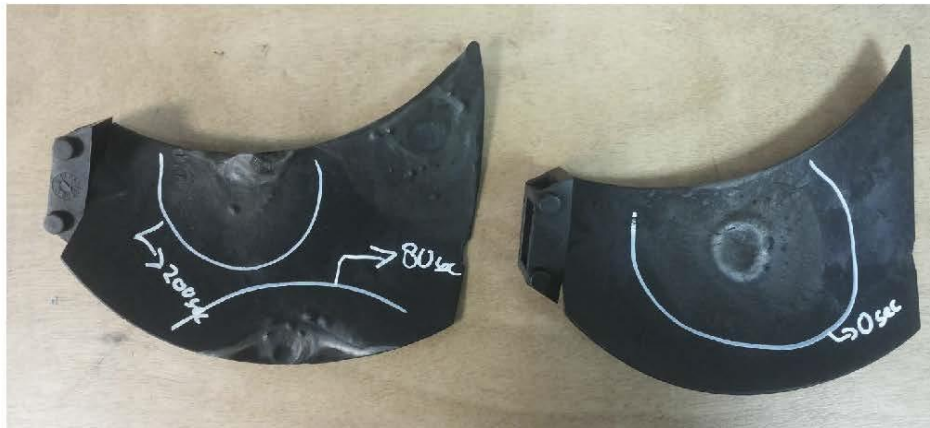
Flammability test according to chapter 4.23 of EN14986 has been carried out by the supplier of PAGAS on moulded blades. The blades selected (1H, 4Z, 6W) range from the smallest and thinnest one moulded in PAGAS (1H) to a "medium large blade", i.e. Multi-Wing International moulds blades in PAGAS larger than the largest one tested but it was deemed that if these satisfy the requirements, so will even larger blades. The flame has been applied on various locations and the time to extinction was recorded. In all tests, the flames – if there were flames – extinguished within 200 seconds, leaving the blade only partly damaged.

Figure 3: 1H blade with times to extinction

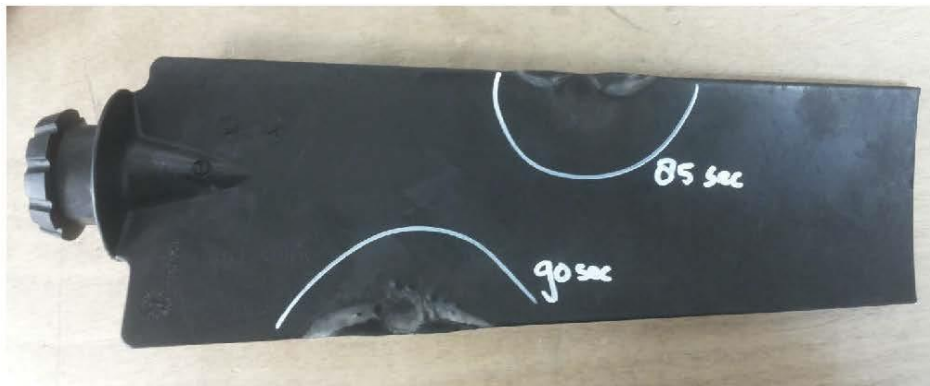
Figure 4: 4Z blade with times to extinction

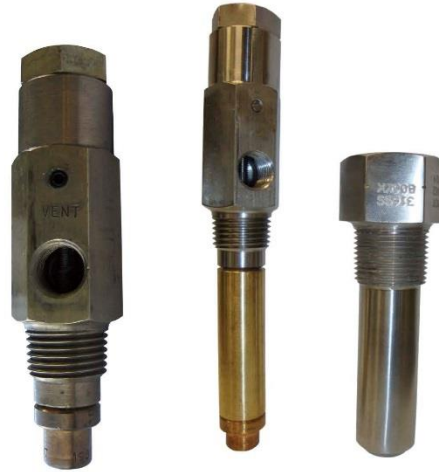
Type 2230 Valve
(Brass)

- Compact, rugged design
- Factory set, field adjustable
- Compatible in hydraulic or gas systems
- Easy maintenance; few moving parts
- Compatible with complete AMOT shutdown systems
- No electricity required; failsafe
- No wires to break or corrode
- Viton seals standard
- Brass (2230) or stainless steel (4430) construction
- Temperature setting available from 30°C to 118°C (95°F to 245°F) standard or 129°C (265°F) high temperature
- Maximum pressure at the IN Port is 8.6 bar (125 psi)
- Maximum internal pressure on the temperature sensing element is 551 bar (800 psi)

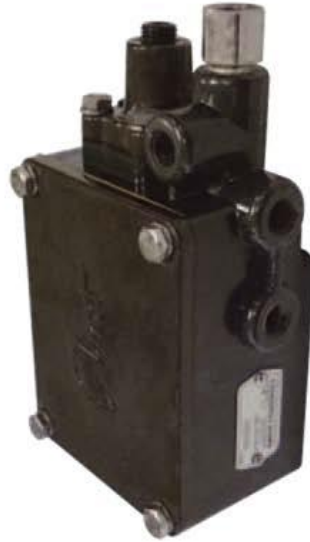
**Model 1672
Pressure Sensing Valve**

- Easy field adjustment
- Compatible in hydraulic or gas systems
- Factory set
- Galfproofed finish and Viton seals
- Pneumatic lockout available
- Diaphragm sensor for pressure ranges from 0.3 - 21.7 bar (5 - 315 psi)
- Piston sensor for pressure ranges from 1 - 248 bar (15 - 3600 psi)
- Works in conjunction with other AMOT devices
