## A coal rib monitoring study in a room-and-pillar retreat mine

**Gamal Rashed\***, **Khaled Mohamed,**  
**Robert Kimutis**

GCB/PMRD//NIOSH/CDC, Pittsburgh, PA 15236, USA

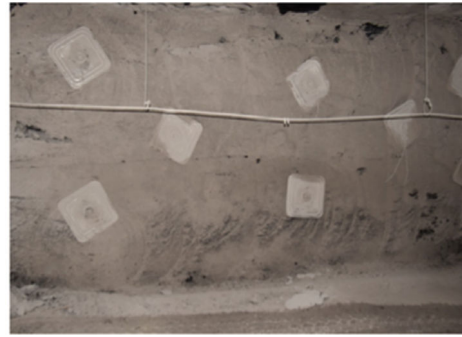
**Fig. 2.** Typical rib support pattern at site-1 for a mining height of more than 2.1 m.

During the development stage, the rib was supported with 1.5 m long #6 fully grouted bolts grade 60 with 0.5 m × 0.5 m pizza pans and a dome plate of size 20.3 cm × 20.3 cm. The rib support configuration is in the form of an H-shape when the mining height is more than 2.1 m as shown in Fig. 2, but it changes to the form of a V-shape when the mining height is less than 2.1 m. The roof was supported with four 1.8 m long #6 grade 60 fully grouted bolts. The bolt spacing is slightly longer near the center of the entry or the cross-cut than near the rib. Two cable bolts of 4.2 m length are used as a supplemental roof support at every two rows of roof supports. The intersection was supported by six cable bolts.

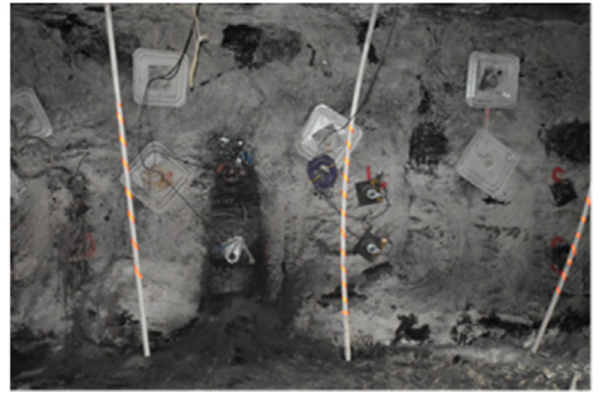
**Fig. 5.** Instrumentation type and location for the cross-cut side of instrumented pillar at site-1.

Figs. 4 and 5 show the layout of instruments at the entry and cross-cut sides of the instrumented pillar. The MPBX near the BPC at 6.0 m was located near the mid-pillar length, and the MPBX in Fig. 5 was located near the mid-pillar width.

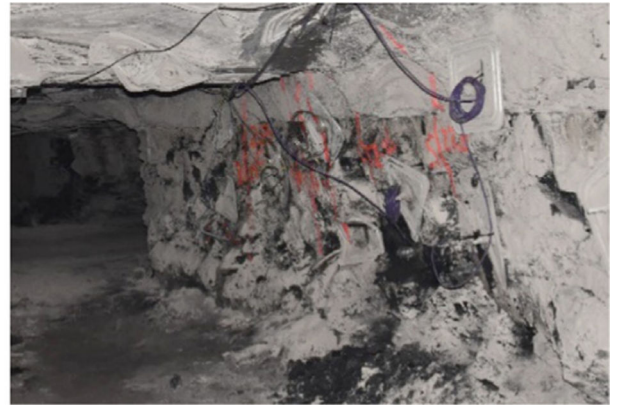
**Fig. 7.** Instrumentation type and location for the cross-cut side of the instrumented pillar at site-2.

Figs. 6 and 7 show the arrangement of the instruments at the entry and cross-cut sides, respectively, of the instrumented pillar at site-2. In Fig. 6, the closest MPBX to the BPC is located at the pillar mid-length.

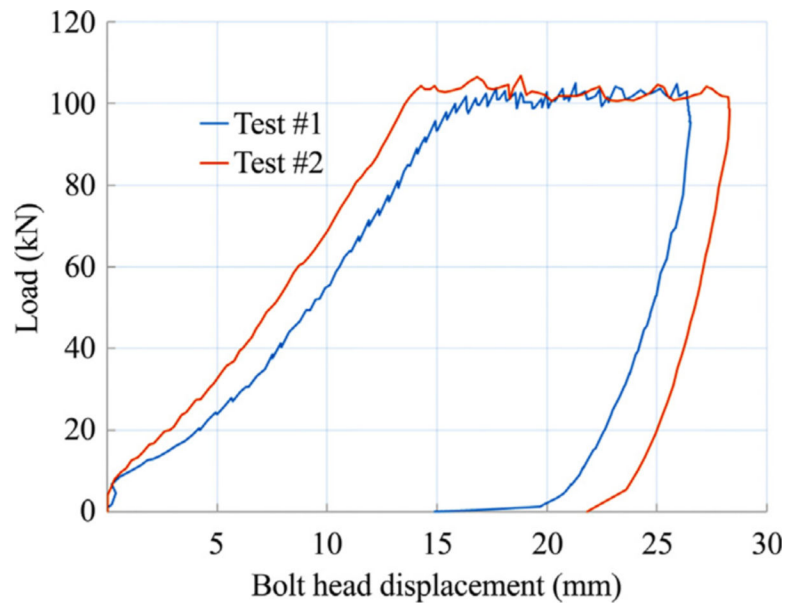
**Fig. 9.**  
Typical load displacement curve for the pull-out test.

A total of nine pull-out tests, six at site-1 and three at site-2, were conducted to determine the anchorage capacity for short-encapsulated #6 grade 60 rib bolts. The bolt length was 1.5 m and the grouted length was about 50.8 cm for a cartridge length of 35.5 cm. Six bolts were tested in the coal seam, and three bolts were tested in the gray shale parting of the rib. Fig. 9 shows the typical load displacement curve obtained from the pull-out tests.

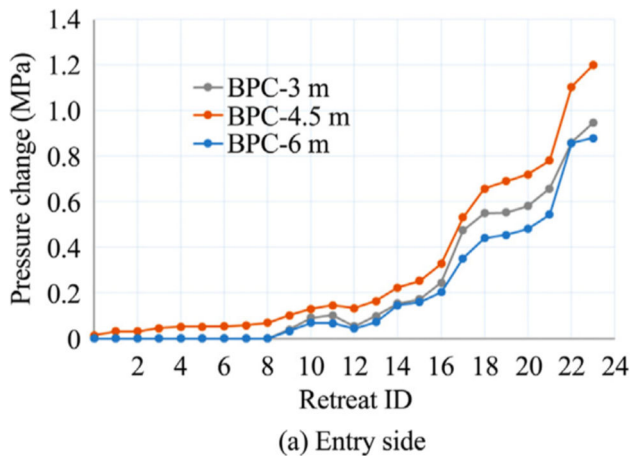
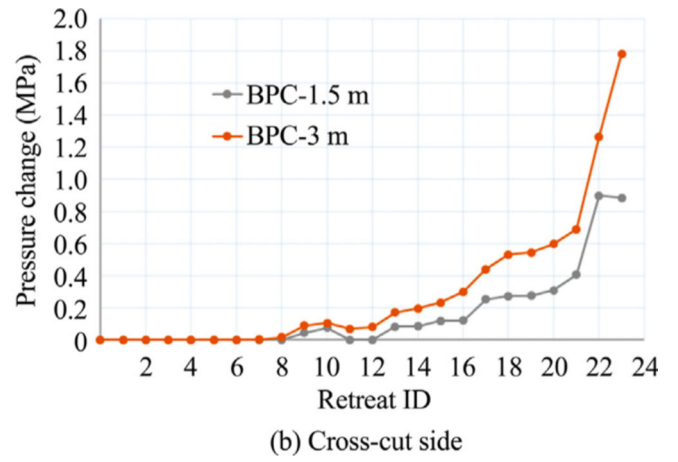
**Fig. 10.** Pressure change in the BPCs for the entry and cross-cut sides at site-1.

Fig. 10 shows the pressure change in borehole pressure cells (BPCs) at the entry and cross-cut sides of the instrumented pillar of site-1 with the progress of pillar retreat. The  $x$ -axis of Fig. 10 (“retreat ID”) reflects the cutting sequence shown previously in Fig. 8. The BPCs are located at 3, 4.5, and 6 m deep for the entry side, while they are located at 1.5, 3.0, and 4.5 m deep in the cross-cut side of the instrumented pillar, although the BPC located at 4.5 m in the cross-cut side was corrupted. The recorded pressure change represents the induced abutment load due to only pillar retreat mining. As shown in Fig. 10, when the pillar line was about two breaks in by the instrumented pillar (retreat ID #9), the pressure change in the BPCs was less than 0.13 MPa, while at retreat ID #16, a significant stress change started to build up in the pillar. When the pillar adjacent to the instrument pillar was mined out (retreat ID #22), the maximum pressure change in the BPCs at the entry and cross-cut sides of the instrumented pillar was 1.10 and 1.24 MPa, respectively. The pressure changes in the BPCs increased to 1.27 and 1.79 MPa for entry and cross-cut sides, while the instrumented pillar was being mined (retreat ID #23). The maximum pressure change at retreat ID #22 was about 25% of the pre-mining stress.

Good caving conditions and the large stumps left near the instrumented pillar at site-1 are among the main factors most likely limited the load transfer to the instrumented pillar, which was confirmed by visual observations of minor rib sloughing and no noticeable roof deformation. Similar rib conditions were observed near the pillar lines at other locations in the same panel.

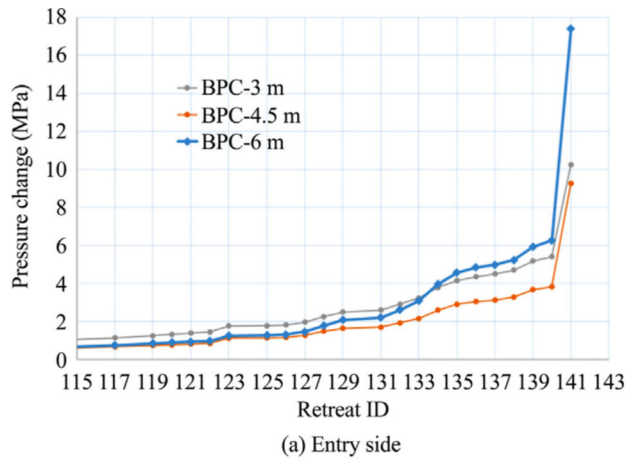
**Fig. 11.** Pressure changes in the BPCs for the entry and cross-cut sides at site-2.

The pressure changes in the BPCs at 1.5, 3.0, 4.5, 5.1, and 6.0 m deep in the instrumented pillar due to pillar retreat mining at site-2 are shown in Fig. 11. The BPCs at the entry side of the instrumented pillar experienced more load than the cross-cut side because they are located closer to the gob. A significant pressure change started to build up in the BPCs when the pillar line was at retreat ID #131 (the pillar line was one-line in by the instrumented pillar). When the pillar adjacent to the instrumented pillar was mined out (retreat ID # 140), the maximum pressure change was about 6.20 and 5.86 MPa at the entry and cross-cut sides of the instrumented pillar, which is about 86% of the pre-mining stress. When the

instrumented pillar was being mined (retreat ID # 141), the maximum pressure change in the BPCs was 17.24 and 12.41 MPa for the entry and cross-cut sides of the instrumented pillar, respectively, which are about 1.7 and 2.4-times pre-mining stress, respectively.

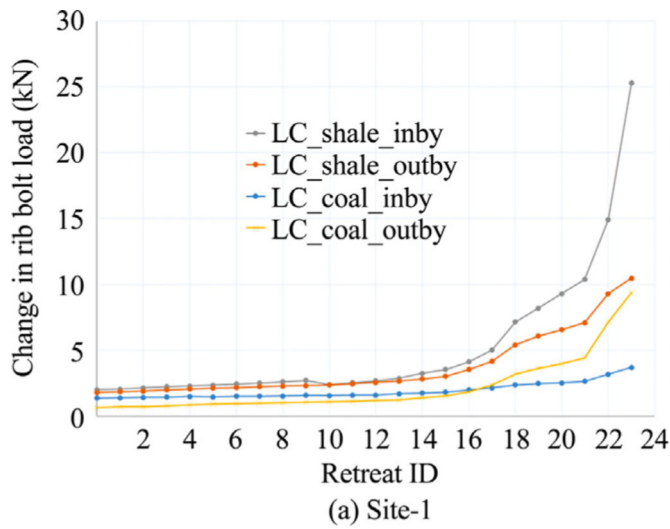
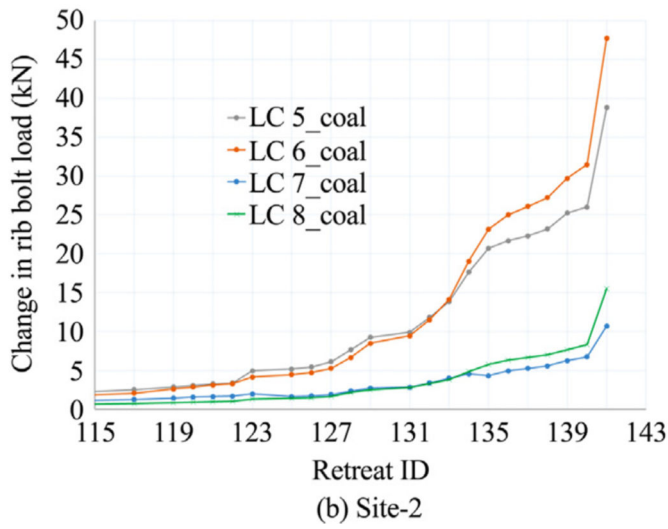
**Fig. 12.** Change in rib-bolt load for the entry side at site-1 and site-2.

The variation of the rib-bolt load with pillar retreat mining for the entry side of the instrumented pillar at site-1 and site-2 is shown in Fig. 12. For the site-1 entry side of the instrumented pillar, two rib bolts with load cells were installed in the coal seam and two bolts were installed in the shale band of the rib. For the site-2 entry side of the instrumented pillar, four rib bolts with load cells were installed in the coal seam. As shown in Fig. 12a, the rib bolts installed in the shale band were loaded more than those installed in the coal seam. For site-1, when the pillar adjacent to the instrumented pillar mined out, the maximum measured rib-bolt load was about 15.57 kN, which is about 13% of the yield capacity of the steel rebar bolt. It jumped to about 24.92 kN while the instrumented pillar was being mined. For site-2, when the pillar adjacent to the instrumented pillar was mined, the maximum recorded rib-bolt load was about 31.15 kN, which is about 25% of the yield capacity of the steel rebar. It increased to 47.61 kN while the instrumented pillar was being mined. “LC 5\_coal” and “LC 6\_-coal” experienced more load than “LC 7\_coal” and “LC 8\_coal” because of their closer proximity to the gob. For the cross-cut side of the instrumented pillar, the maximum rib-bolt load was about 1.33 kN at site-1 and 6.67 kN at site-2. The anisotropy of the recorded rib-bolt load at the entry and cross-cut sides for both sites 1 and 2 could be attributed to the orientation of the maximum horizontal stresses.

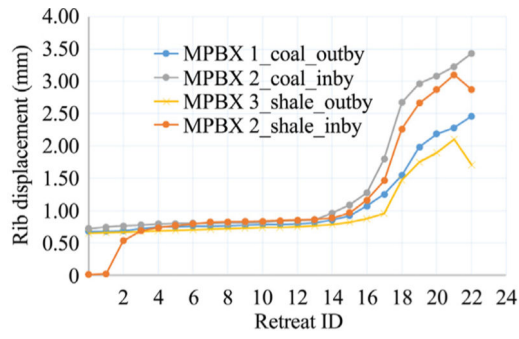
(a) Rib-edge displacement

(b) MPBX 1\_coal\_outby

**Fig. 13.** Measured rib displacement at rib edge and multi-anchor points inside the pillar for the entry side at site-1.

The two main factors contributing to an increased risk of rib falls during retreat mining are thicker coal seams and higher stress levels [12,13]. The Multipoint Rib Extensometers (MPBX) were used to monitor deformation of the coal seam and the shale parting of the rib. MPBX # 2 and # 4 were closer to the inby direction during the pillar recovery. The deepest MPBX anchor, located at 9.1 m deep in the pillar, reflects the horizontal displacement of the rib edge. Fig. 13 shows the rib deformation and movement of the anchors with the progress of pillar retreat mining for the entry side of the instrumented pillar at site-1. The maximum deformation occurred at the rib edge. As shown in Fig. 12b, the horizontal displacement was almost zero at 1.2 m deep inside the pillar. A significant change in the rib displacement gradient occurred at retreat ID #16. The maximum rib displacement was 3.5 mm and occurred when the pillar adjacent to the instrumented pillar was mined out. Such small rib displacement was not expected to cause a significant fracture in the rib, which was confirmed by field observations. The measured rib displacement for the cross-cut side of the instrumented pillar was almost zero at all anchor points.

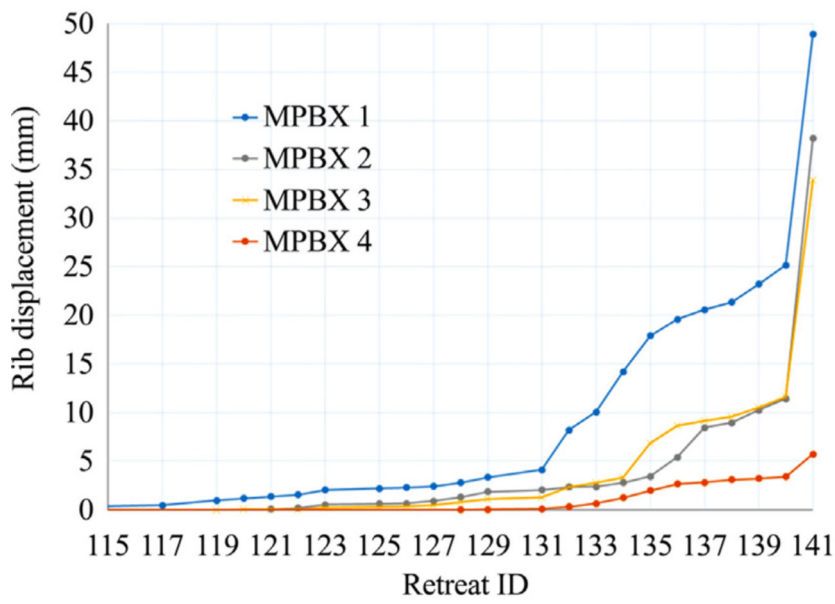
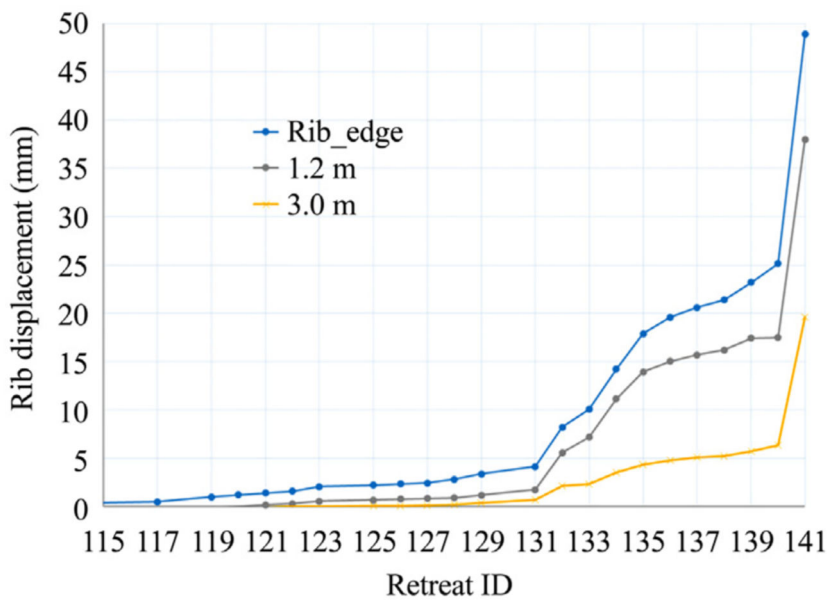
(a) Rib-edge displacement

(b) MPRX 1

**Fig. 14.** Measured rib deformation at rib edge and multi-anchor points inside the pillar for the entry side at site-2.

Fig. 14 shows the measured rib displacement from the MPBX for the entry side of the instrumented pillar at site-2. The anchor locations of the MPBX are shown in Table 2. When the pillar adjacent to the instrumented pillar was mined out, the maximum horizontal rib-edge displacement was about 25.4 mm, and the horizontal displacement at 1.2 m deep in

the pillar was about 15.2 mm. A big jump in the horizontal rib displacement of almost 25.4 mm occurred at MPBX #1, #2, and #3 when the instrumented pillar was being mined out. The MPBX #1 experienced more deformation than MPBX #4, most likely because it was closer to the inby side of the instrumented pillar.

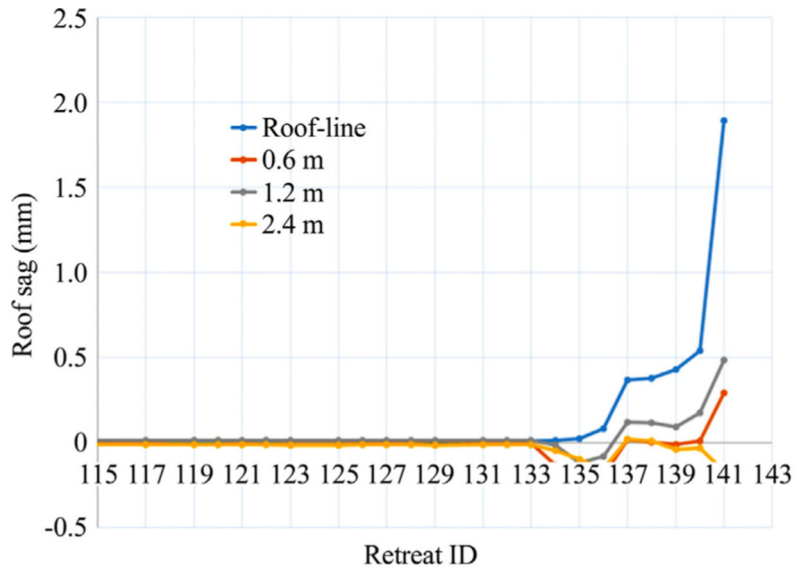
**Fig. 15.** Measured roof displacement at site-2 and schematic for anchor locations.

For site-2, the maximum roof sag was about 0.5 mm and occurred when the pillar adjacent to the instrumented pillar was mined out. The roof sag increased to 1.7 mm when the instrumented pillar was being mined out (Fig. 15). An explanation for the minimal measured roof displacement at site-2 could be that the deepest anchor may be in moving ground. The roof line displacement would be accurate only if the deepest anchor was installed in fixed/stable ground.
